West Bradley House

The Little Stone Barn existing elevations

315-SB-00-021-P1 1:50@A1, 1:100@A3 Date of First Issue March 2024

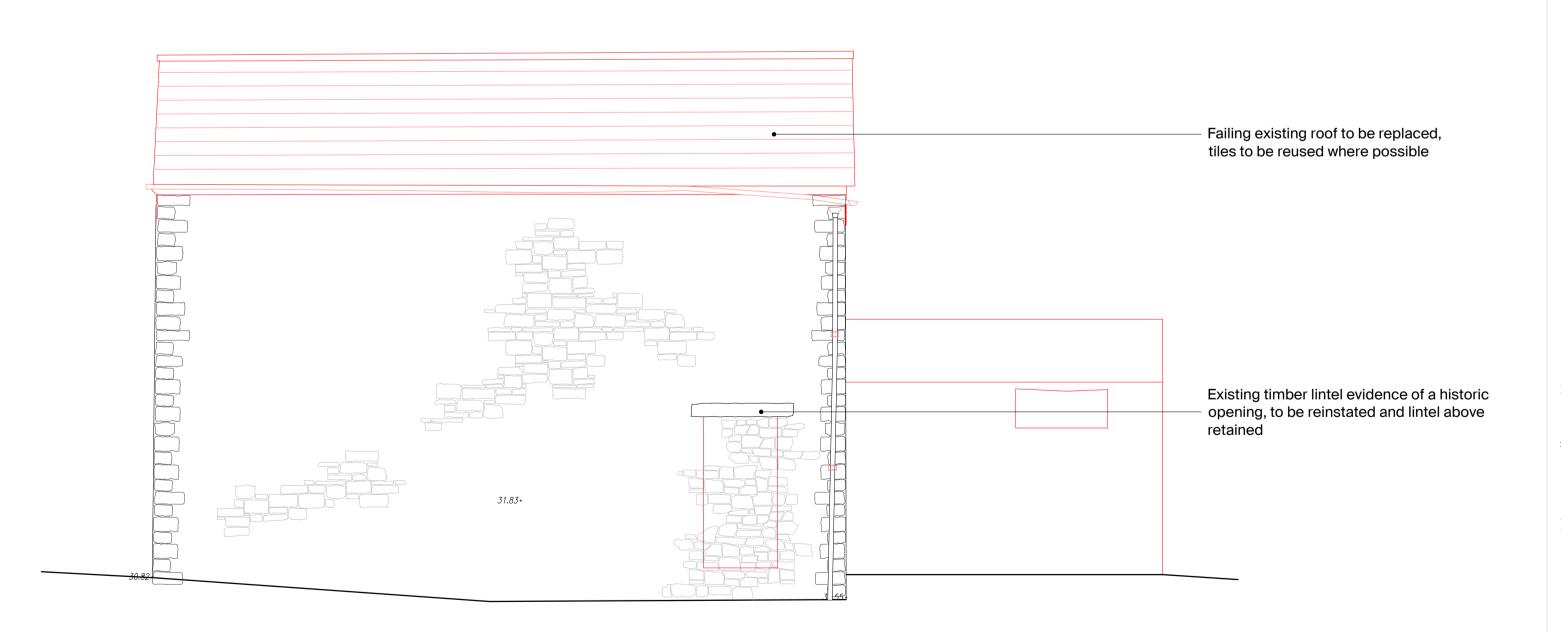
Finishes to be set aside for reuse where possible Modern and failing roof structure to be replaced Existing stone gable to be refurbished and repointed with lime mortar Considerable bulging has occurred in the central area of the elevation Coursed stone is neatly gauged although the stone is showing signs of deterioration across the entire wall.

Poor condition clay tile roof Small section of stone and brick to be carefully removed Moderate bulging occurring in the upper Stone quouins in good condition to be third of the quoins repointed with lime mortar Flemish bond red brickwork Patchwork repair of similar red brickwork runs out of gauge to the existing brickwork, approximately 1800(H)x1200mm Area of heavy spalling has occurred, approximately 1800(H)x1000mm Coursed stone quouins with brickwork internally Rotten timber shutter to be replaced O2 Existing/Demolition North Elevation 1:50@A1; 1:100@A3

Existing stone gable to be refurbished and repointed with lime mortar Modern blockwork lean-to removed
