# Croome Cottage, Fishery Road, Maidenhead SL6 1UP:

## Report to Address Condition 5 of Planning Permission 23/03176

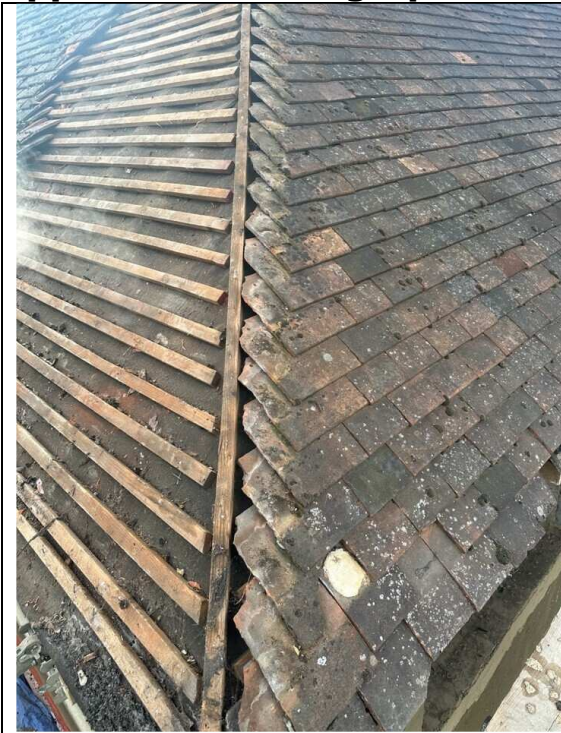
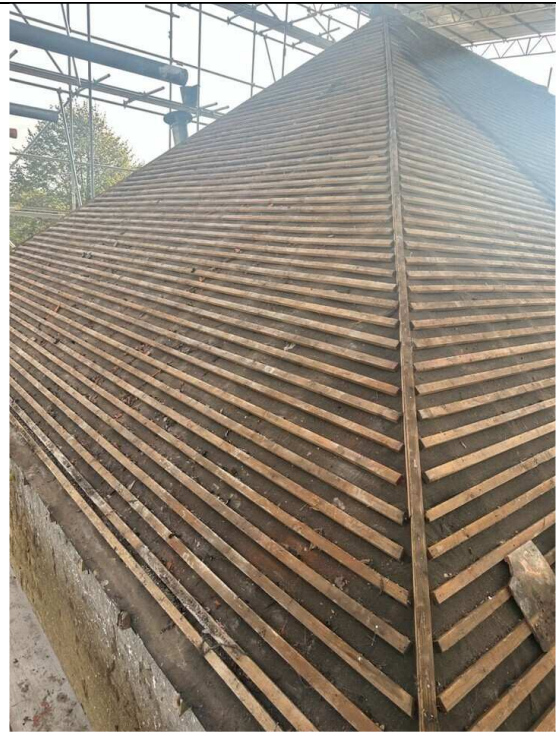
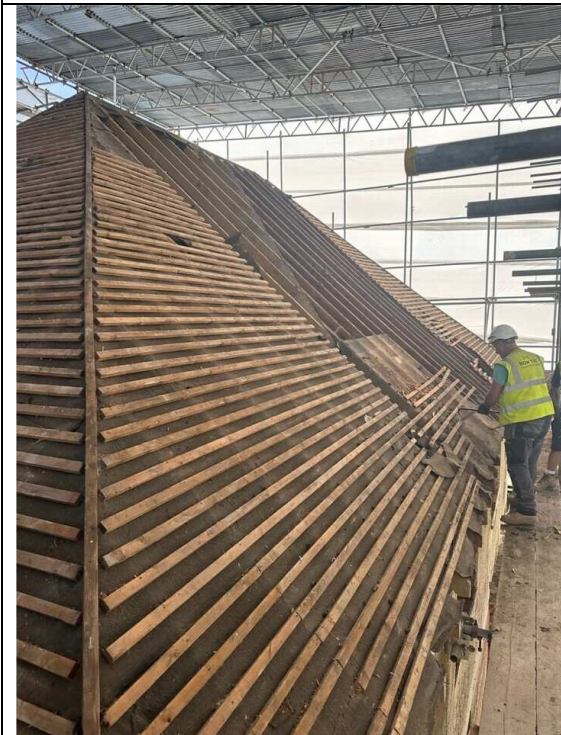
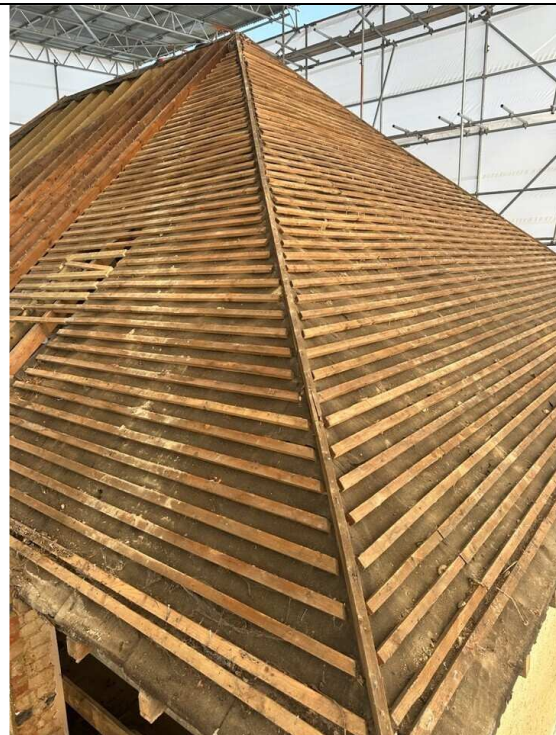
## Appendix 2: Photographs

4. The roof works were undertaken in October 2023. The works were carried out in calm weather and with the whole of the property under cover (see photographs at Appendix 2). The site manager, Michael Wysokinski, has confirmed that there was an initial induction/toolbox talk for construction staff working on the roof, with daily reminders provided at the start of each working day.
