Arboricultural Impact Assessment:

Miner's Welfare Ground & Charlie Wayman Fields
Ferryhill
County Durham

Report ref: FSL_MWG&CWF_AIA1.1

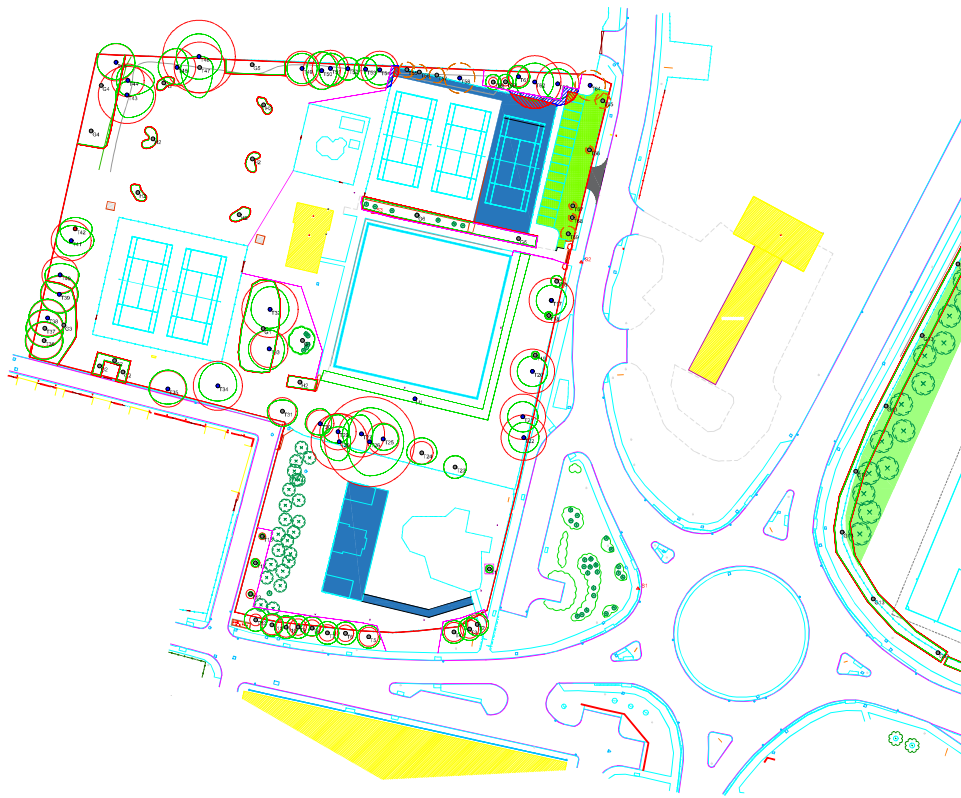
Appendix 1a
Tree Protection Plan - MWG

4.2.1 The proposals will require the removal of T55, T56, T57, T58, T64, T65, T66, T67, T68 and T69. This comprises of low and moderate value trees. All of these trees are situated on the Miner's Welfare Ground site.

4.4.3 Proposed new car parking will breach the RPA of T63, a moderate value tree, on Miner's Welfare Ground, and G7 on the Charlie Wayman Fields. Standard construction methods could result in root damage to this tree.

4.4.4 Installation of a third tennis court and extension to run off areas of the existing courts will breach the RPA of T54 and T62 on Miner's Welfare Ground. Standard construction methods could result in root damage to these trees.

5.2.1 To prevent the potential for direct damage during site works, tree protective fencing should be erected, specified in figures 3 or 4 below, as shown on the tree protection plan. The fencing should remain in place for the entire project. Signs will be attached to the fencing to state that it is a protected area.

5.3.3 Construction of new car parking spaces and third tennis court/run off area within the RPA of T54, T62, T63 and G7 should be undertaken sensitively. The following methodology is recommended:

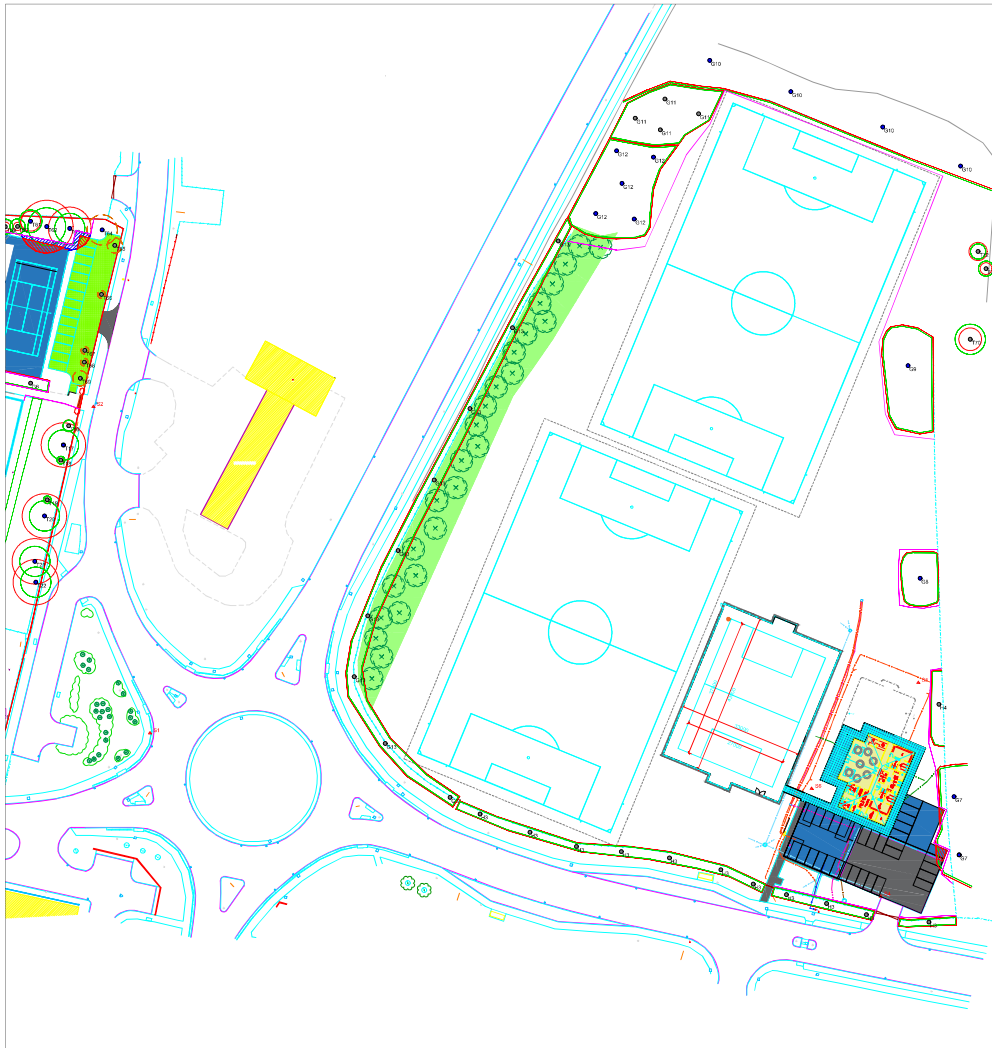
Appendix 1b
Tree Protection Plan - CWF

4.2.2 No tree removals are required to facilitate the proposals on Charlie Wayman Fields.

5.4.2 Pruning of G7 is also likely to be required to provide suitable clearance over the car parking area on Charlie Wayman Fields.
