Design and Access Statement

Removal of certain timber subframes; the replacement of rotten timber subframes;
removal of all timber and steel window frames; and replacement by steel heritage double glazed windows.

Green Cottage, Great Rissington, Glos. GL54 2LP

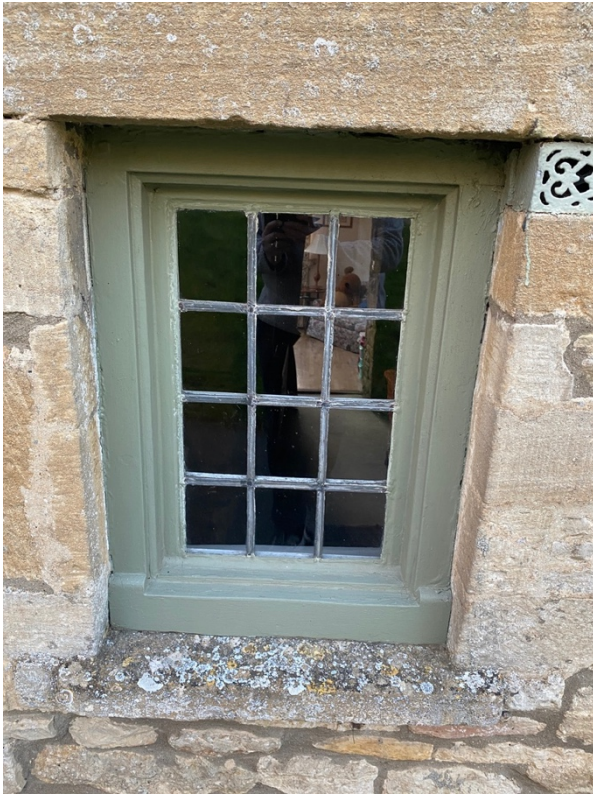
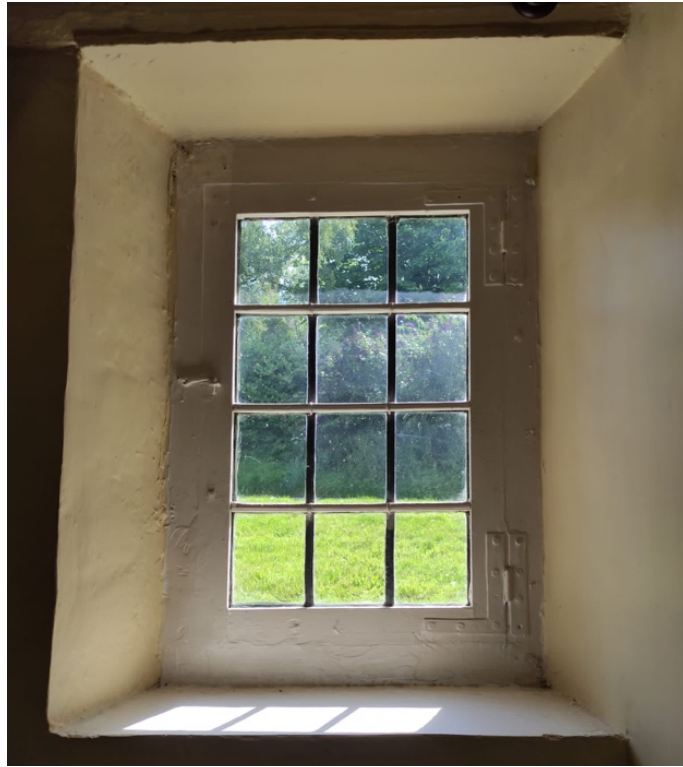
1. Sitting Room Window (Roadside)

Timber frame and subframe; lead is in poor condition, backed by horizontal timber bars; single glazed. Opening functionality is inoperable.

Remove timber frame and subframe. Insert a heritage double glazed steel unit with antique lead bars directly into stone casement.

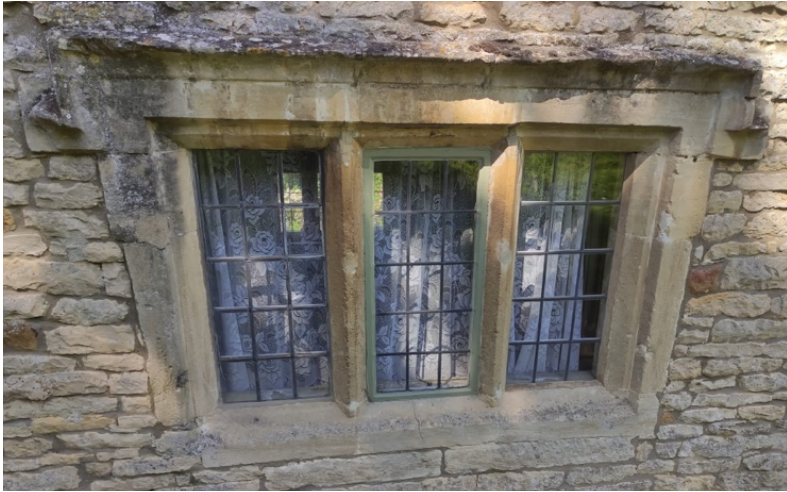
2. Dining Room Window (Roadside)

Stone Mullion with LH pane being single glazed glass only with integrated lead backed by horizontal timber bars; middle section with a timber frame and single glazed glass with stick on lead bars; RH pane being single glazed glass only with stick on lead backed by horizontal timber bars

Remove all glazing and the timber frame.
Insert heritage double glazed steel units with antique lead bars directly into stone mullion casements.

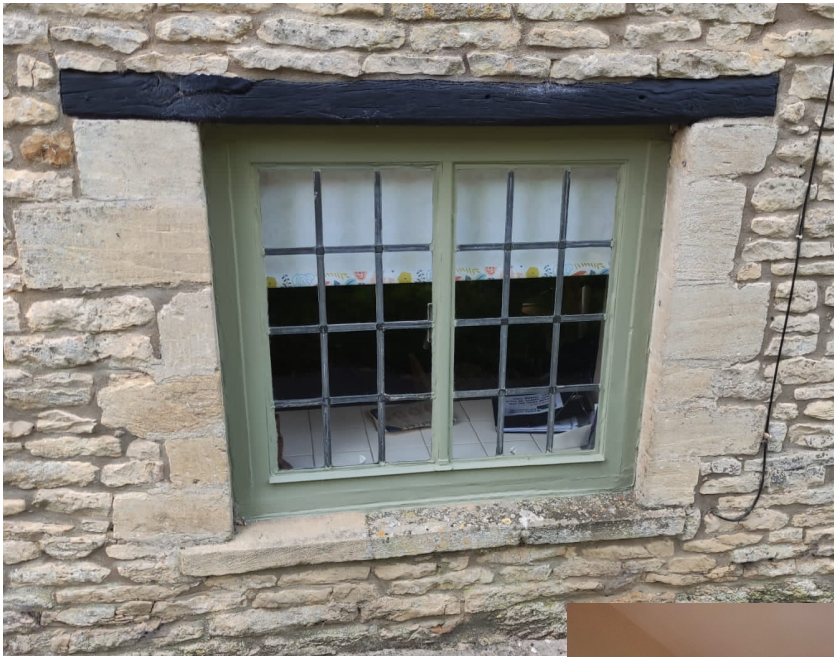
3. Kitchen Window (Roadside)

Timber subframe; steel casement;
integrated lead; single glazed

Opening functionality is inoperable.

Note: Glass is compromised
and broken

Remove the timber subframe and steel casement.

Insert a heritage double glazed steel unit with
antique lead bars directly into stone casement.

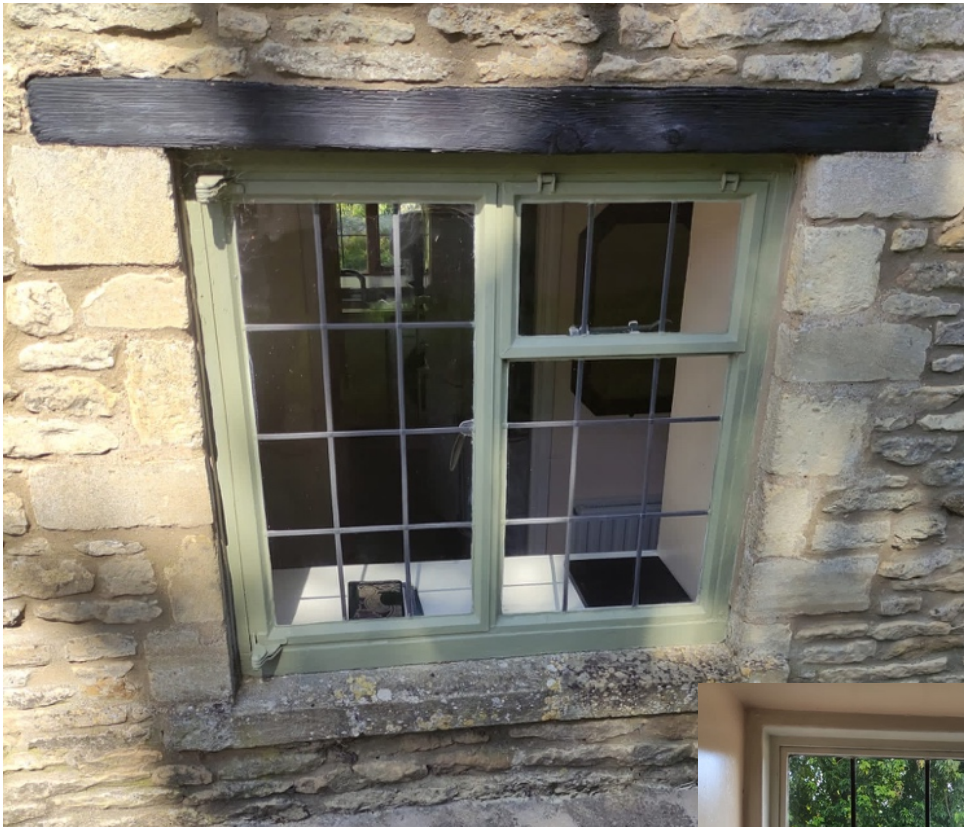
4. Entrance Hallway Window

Timber subframe; steel casement;
stick on lead; single glazed

Remove the timber subframe and steel casement.
Insert a heritage double glazed steel unit with
antique lead bars directly into stone casement.

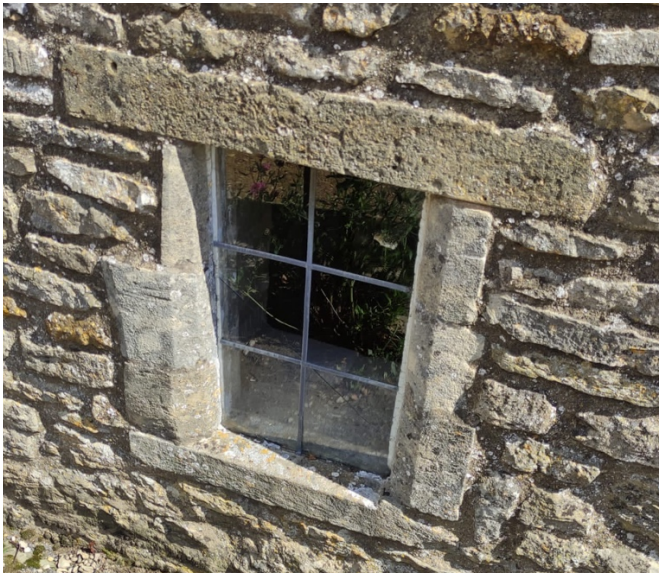
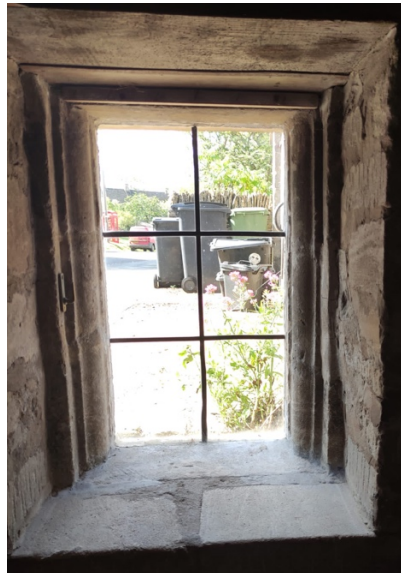
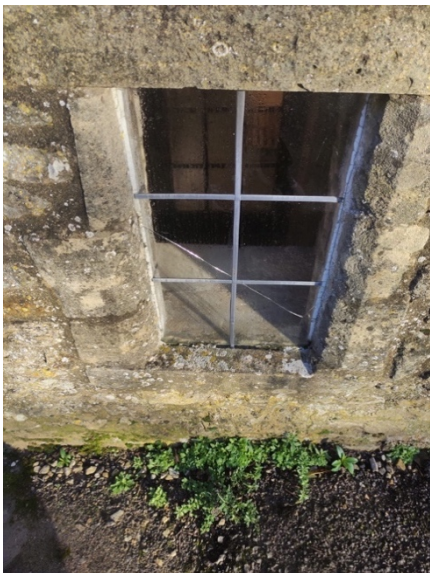
5. Entrance Porch Window

Single glazed glass directly inserted into the stone casement with stick on lead

Note: Glass is compromised and broken

Remove glass and lead.
Insert a heritage double glazed steel unit with antique lead bars directly into stone casement.

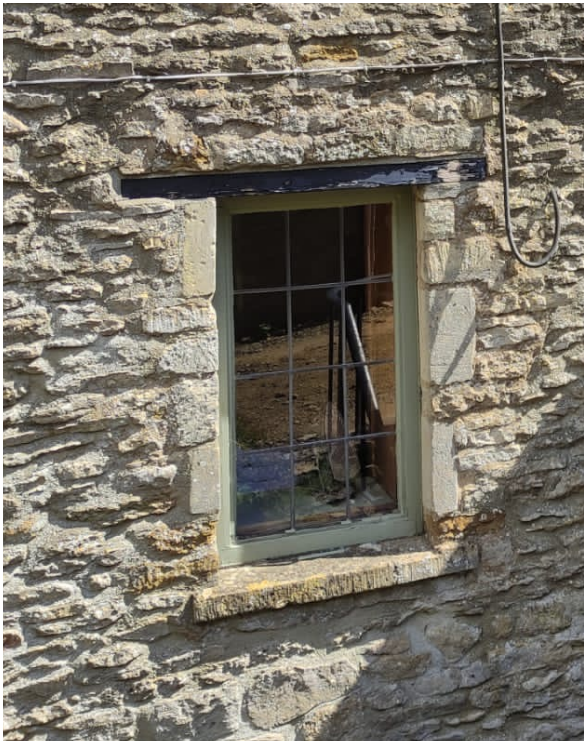
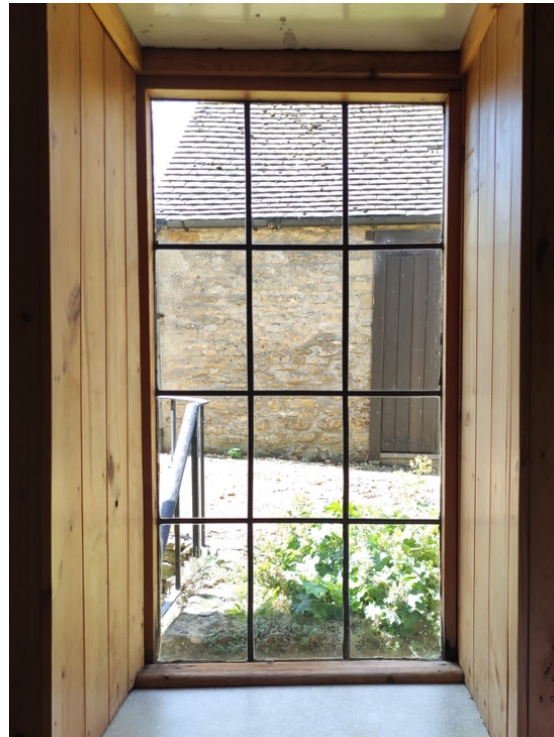
6. Utility Room Window (End)

Timber frame; single glazed with stick on lead

Remove timber frame, glass and lead.
Insert a heritage double glazed steel unit with
antique lead bars directly into stone casement.

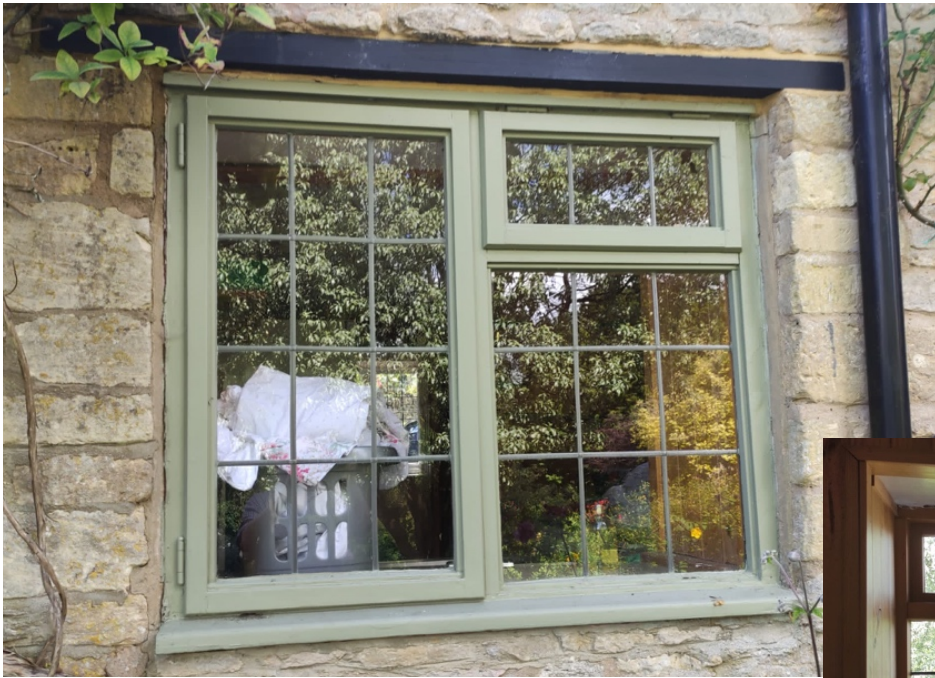
7. Utility Room Window (Garden)

Several of the timber windows are seriously rotten (see window numbers 17 and 21 in schedule B) and need replacing as they have already been repaired over the years and some of the other timber windows show signs of needing repair (see window numbers 7 and 8 in schedule A). In addition, the subframe of window 20 in schedule B needs replacing by virtue of rot.

Timber frame & sill; single glazed with stick on lead

Remove timber frame, glass and lead.
Insert a heritage double glazed steel unit with antique lead bars directly into stone casement.
The sill will be remade due to no stone sill in place.

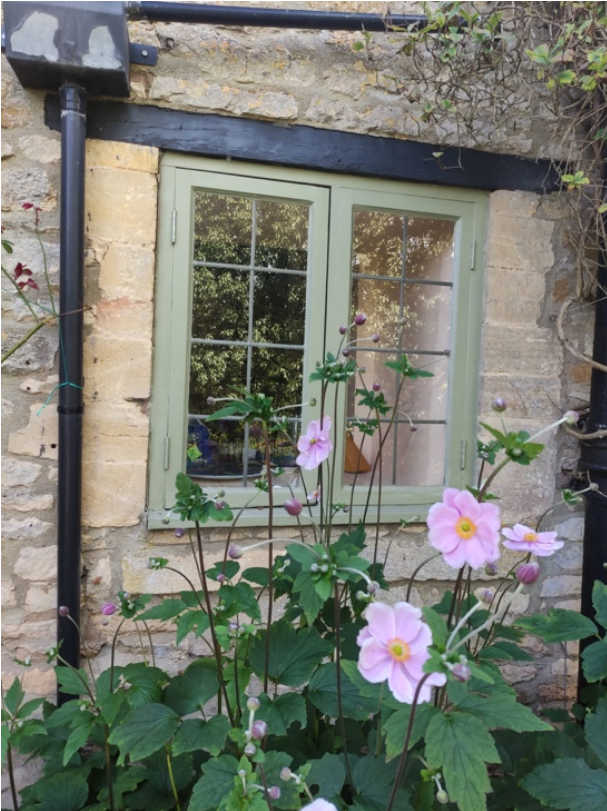
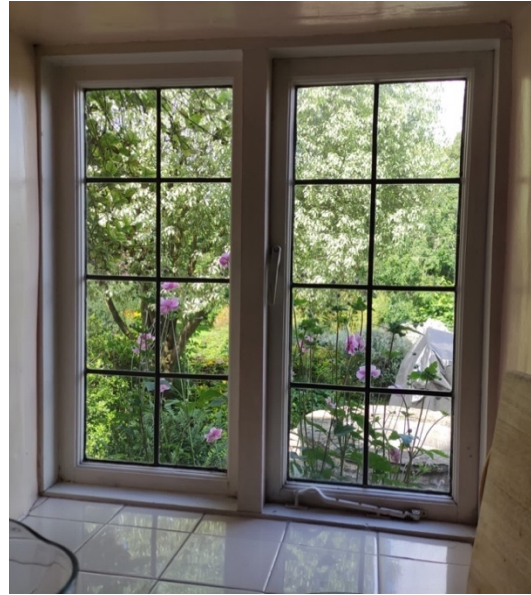
8. Kitchen Window (Garden)

Timber frame & sill; single glazed with stick on lead

Remove timber frame, glass and lead.
Insert a heritage double glazed steel unit with antique lead bars directly into stone casement.
The sill will be remade due to no stone sill in place.

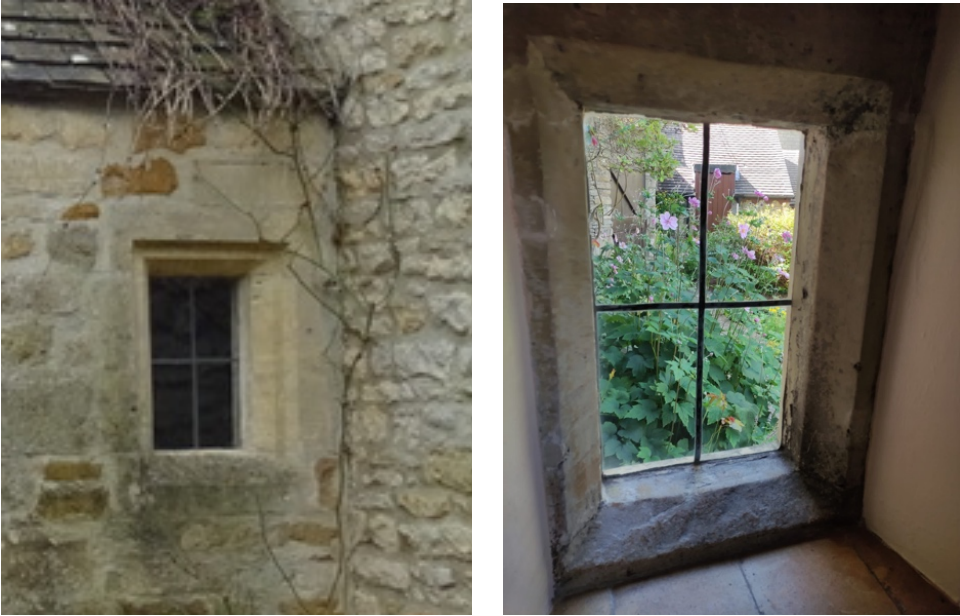
9. Backdoor Porch

Single glazed glass directly inserted into the stone casement with stick on lead on the exterior only

Remove glass and lead insert.
Insert a heritage double glazed steel unit with antique lead bars directly into stone casement.

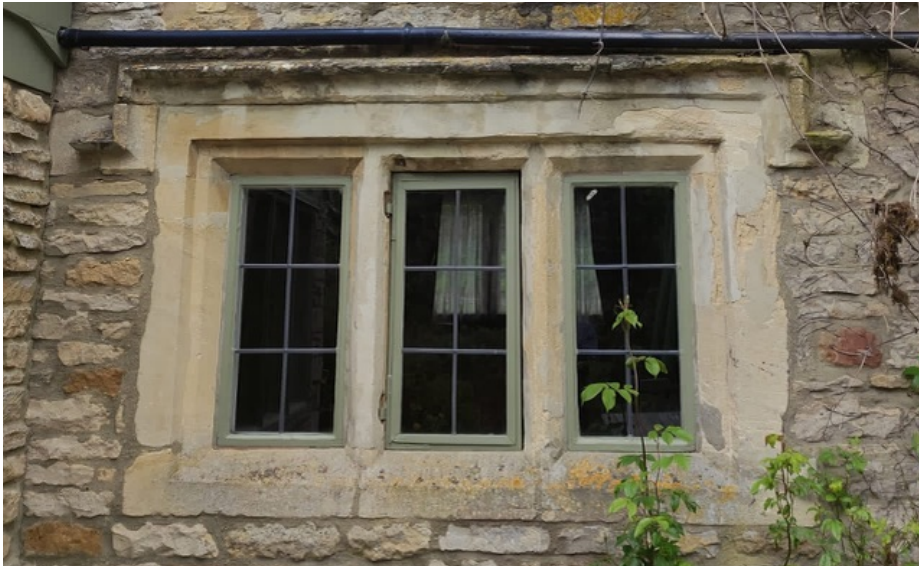
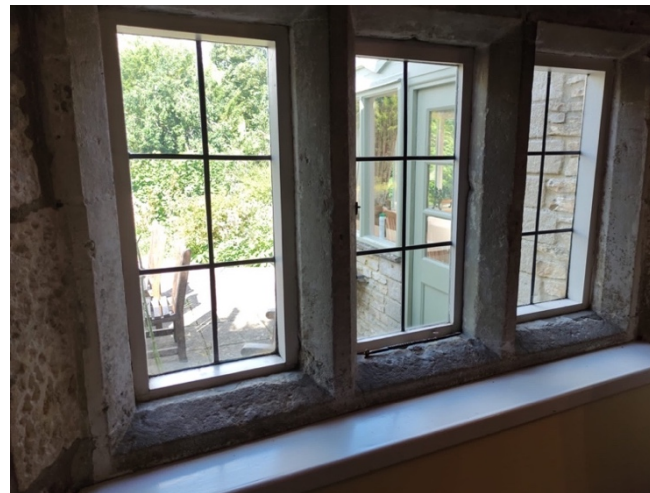
10. Dining Room Window (Garden)

All three sub windows have timber frames, single glazed with stick on lead

Note: the middle window is so badly fitted there are large gaps exacerbating heat loss

Remove timber frames, glass and lead.
Insert heritage double glazed steel units with antique lead bars directly into stone mullion casements.

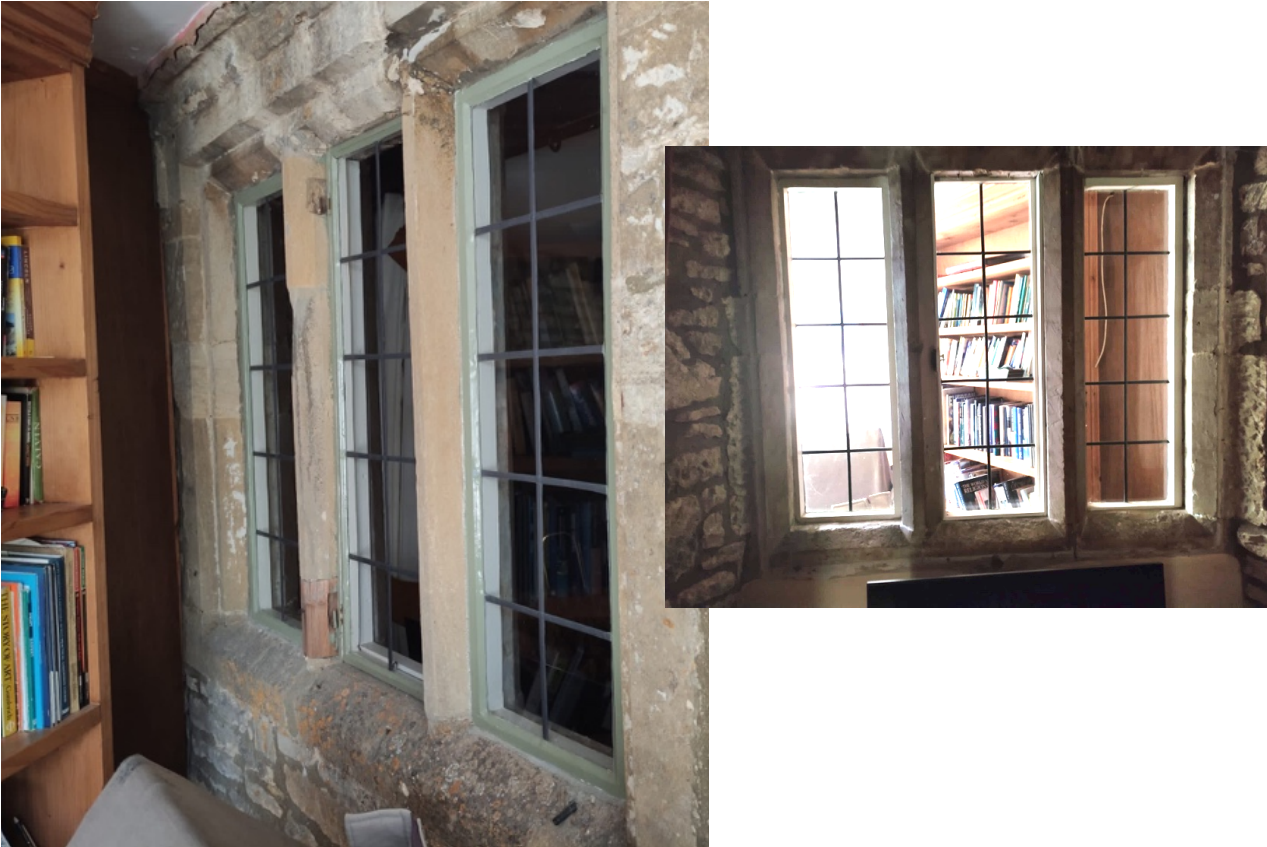
11. Sitting Room Window (Garden & Sunroom)

Timber frames, single glazed with stick on lead

Remove timber frames, glass and lead.
Insert heritage double glazed steel units with antique lead bars directly into stone mullion casements.

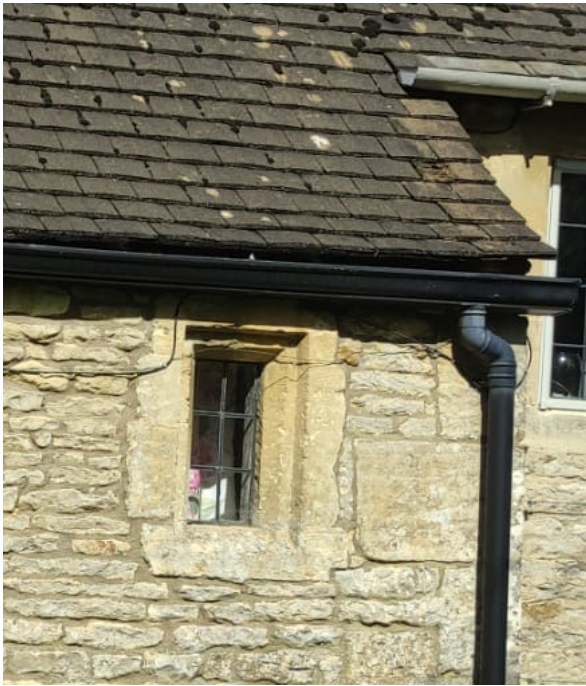
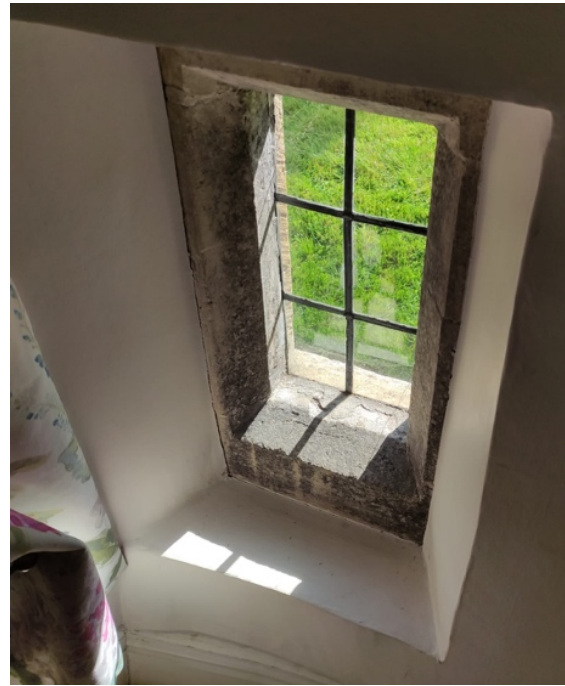
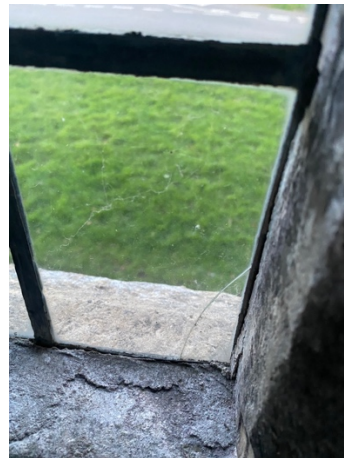
12. Small staircase window 1

Single glazed glass directly inserted into the stone casement with integrated lead

Note: Glass is compromised and broken

Remove glass and lead.
Insert a heritage double glazed steel unit with antique lead bars directly into stone casement.

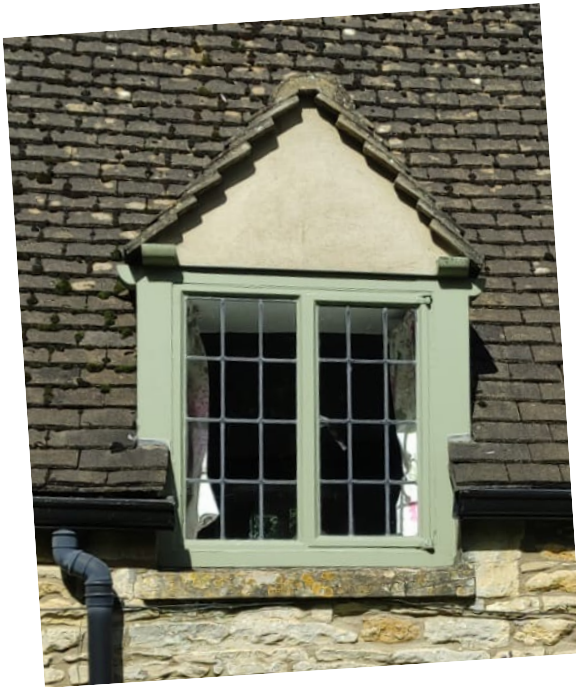
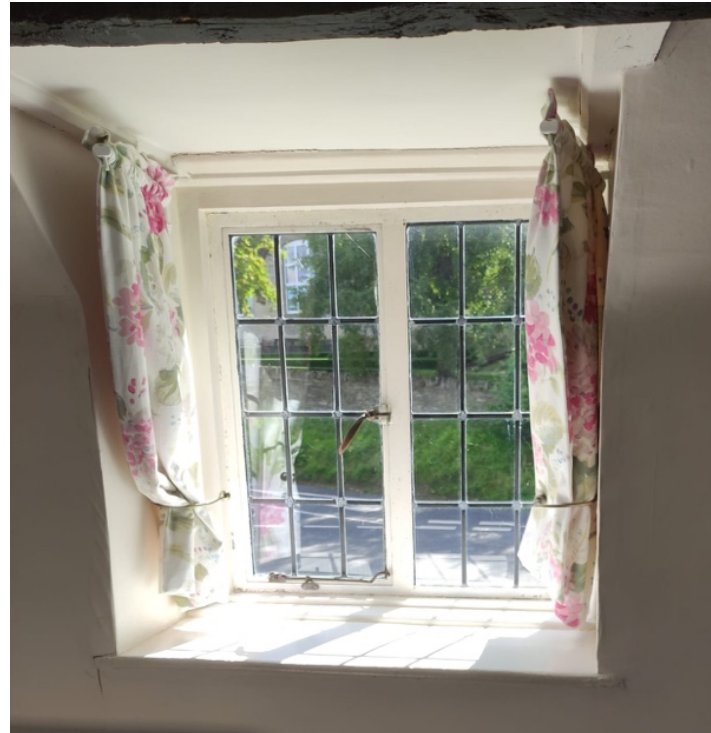
13. Bedroom 1 window (Roadside)

Timber subframe; Steel casement; single glazed with integrated lead

Keeping the structural timber subframe.
Insert a heritage double glazed steel unit with antique lead bars into timber subframe.

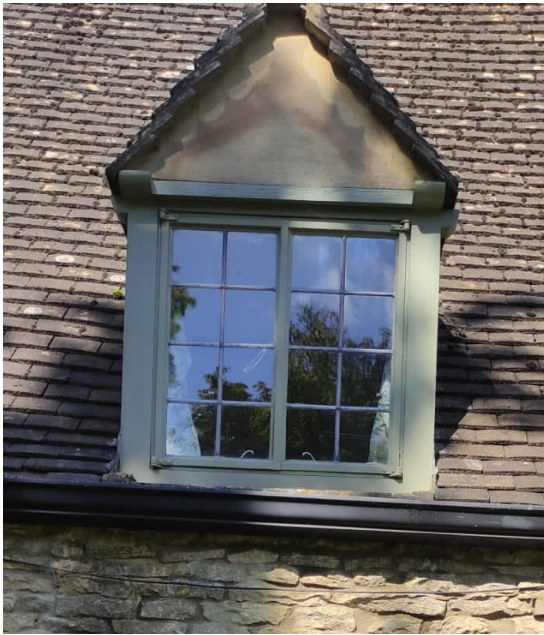
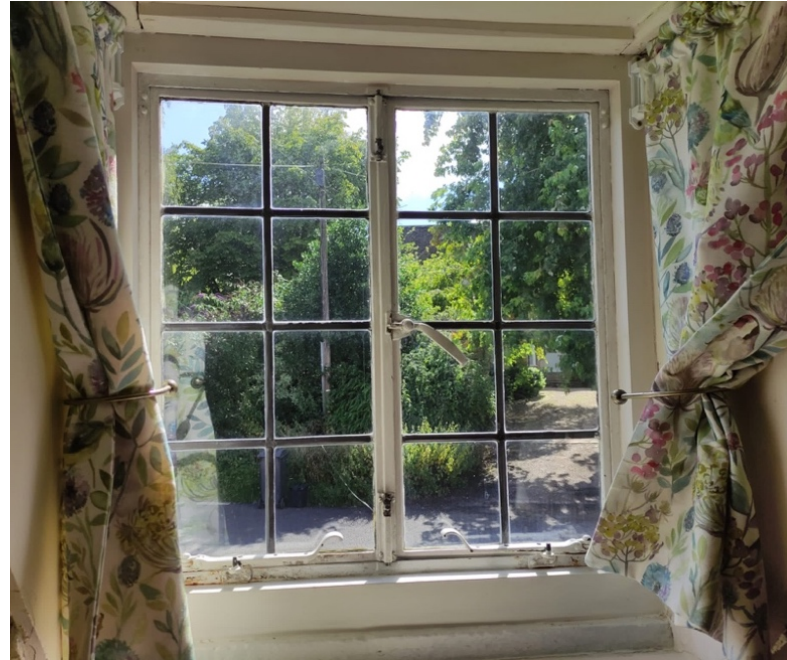
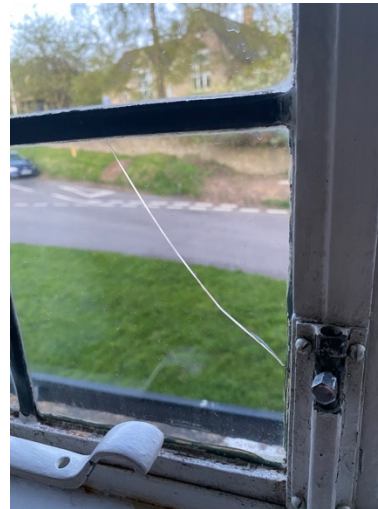
14. Corridor Window 1 (opp. airing cupboard ish!)

Timber subframe; Steel casement; single glazed with integrated lead

Note: Glass is compromised and broken

Keeping the structural timber subframe.
Insert a heritage double glazed steel unit with
antique lead bars into timber subframe.

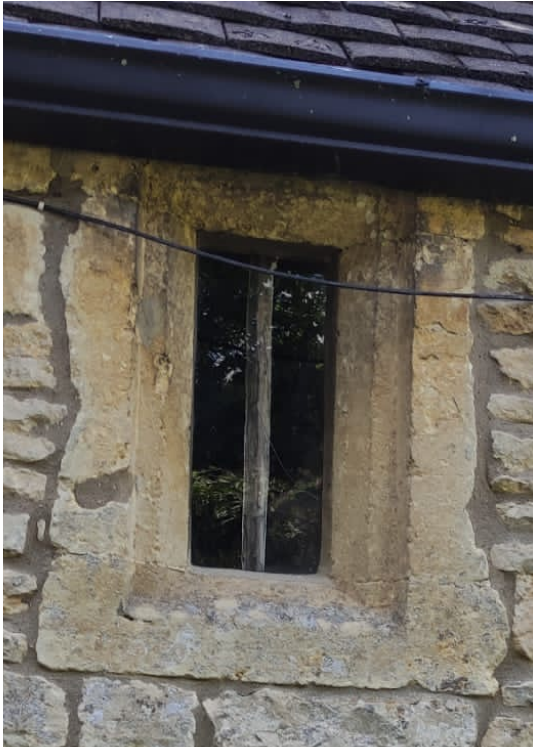
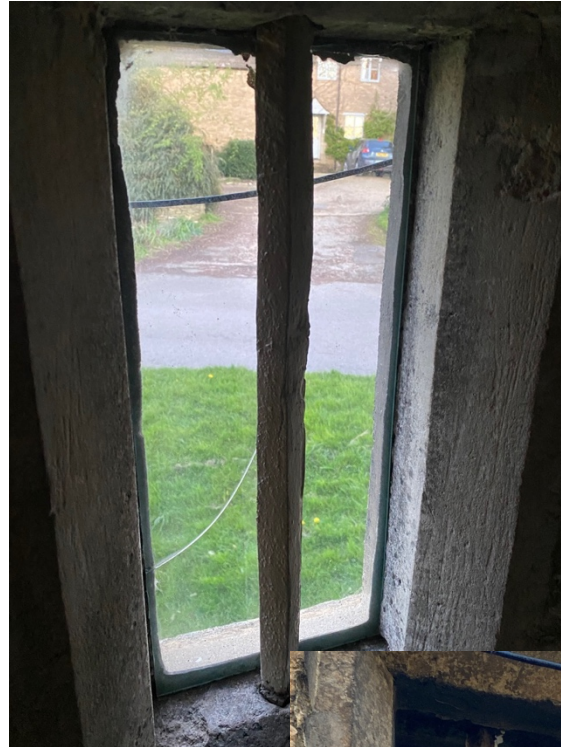
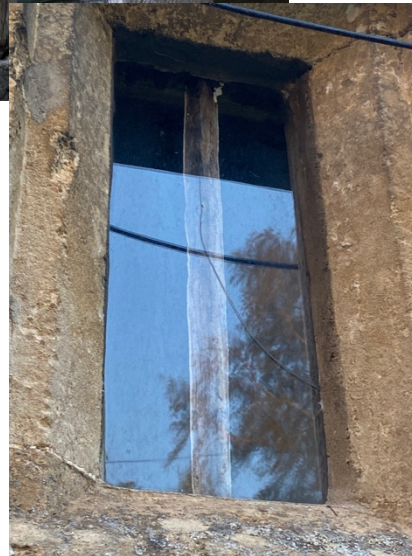
15. Small staircase window 2

Single glazed glass directly inserted into the stone casement

Note: Glass is compromised and broken

Remove glass.

Insert a heritage double glazed steel unit with antique lead bars directly into stone casement. The bar behind the window will be left in place.

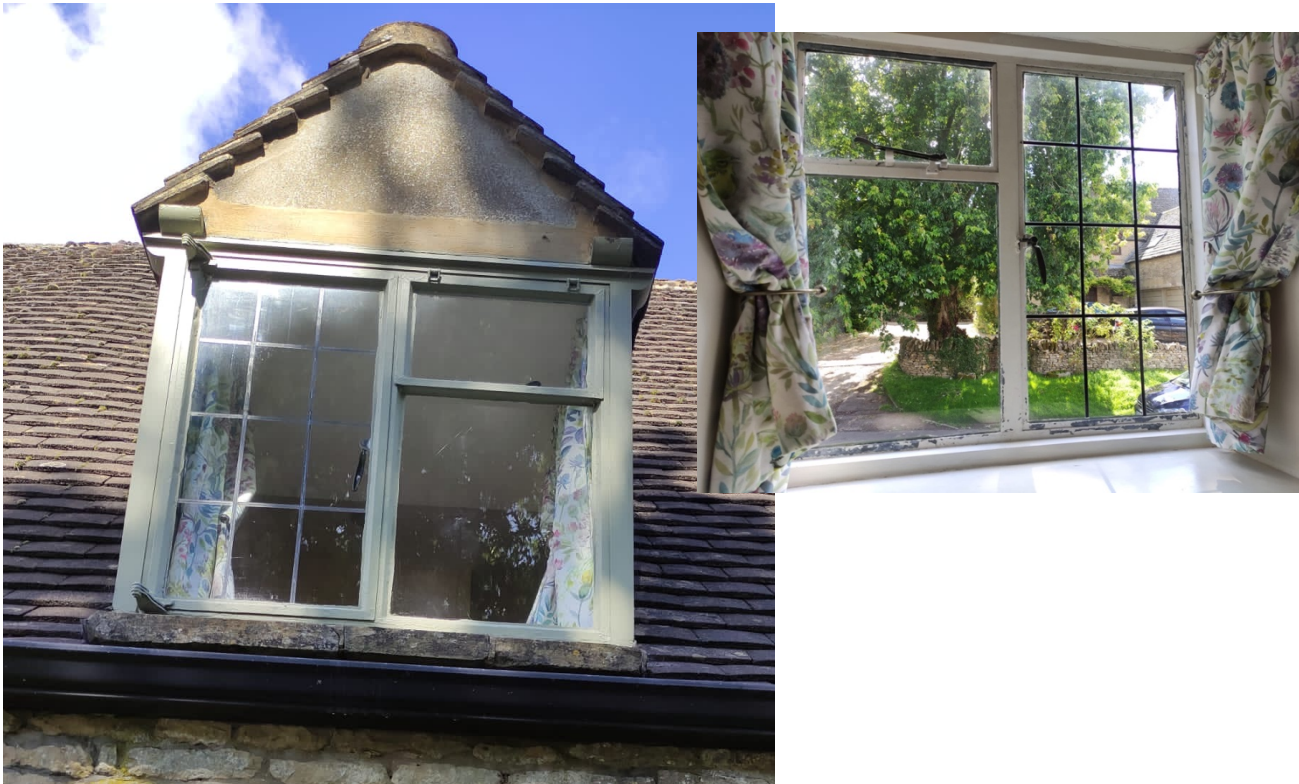
16. Corridor Window 2 (opp. Family bathroom)

Timber subframe; steel casement; stick on lead remains on one window only and is on the inside of the glass only; single glazed

Keeping the structural timber subframe.
Insert a heritage double glazed steel unit with antique lead bars into timber subframe.

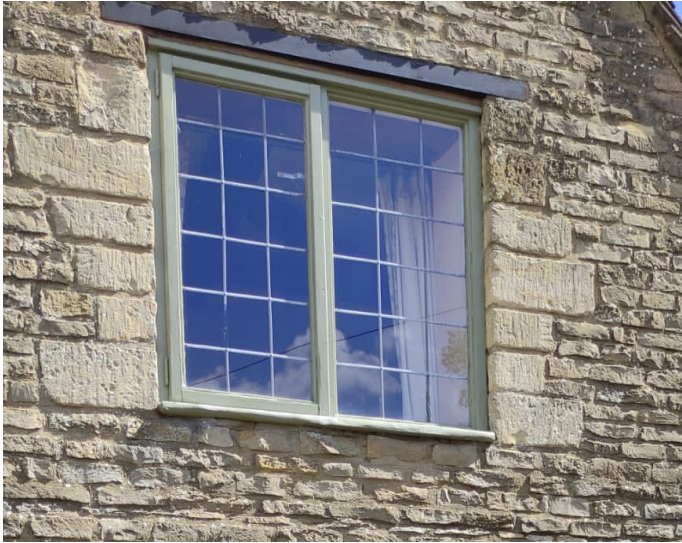
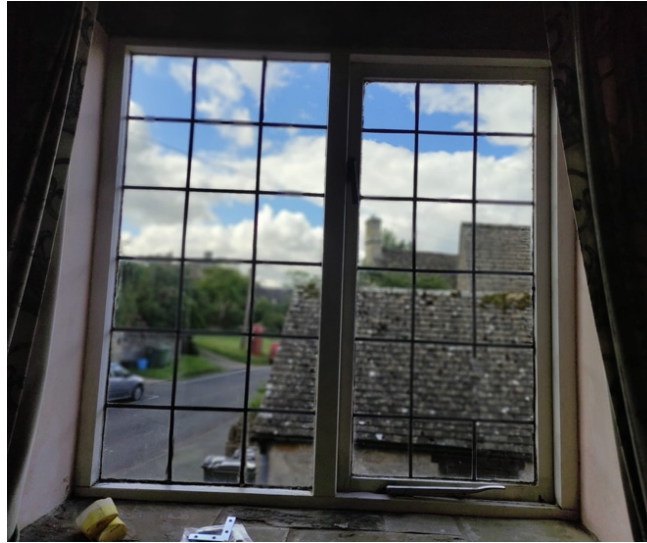
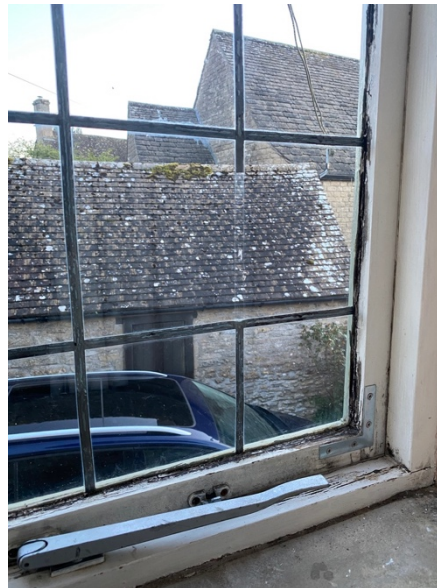
17. Bedroom 2 window (End)

Timber frame; partially has stick on lead and on the inside only; single glazed

Note: the timber for the window is rotten; window is close to being condemned

Remove timber frame, glass and lead.
Insert a heritage double glazed steel unit with antique lead bars directly into stone casement.
The sill will be remade due to no stone sill in place.

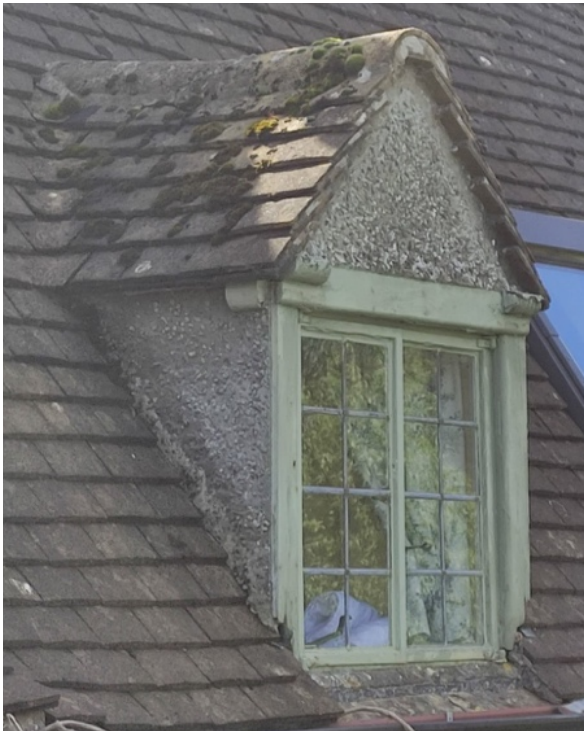
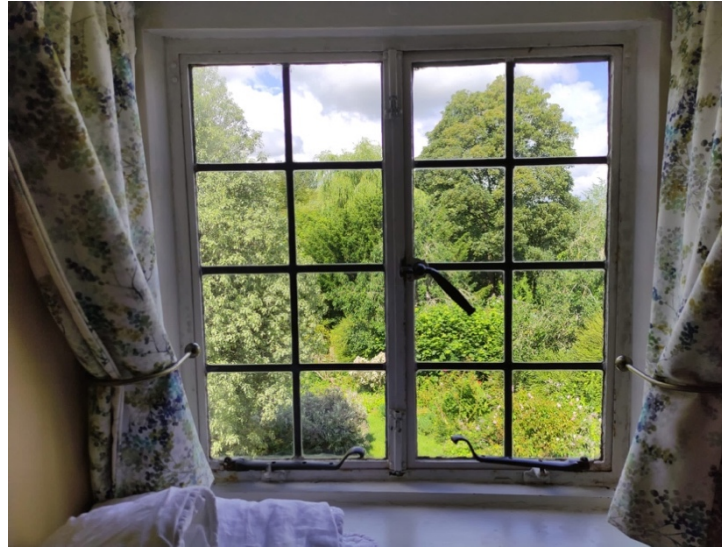
18. Bedroom 3 window

Timber subframe; steel casement; single glazed with integrated lead

Keeping the structural timber subframe with new hardwood cover strips.
Insert a heritage double glazed steel unit with antique lead bars into timber subframe.

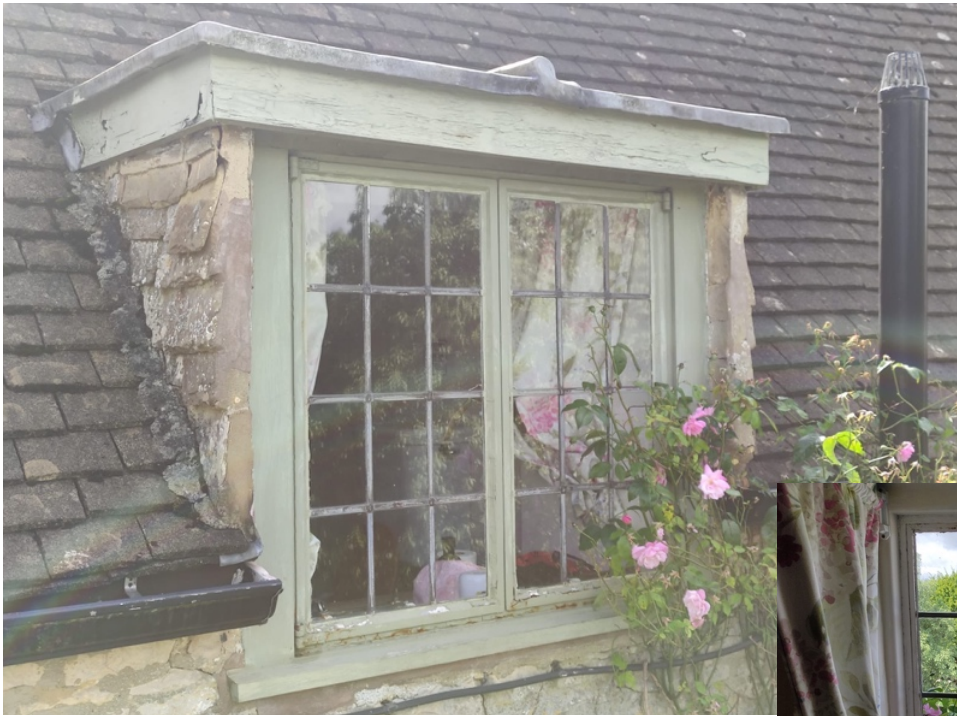
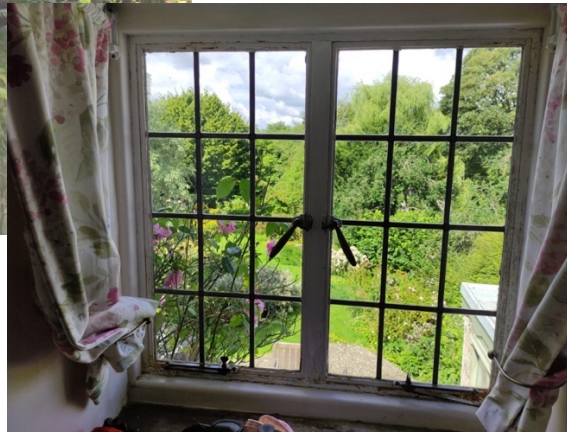
19. Ensuite Bathroom

Timber subframe; steel casement; single glazed with integrated lead

Note: steel frame in bad condition and broken ironmongery

Keeping the structural timber subframe but replacing the timber boarding immediately underneath the roofline with new hardwood surrounds, painted in the same colour to match existing timber.

Insert a heritage double glazed steel unit with antique lead bars into timber subframe.

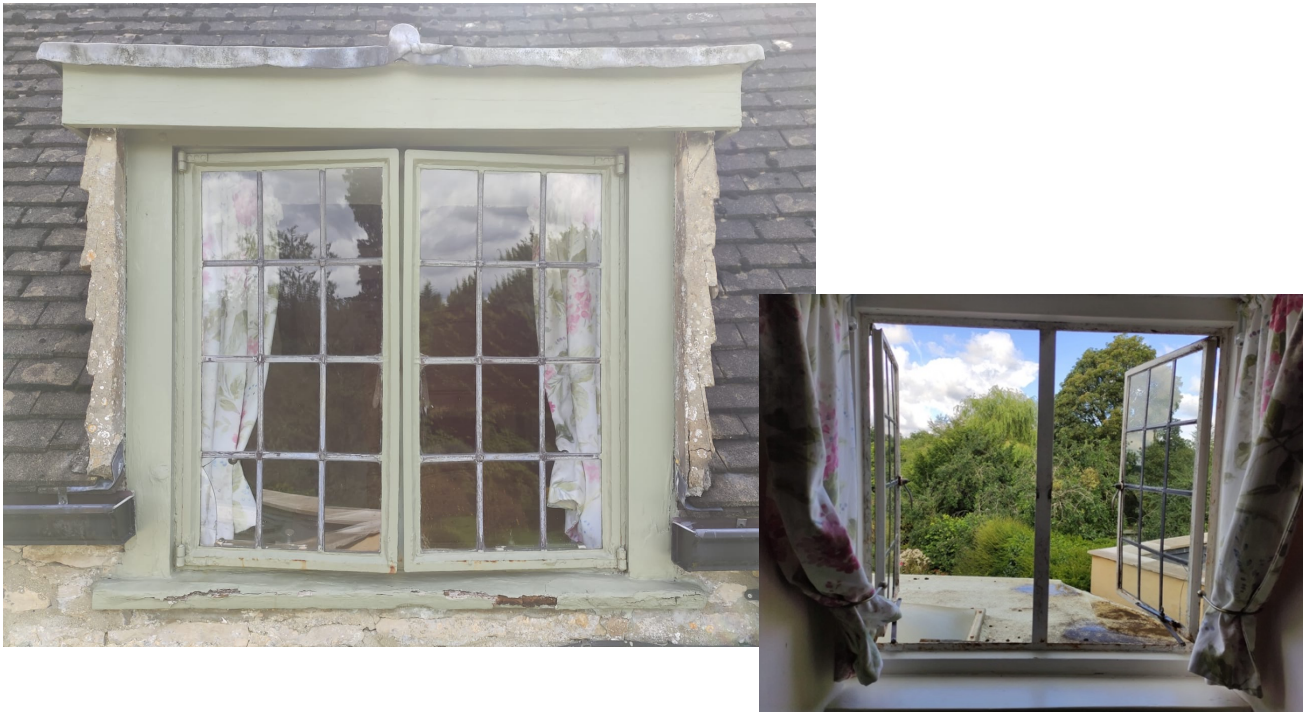
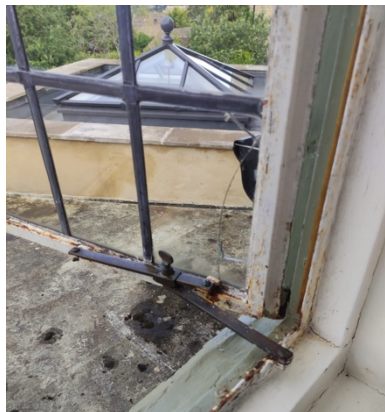
20. Bedroom 1 window A (Garden)

Timber subframe; steel casement with integrated lead; single glazed

Note: the timber for the subframe and sill is rotten

Note2: Glass is compromised and broken

New structural hardwood subframe and sill. Also replacing the timber boarding immediately underneath the roofline with new hardwood surrounds. New timber to be painted in the same colour to match existing timber.

Insert a heritage double glazed steel unit with antique lead bars into timber subframe.

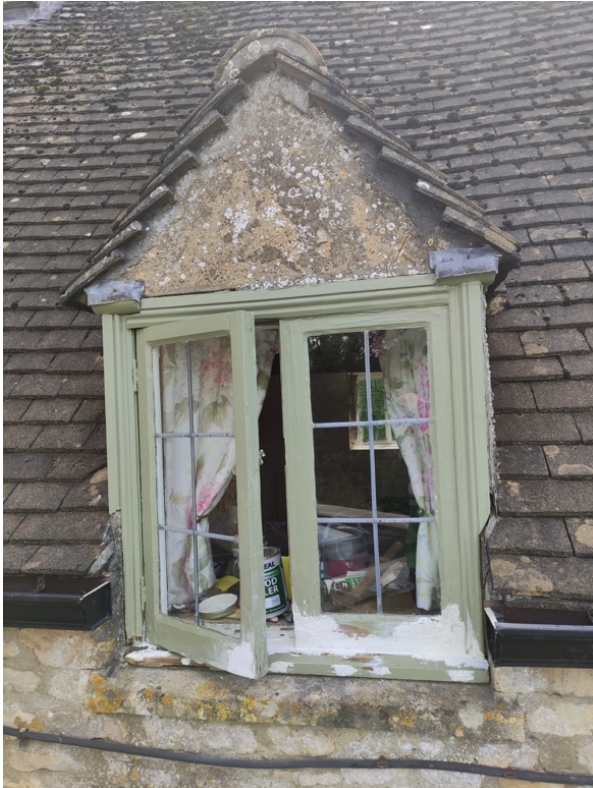
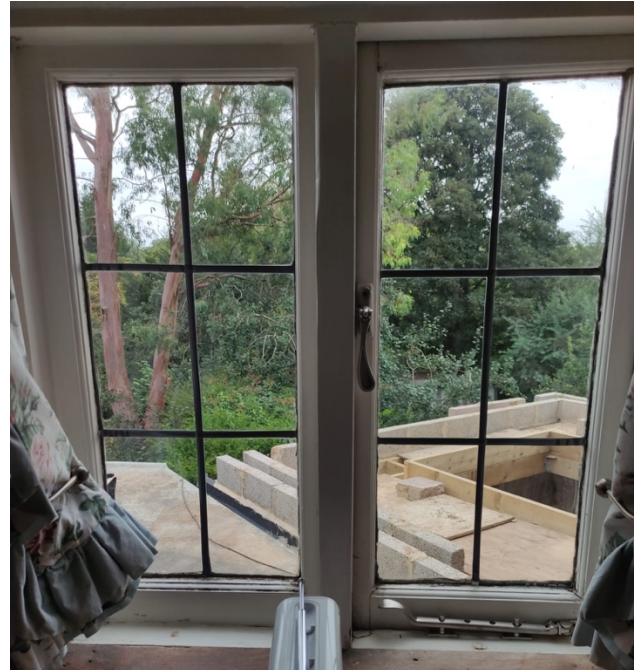
21. Bedroom 1 window B (Garden)

Timber frame; stick on lead; single glazed

Note: the timber for the window and sill is rotten; window is close to being condemned

New structural hardwood subframe and sill.
Insert a heritage double glazed steel unit with
antique lead bars into timber subframe.
