Arboricultural Report

First View, Lamorna Cove, TR19
6QX

Wildwood Trees

Date: February 2024.

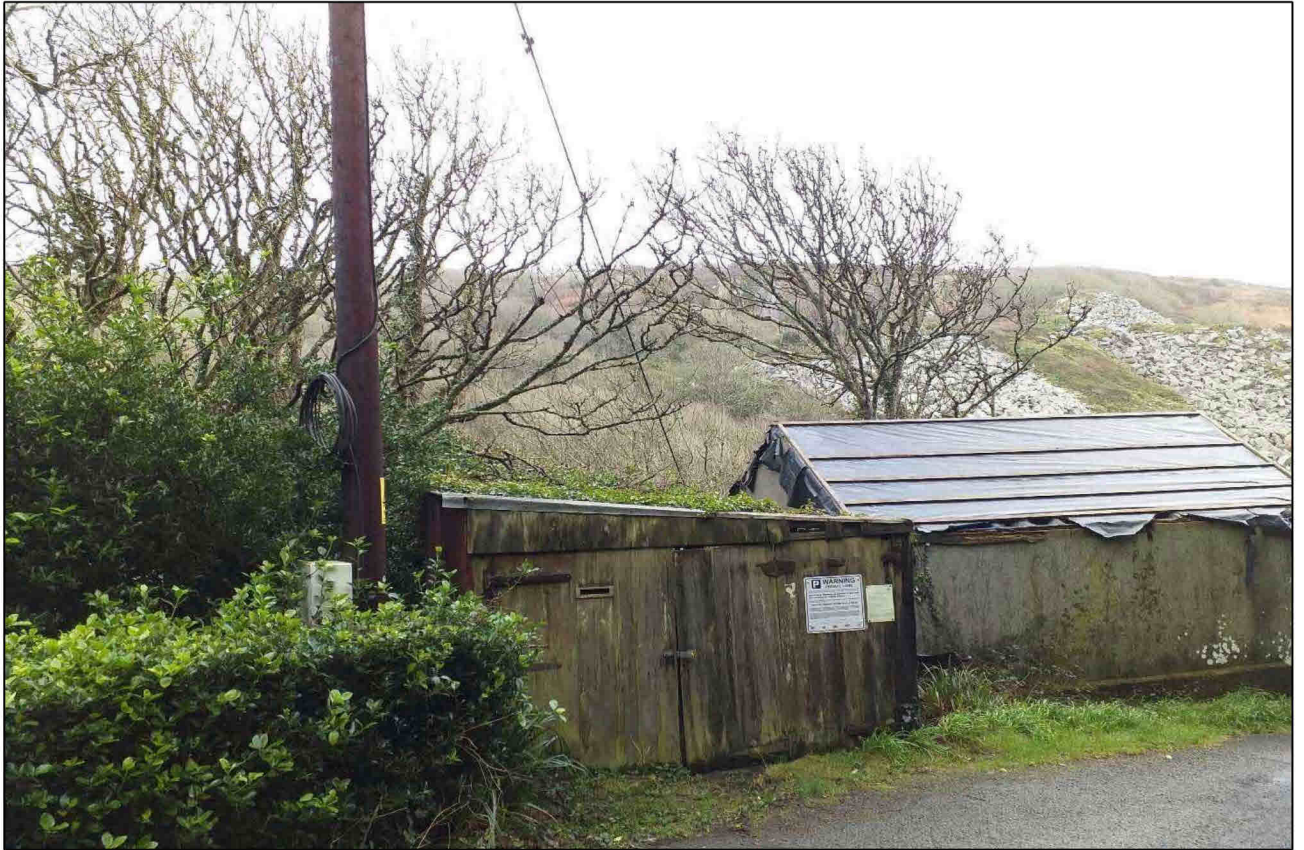
- 6.5 Minor crown raising tree surgery is recommended to the lower branches of (T2) and (T3) to allow construction of the proposed building to take place and to avoid damage to the trees and reduce interference with the installed building in the future. The minimum size and number of branches should be removed to achieve this. All work should be carried out by a suitably qualified arborist and all work done to BS3998:2010 specification

Fig 1: Existing garage and shed at Lamorna, with Sycamore (T2) on the left and sycamore (T4) behind.

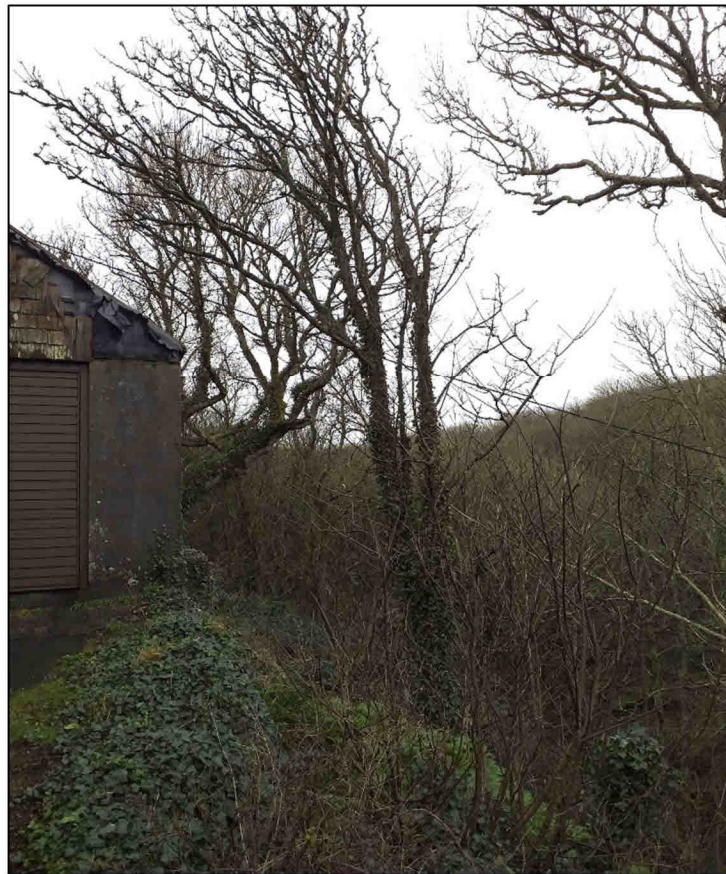
- 6.2 Ash tree (T5) is recommended for felling, on health and safety grounds, due to the Ash dieback infection it has. Sycamore (T4) is likely to be damaged by the proposed construction and if left may also come under pressure to be removed, as it matures, given its location, close to the new dwelling. Again, it is recommended for removal.

Fig 2: Sycamore (T4) with existing garage to the left.

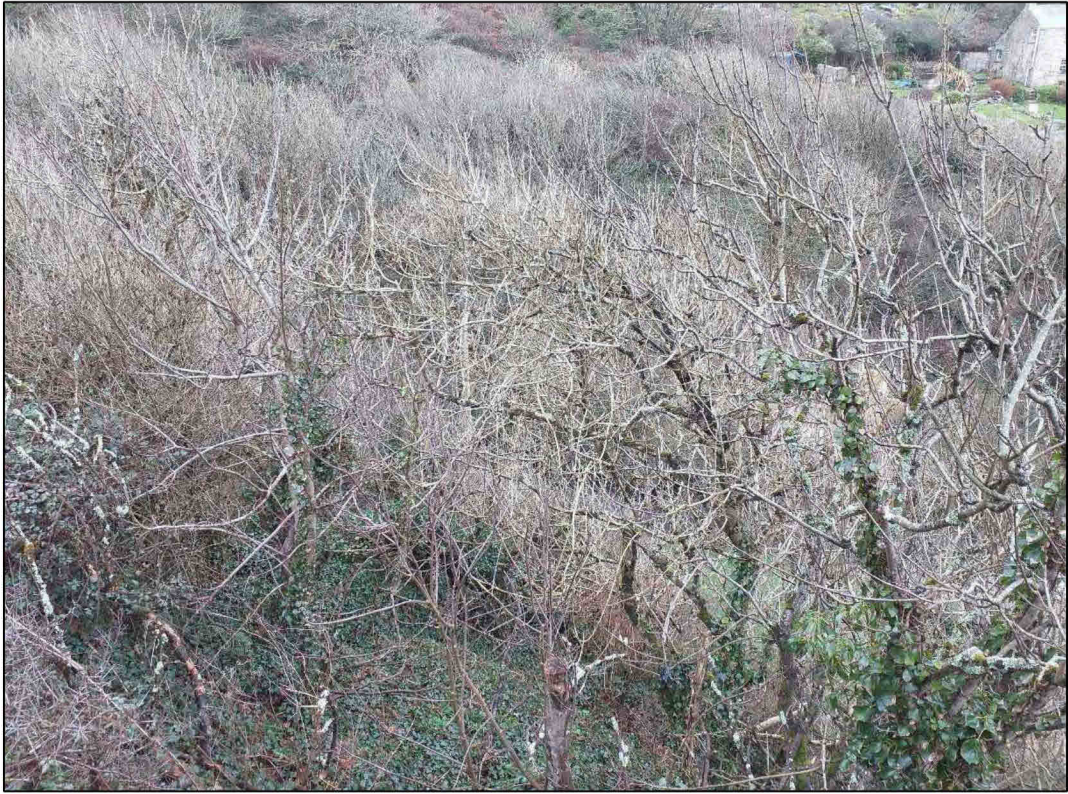
Fig 3; General view of the ash and sycamores of group (G1)

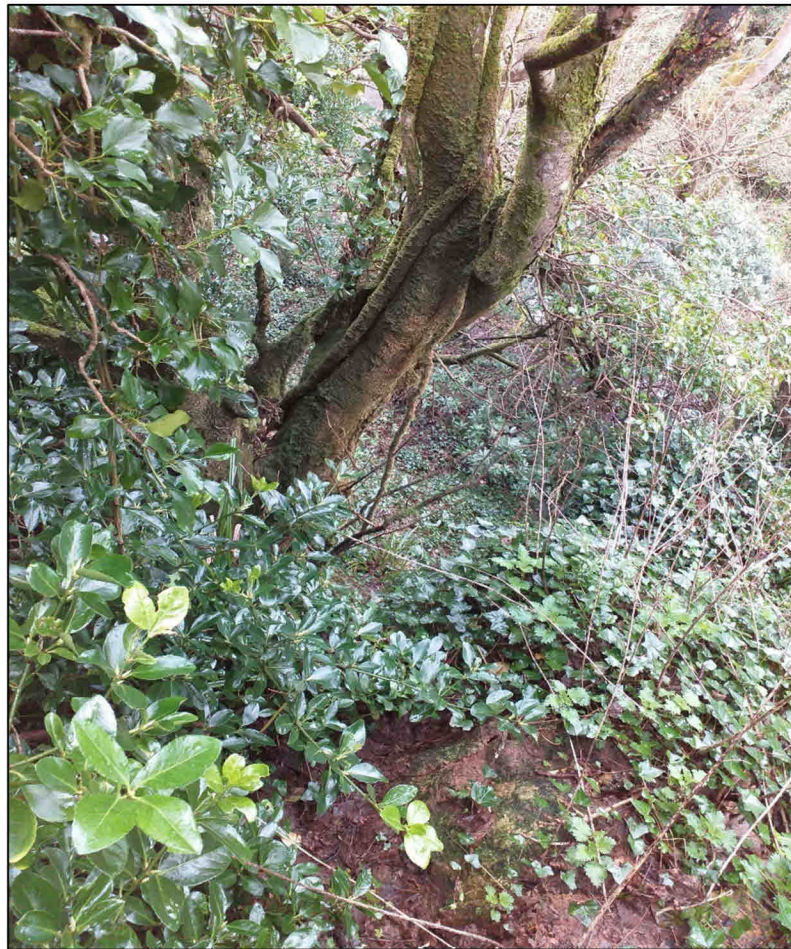
Fig 4; Base of Sycamore (T3), showing the steepness of most of the site

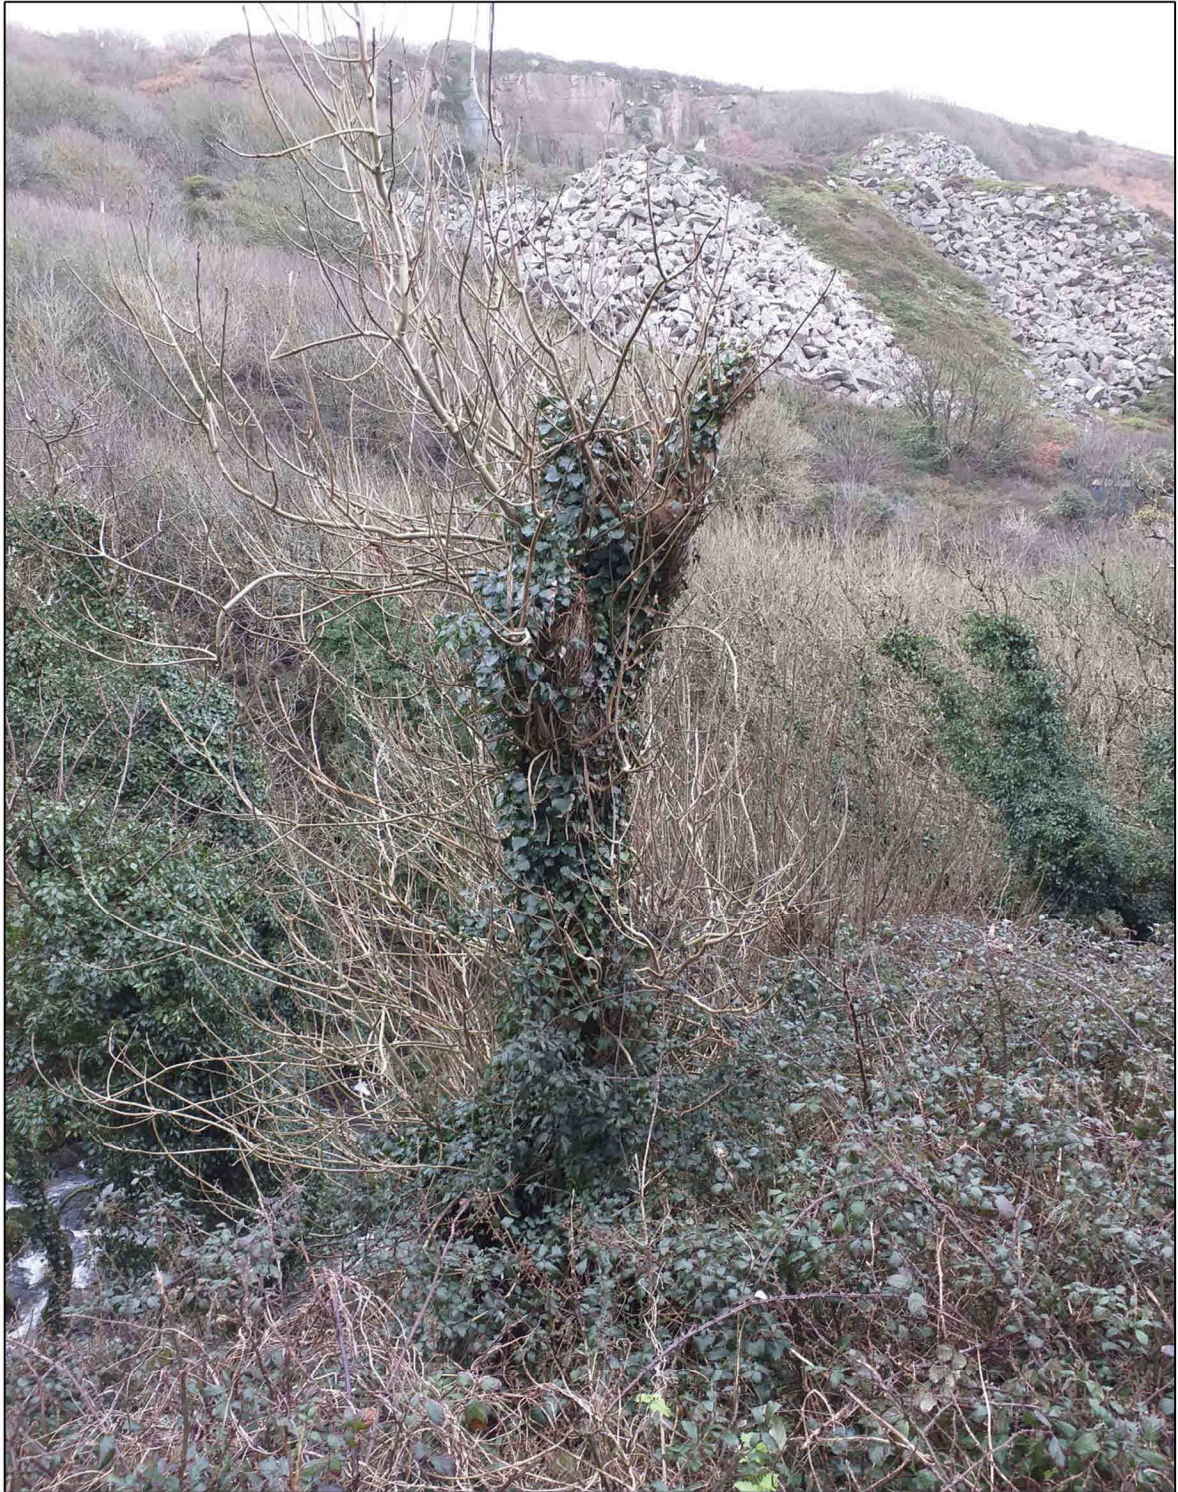
- 5.2 Ash Dieback fungal infection (*Hymenoscyphus fraxineus*), was observed in almost all the ash stock on the site and in the wider Lamorna valley. Significant trees with the infection include; (T1) –off-site, (T3) and (T5). The risk from this fungal infection is that ash branches, as they die, become brittle and can then fall with little warning. The brittleness of the branches also means it is dangerous to climb fully infected trees, to carry out any tree surgery operations. MEWPS ('Cherry pickers') then have to be used. Ash trees in the wider site, infected by Ash Dieback, and where there is very little or no risk to any site users or neighbours, public, etc can be left to slowly collapse into the woodland.

Fig 5: Ash pollard (T6) with extensive Ash Dieback infection
