Mark Tunmore BSc, MCIEEM
The Boat House, Church Cove, Lizard,
Helston, Cornwall, TR12 7PH
T: 01326 290287
M: [REDACTED]
30 December 2020

1. INTRODUCTION

1.1 Background

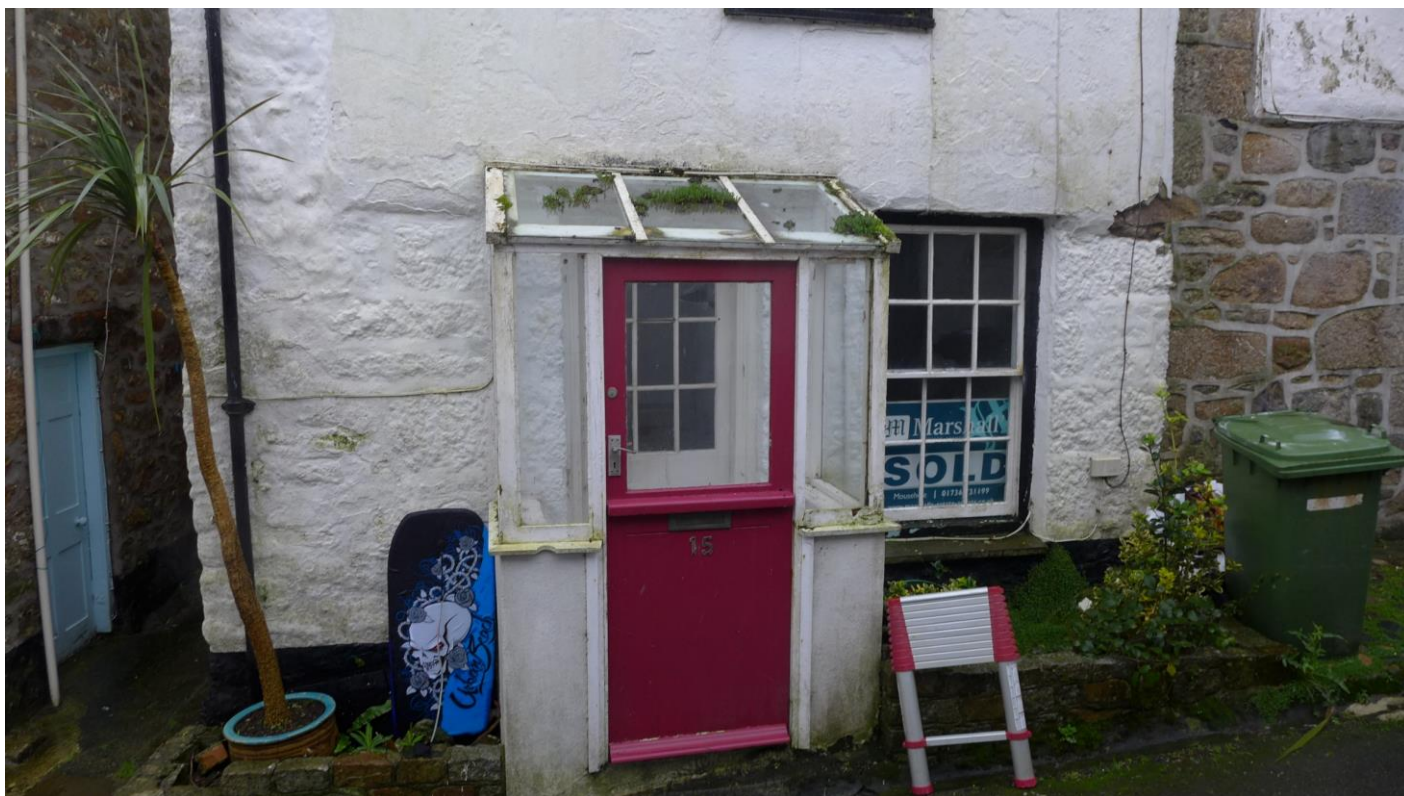
Figure 1. Main entrance to the property, eastern aspect.

The building was stone-built with rendered walls and had a pitched slate roof with a cement covering in places, which did not leave any visible gaps for roosting bats. The property was accessed on the east side by a porched entrance with glass sides. Internally there were three upstairs rooms and four downstairs room with an interlinking staircase. A small roof void was present of very approximately 2.5m high, 6m long and 6m wide, which was accessed through an open loft hatch; the internal space was further reduced by the amount of stored items present. The roof was unlined and a layer of old and deteriorating fibreglass insulation was present on the floor of the void.

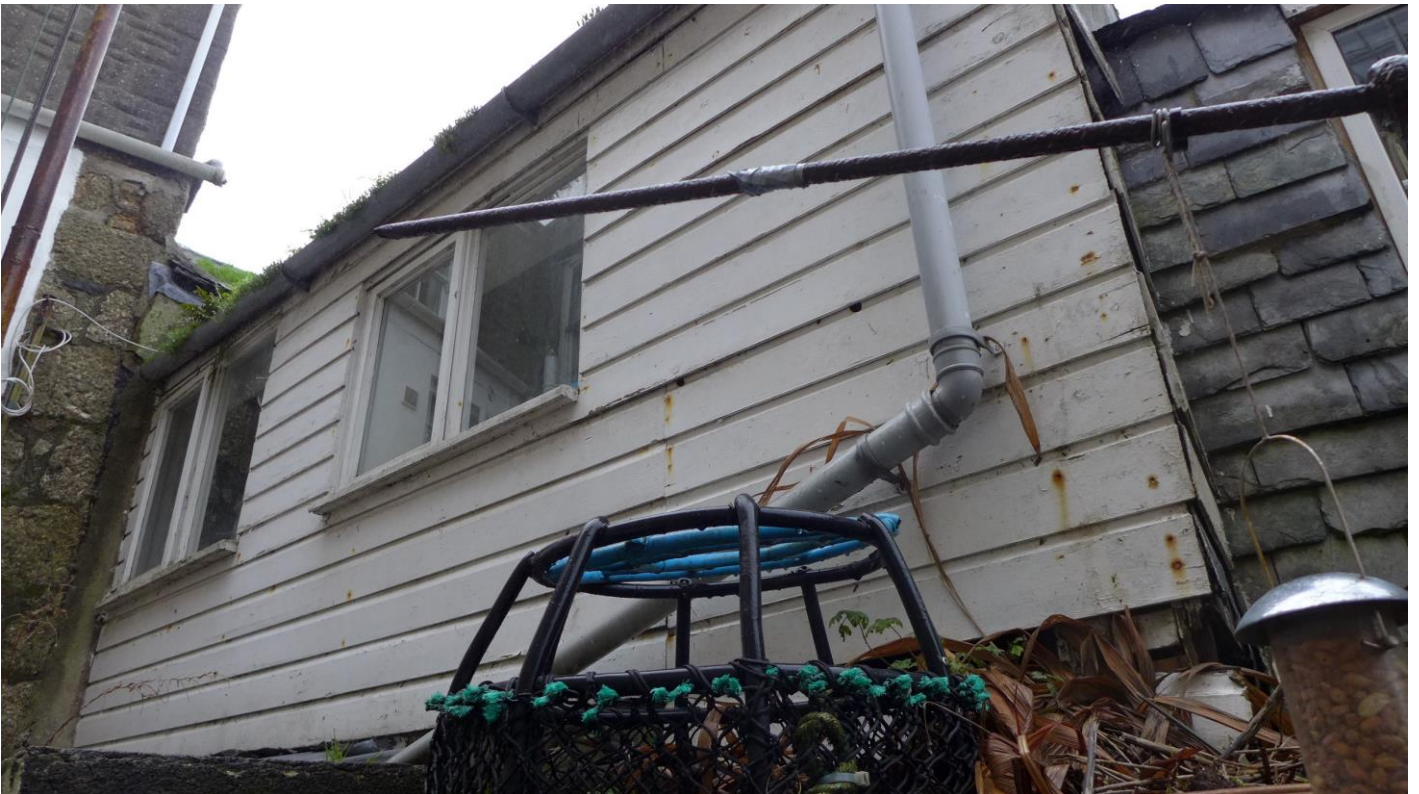
Figure 5. Weatherboarding on the western aspect, upper floor.

The back door of the property led into a small alley with close-facing housing. White weatherboarding was present on the walls of the property on this western aspect of the building and there was a small corrugated perspex overhang above the remains of an old coal bunker outside.
