# Ecological Assessment

## Middle Lypiatt

December 2020

**Project: ETH20-078**

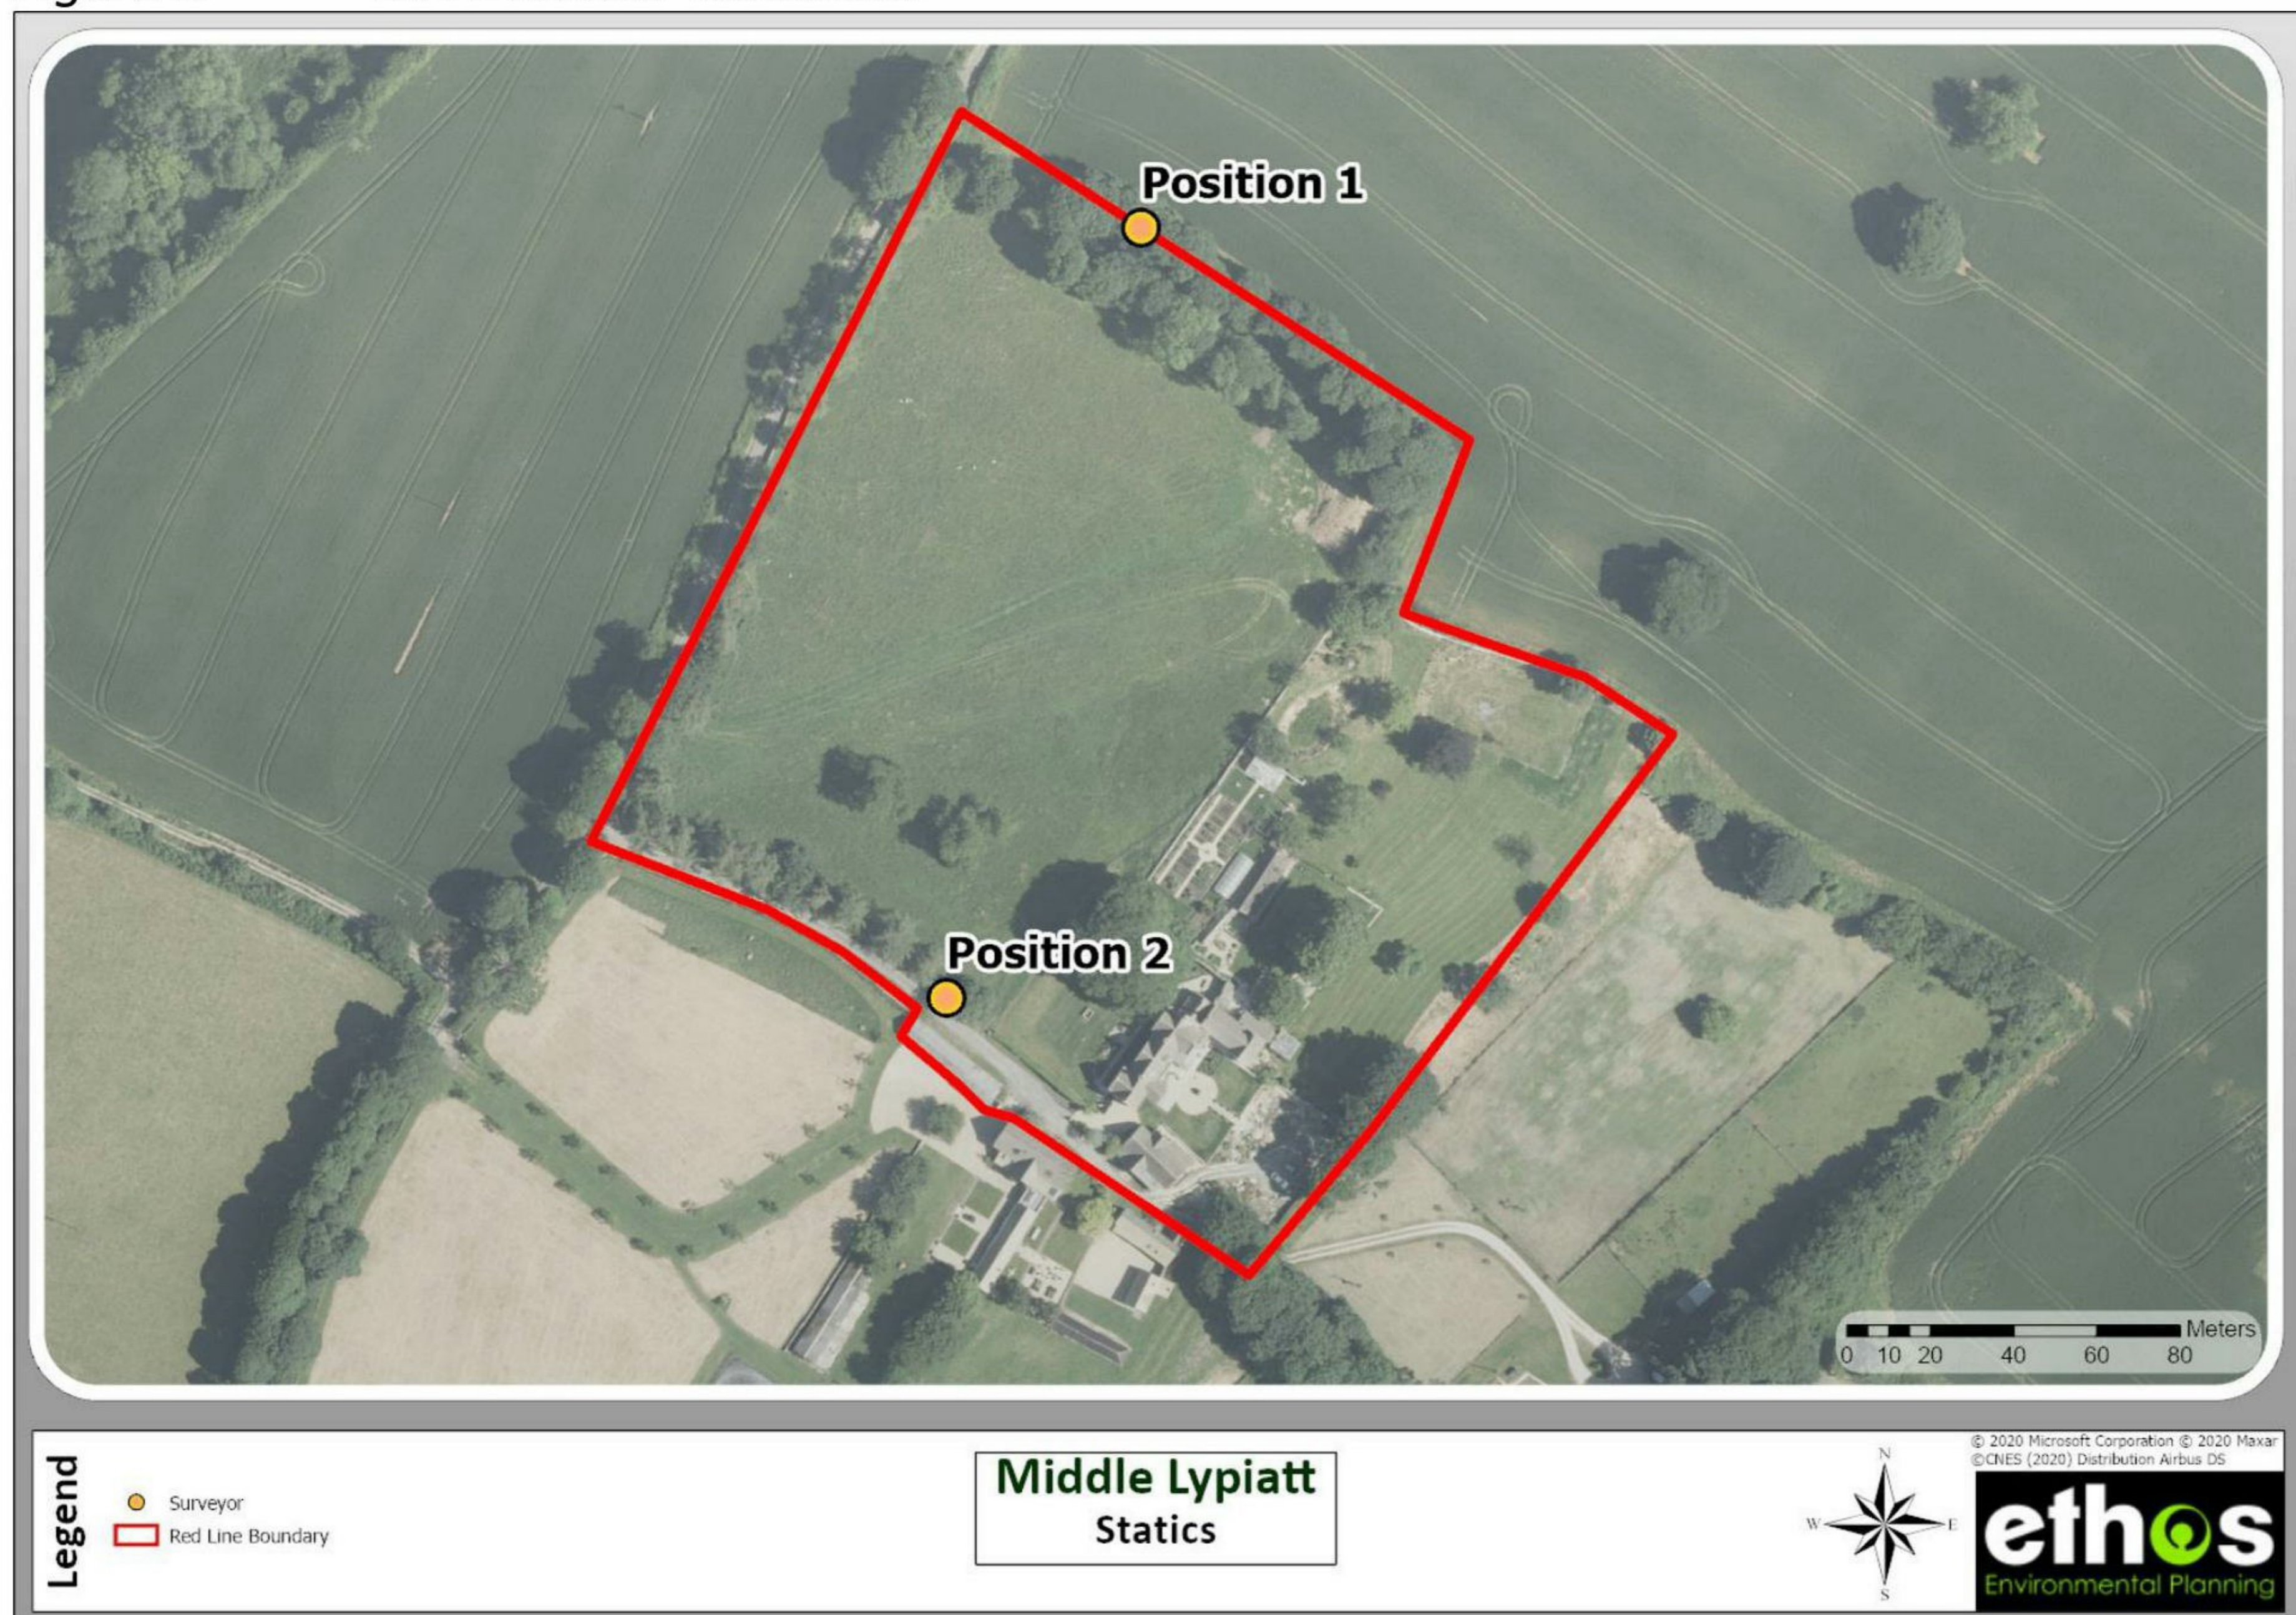
**Figure 3** Bat Detector Locations

Two Wildlife Acoustics Song Meter 4 (SM4) passive bat detectors were deployed in suitable locations on site (Figure 3) between April and September. This provided an assessment of the bat species composition on site and may provide data regarding areas of high activity. All calls recorded were analysed using Kaleidoscope Software.

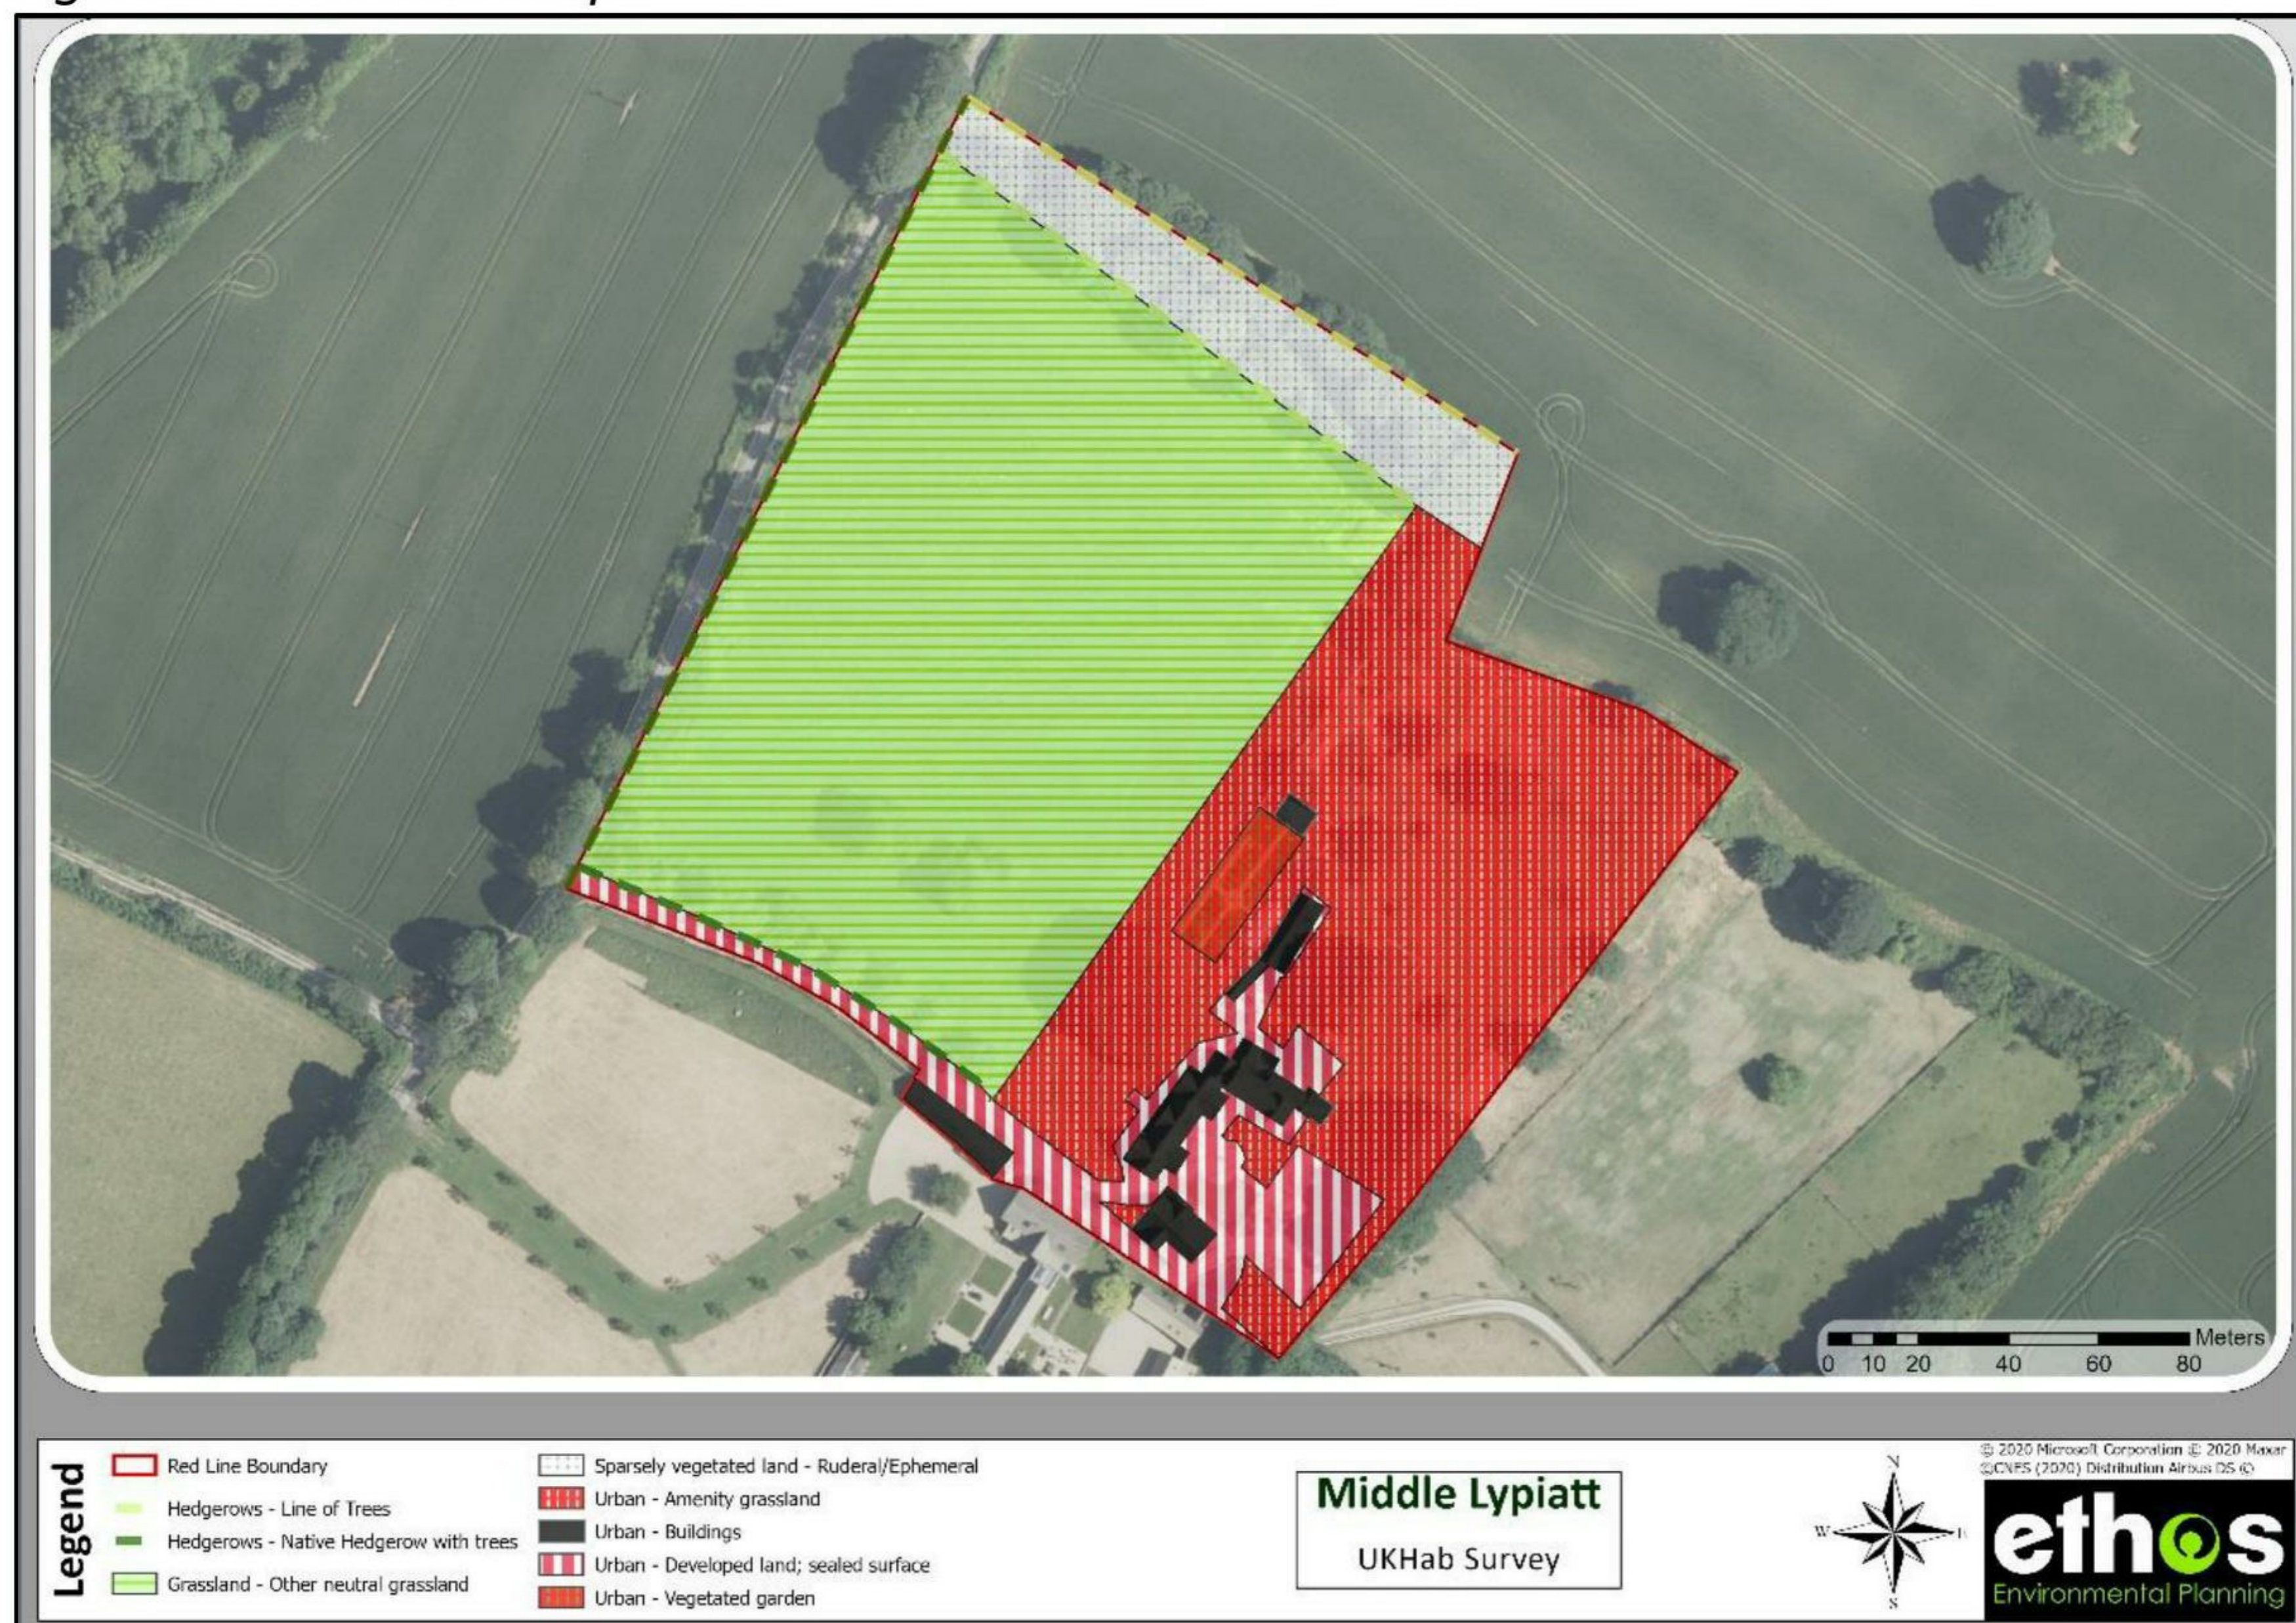
Figure 8 UKHabs Map

- Neutral Grassland;
- Line of Trees;
- Amenity Grassland;
- Buildings;
- TN1 (dry pond); and
- Ruderal vegetation.

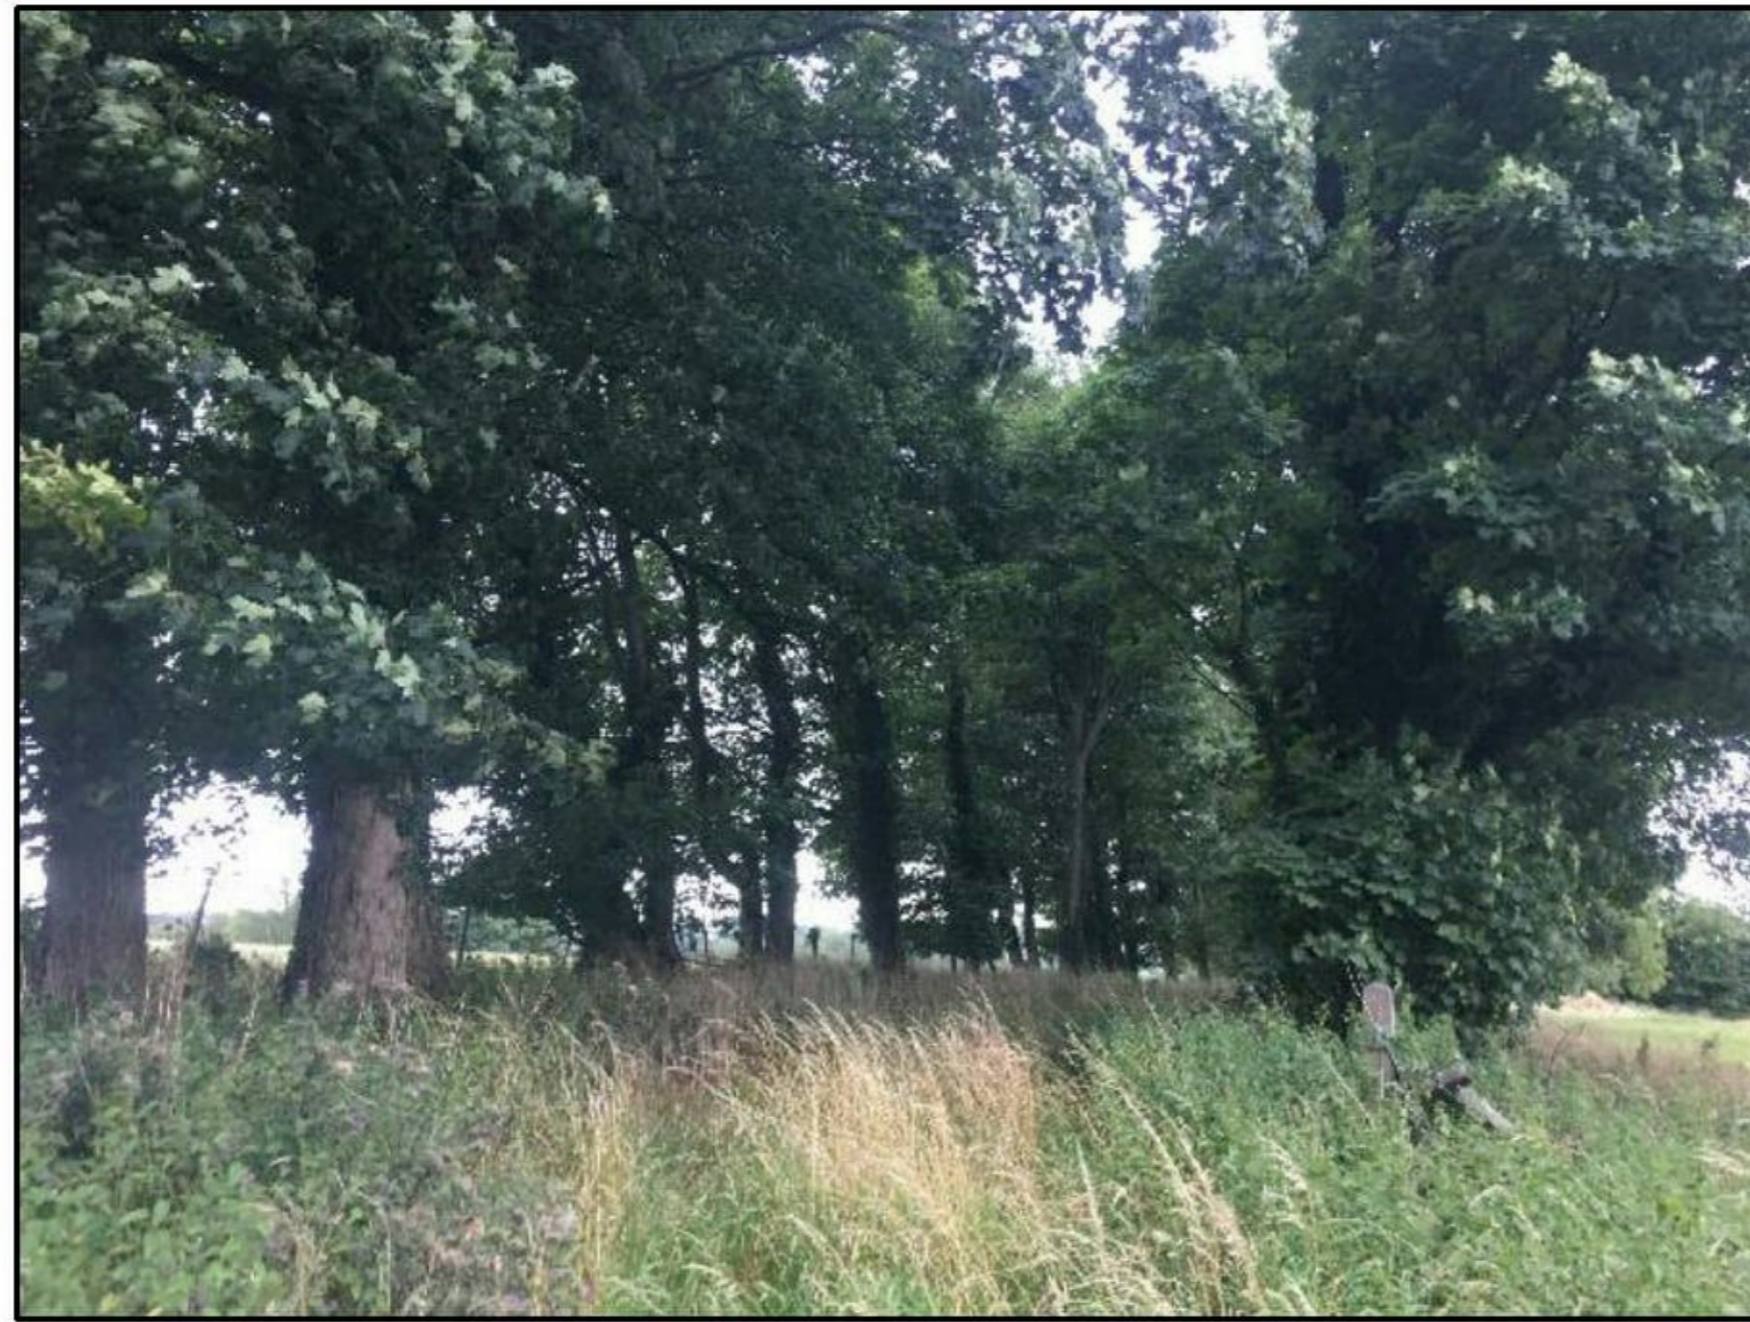
*Photo 1: Tree avenue*

There was an avenue of trees located in the north-east of the site, as shown in photo 1 and 2. The trees were dominated by mature sycamore with some beech and ash. The trees were bordered by permanent pasture to the west and arable land to the east. The habitats within the tree-lined avenue comprised ruderal vegetation with abundant common with scattered white dead nettle, ivy, cleavers, couch grass, hedge woundwort, wood spurge and herb Robert.

The development proposals will necessitate the removal of the vegetation within the tree avenue to reinstate the historic driveway. The following precautionary mitigation is recommended:

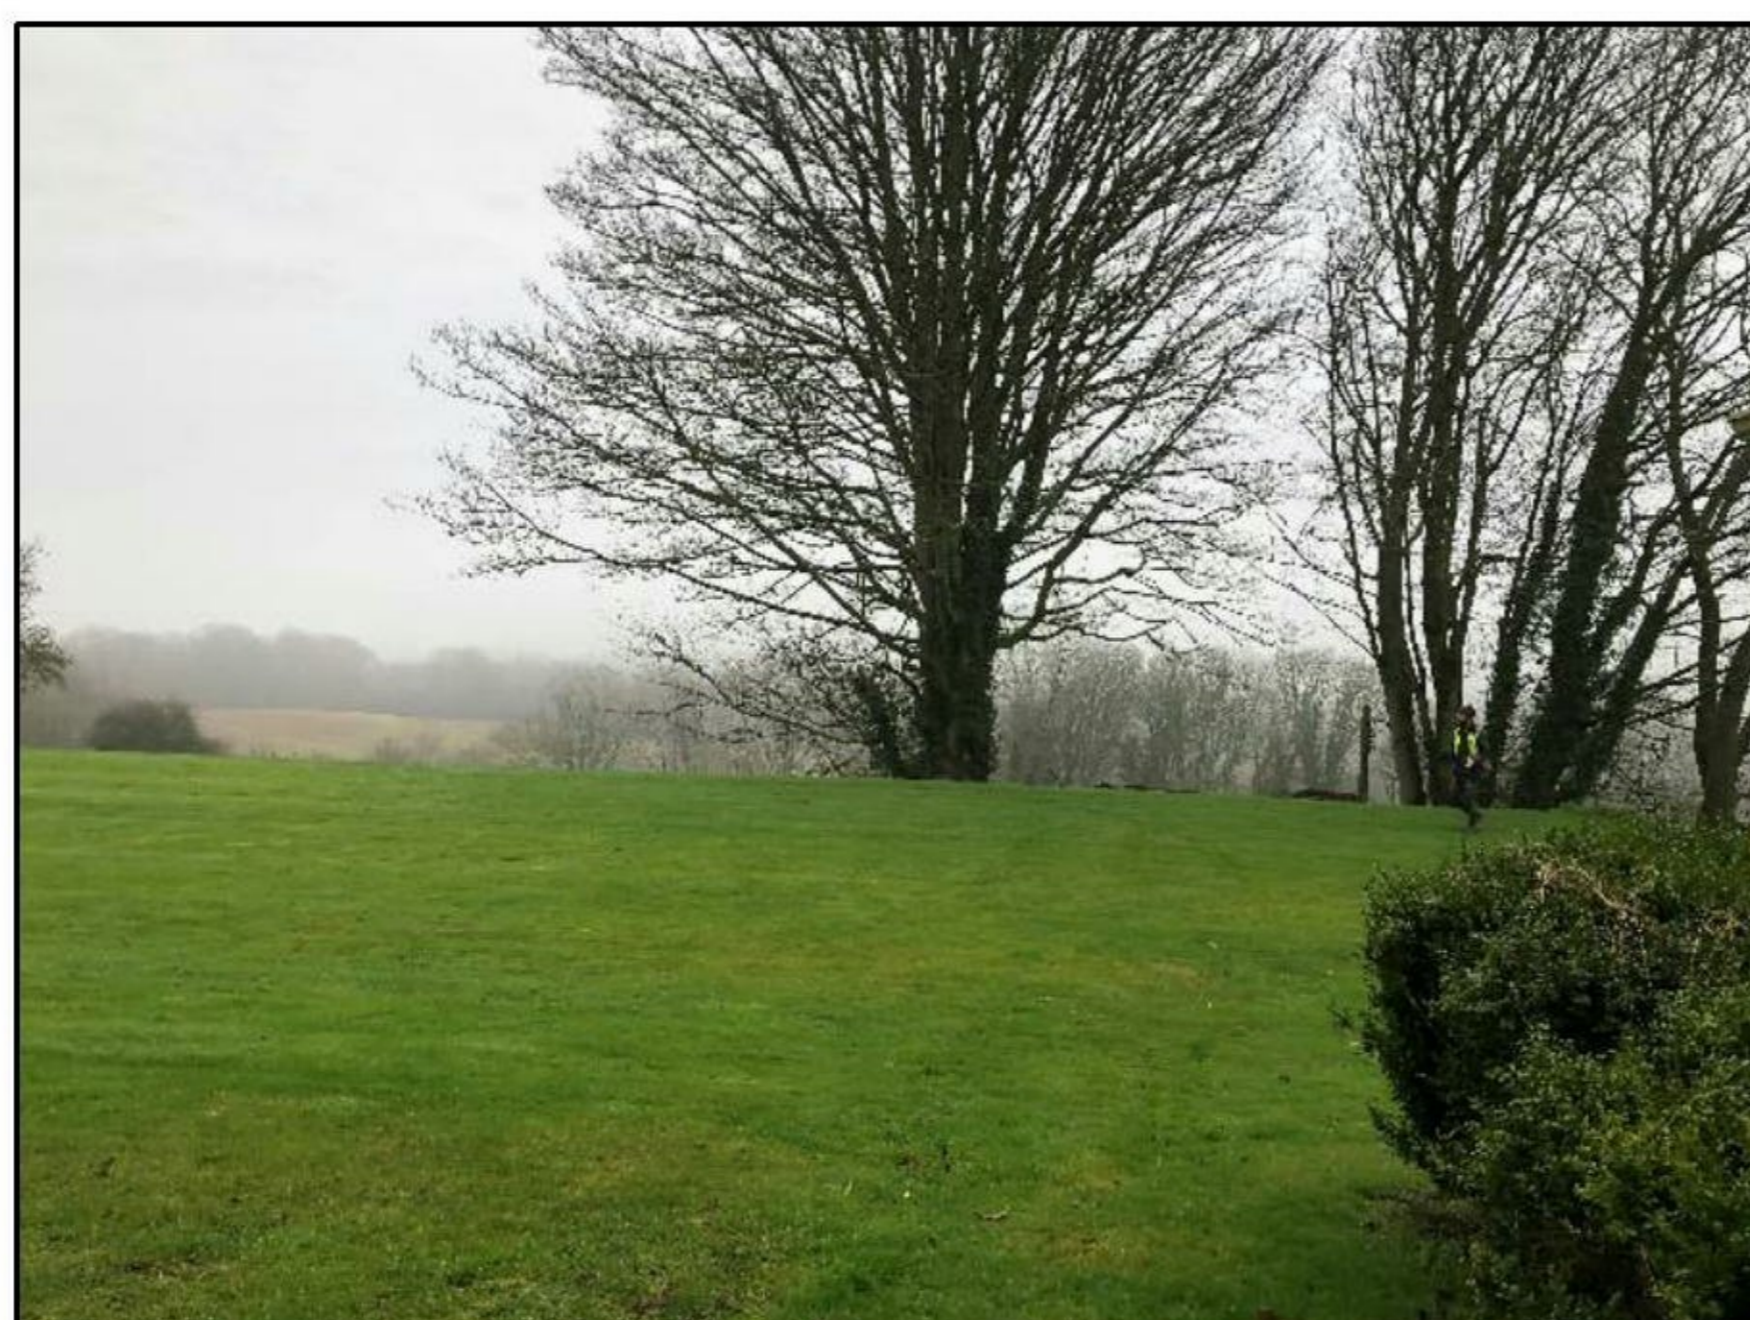
*Photo 3: Amenity grassland in the south*

The grounds of the manor were dominated by amenity grassland which was assessed to be intensively managed and cut regularly, as shown in Photos 3 and 4. Subsequently, the grassland was dominated by grasses with low numbers of herbs present and was assessed to be species-poor.

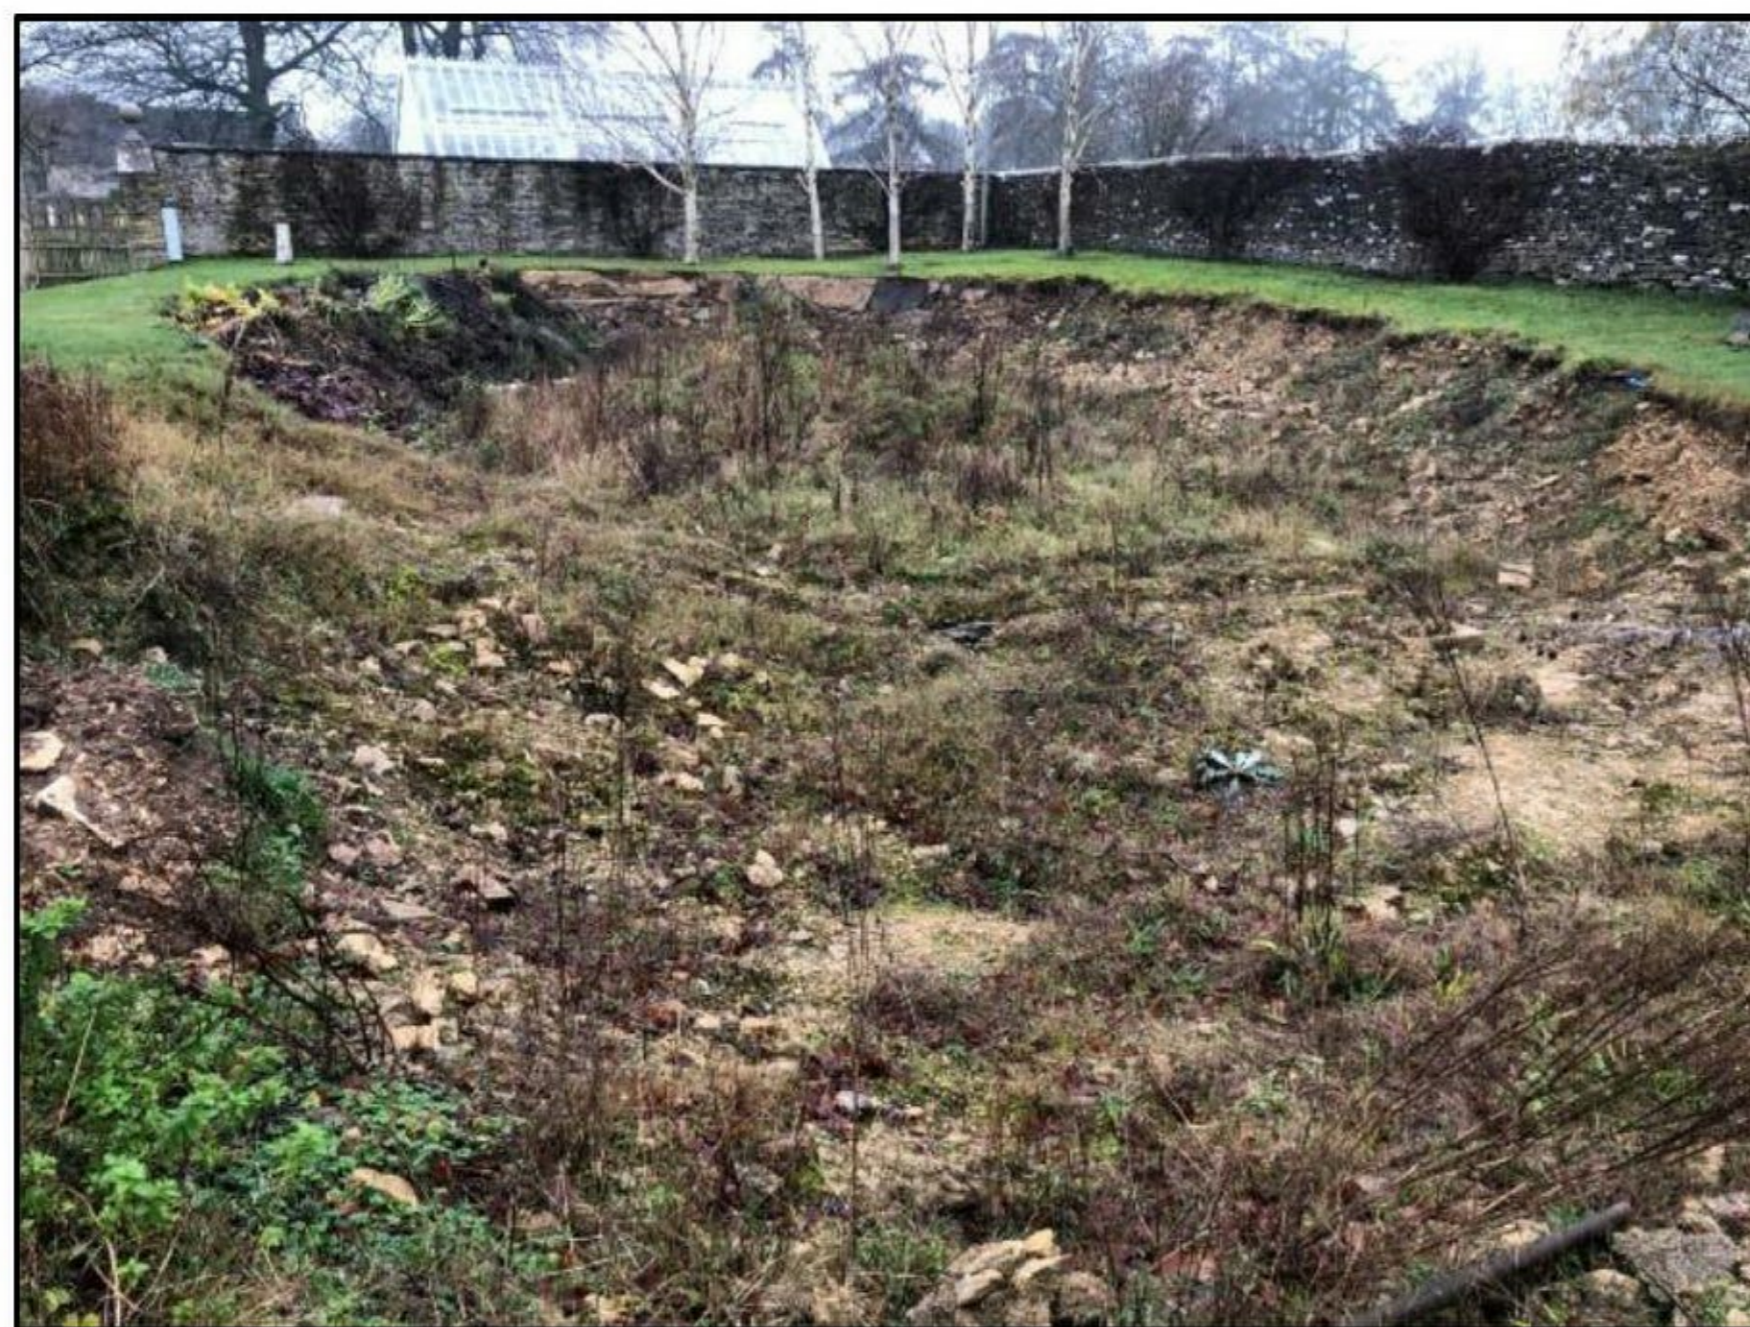
Photo 5: scrub south of track

There was a dry pond located within the centre of the site, as shown in Photo 5. There was no pond liner present and no riparian vegetation. The dry pond was bordered by amenity grassland on all sides and comprised stone and bare earth with low levels of vegetation. Species present included ribwort plantain, fleabane, willowherb, creeping buttercup, rough hawkbit, smooth hawk beard, clover, teasel, butterfly bush, black medick, scarlet pimpernel, curly dock, ivy leaves toadflax, white campion, common nettle, oat grasses, timothy grass, common vetch and rye grass.

It is recommended to restore the pond to provide habitat for a range of wildlife and to seek a net gain in terms of biodiversity onsite. The following measures are recommended:

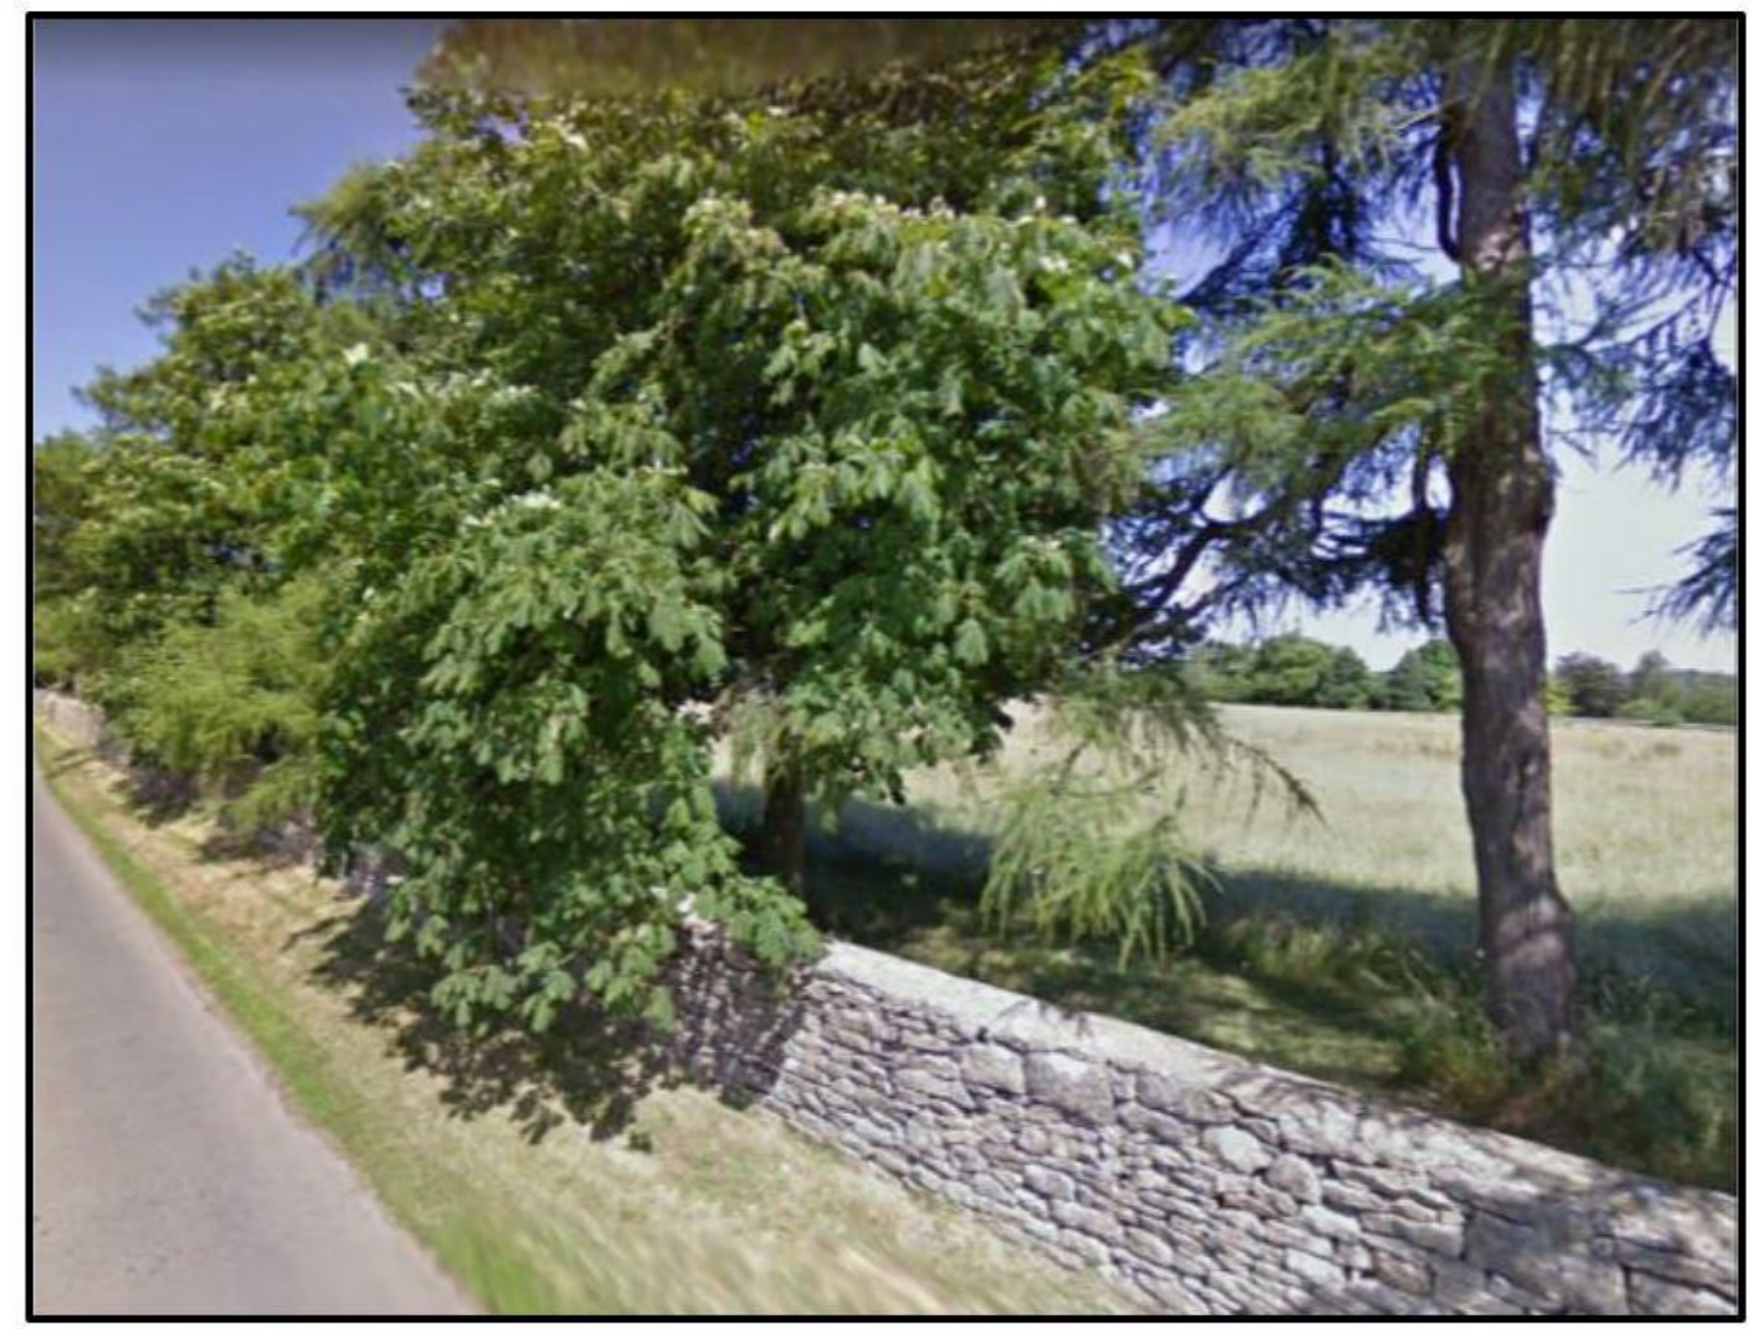
*Photo 7: Hedgerow western boundary*

There were two hedgerows located on the western and southern boundaries of the site. The hedgerows were comprised of line of trees comprised of horse chestnut, sycamore, spruce, and scots pine. The hedgerow had no shrub layer, and the ground layer was comprised of sheep grazed grassland.

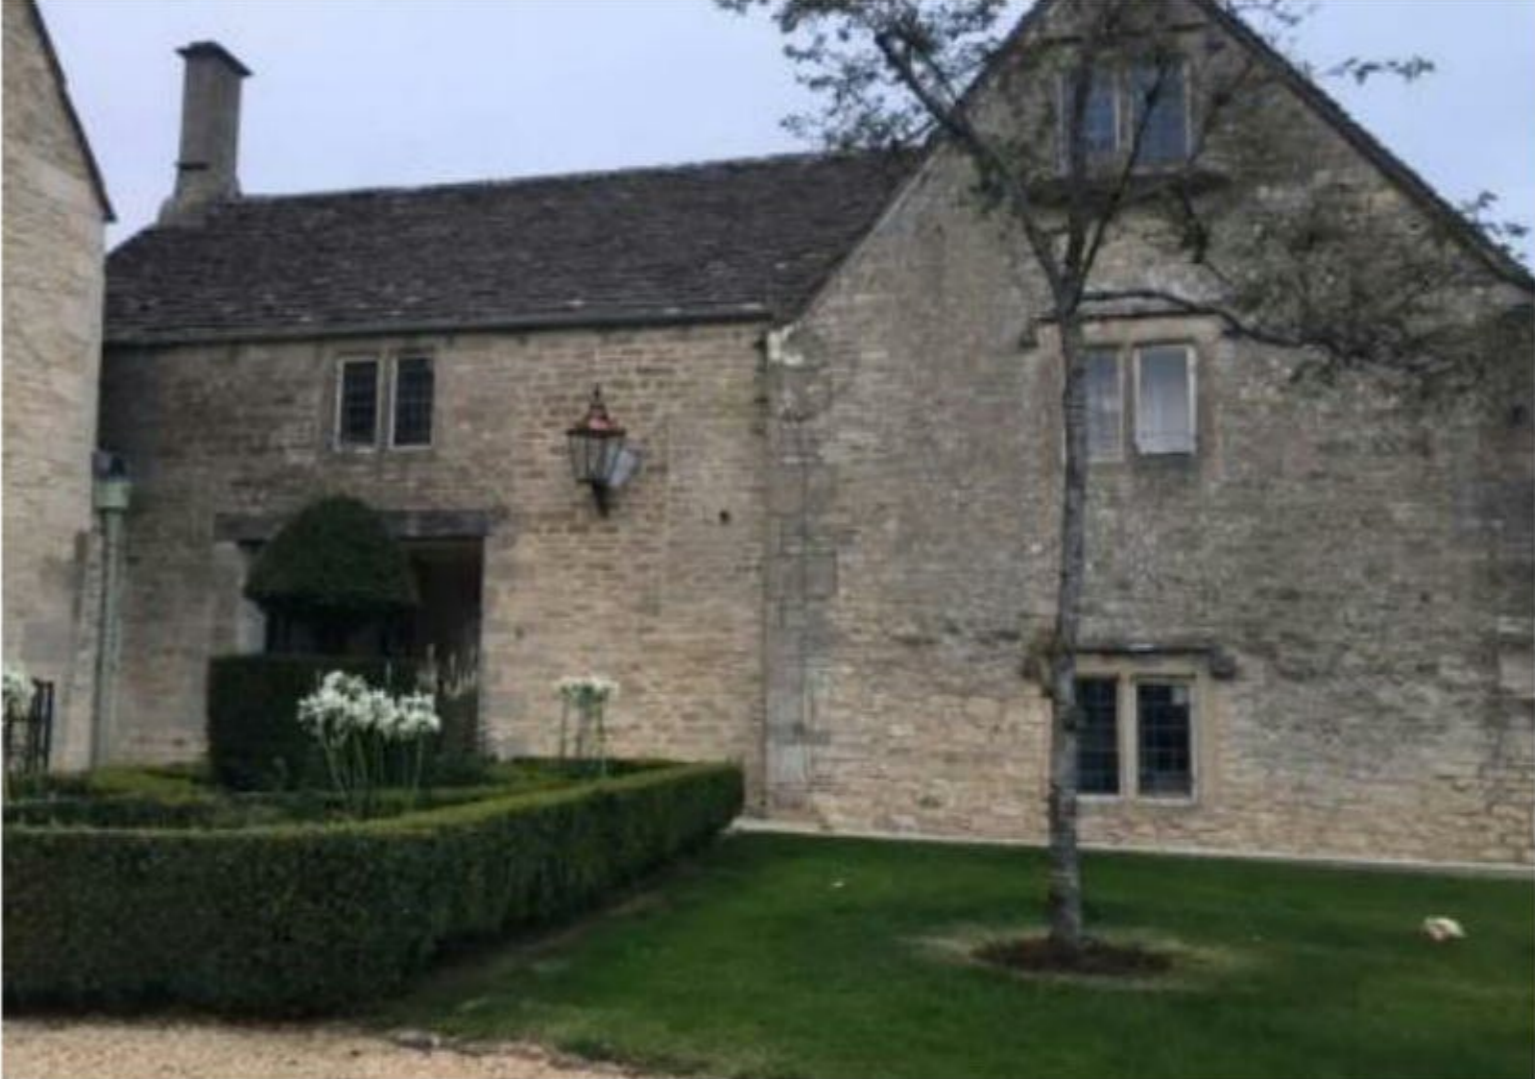
Structure and proposals	Description	Photo
<p><b>B1 Garden Cottage (Proposed extension)</b></p>	<p><b>External</b></p> <p>B1 adjoins the Middle Lypiatt House. The structure included a building with an open section to provide access for carriages and a larger living area with two storeys. There was also a conservatory to the south of the structure.</p> <p>The structure was of traditional construction comprising limestone and pitched Cotswold stone tiles. A dove loft was located within the southern elevation of the structure (Photo 7). There was no evidence of bats on the external features of the building. The building was assessed to be in a good structural condition.</p> <p><b>Internal</b></p> <p>The loft was 'T' shaped, with the small part of the T comprising a dove loft and the long section being a standard loft void which could not be accessed.</p> <p>The dimensions of the dove loft were 3m in height, 4.5m in width and 6m in length. There was one large window on the south-western gable, which made the loft light as a result. The loft comprised old timbers with gaps where beams met the walls, Bitumen felt sarking laid above the beams and batons onto Cotswold tiles. Lots of missing sarking exposed the tiles, providing potential access into the loft. There were several gaps between the gable-end and the roof with some light spill. No evidence of bats was identified in small section of loft.</p>

<p>Photo 8: B1 south-western elevation</p>

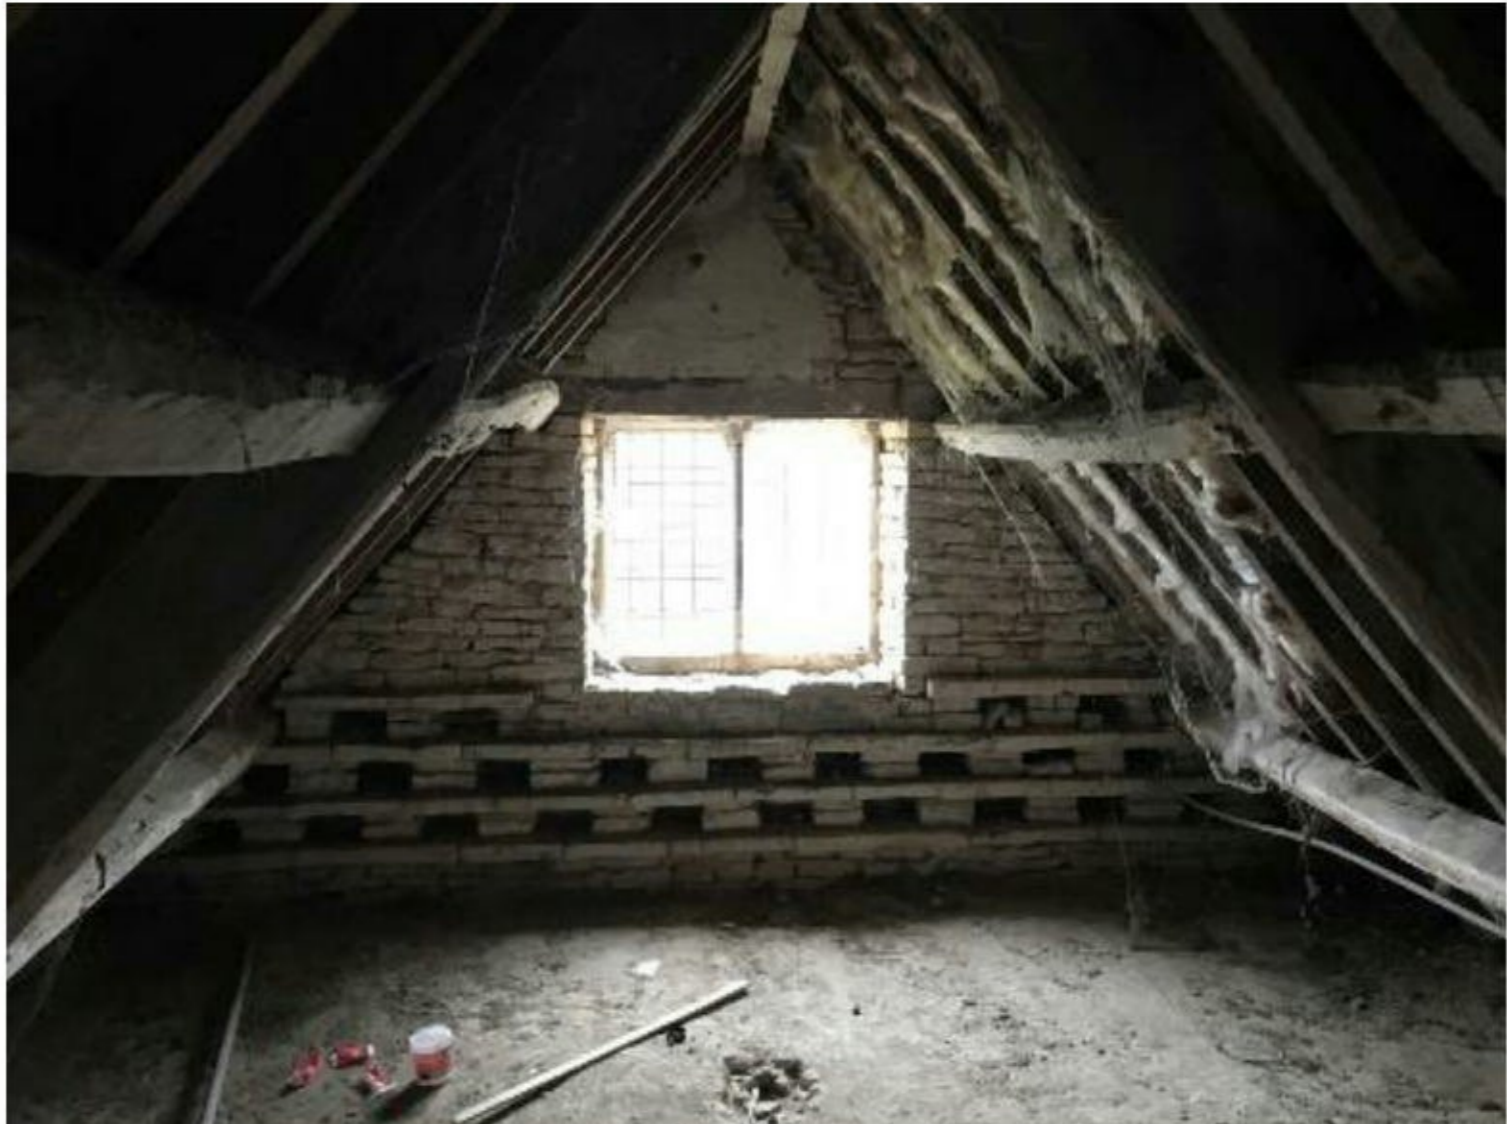
<p>Photo 9: Dove loft</p>
