# Ecological Assessment

## Middle Lypiatt

December 2020

**Project: ETH20-078**

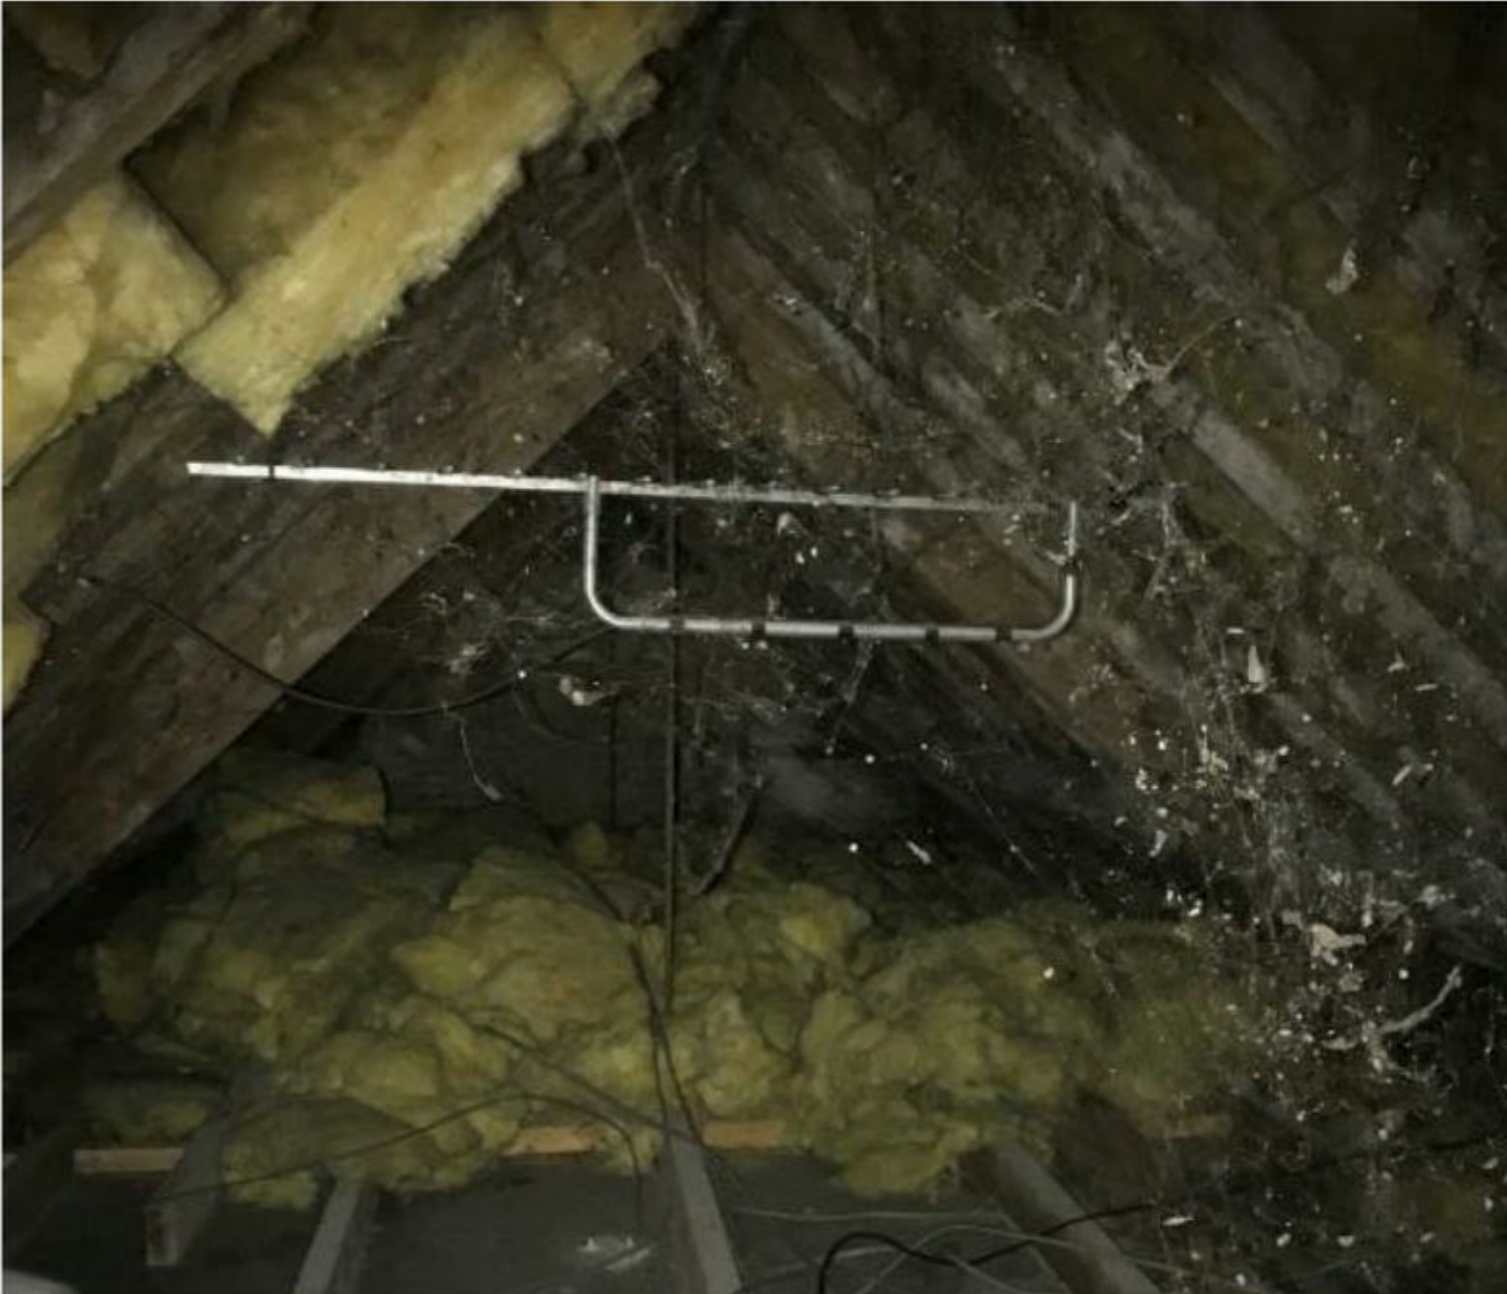
<p>Photo 10: Loft void</p>

<p>Large section of the 'T' was full of cobwebs with lots of rock wall insulation.</p> <p>It was assessed that B1 provided suitable conditions for roosting bats and several access points into the building. Therefore, the structure was assessed to hold <b>high potential</b> for roosting bats.</p>	
<p><b>B2 Outbuilding (not impacted within proposals)</b></p>	<p>B2 comprised an outbuilding divided into three section; 1) an outhouse, 2) storage, and 3) garden shed.</p> <p>Overall, the building was a single storey from floor to ridge beam, traditional build, limestone with Cotswold stone roof. Small gaps were present in the stonework as well as damaged tiles with gaps and lifting. The timberwork had gaps at the top.</p> <p>Section 1 is old fashioned drop toilet with bitumen felt between the timber and tiles. Approximately five old bat droppings were identified within this section.</p> <p>Section 2 was used for storage. Traditional construction, timber beams, bitumen felt and connected to section 3 by a gap in the internal wall. This section was assessed to have very low levels of light but limited potential access points for bats.</p> <p>Section 3 was used for garden machinery storage. There were skylights present within the structure and wooden beams with bitumen felt sarking with several gaps within the southern elevation.</p>	  <p><i>Photo 11: B2 in the left of the picture and gable of B3 on the right</i></p>   <p><i>Photo 12: Scattered bat droppings B2 section1</i></p>

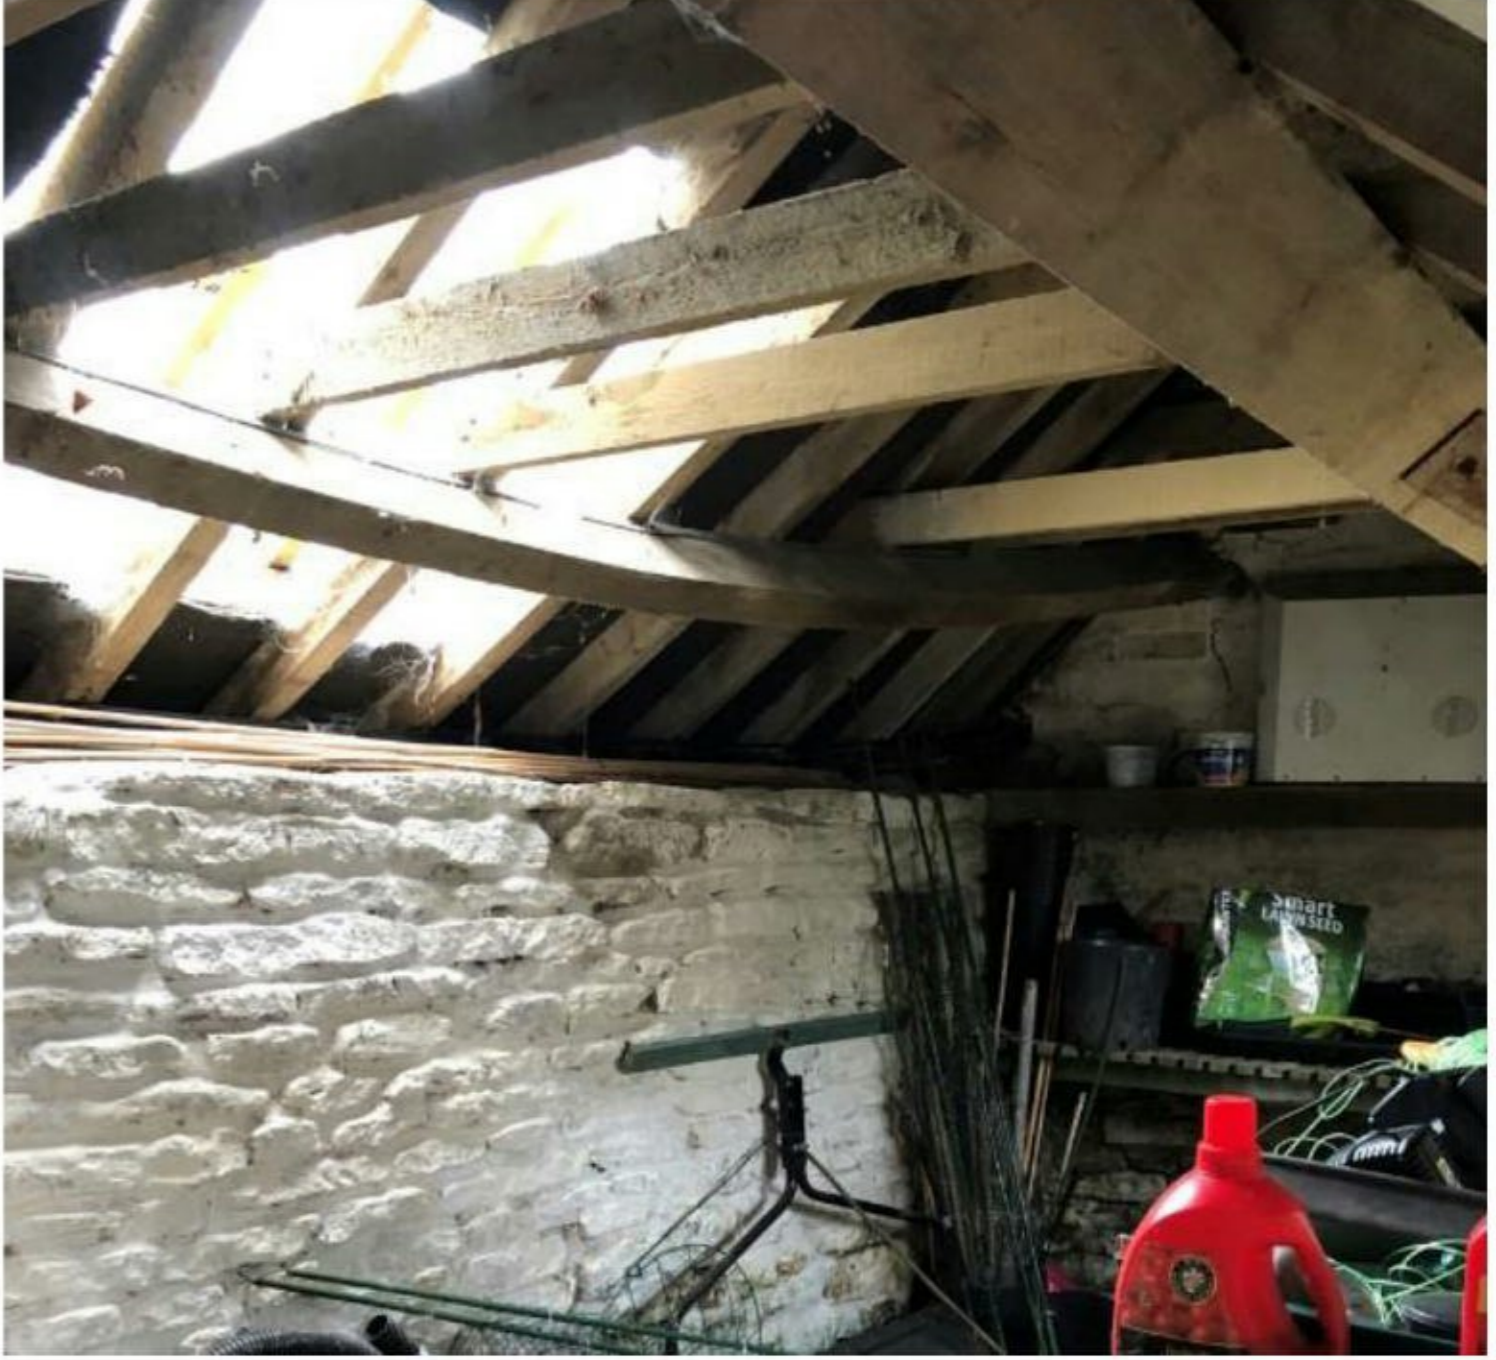
<p>Overall, it was assessed that the structure provided <b>high potential</b> for roosting bats</p>

<p>Photo 13: B2 section 3</p>
<p><b>B3 Outbuilding (Convert to ancillary accommodation)</b></p>	<p><b>External</b> B3 was connected to the north-eastern gable of B2. The building was used for storage of tools and was assessed to be actively used on a regular basis.</p> <p>The building was of traditional construction, limestone build, with tight shingle pitched roof which was in a good structural condition. The fittings were wooden with flush lead flashing, and PVC guttering.</p> <p>The southern elevation included three dormer bay windows which were all tight and in good condition.</p> <p><b>Internal</b> The structure included an iron gate and the internal features were freely accessible for bats.</p> <p>The building contained modern timbers and bitumen felt sarking.</p> <p>There was a dividing wall within the structure creating two rooms. There was no loft void of the structure was a single void from floor to ridge beam.</p>

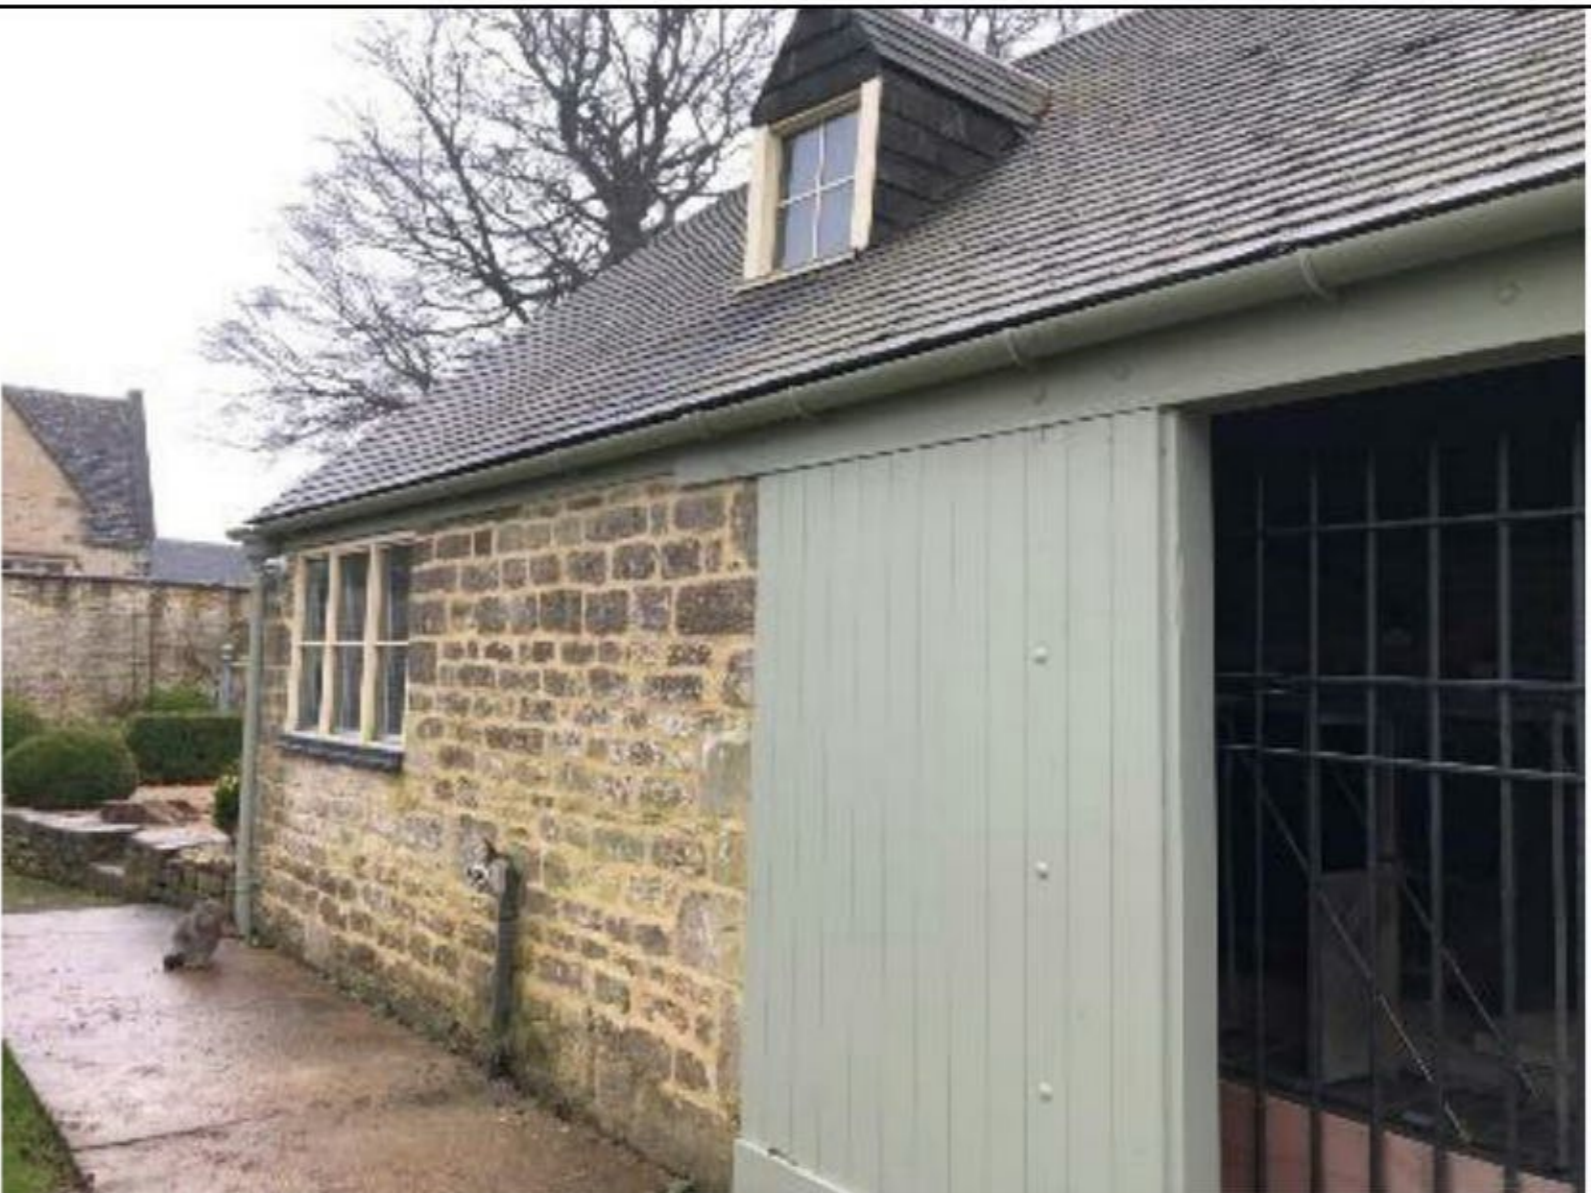
<p>Photo 14: B3 southern elevation west</p>

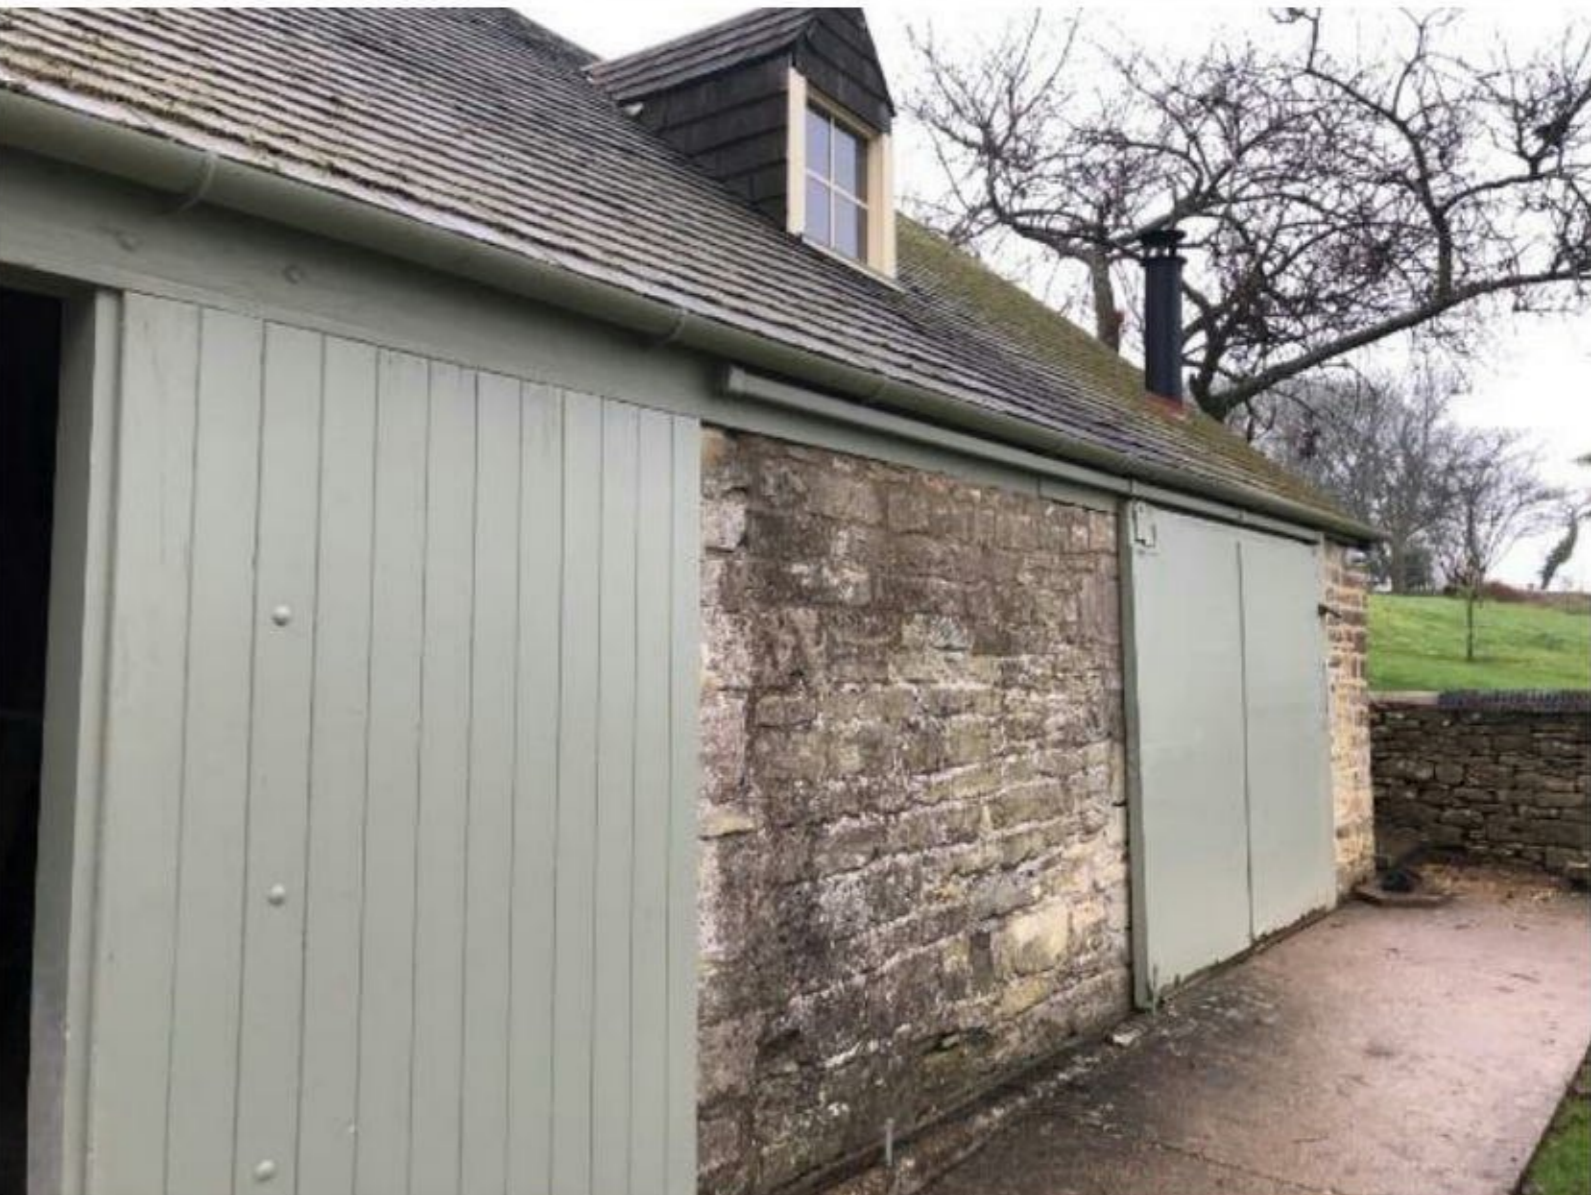
<p>Photo 15: B3 southern elevation east</p>

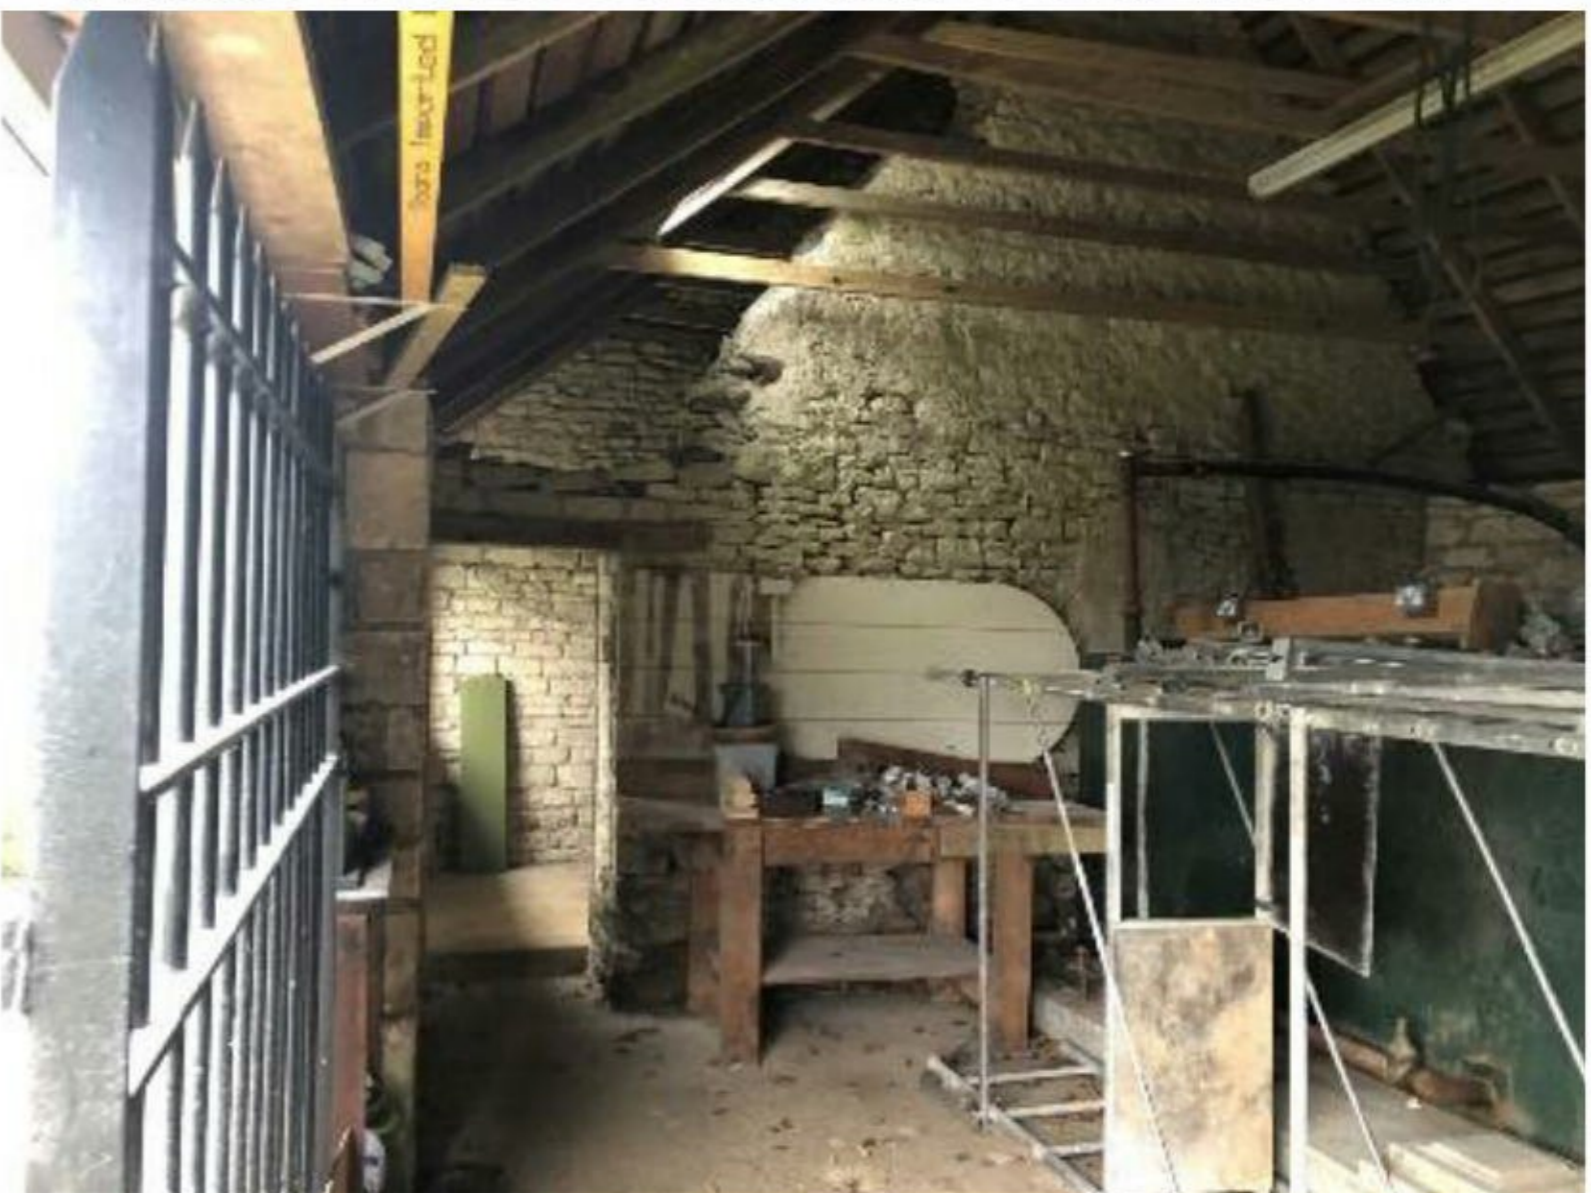
<p>Photo 16: B3 internal</p>

<p>There were five swallow nests located on the ridge beam of the structure.</p> <p>Approximately three droppings were identified on a workbench to the west of the structure.</p> <p>Although the external features of the structure were tight and in a good condition it was assessed that the internal features of the structure were freely accessible to bats and may provide roosting opportunities for low numbers of bats. Therefore, the structure was assessed to provide <b>high potential</b> for roosting bats.</p>

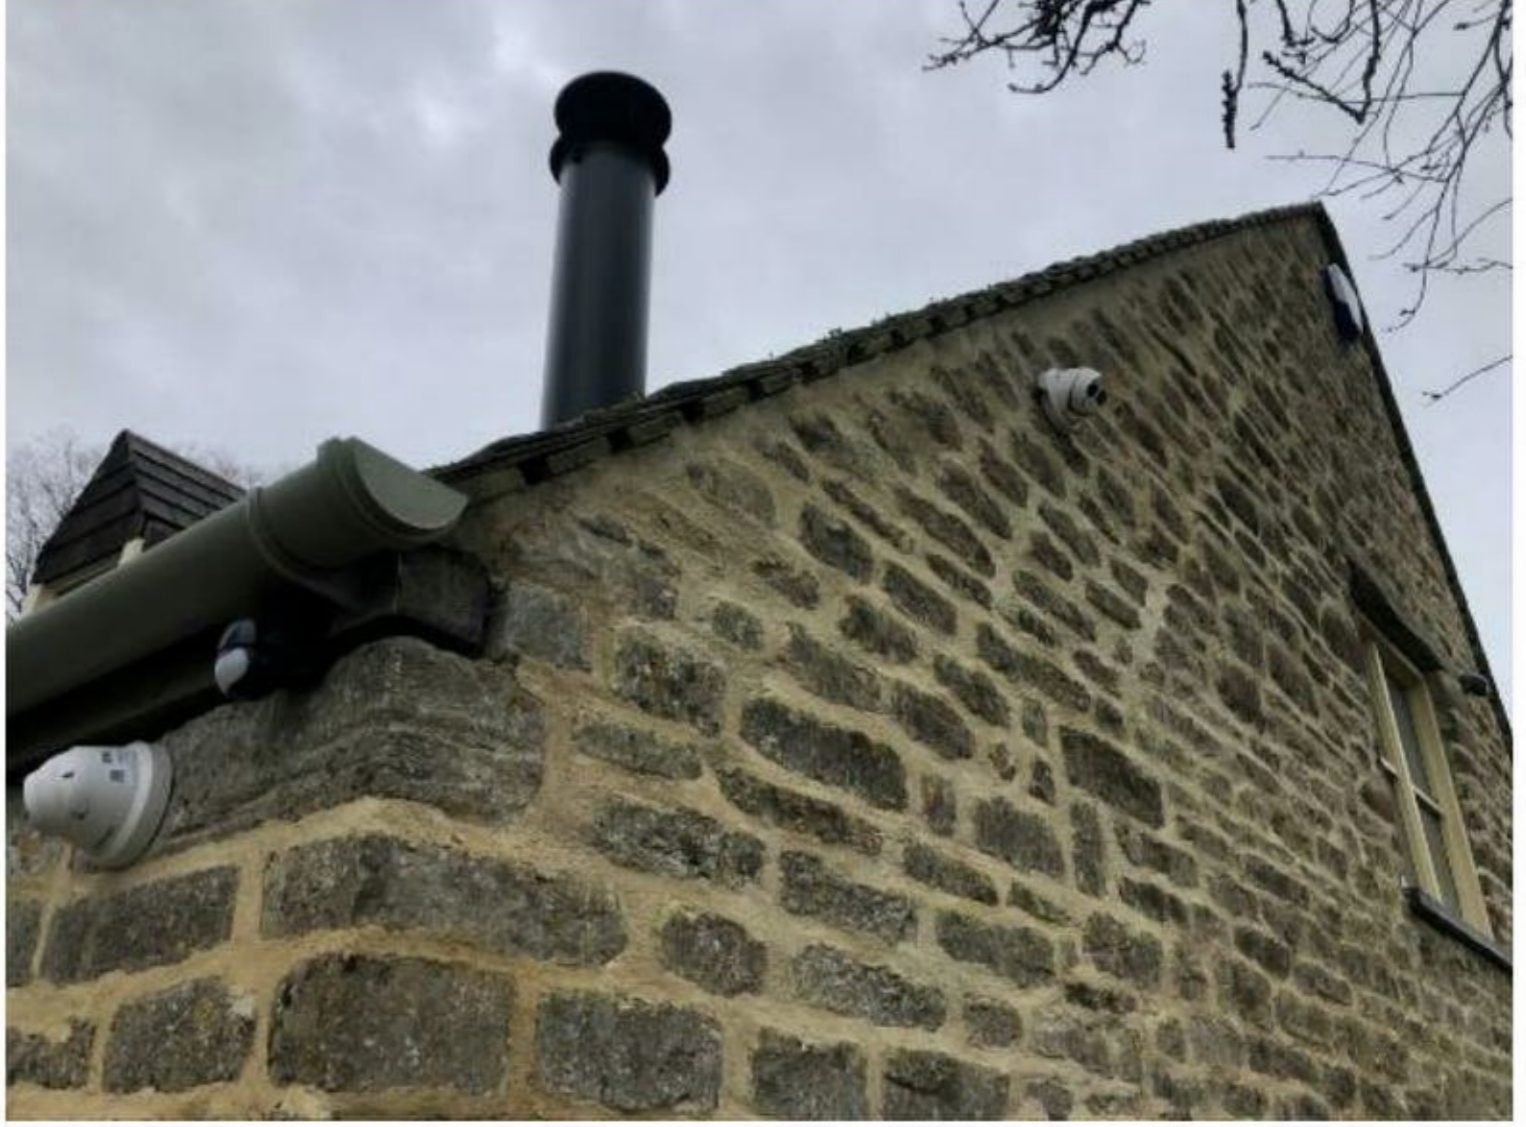
<p><i>Photo 17: B3 eastern gable</i></p>
--	---	--

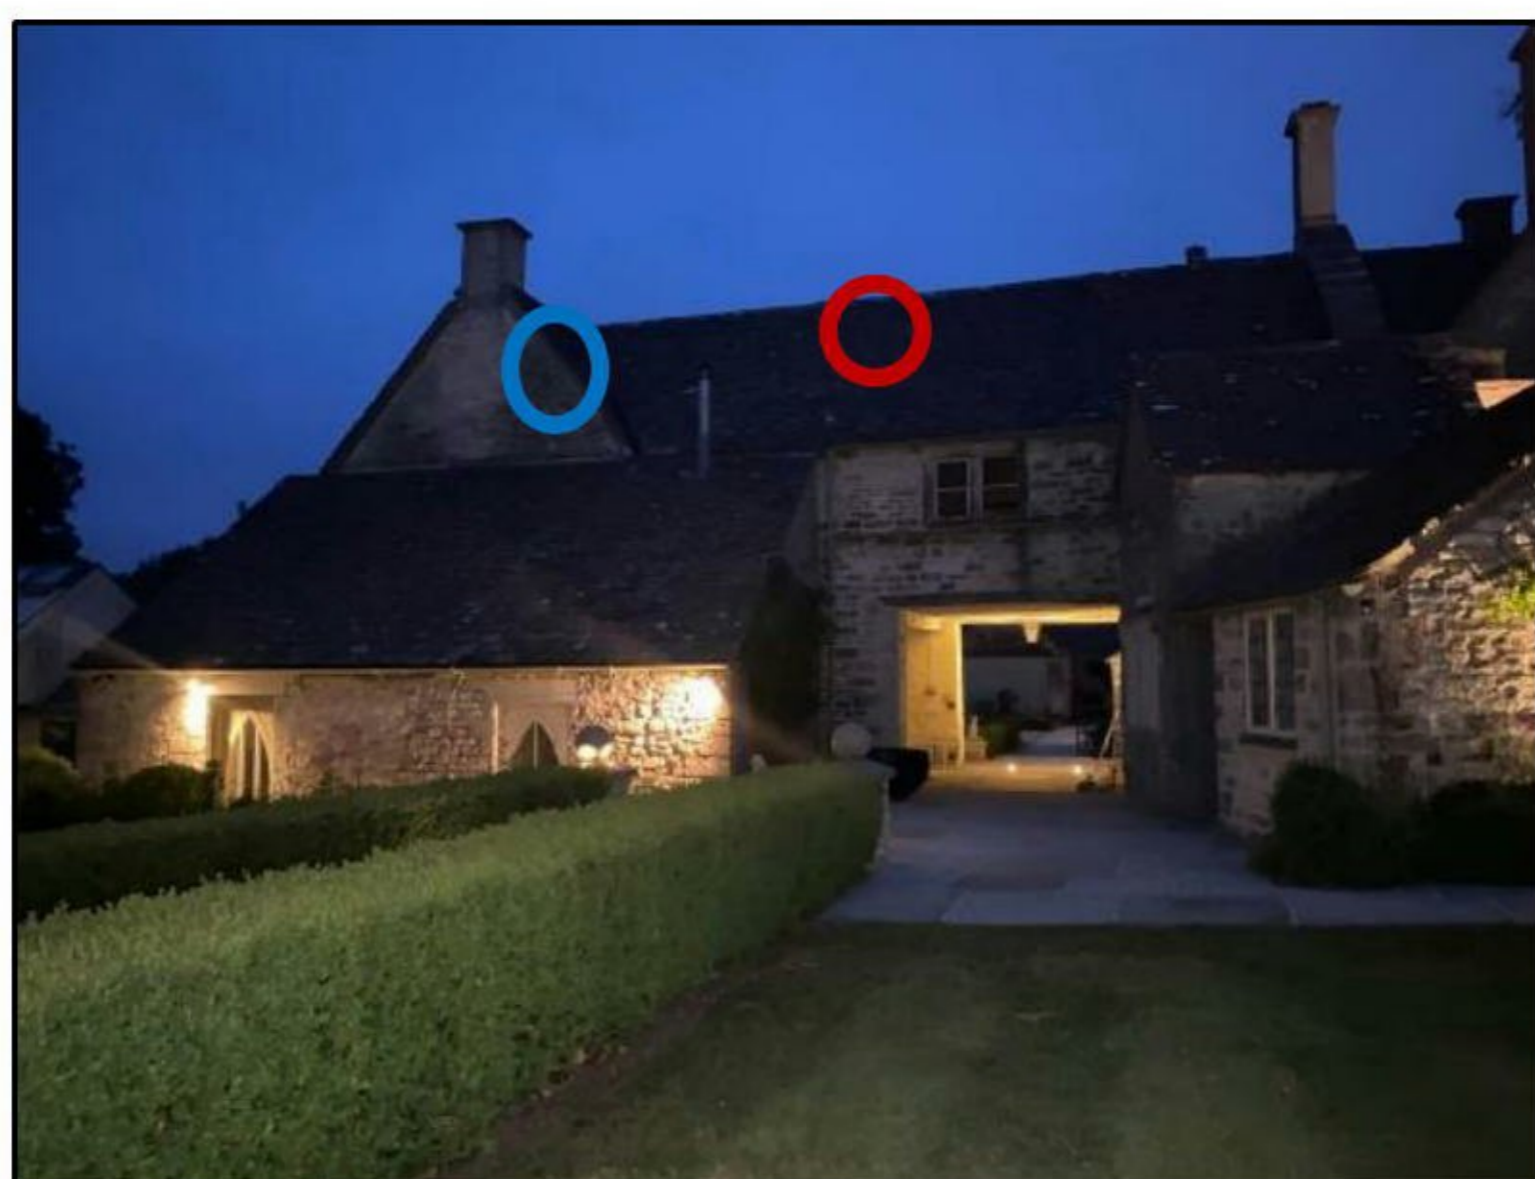
Constant CP foraging onsite with NP recorded onsite. Also, a DAUB was recorded during the survey. One CP was recorded emerging from under the tiles of the northern gable of B1 at 21:22 (Photo 16). Two CP were recorded emerging from the main structure (Photo 17), which is not included within the proposals.

Photo 16: emergence locations B1

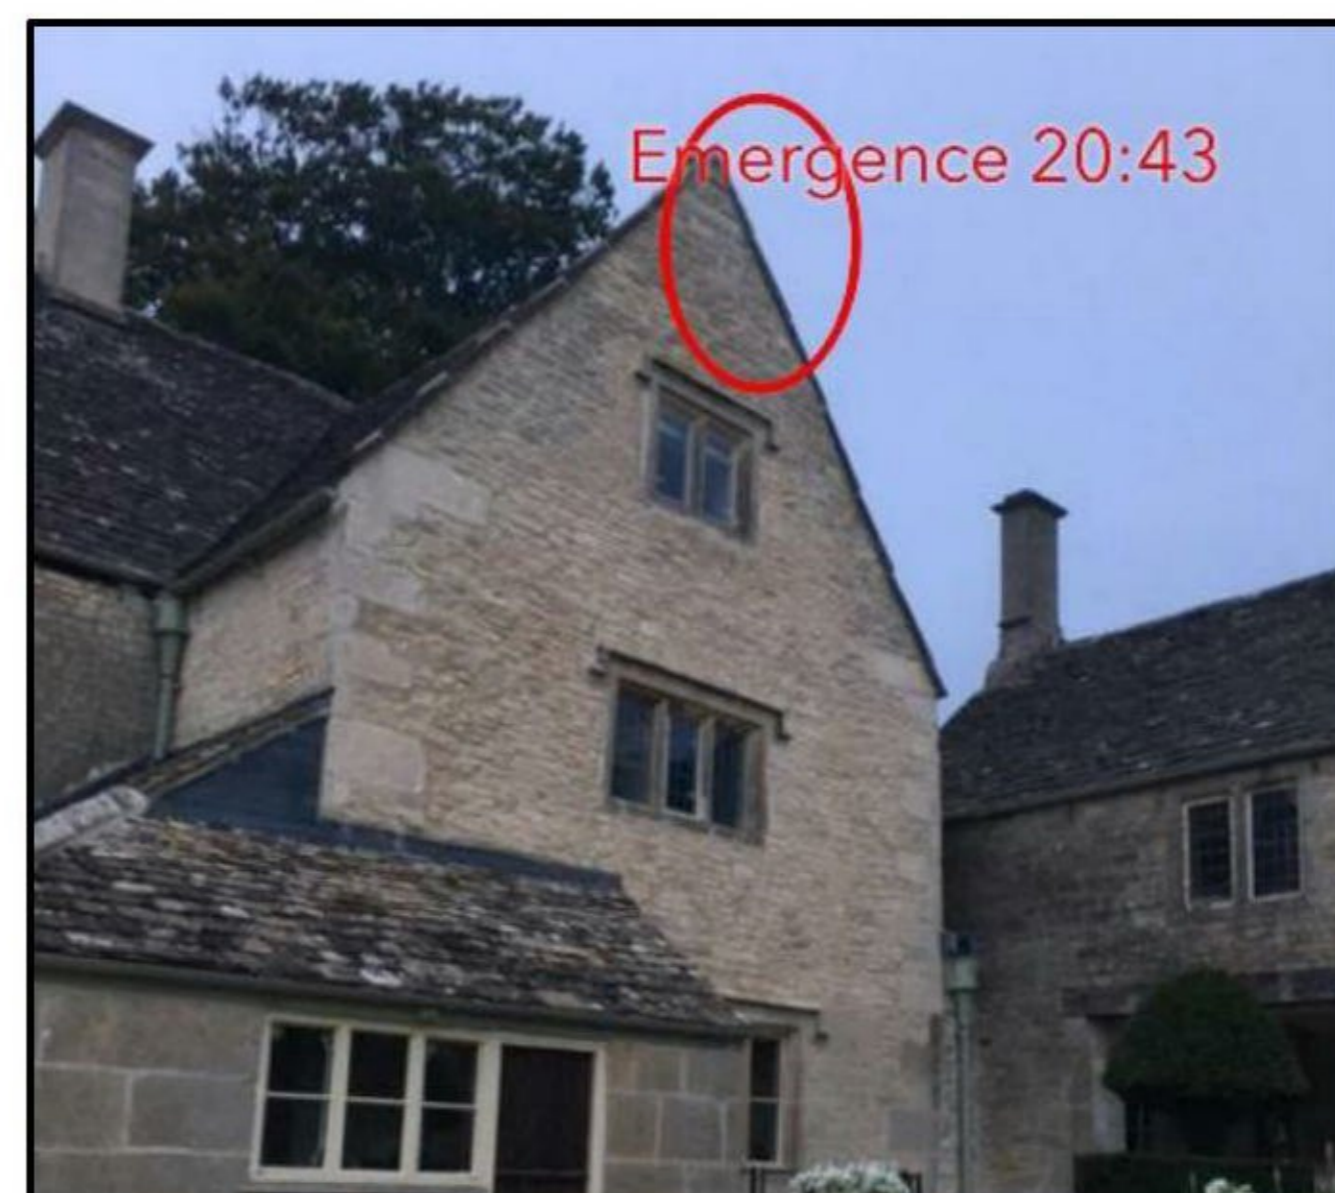
Photo 17: Emergence location of building west of B1 not impacted

Four bats were recorded emerging from the main house (north of B1) which is being retained within the proposals. Suitable lighting has been recommended within Section 8.2.2 to ensure no excessive light spill and that artificial lighting is directed away from any existing roosts. Additionally, good working practices were recommended to avoid light pollution during the development works.

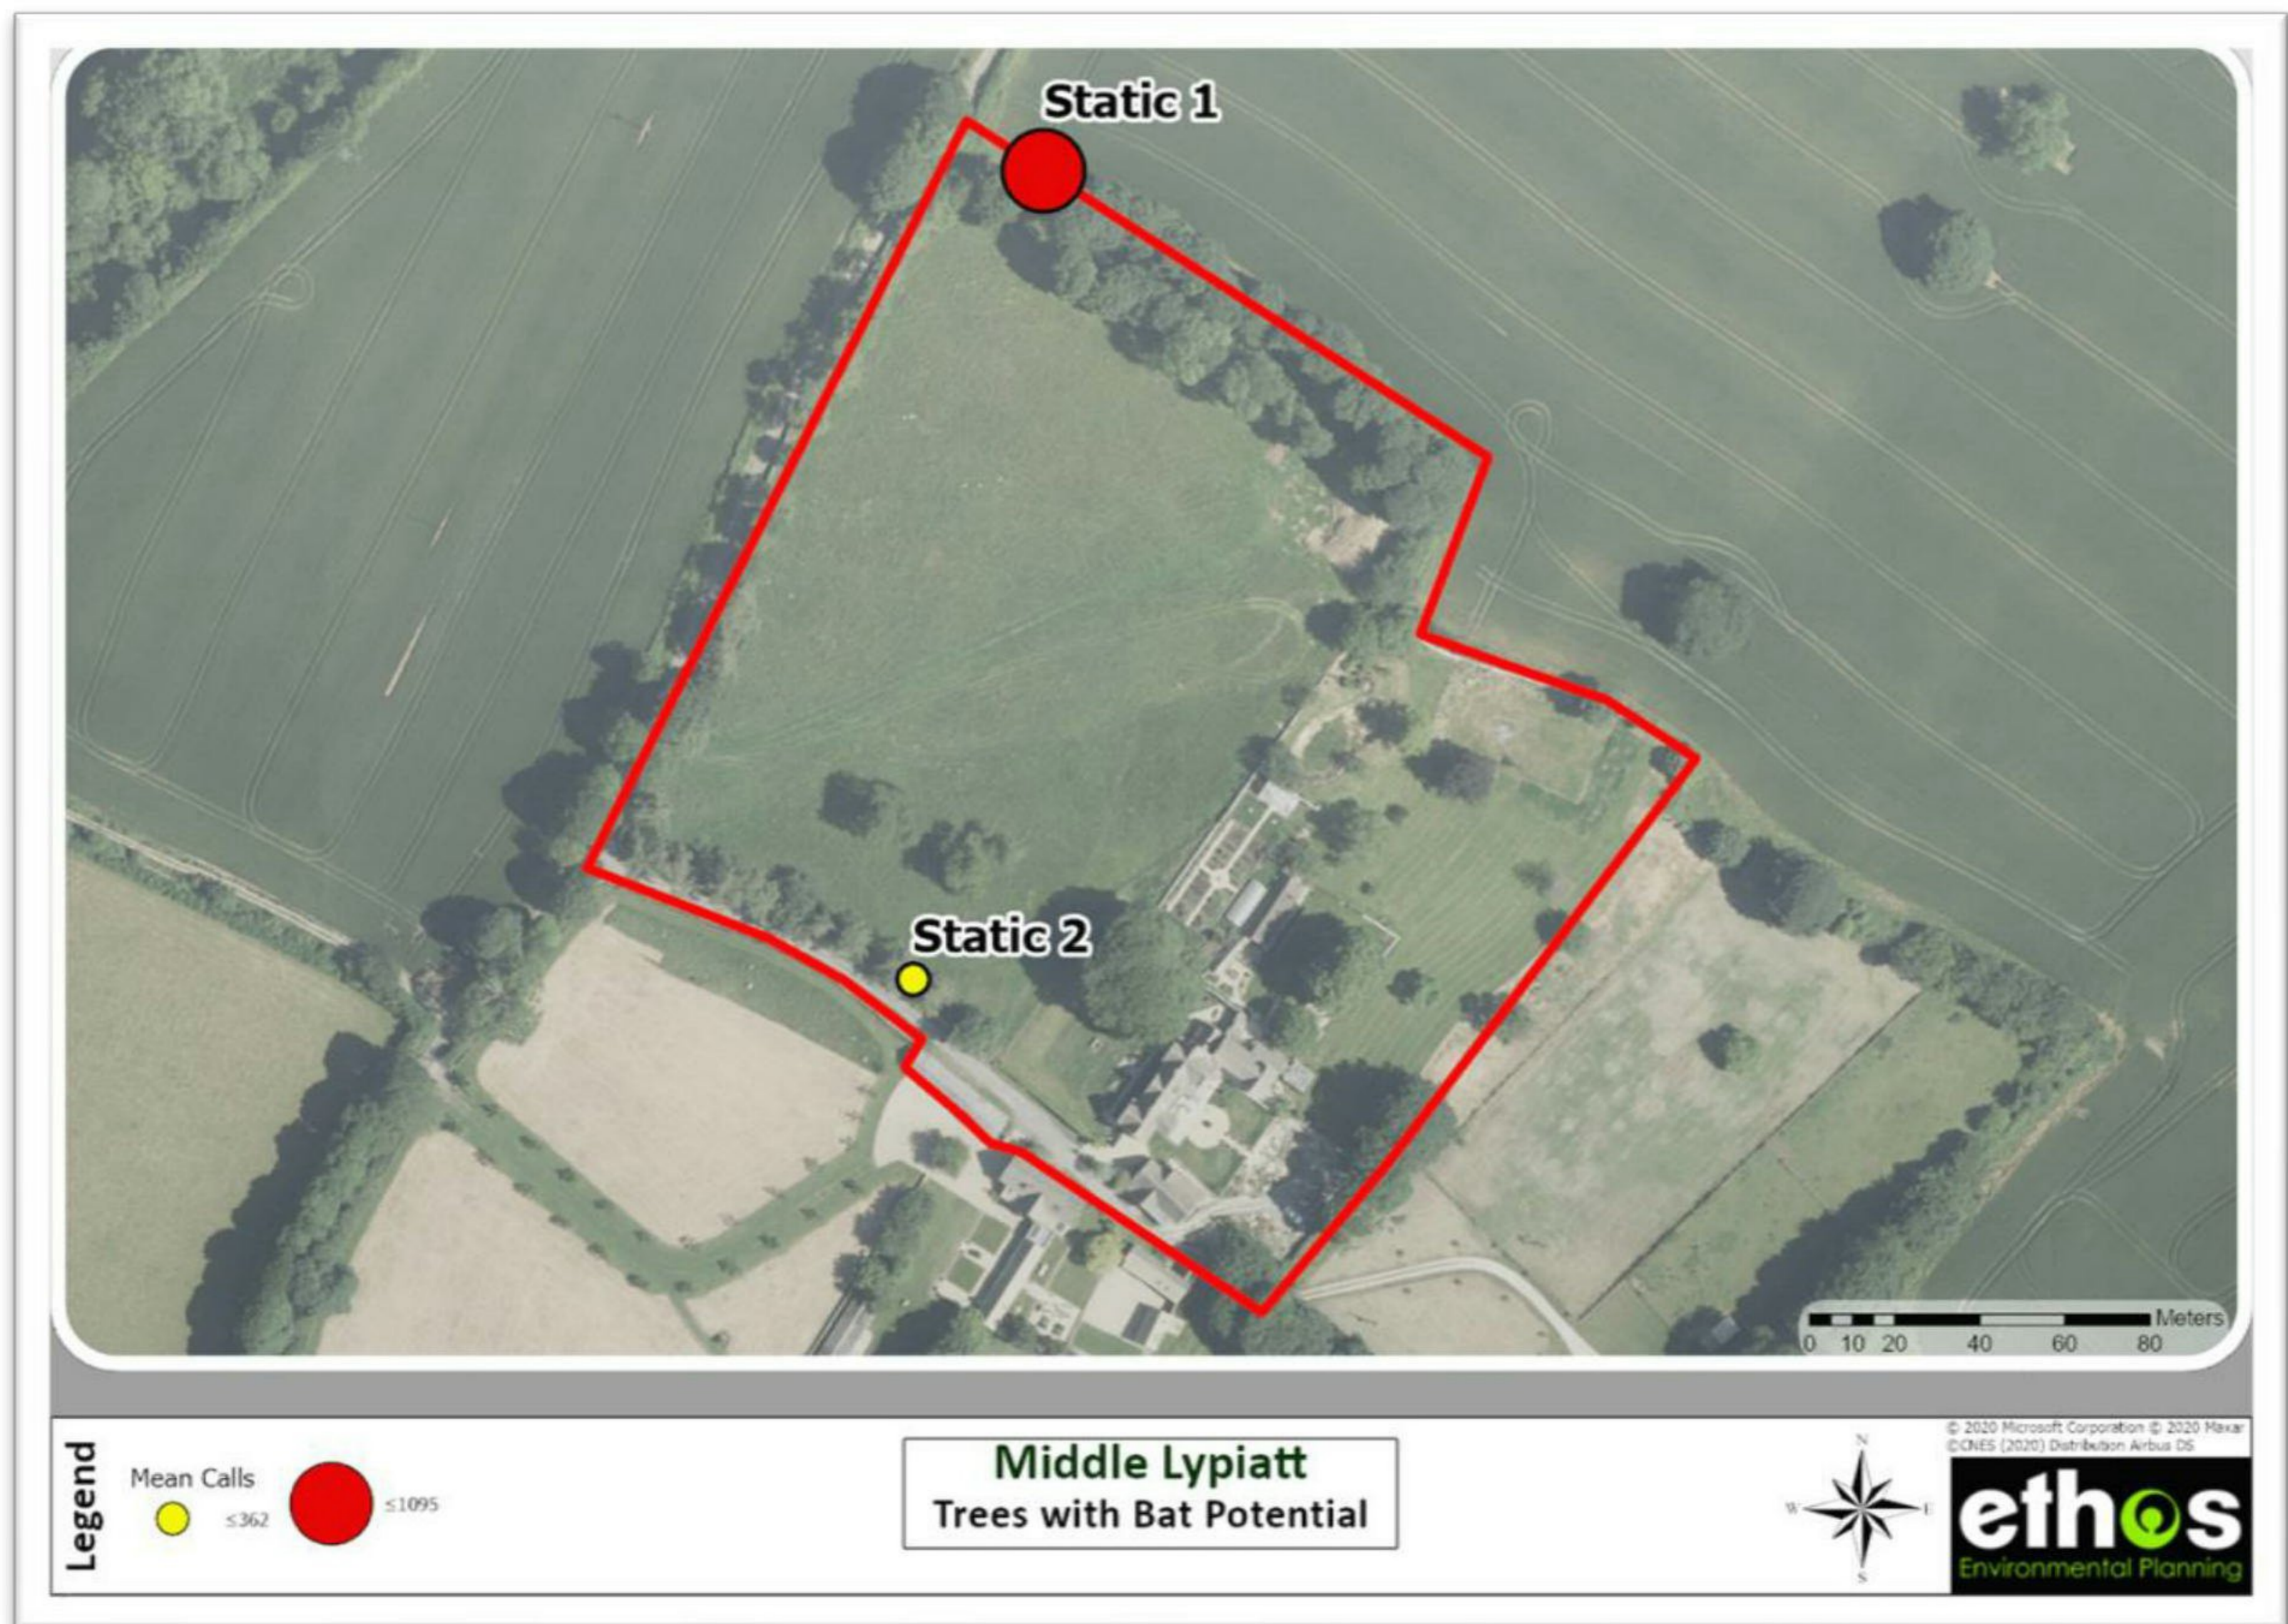
Figure 15 Comparison of static detectors

- There were eleven bats species identified on the static detectors.
- Three Annex II species were recorded, namely LHS, GHS and BARB.
- The bat calls were dominated by CP with 93.22% of the overall calls.
- Five calls were recorded of BARB over the entire survey period indicating that there were several passes and not indicative of prolonged foraging onsite.
- There were 12.22 mean calls of LHS over the entire survey period, which was the fifth most common bat recorded onsite.
- LHS and GHS were recorded at both static positions.
- GHS were recorded in low numbers (1.94 mean calls) over the entire survey period.
- GHS were not present during the months of May and June.
- There were 1095 mean calls recorded at static position 1, compared to 362 at static position (visualised in Figure 14).
