# Ecological Assessment

## Middle Lypiatt

December 2020

**Project: ETH20-078**

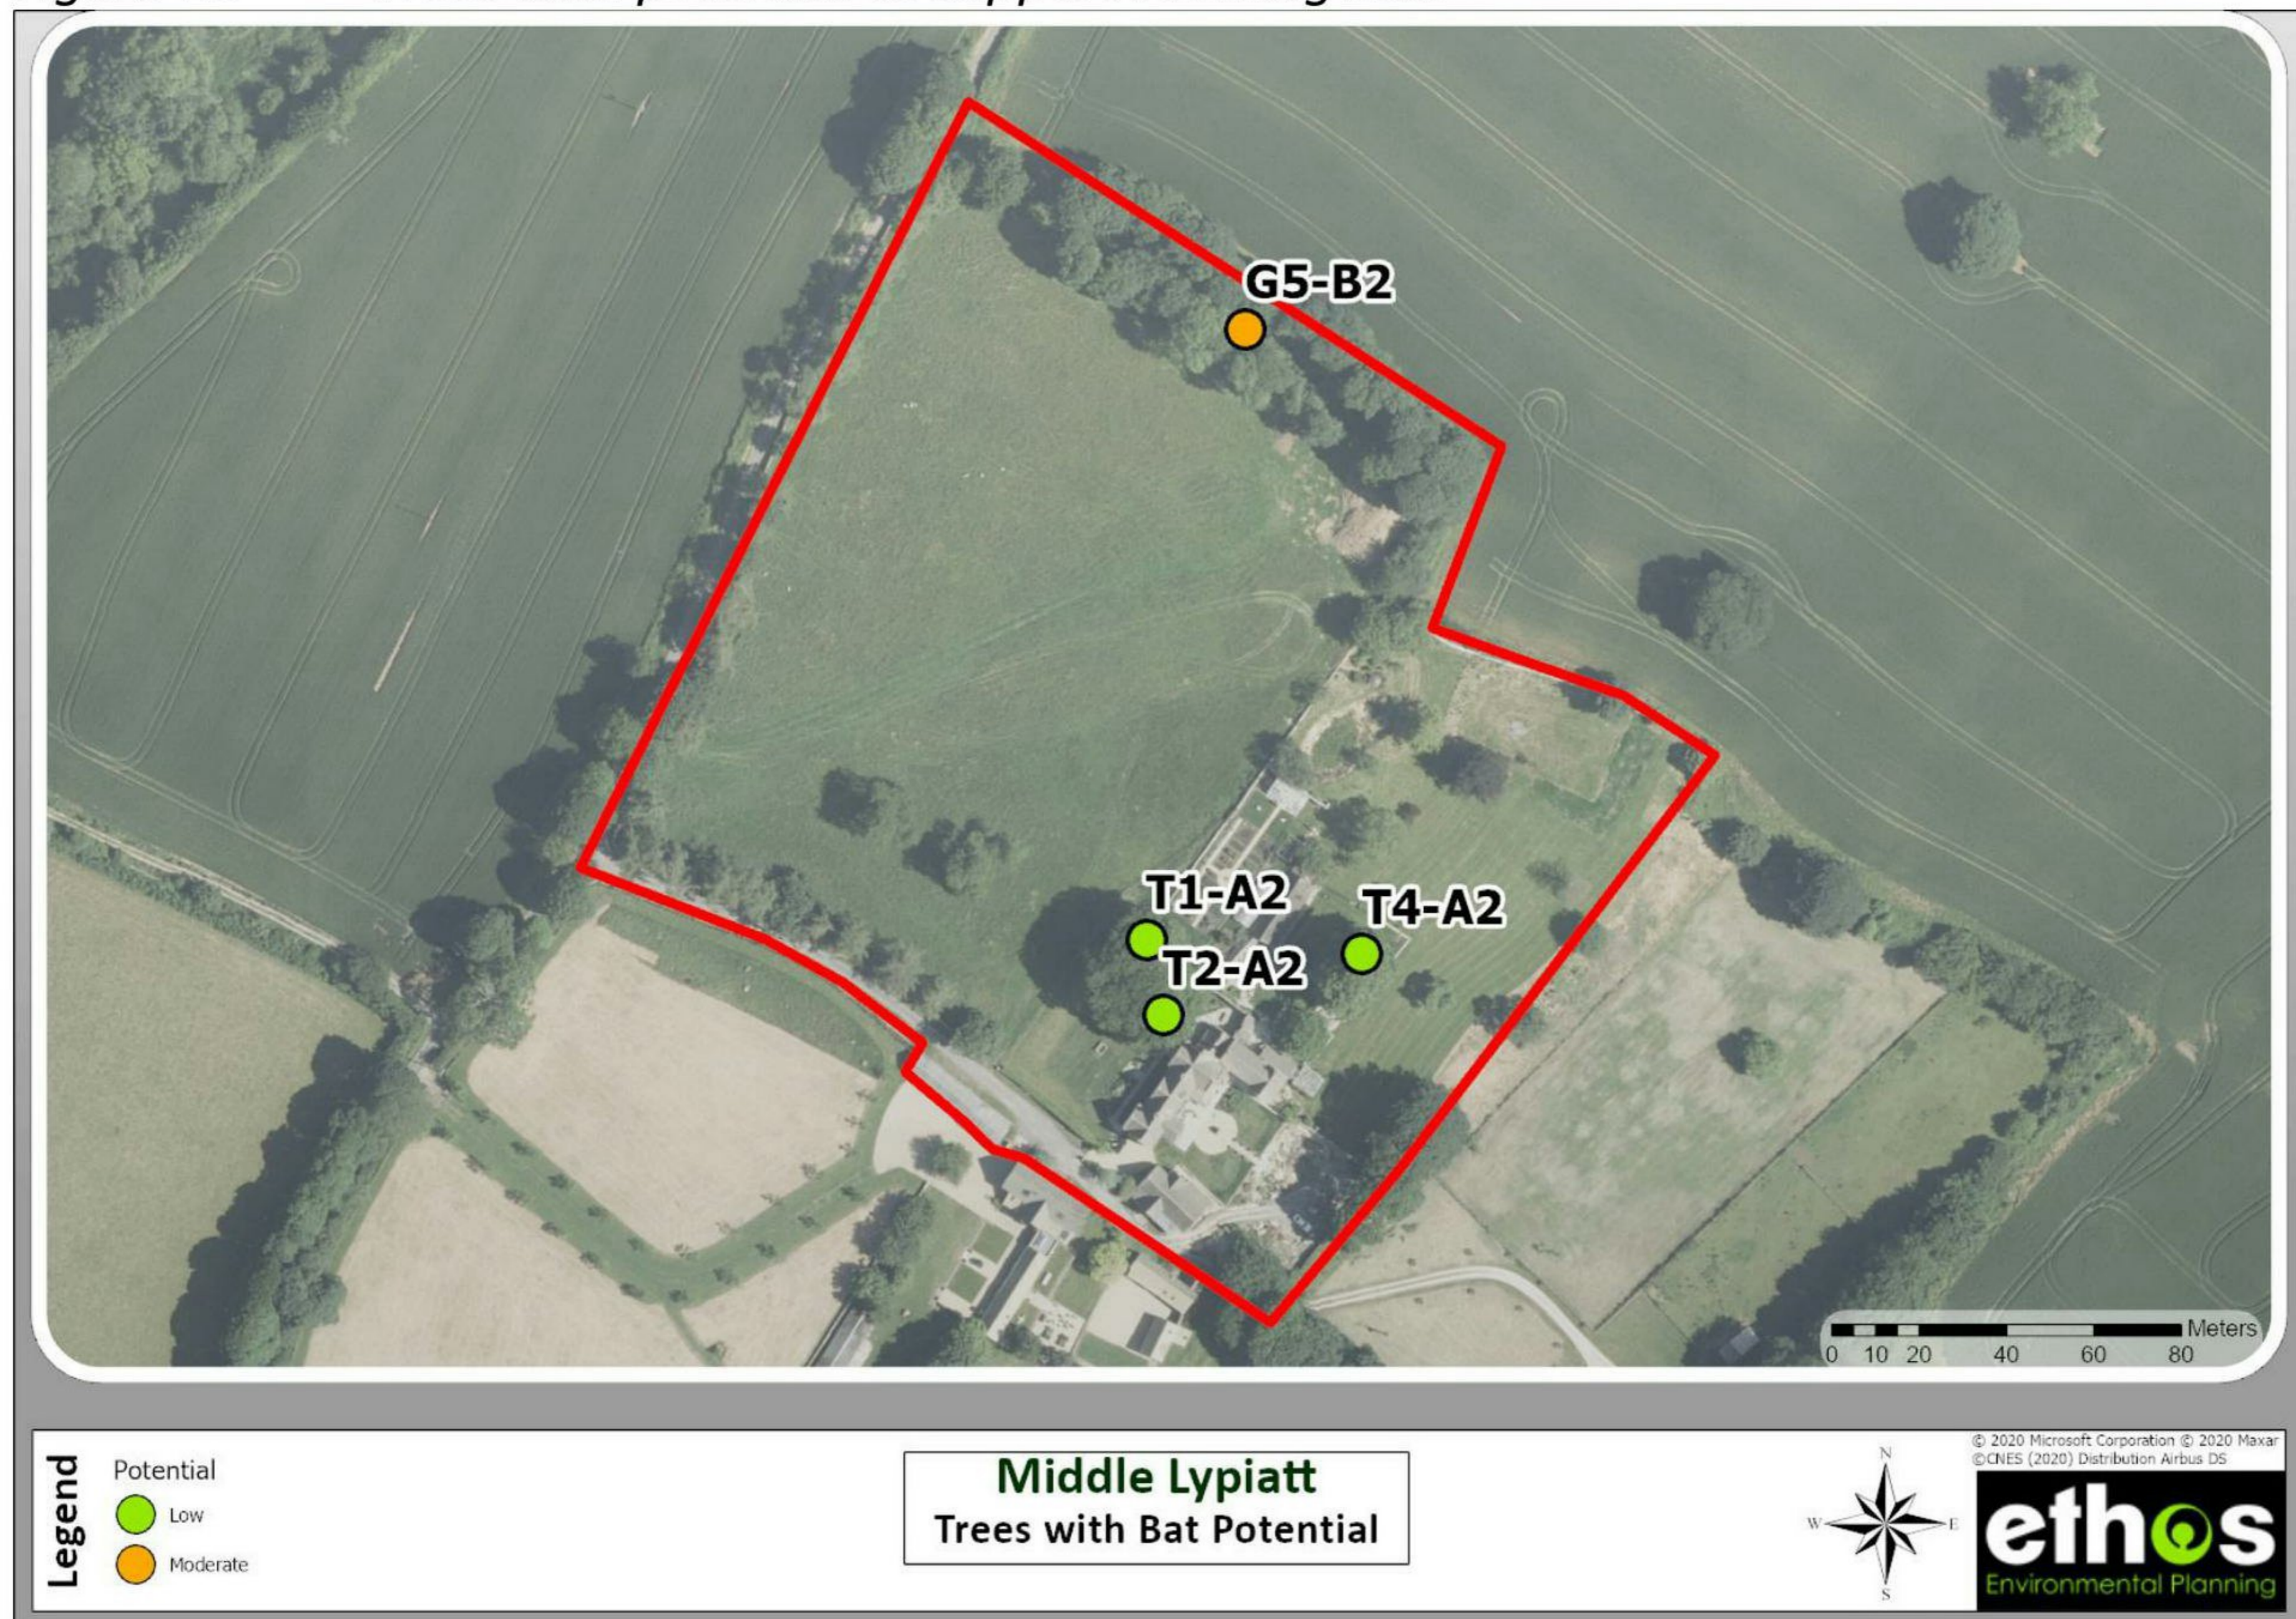
Figure 16 Trees with potential to support roosting bats

The ground level roost assessment surveys identified four trees as having the potential to support bats, as shown in Figure 13. The remaining trees were assessed to contain negligible potential for roosting bats; the tree survey has been provided by Barton Hyett Associates and is detailed in Appendix 1.

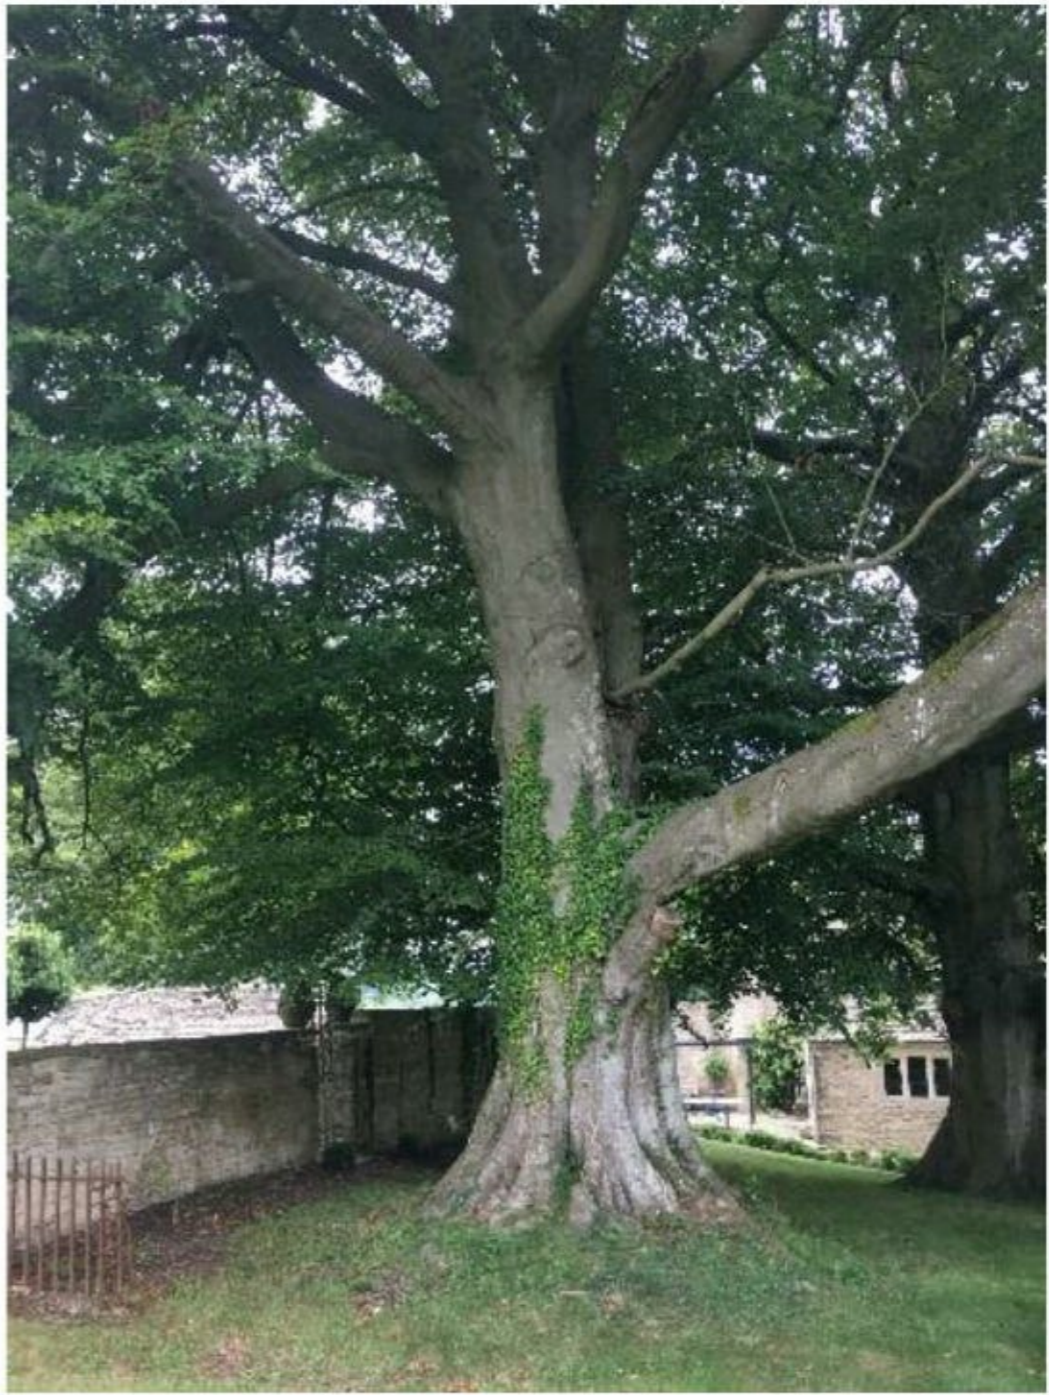
Tree Number	Species	Description	Potential	Photo
T1 – A2	Beech	Height 20m, mature, tear out on lower limb on lower edge of the branch, tear out on higher branch facing downwards, tear out on branch higher up on southern elevation. Dead limb on western elevation. Dead over hanging limb on eastern elevation. Although, there were multiple features they were assessed as being exposed and superficial providing low potential for rooting bats	Low

<p>Photo 16: T1 -A2</p>
T2 – A2	Beech	Height 21m, mature. Small dead limb coming off western elevation, two pruning cuts on western elevation (unsure of depth). Three suitable features in total.	Low

The three low potential roost trees and the one moderate potential tree identified by the ground level roost assessment are being retained within the proposals. Recommendations will ensure that they are not subject to increased lighting levels as part of the proposals.

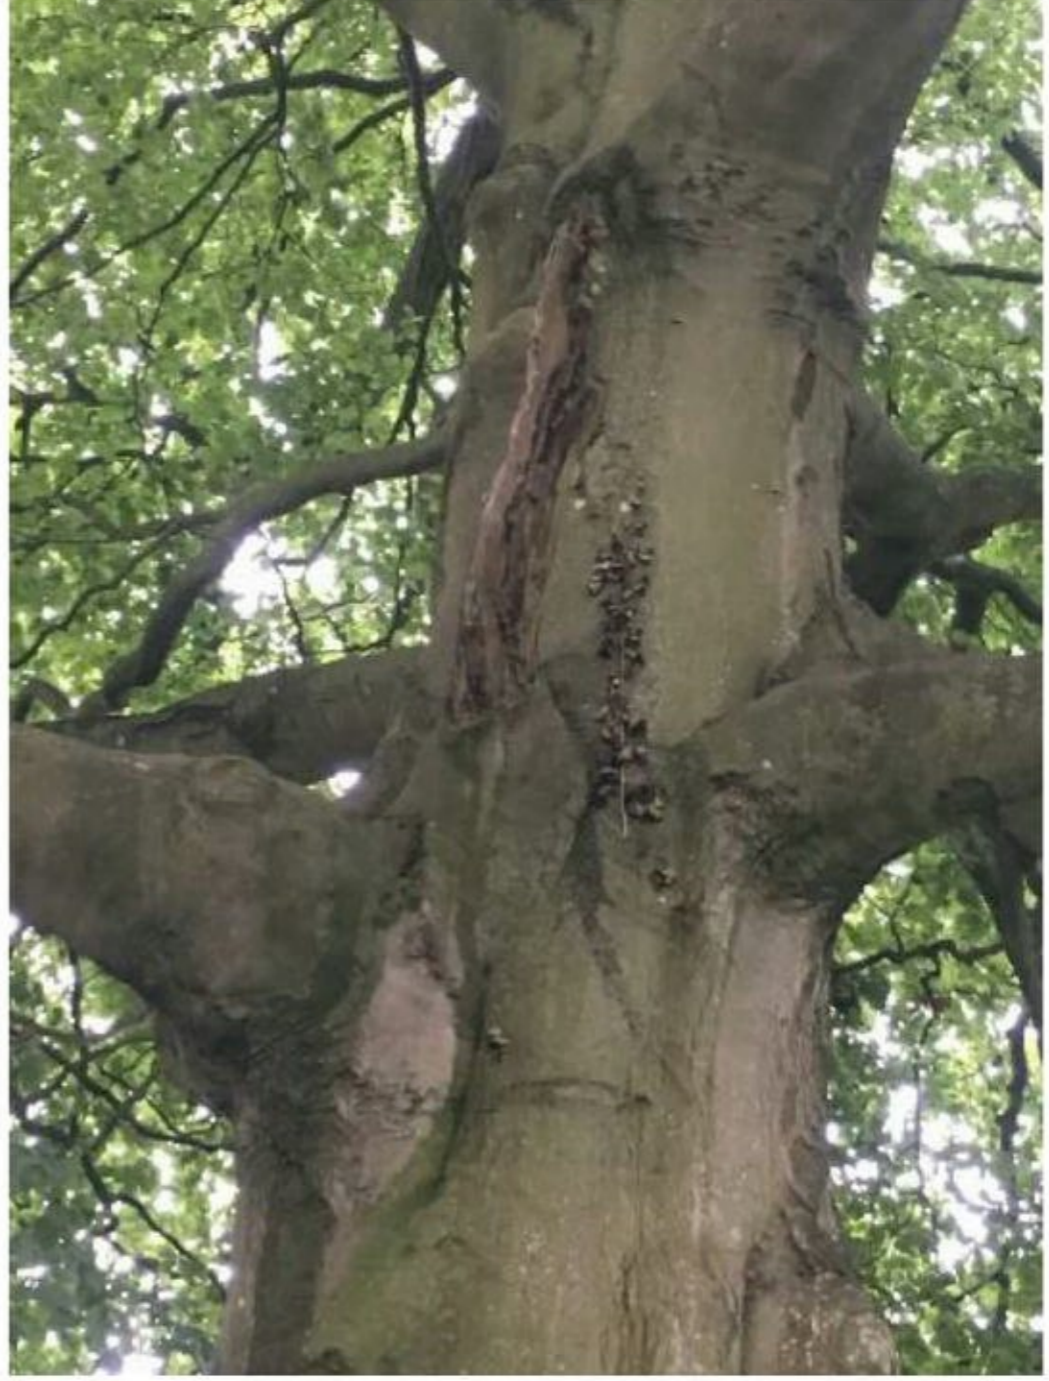
<p>Photo 17: Main stem T2 -A2</p>
T4 -A2	Lime	Height 21m, mature, crack on western branch, weld on eastern branch approximately 35 mm deep.	Low

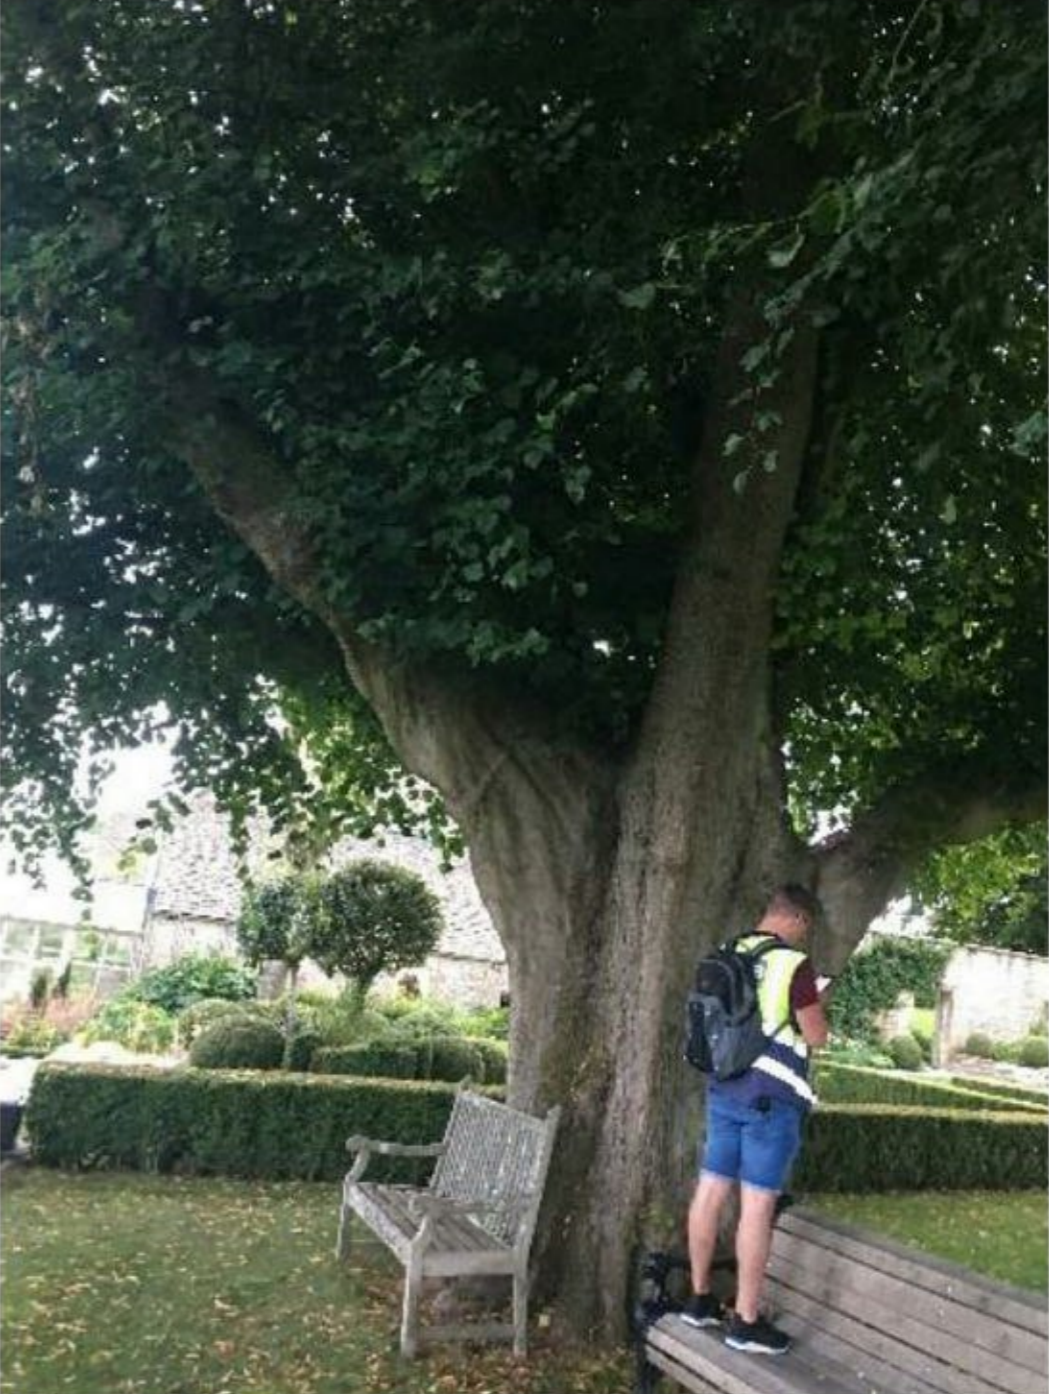
<p>Photo 18: T4 – A2</p>

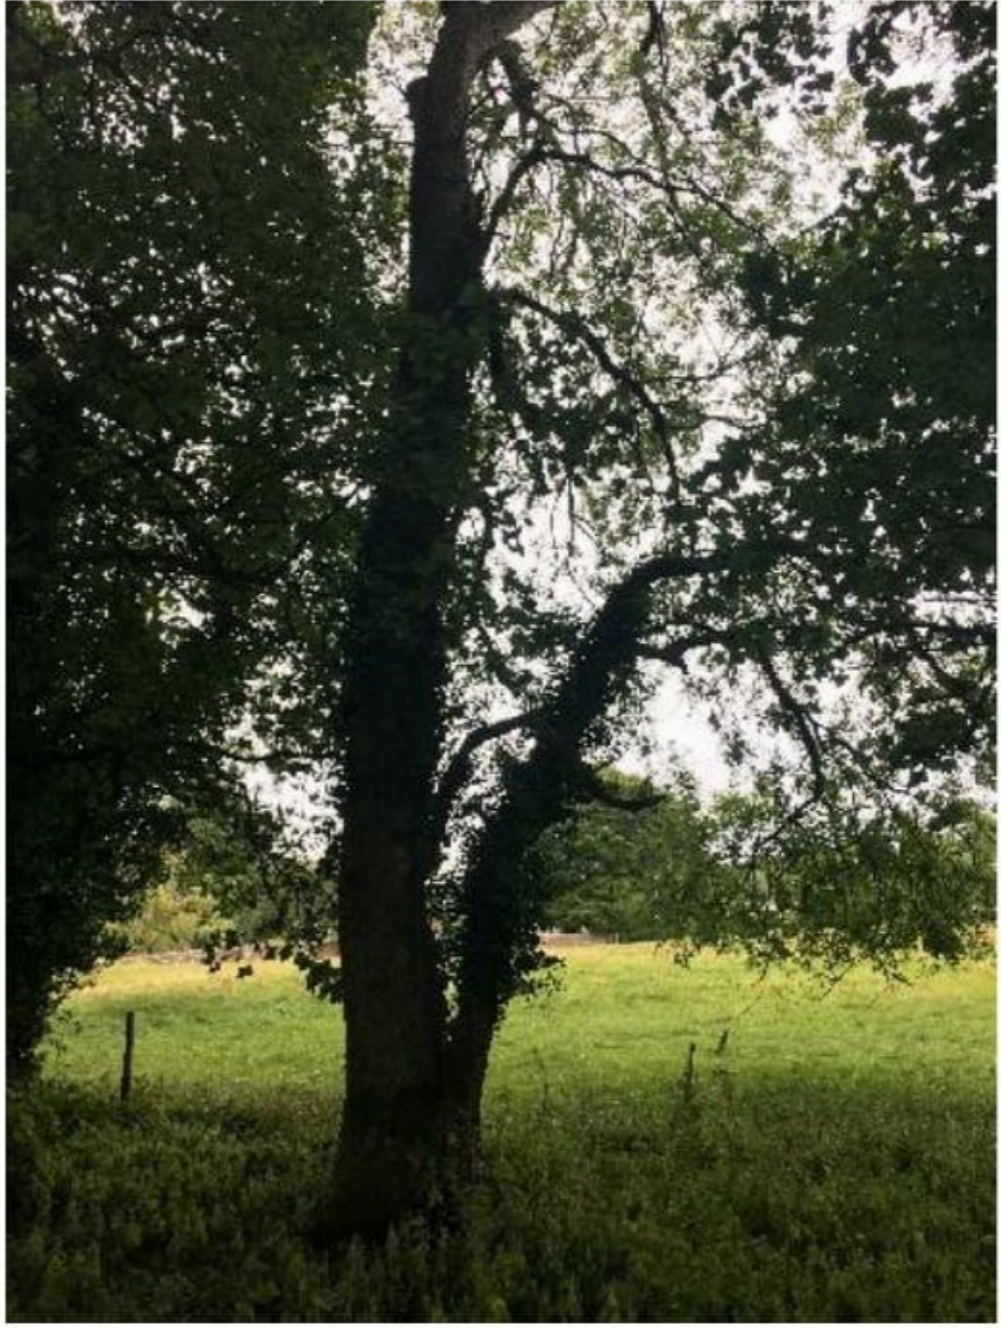
Tree Number	Species	Description	Potential	Photo
G5 – B2	Ash	Mature ash. Pruning hole at approximately 10 metres height on northern elevation, large woodpecker hole on eastern elevation at 12 metres. Pruning cut on eastern fork facing up. Wound on southern elevation.	Moderate

<p><i>Photo 19: G5 -B2 ash with features</i></p>

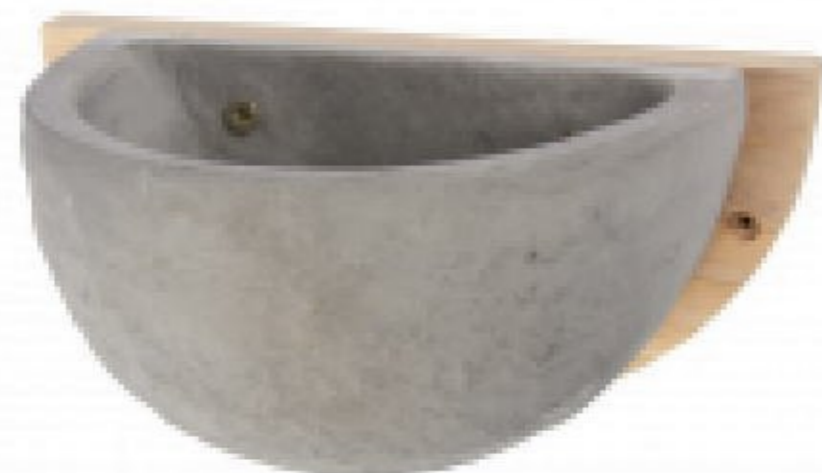
Ceramic nest bowl	6	<b>Species:</b> Swallow Ceramic nest bowl mounted on a wooden back	Installed under eaves. 2-3m height minimum. On eastern gable of new garage

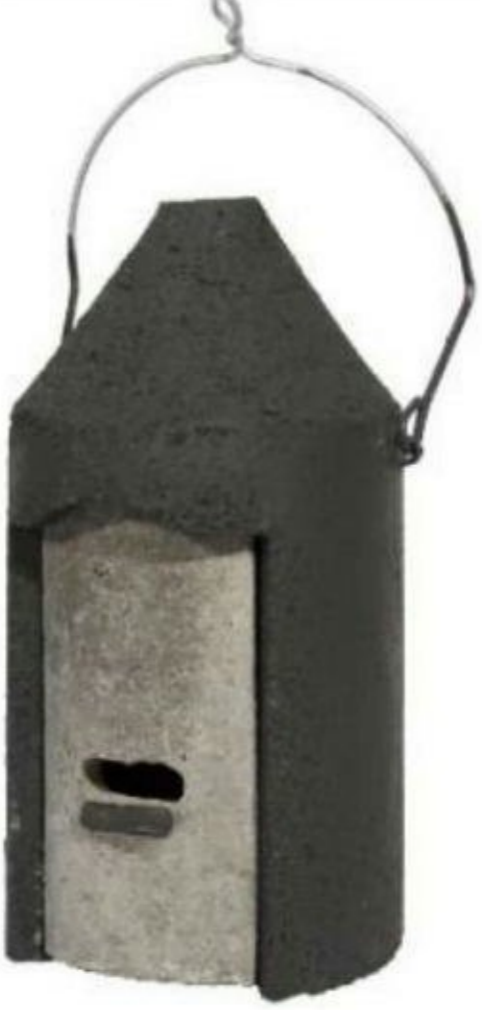
<p>2F Schwegler Bat Box</p>	1	<ul style="list-style-type: none"> <li>• 33 (h) x 16 (d) cm</li> <li>• Weight 4kg</li> </ul> <p>Woodcrete, blend of concrete and clay which will not rot, leak, crack or warp. 20-25 years lifespan. Removable front panel.</p>	<p>Installed between 3-6m within a mature tree onsite.</p>
