**STATEMENT OF HERITAGE SIGNIFICANCE
KINGSLAND HOUSE, SALWAYASH, NETHERBURY**

Peter Child MA (Cantab), Dip Conservation Studies (York), IHBC

This statement is prepared on behalf of Sadie Snelson and Matt Boyd in accordance with the requirements of West Dorset, Weymouth & Portland Local Plan 2015 polices and NPPF advice to inform an application for listed building consent for alterations to the house.

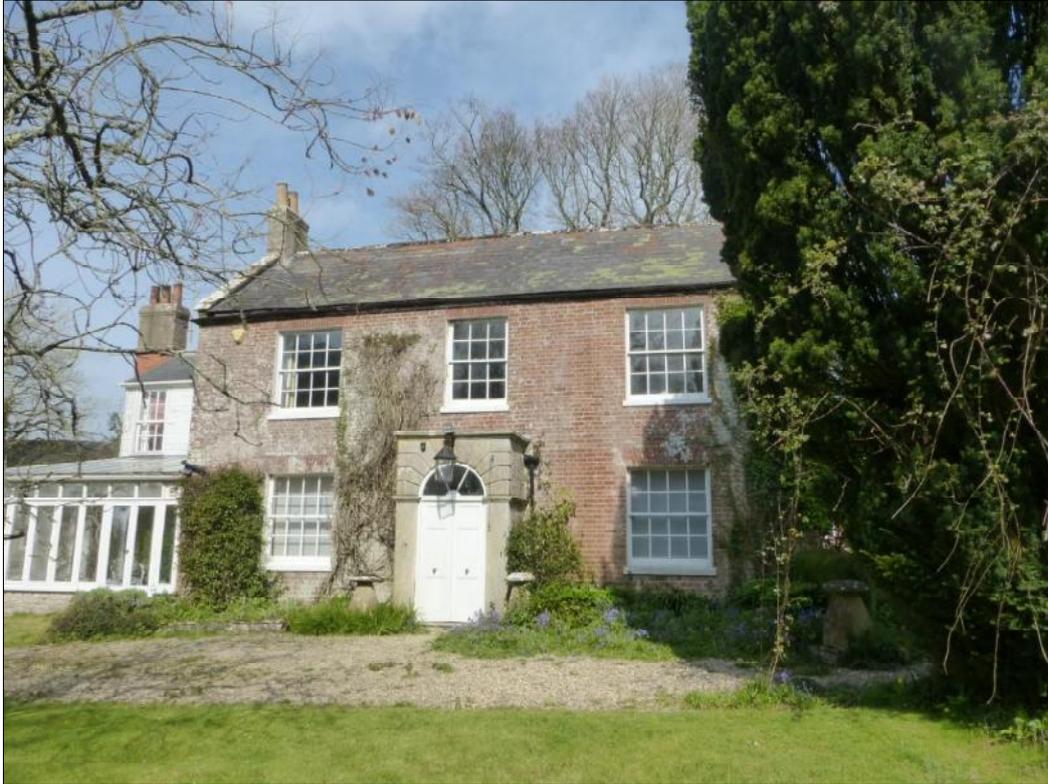
Fig.1 Kingsland House: Front elevation.

2.1 The two-storey house is constructed in red brick in Flemish Bond under a slate roof with coped gables. It originally had a symmetrical principal elevation with a single window on either side of a central entrance behind a substantial enclosed porch (Figure 1). The windows in the front elevation are original sliding sashes, all except that over the entrance, of eight panes over eight. The original plan was L-shaped with a rear wing extending from its north end. The angle between the wing and the main range has subsequently been infilled with extensions. In the 19th or early 20th century this added rear section was extended on two storeys in orange brickwork (now with its rear and end elevations over-painted) as a wing under a mono-pitch roof projecting south-west behind the line of the main block.

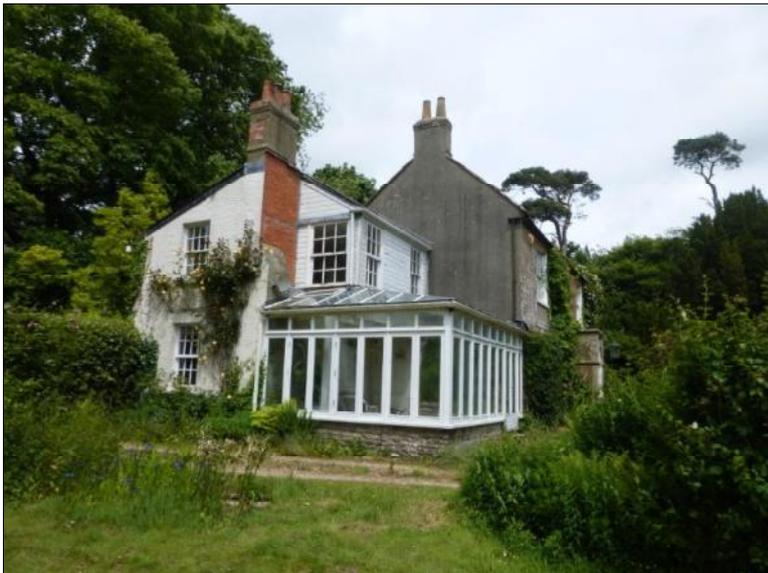
Fig.2 The South-West elevation showing the original gable (now rendered) end of the house, the extension of the rear range and the 20th century conservatory and timber first floor extension.

In January 1992 a planning application was approved for a replacement of an existing greenhouse with the current conservatory. This was constructed against the front wall of this wing under a jettied and sash-windowed timber extension to the bedroom above (Figure 2). This conservatory has internal access from the two abutting rooms.

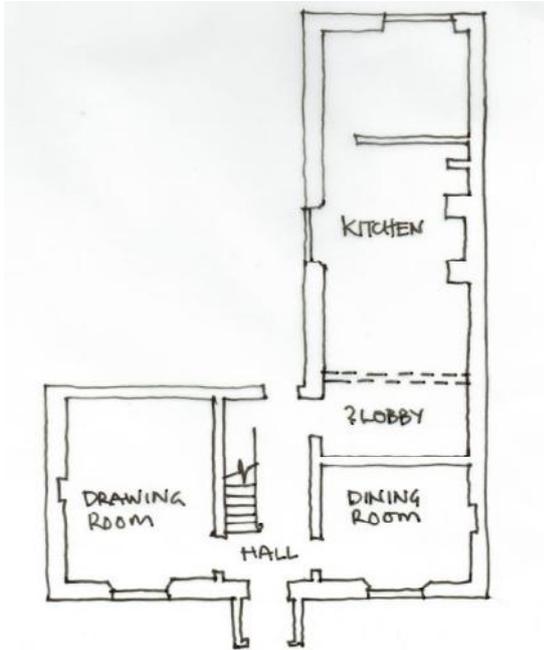
Fig.3 Indicative sketch of the early ground floor plan of Kingsland house. An external door certainly led from the scullery to the garden although evidence of any other openings would require further investigation.

2.2 The original plan of the house (Figure 3) consisted on both floors of a principal room placed on either side of a wide entrance hall containing the main stair rising away from the front door. An original service wing extends from the northern corner of the house; this is constructed of the same brickwork as the main range and contains the same sash windows (Figure 4). Behind the main range is a parallel narrower range. This is a later addition and was subsequently extended with the narrow wing described above in para 2.1.

2.3 As originally built (Figure 3), the rooms on either side of the hall on both floors were unequal in size with those on the north-east side of the entrance hall some 1.5m feet narrower from front to back than the those on the south-west. This allowed the construction of an internal entrance to the rear service wing on the ground floor and the formation of a third bedroom on the first floor behind the front east bedroom; this third bedroom was provided with a sash window matching those in the front of the house (Figure 4).

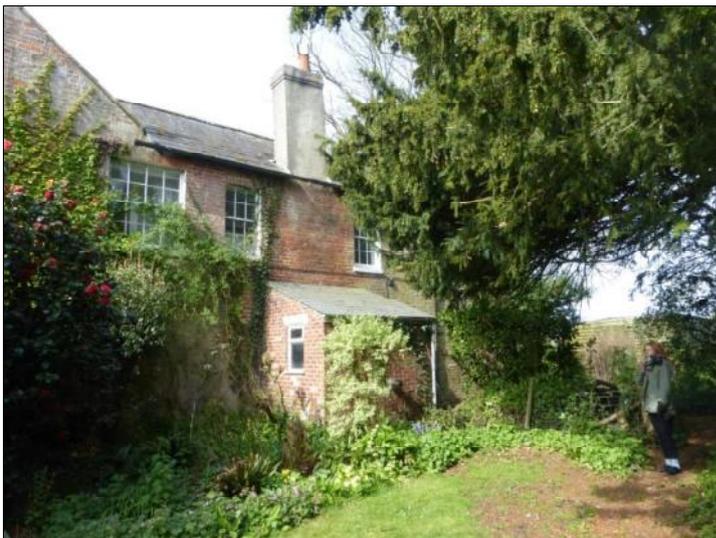
Fig.4 The rear wing with the sash window (left) which originally served the third bedroom. The other windows are later insertions.

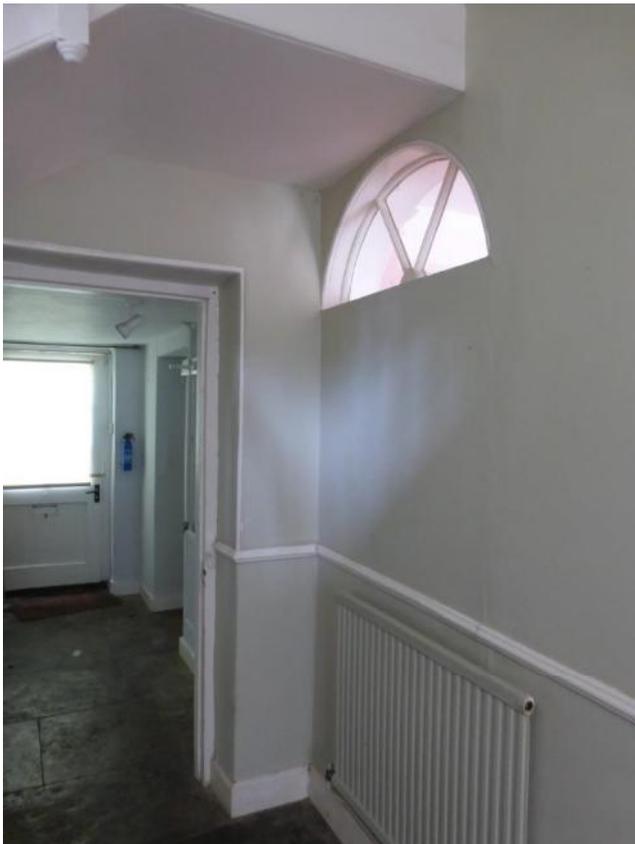
Fig.5 Fanlight over the blocked original doorway into the rear service wing.

2.4 Subsequently, in order to give the north ground floor room (the dining room) greater space, this plan was altered to give the dining room the same depth as the drawing room. This was achieved by taking the nearer part of the rear service wing, blocking the doorway from the hall into it (Figure 5) now unblocked with the fanlight insitu and a new panelled door to match existing. At the same time a new back stair was constructed between it and the kitchen. This new stair emerged into what had been rear bedroom above, taking up most of its space which then became largely used for storage. The kitchen and the dining room were connected by a serving hatch through the new internal wall, while the angle between the rear wing and the main range was infilled with an extension to maintain internal access to the kitchen.

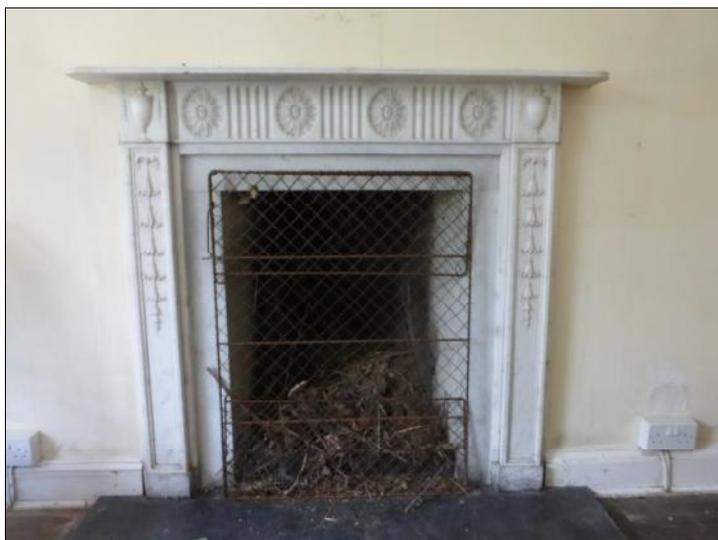
Fig.6 Drawing room fire surround.

2.6 The house retains various good period features. Of particularly high quality is the white marble fireplace (Figure 6) in the drawing room with its carved swags, paterae and urns (no other period fire surrounds survive). A woodburning stove has been installed in this fireplace and the chimney lined with a stainless-steel flue liner and the surround remains undisturbed.

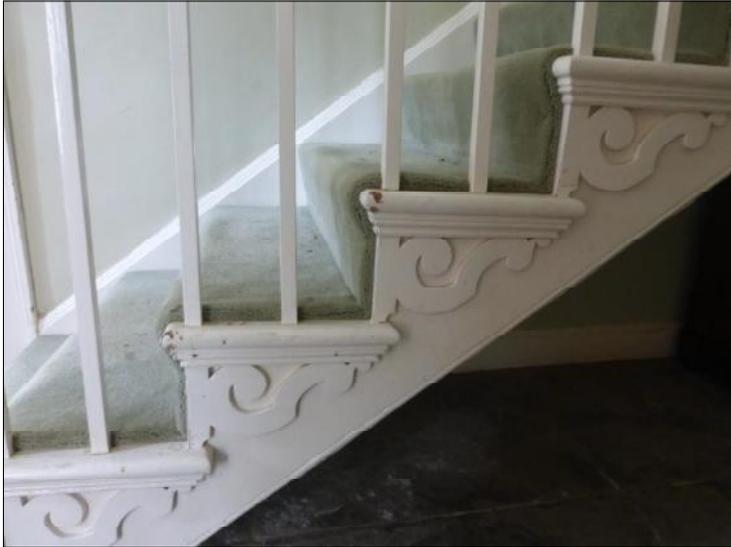
Fig.7 Scrolled stair tread ends.

2.7 The staircase is elegant with stick balusters, scrolled tread ends (Figure 7) and a wreathed terminal. There are substantial panelled doors to the principal rooms. Of lesser significance but which are interesting survivals, are the servants bells in the kitchen (and the pulleys for them in the attic) and the iron baking oven, with its unusual removable lining, set in the kitchen wall to the left of the fireplace.

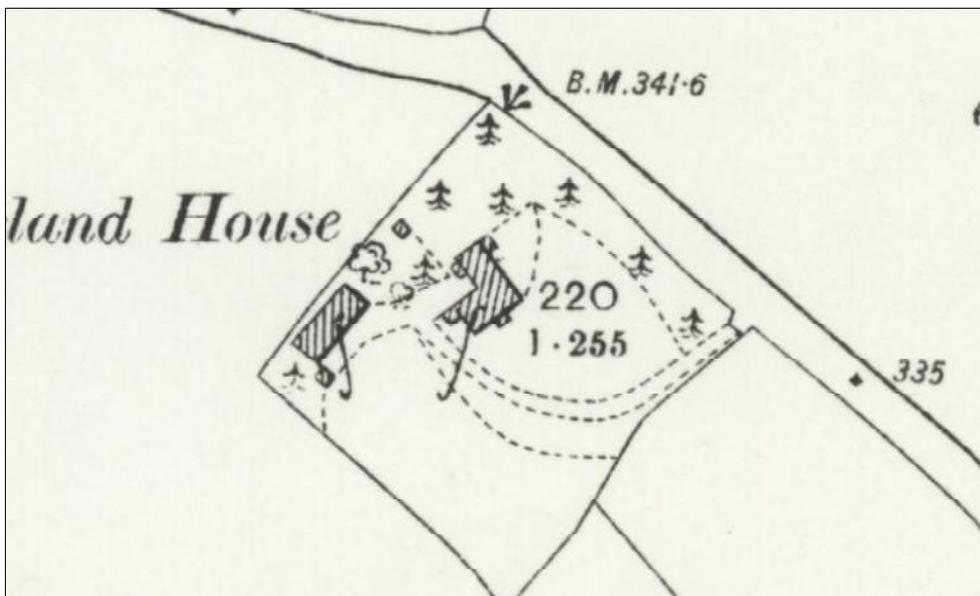
Fig.8 Extract from the 1903 OS 25" map (NTS).

3.4 Planning permission was approved for the conservatory in January 1992. The 1903 25" OS map (Fig 8) does not show any structure in this position, only a small extension south-west of the rear range. The latter may be the section which contains today's 'snug', but it seems more likely that after 1903 a completely new extension was constructed which was designed to accommodate a greenhouse against a tall south wall. The next available 25" map is not until 1963 and this confirmed the existence of the greenhouse, but unlike the conservatory, it is set back from the line of the front wall of the house. It therefore looks as if the extension was constructed after 1903, designed to take a greenhouse placed against its front wall, and that this was replaced in 1992 or shortly afterwards. Its design is typical of its period.
