**Units 1-5 Admiralty Park,
Admiralty Way,
Camberley**
Verification Report

On behalf of **Stargas Nominees Ltd**

Project Ref: 40198/3512 | Rev: 01 | Date: November 2020

Report Title: Verification Report

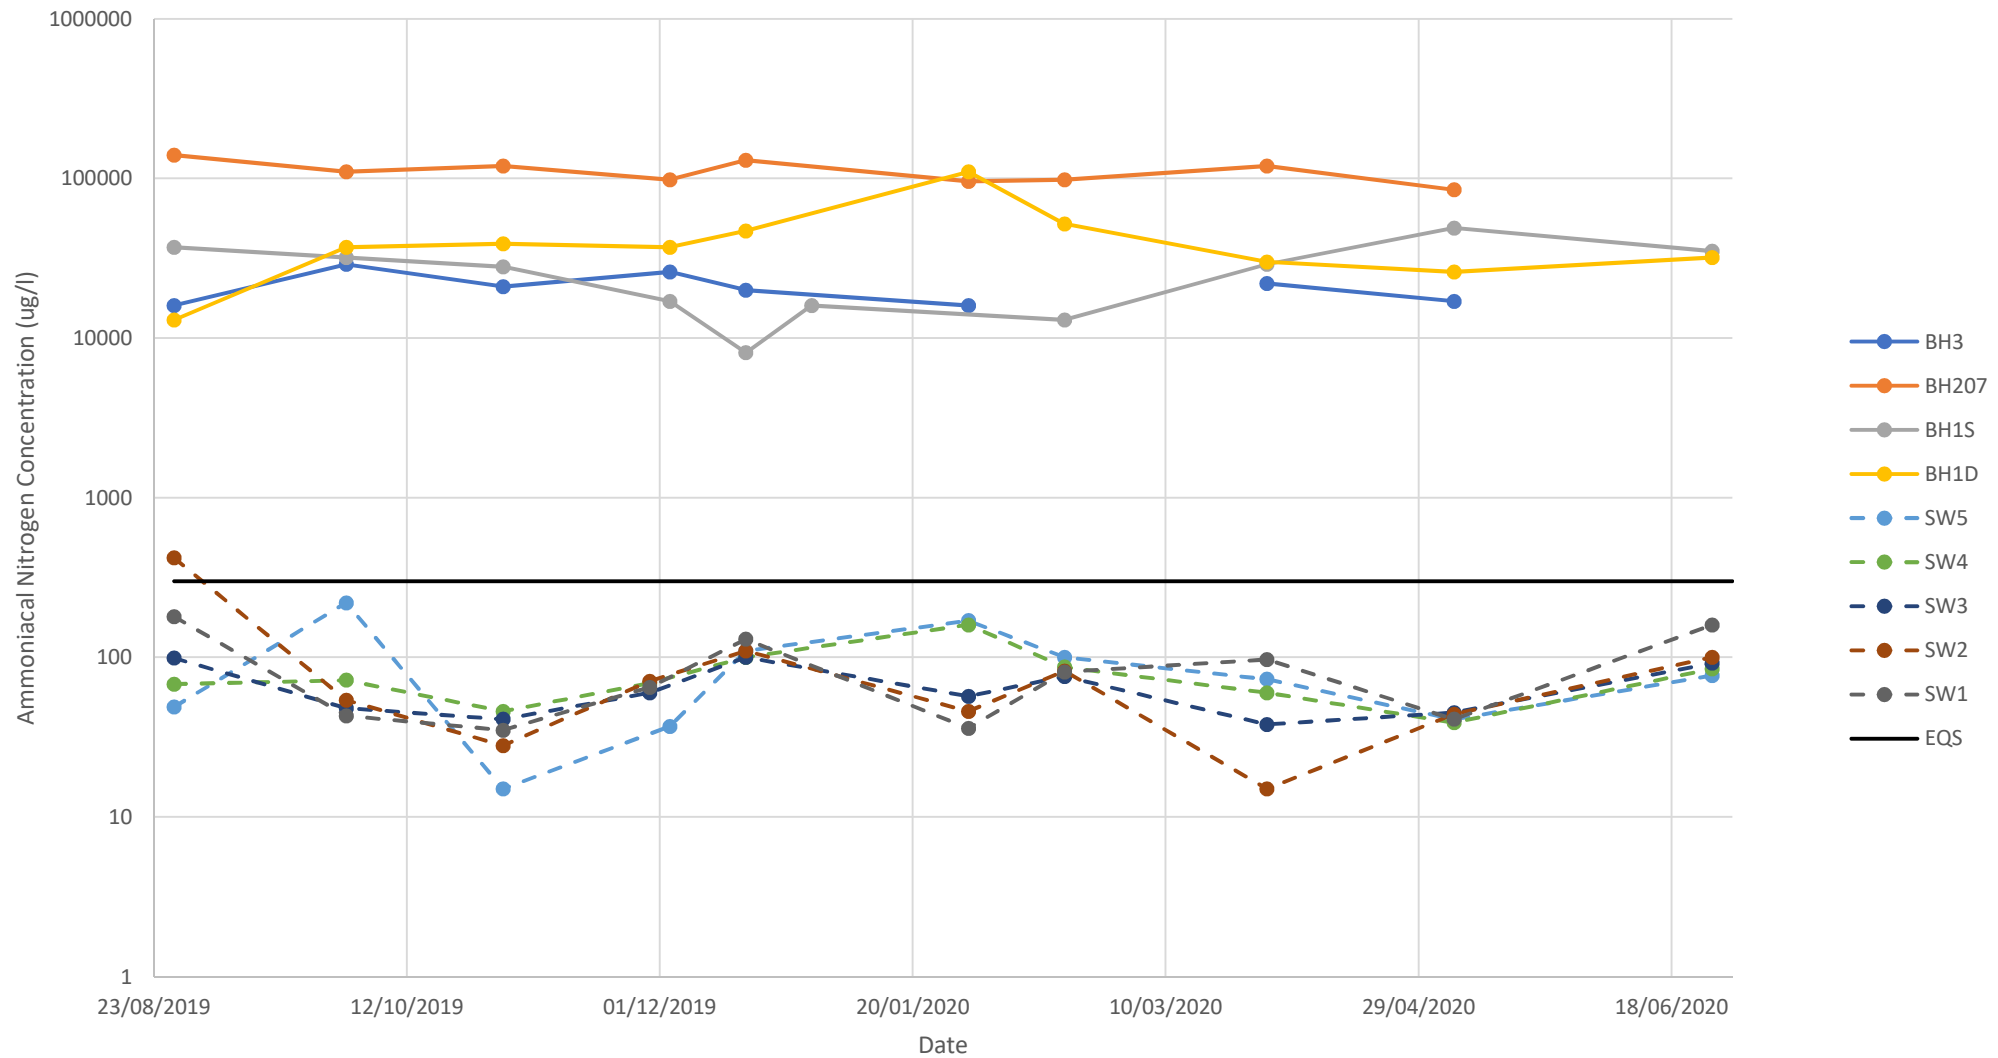
Date	August 2020
A4 Scale	NTS
Drawn	MRG
Checked	RF
Figure	2a

Admiralty Way, Camberley
Groundwater and Surface Water Concentrations of Ammoniacal Nitrogen during Remediation Works

*Notes: Where recorded concentration is below limit of detection, a concentration of 0.01ug/l has been plotted

- 3.8.4 Concentrations of ammoniacal nitrogen are consistent in both groundwater and surface water during the remediation period. Concentrations in surface water are below the EQS. Concentrations in groundwater are significantly above EQS.
- 3.8.5 Concentrations of naphthalene in groundwater are more variable, being recorded generally above EQS in BH207 with occasional spikes in samples from the other boreholes. Concentrations in surface water have remained below EQS during the remediation period.
- 3.8.6 In general, the surface water testing has shown no significant deterioration of river water quality during the remediation works. Groundwater quality has remained poor, although improvements may be expected in the months following completion of the remediation works.

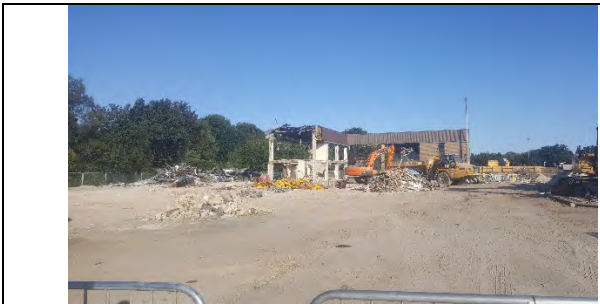
View from compound of remaining buildings

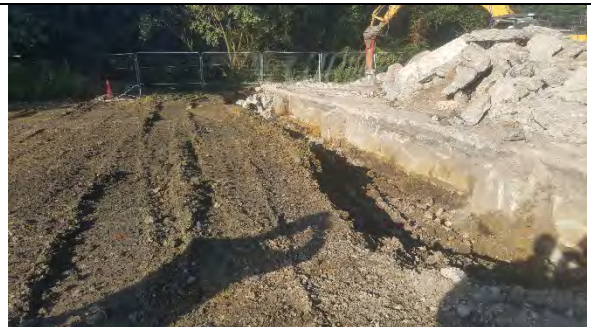
Area in SW (nr BH3) where slab is being lifted

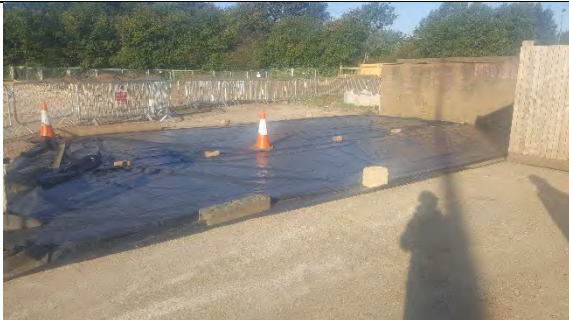
Bund area for water treatment

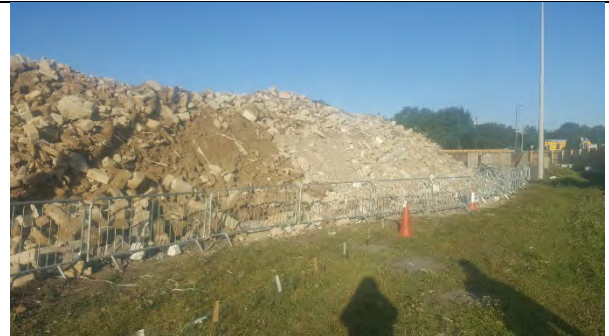
Sorted concrete ready for crush

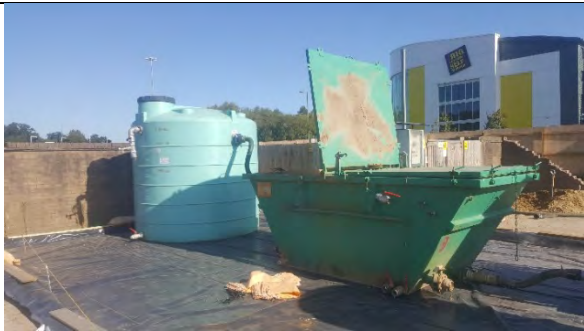
Water / oil separators

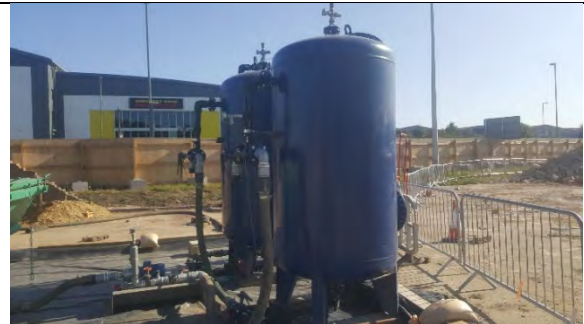
Water carbonisation tanks

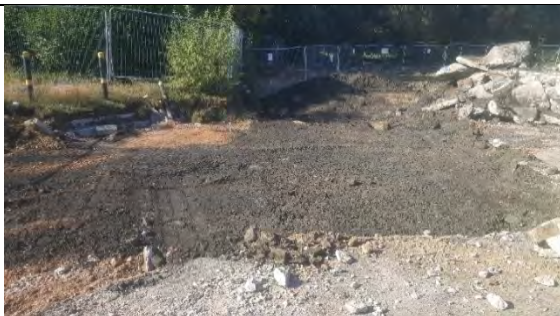
Blackend soils exposed at southern end of site
whilst looking for rising main entry

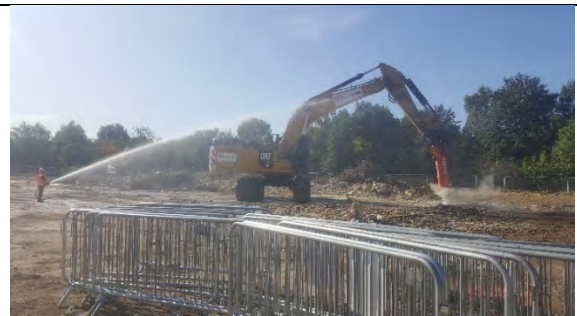
50t excavator, dust suppression breaking out
concrete

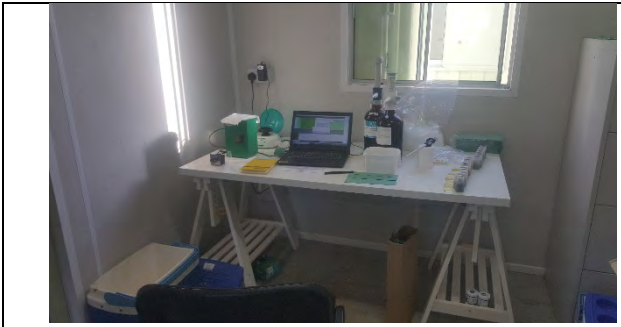
QED set up in site office

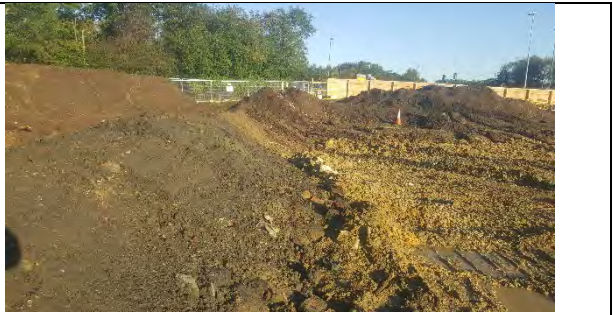
Mounded arisings from gas trench

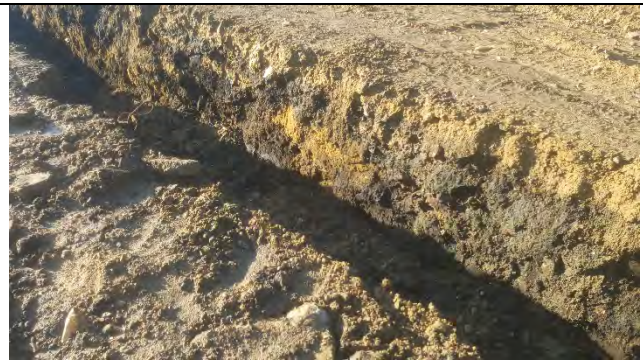
View of gas trench, c1.5m depth

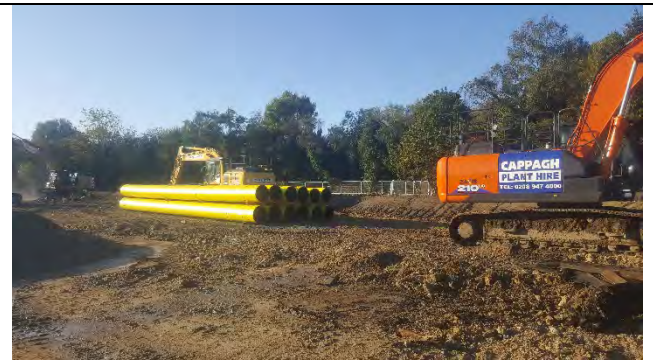
Stockpiled pipework awaiting installation

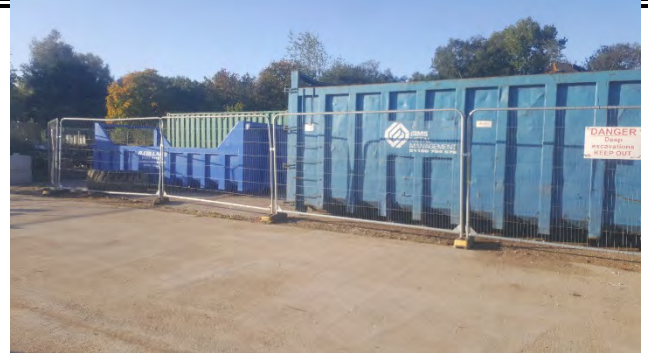
Skips & containers in southwest of site being used by Cappagh

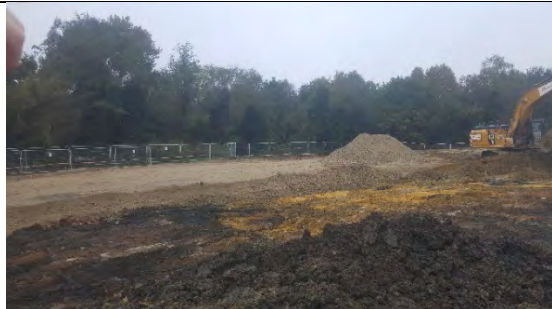
Area in SW being stripped of 'clean' material pre excavation to 2.5m depth. Background shows crushed concrete layer at surface

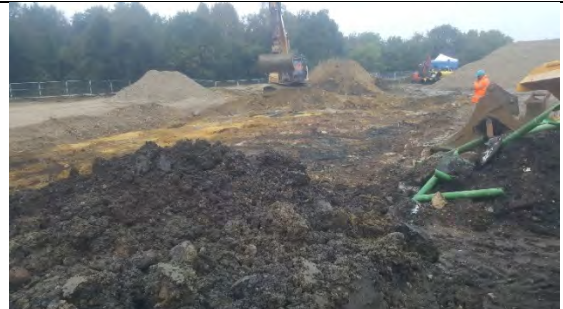
Area in SW being stripped of 'clean' material pre excavation to 2.5m depth. Background shows crushed concrete layer at surface

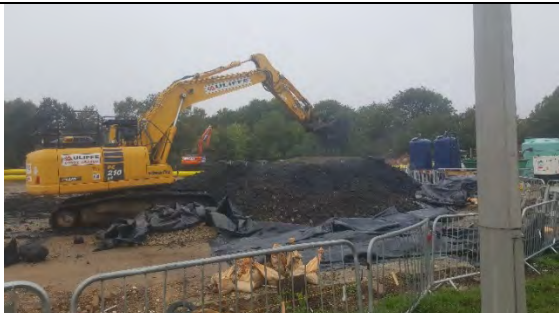
1st biopile being turned by riddle bucket

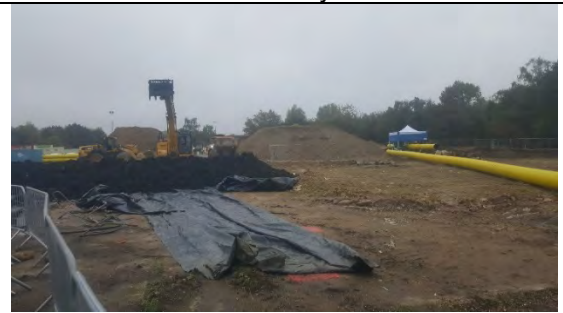
Visqueen ready to be placed over pile at end of day

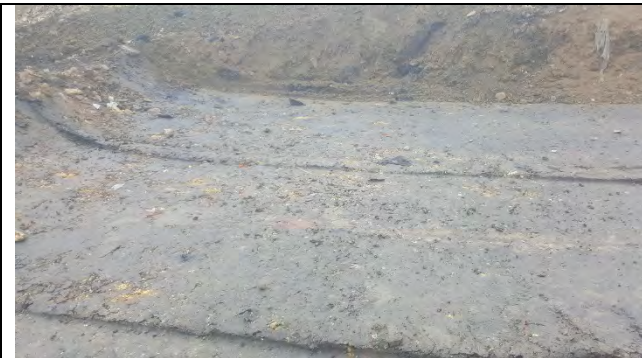
Rolled in material pre crush concrete 'firm clay'

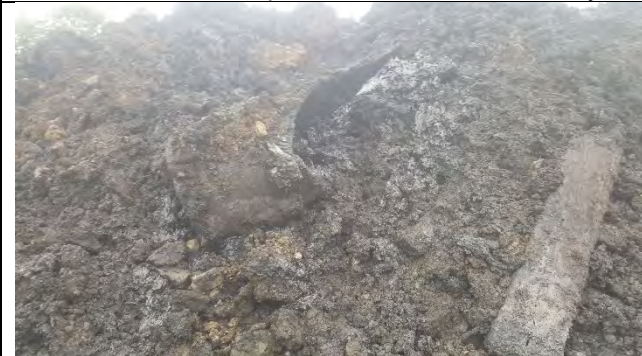
Relict gas works pipework pulled out, with tar like substance settled in base now oozing out

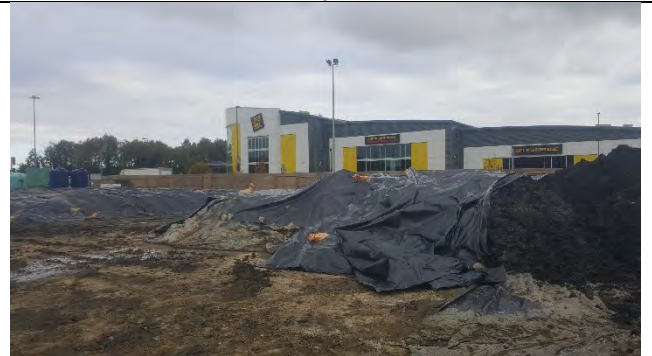
Biopiles covered in visqueen

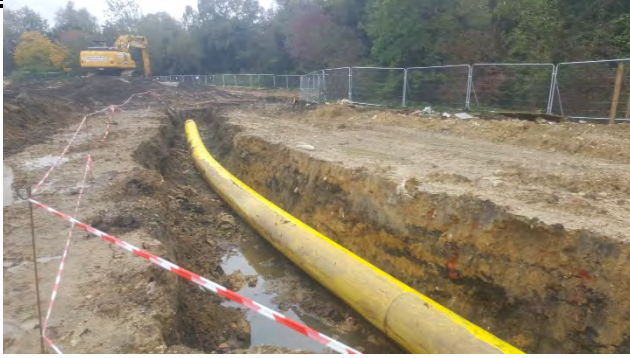
Gas main starting to be laid

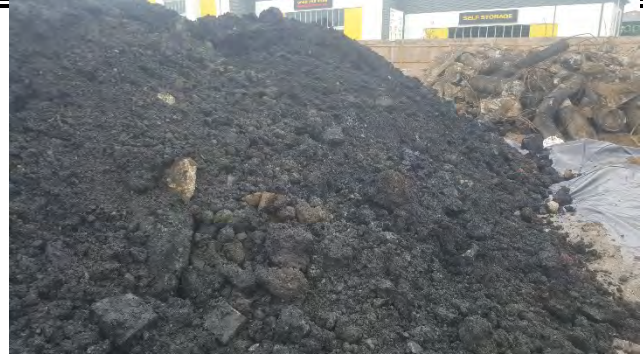
Colour of material in biopiles

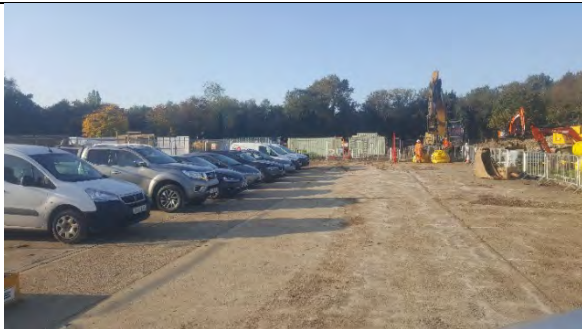
View of car park with new car park in background

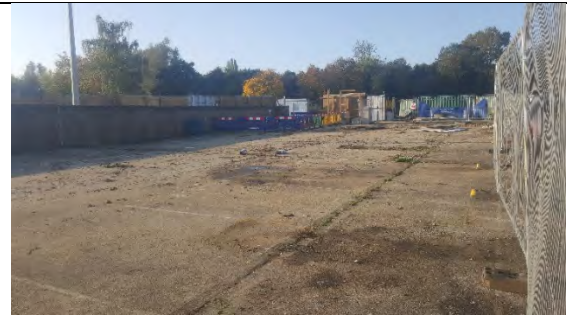
Former compound/cabin area

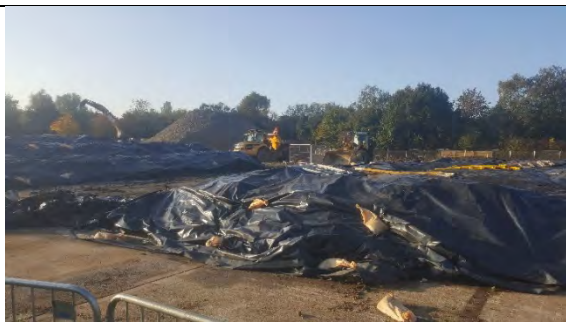
View of covered biopiles with crushed concrete stockpile in background

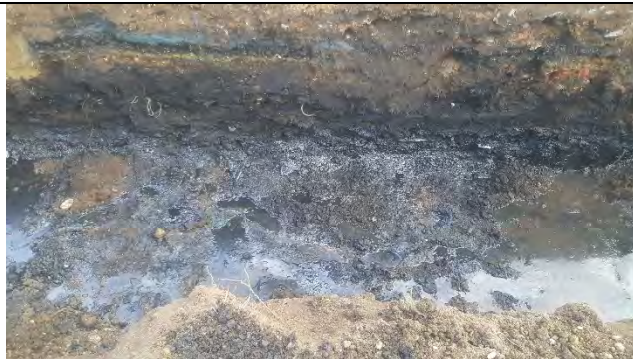
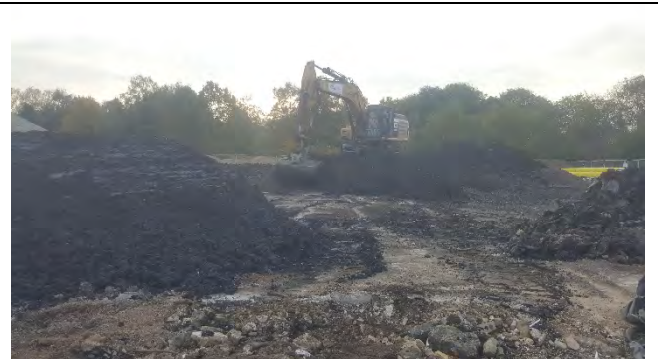
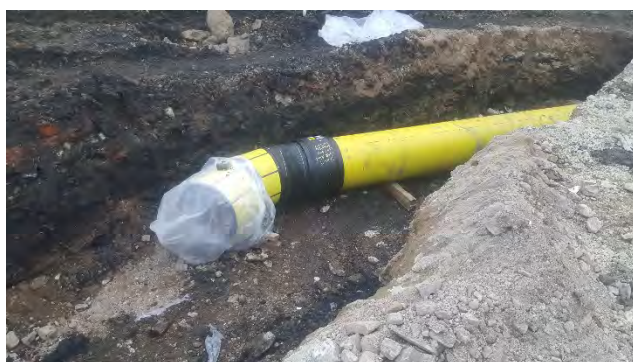
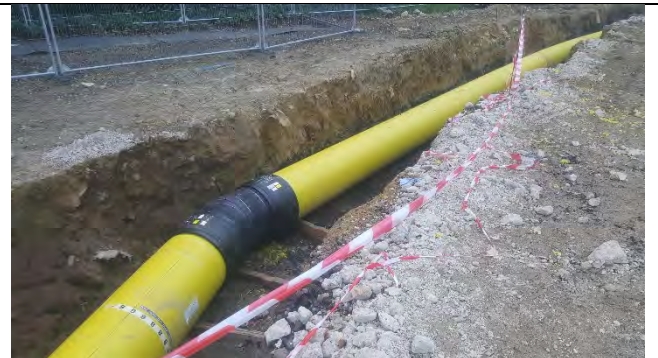
- VISIT NOTES [GENERAL DETAILS]:**
- MCA expect to TP base plate on Tuesday
 - RHS of entrance Cappagh have stopped – 2 pipes found not on plans c18inch D
 - SGN called out to inspect
 - Most of new pipe laid – some being joined
 - New material in biopiles from I&G/Cappagh trench to LHS of entrance. Soils in pipe trench noted to be 'weeping' HC
 - Allu bucket being used to add cement to biopiles
 - Week 1 of 4 'standing'

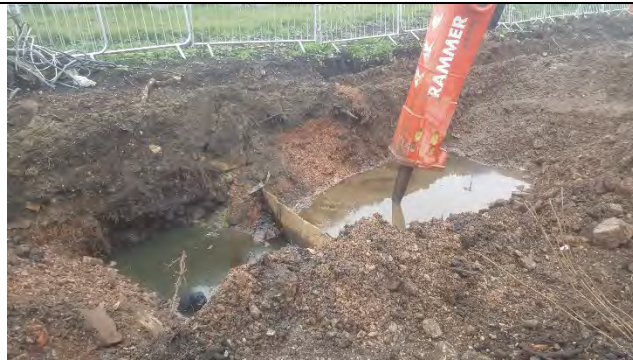
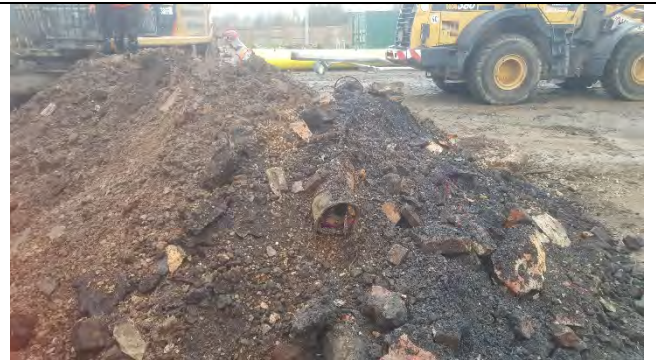
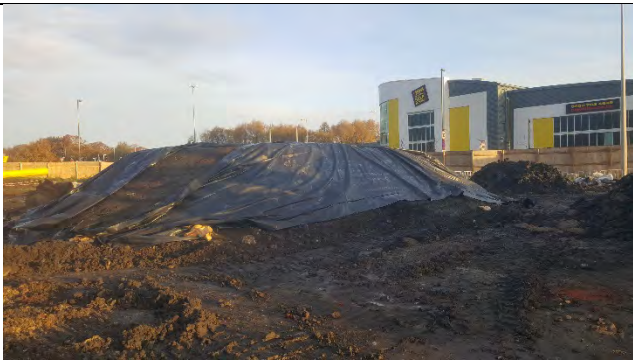
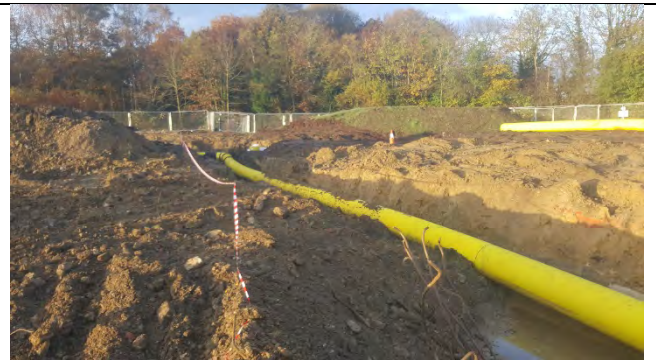
- Gas holder base plate located via excavation – encountered 1.5m bgl
- Sides of plate were still in place, and collecting water
- Above plate was brick-fill. Outside plate was dark grey sand and silt
- No sludge noted at base of plate – relatively ‘clean’

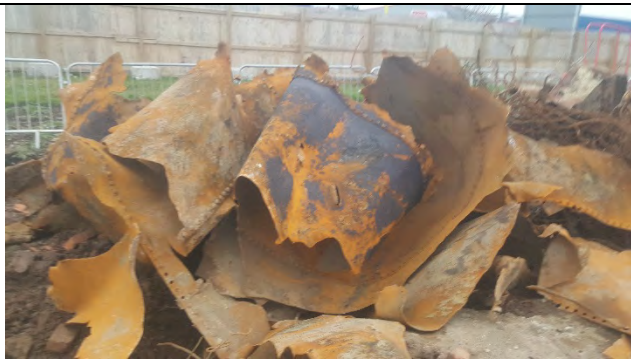
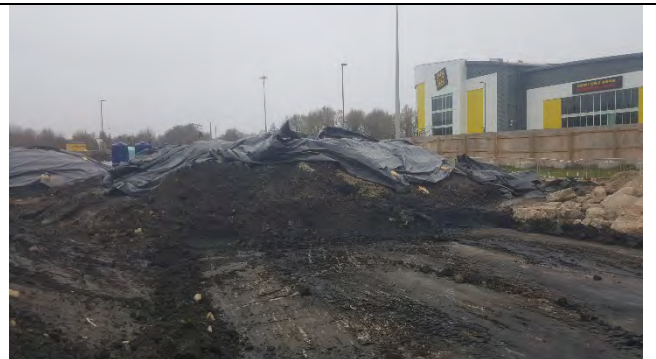
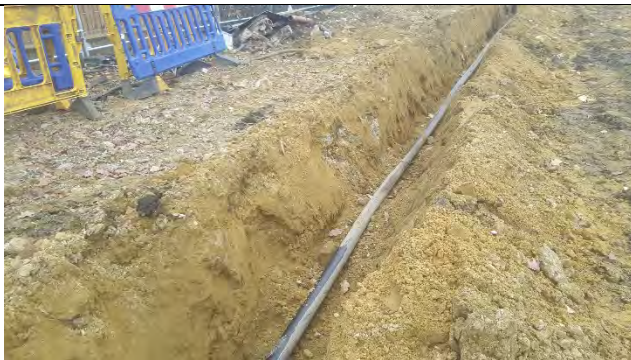
- Monthly site meeting including walkover
- Part of gas holder plate now removed and stockpiled
- Week 4 of 4 stand down
- Foul main now laid

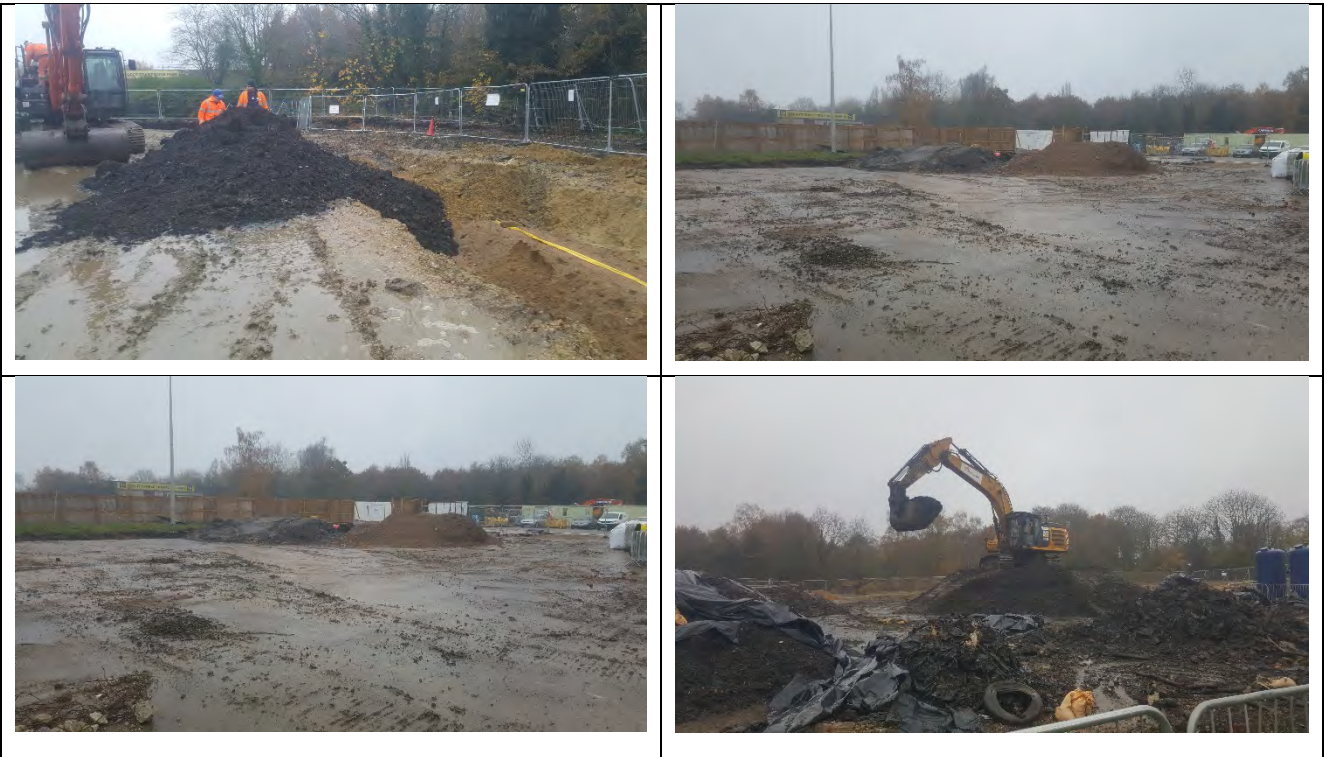
VISIT NOTES [GENERAL DETAILS]:	<ul style="list-style-type: none"> Very wet weather, limiting work Since last week works have mainly comprised backfilling of gas trench. Biopile1 now treated (confirmed with QED) and is being used as backfill. Once trench is backfilled crush will be moved from site centre to NW corner of the Site
---------------------------------------	---

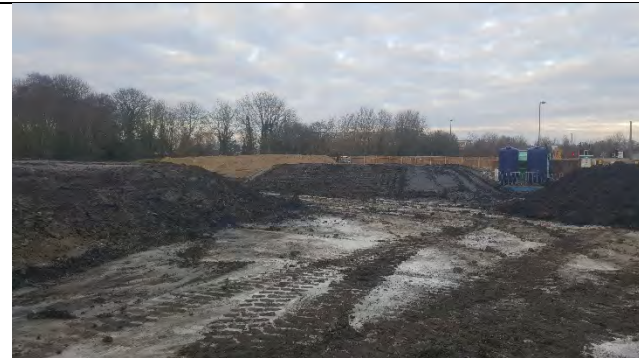
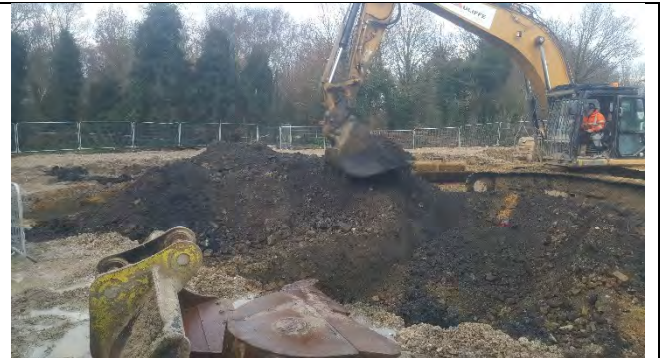
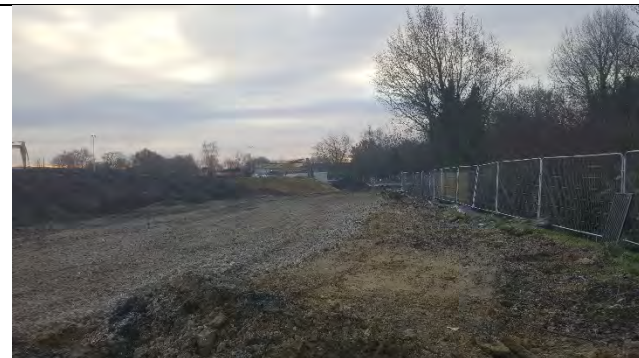
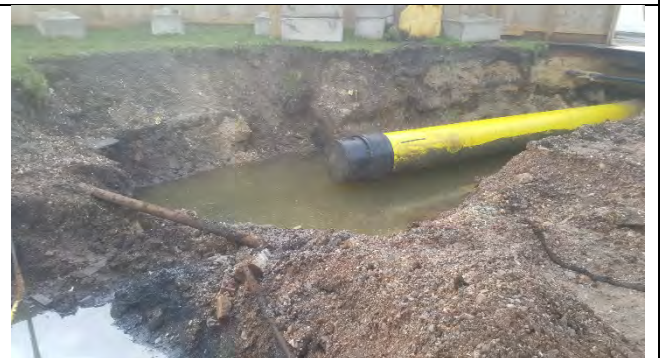
- Crush now moved
- Turnover now started between old foul main and new gas main.
- Biopile 1 has now been used
- Biopile2 has partly passed, split into A & B (passed and failed sections respectively)
- Biopile 3 has now been established, containing material from north of compound and car park area
- Cement is being added to non-contaminated soil to improve handling properties and enable use as backfill

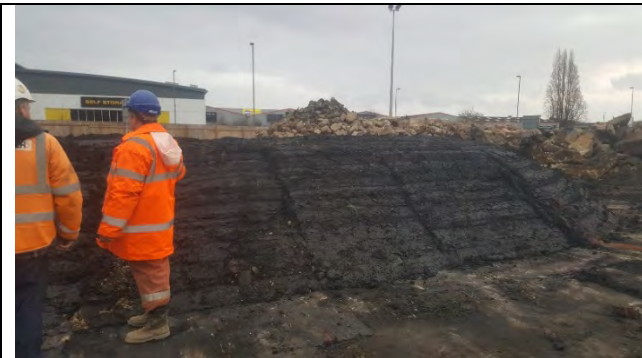
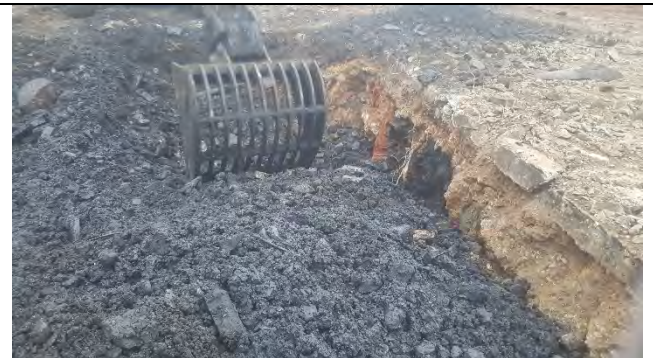
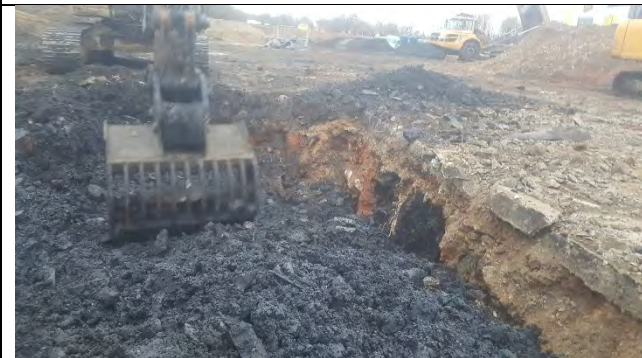
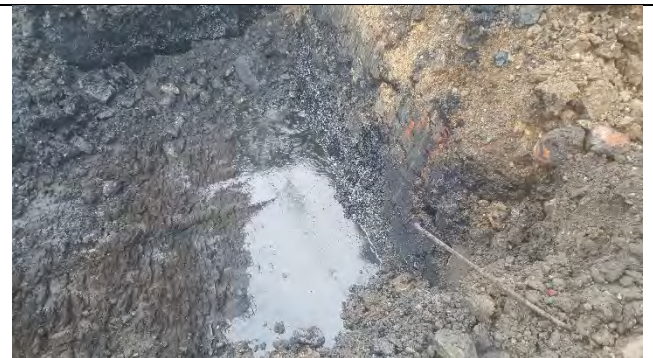
- All biopiles now tested and suitable for re-use (some cement might be added to improve handling)
- Turning over area directly in front of site gate – visible hydrocarbon impaction of soils noted. Strong odour.
- Generalised process for turn over 1. Break out surface 2. Remove obstructions and oversize (riddle bucket) 3. Quarantine material pending testing with QED 4. backfill (from base up) with appx 300m brick crush to come above water level, 2000mm material, 200mm of 6f2 rolled in,

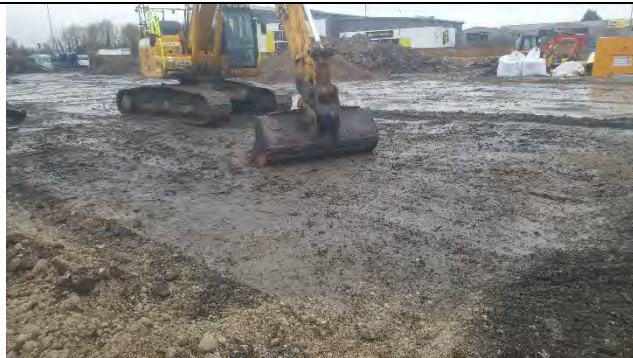
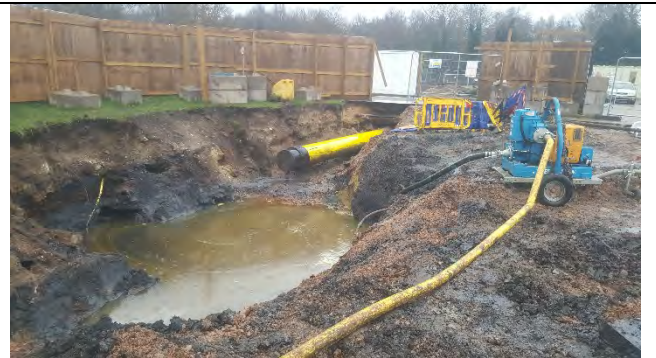
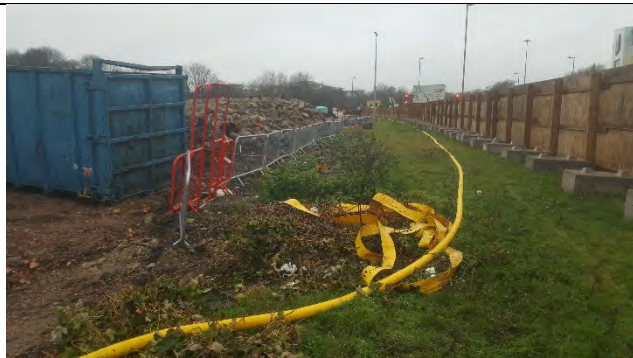
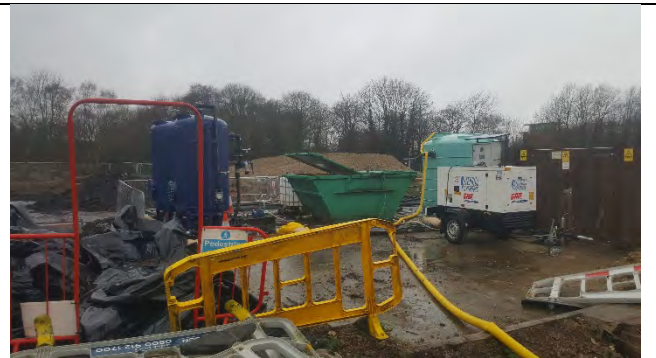
- No turn over, due to heavy rain
- Water being pumped out of connection excavations
- Some stockpiles being moved to tidy site

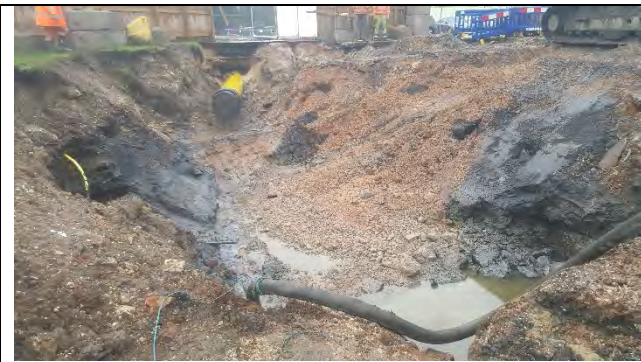
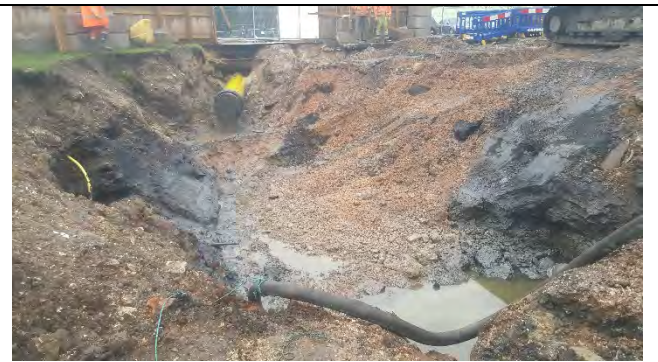
- I&G looking for gas pipe in south of site ahead of connection
- No turnover as MCEL are helping I&G and poor weather
- Site activities winding down for Christmas

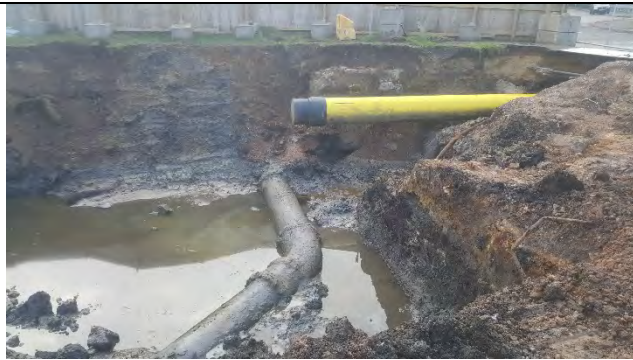
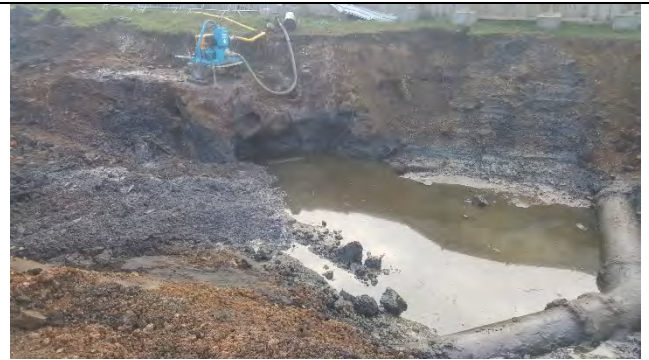
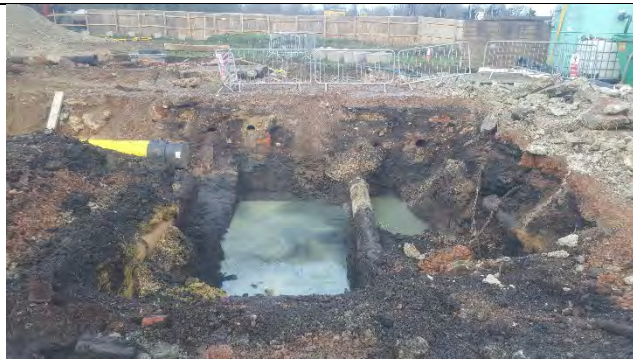
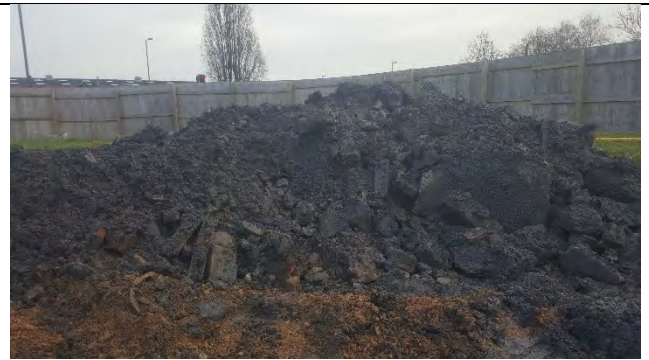
- Monthly site meeting (rearranged from Dec)
- Walkover revealed
- Gas connection pits being opened to give I&G required working area

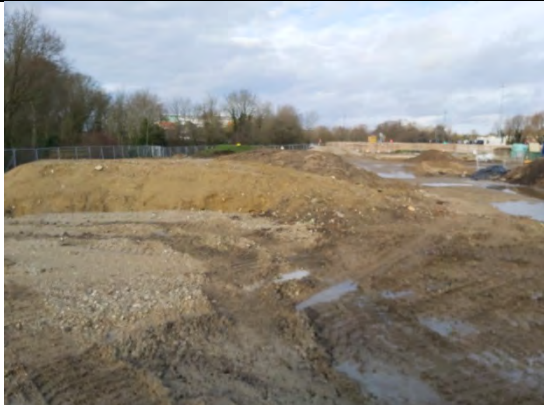
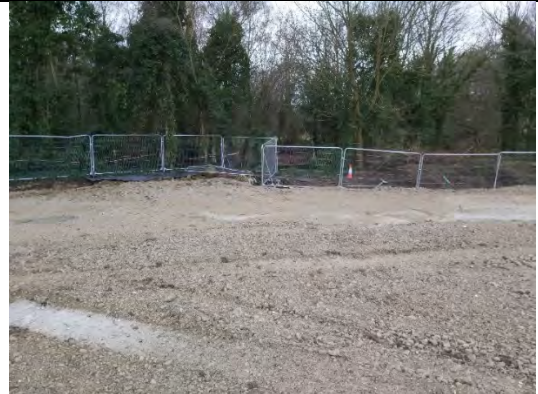
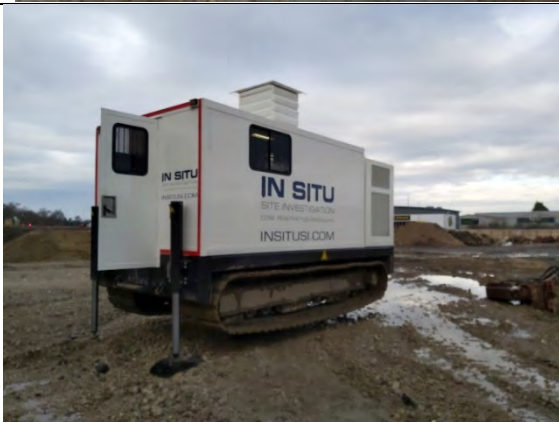
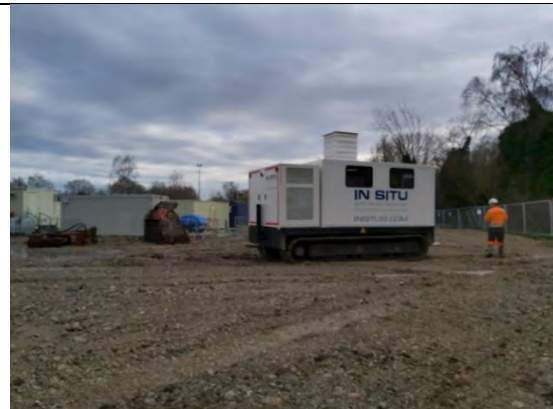
- CPT testing in west of site, in the area already treated & turned over
- MCEL to GPS locations upon completion
- Existing main now located, deeper and c5m east of where expected. Sheet piles being installed to support working area for connection

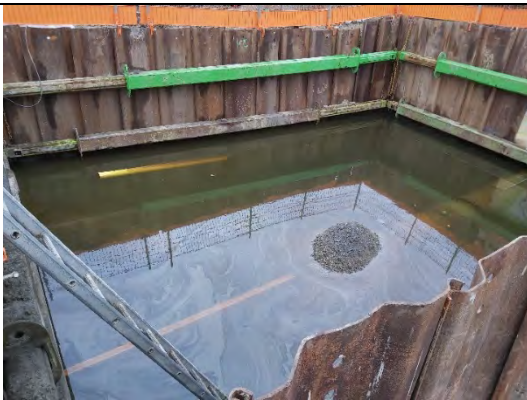
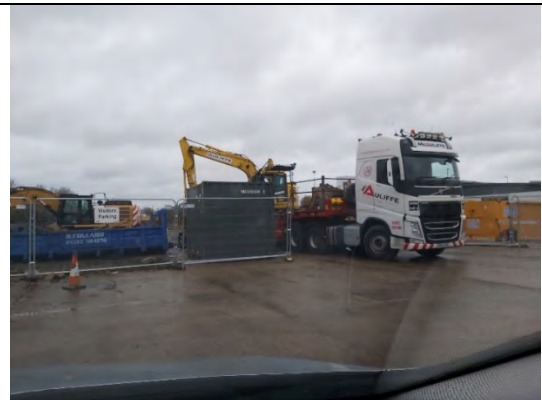
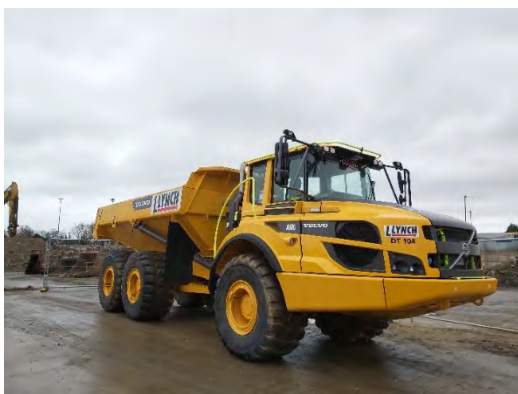
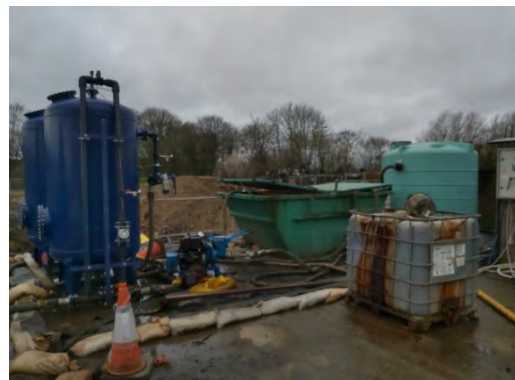
- 1st day on site after stand down (to allow connection work to be completed)
- Tree protection now set up against river
- Log piles adjacent to river now constructed (wildlife zones)
- North connection area being pumped dry
- Adding a valve to 6inch water main in south of site so the pipe can be removed across site
- Carbon in WTP needs changing soon

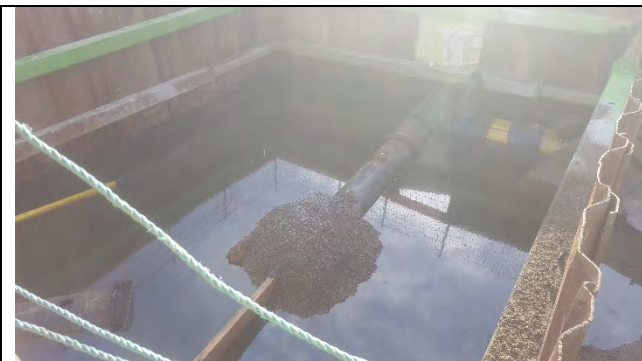
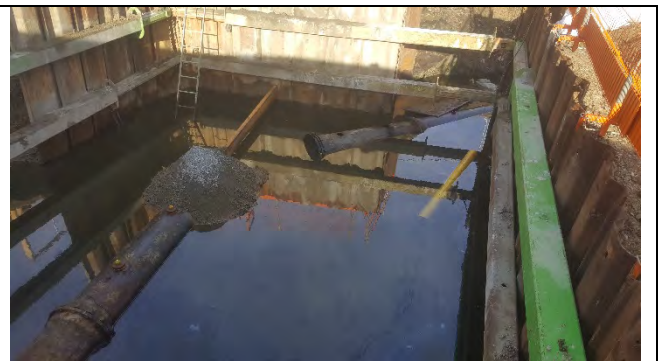
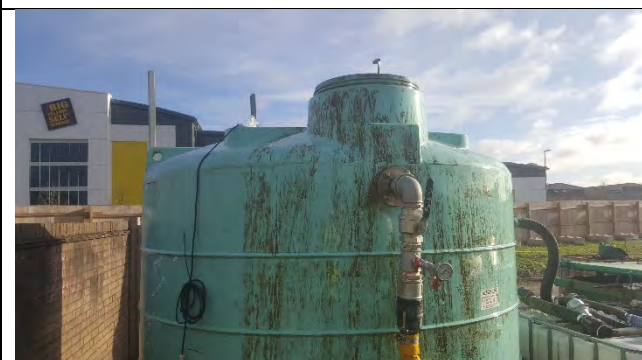
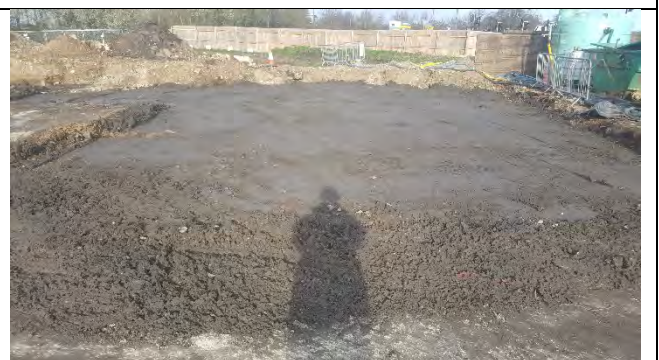
- Concrete stockpile being moved from north of site to west (treated area) to free up space to start rem work
- Sheet piles to be removed in south
- Northern connection excavation now backfilled
- WTP noted to be overflowing, so pump stopped to allow WTP to catch up.

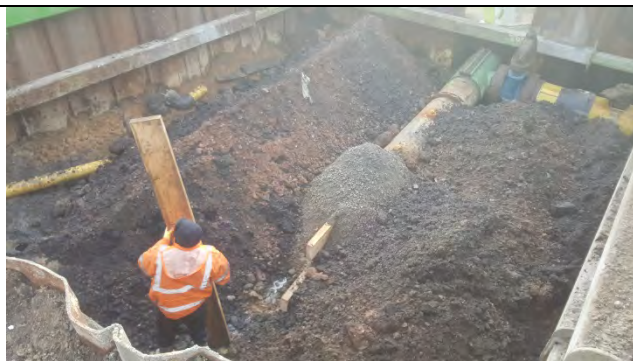
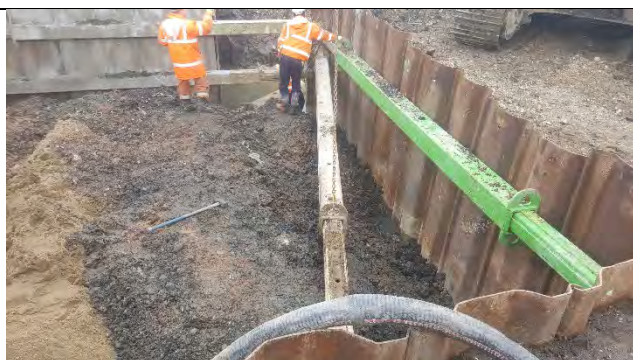
- Base of excavation treated with cement to provide firm platform for backfill
- Backfill started with treated material, tamped in carefully around gas main
- Sand used over gas main
- Sheet piles wont pull with excavator – tool required
- Cement being added to biopiles to improve handling

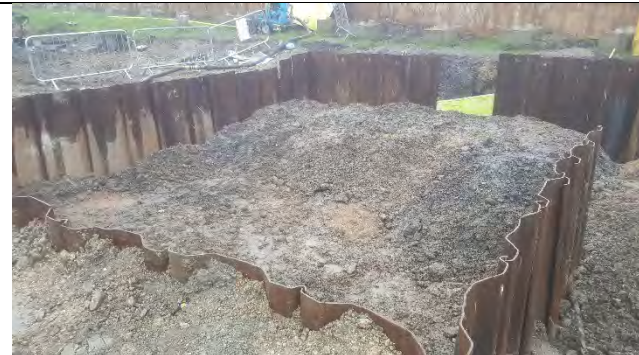
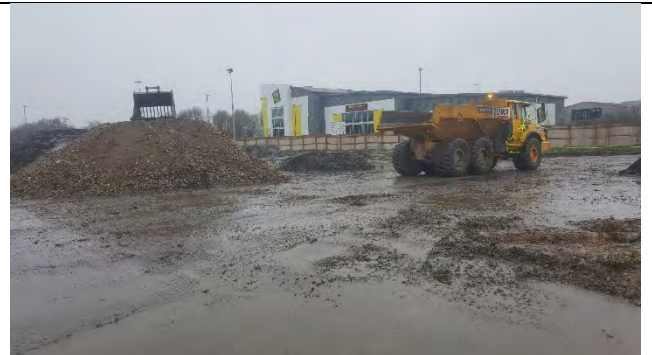
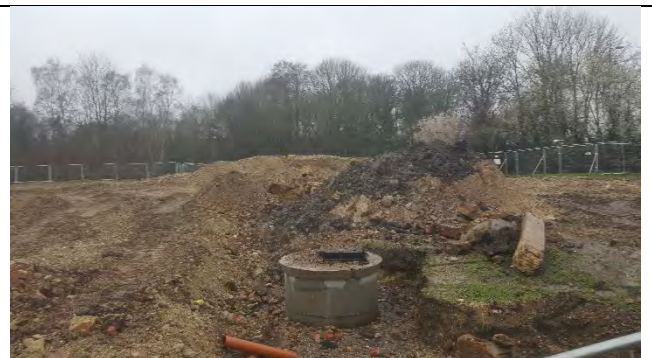
- Backfilling connection, cement treating and remediation works not taking place due to poor weather
- WTP still running to pump out excavations and old gas main
- Todays task mostly tidying and continuing to move concrete stockpile to western area

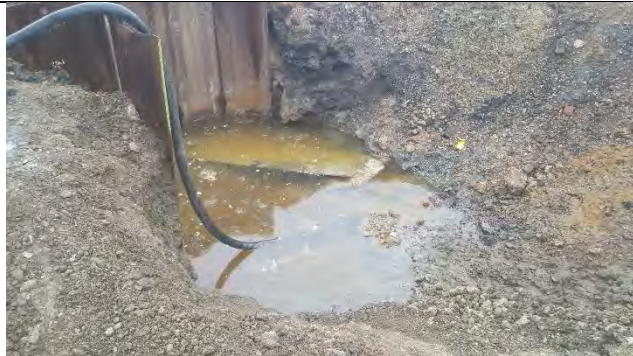
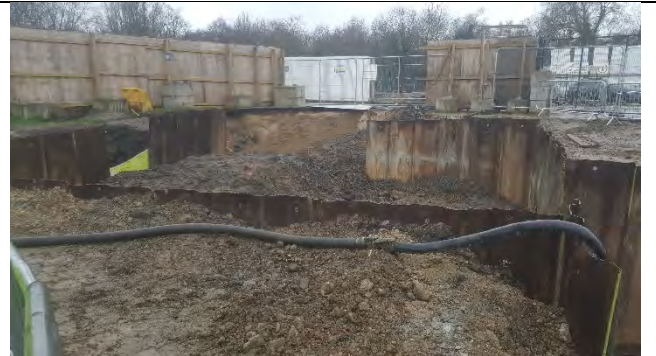
- Revised backfill methodology still to be confirmed
- Cement being added to stockpiles to aid stabilisation
- No remediation works due to weather

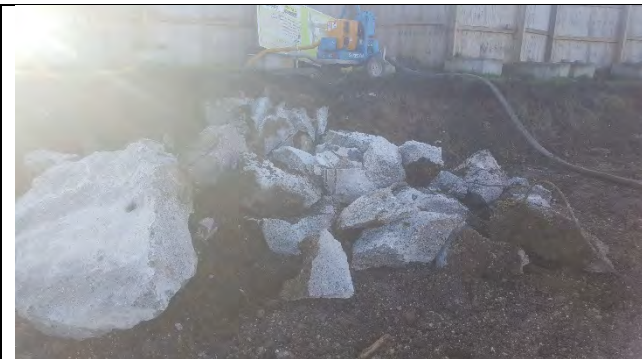
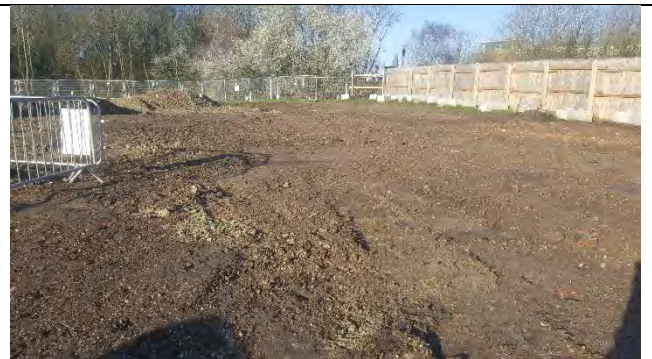
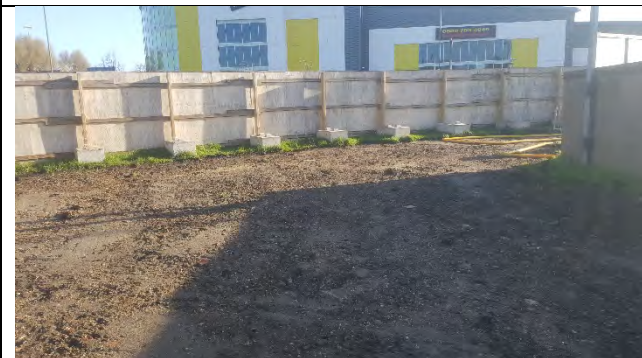
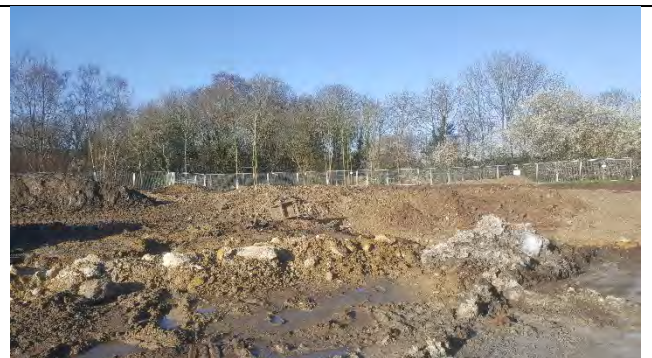
- In the last week the car park areas in no dig zone have been stripped of turf, concrete has been partially removed in former compound area and more cement added to existing stockpiles
- High volt cable damaged in north of site when removing street light foundations. – MCEL report not on service plans
- SSE have attended to make safe, repair works to follow

- SSE have now supervised removal of concrete – it is believed that the HV cable was 'resting' on the foundation and snagged as it was pulled
- Car park areas now tidied and rolled ready for placement of crush concrete

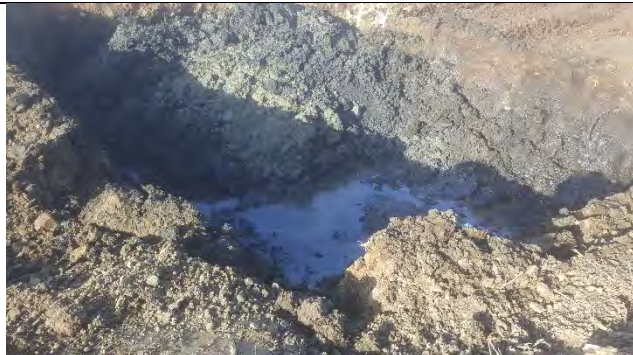
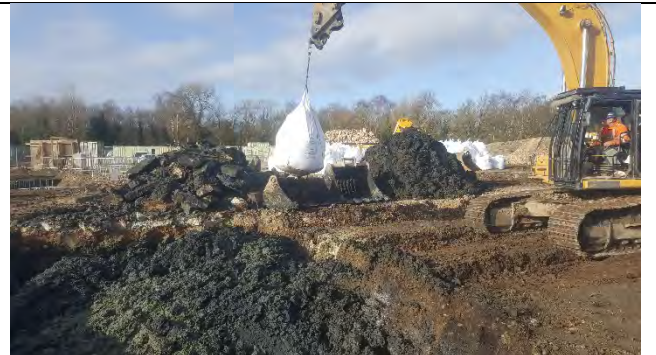
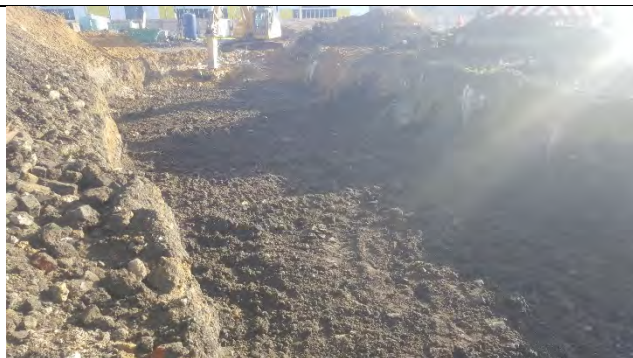
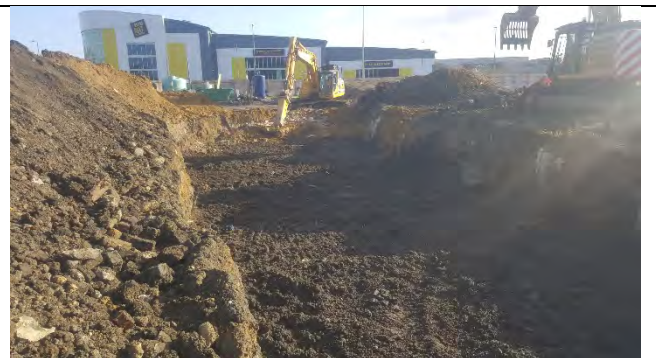
RECORD PHOTOGRAPHS:

- Remediation works now started!
- In south adjacent to former compound area, 10m x 5m boxes are being opened. Perched water entering from c1mbgl arisings are all sloppy. Cement is being added as soils removed to improved handling
- In north, c5m x 40m trenches are being opened. Groundwater is present at base only. Stabilised material is being left in base to set, then rolled. Layers added on top (not seen)
