**Units 1-5 Admiralty Park,
Admiralty Way,
Camberley**
Verification Report

On behalf of **Stargas Nominees Ltd**

Project Ref: 40198/3512 | Rev: 01 | Date: November 2020

Report Title: Verification Report

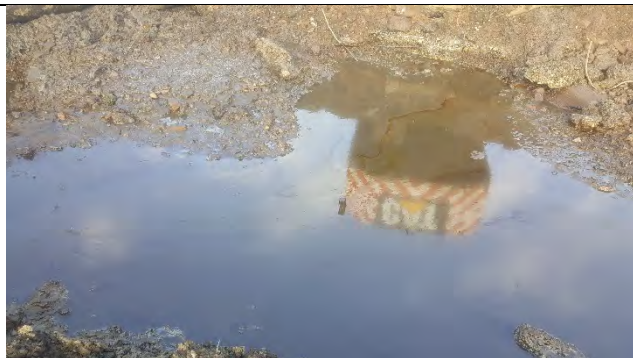
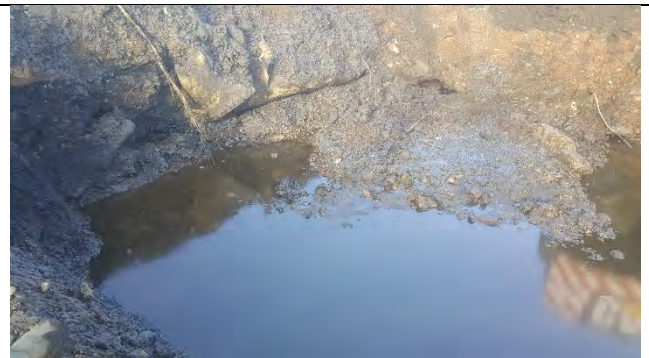
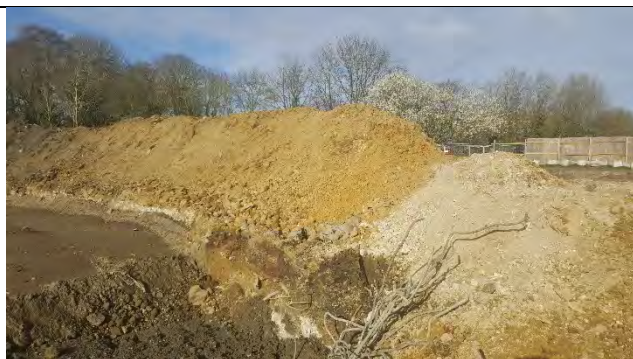
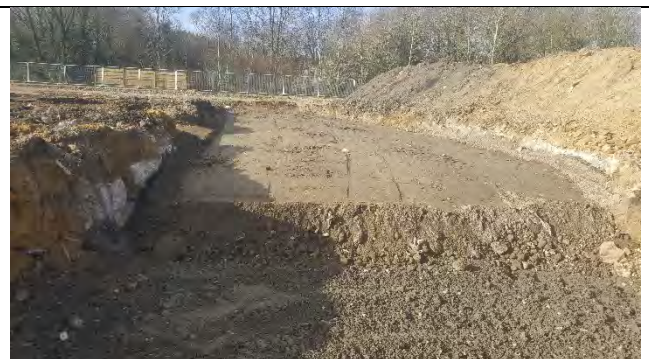
- Excavation at gas holder base now being pumped out. LNAPL visible emanating from gravels beneath gas holder base.
- Arisings from excavation to be stabilised
- Excavation in north now appears to be rolled (MG not observed directly)
- Garry Carter discussed possibility leachate testing the stabilised monolith at pH to match groundwater.
- SF reports that PID testing yesterday recorded 2ppm adjacent to excavation and 0ppm at site boundary

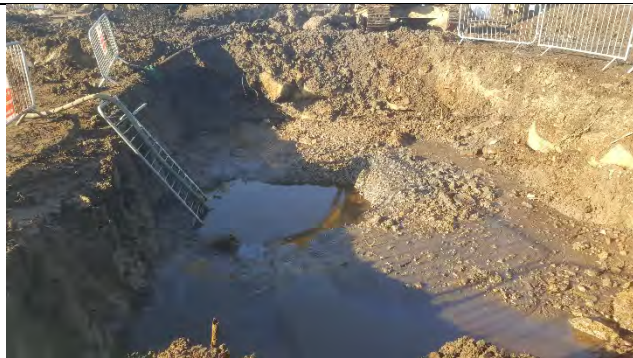
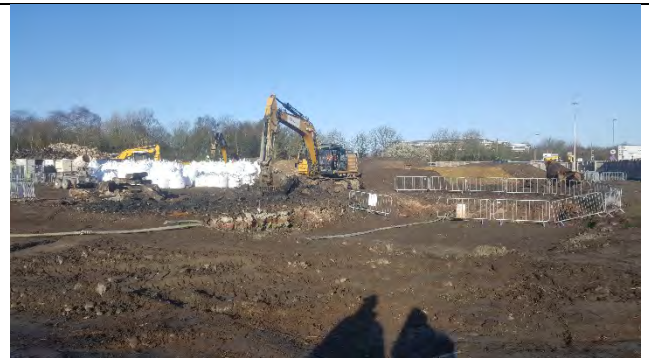
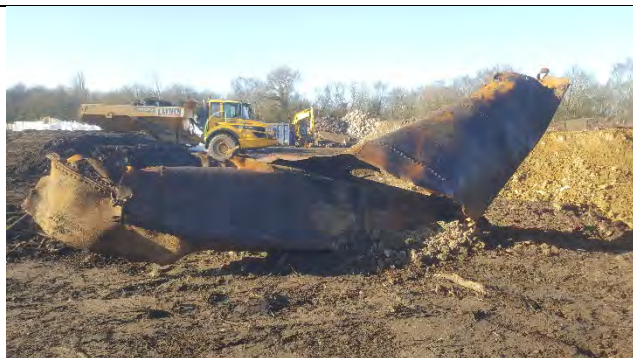
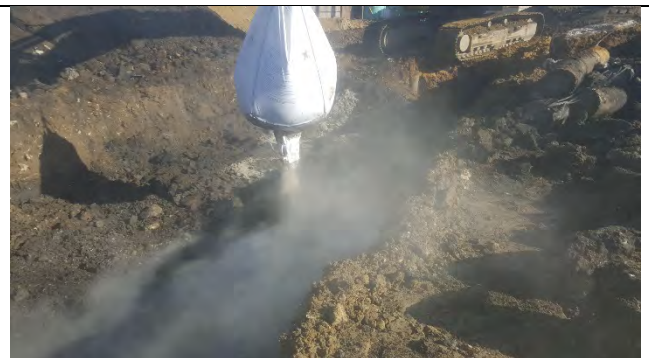
RECORD PHOTOGRAPHS:

- In north strips 50x10m appx are being excavated still, generally quite 'clean'. Bottom meter is being stabilised with cement and left to set overnight before rolling and additional layers are added
- In south material excavated is very wet and sloppy, arising smell of hydrocarbons and ammonia. Excavations require dewatering – sump is dug in part of each excavation to assist

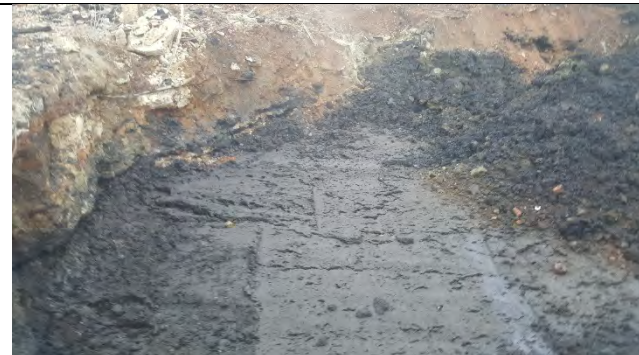
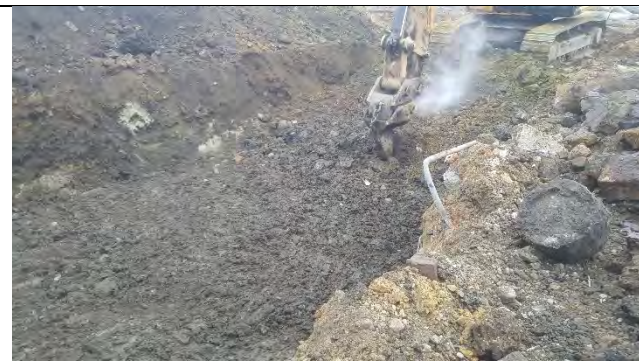
RECORD PHOTOGRAPHS:

- Roller is broken down
- Turn over works continuing across site

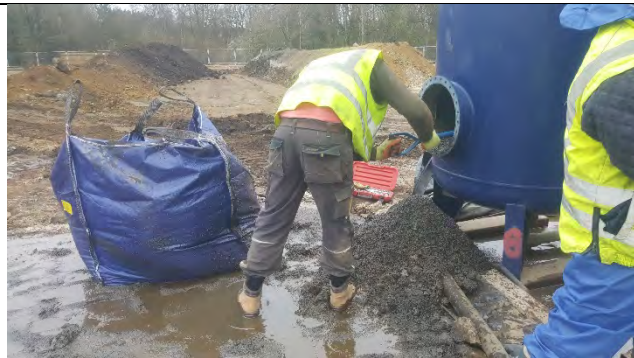
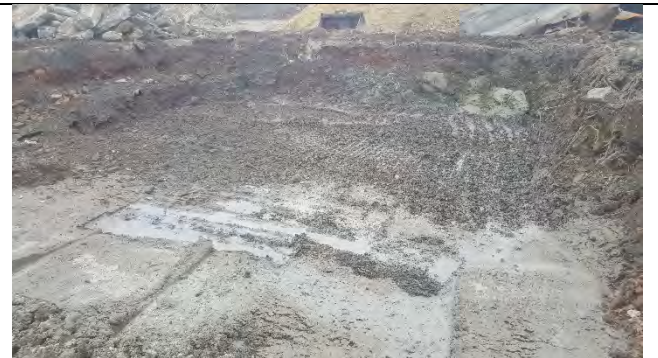
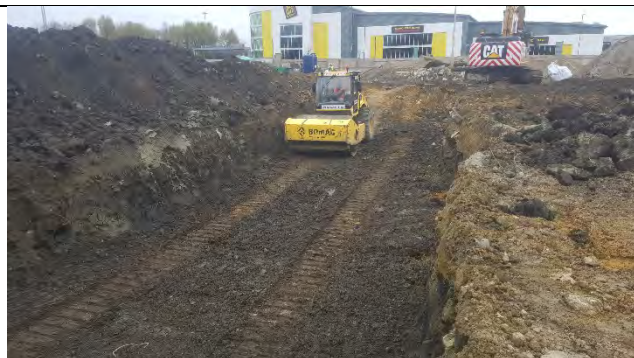
RECORD PHOTOGRAPHS:

- Carbon in water treatment plant being replaced – 500kg being added to each tank
- Excavation in north has been to c1.5mbgl and dead rolled 8 no passes. Additional c300mm layers then added, before being rolled again (6 passes) until 100mm below finished level

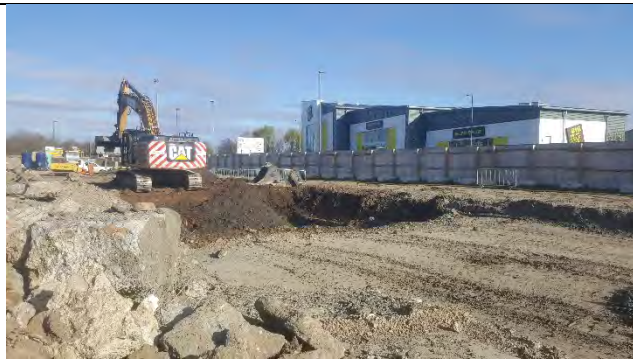
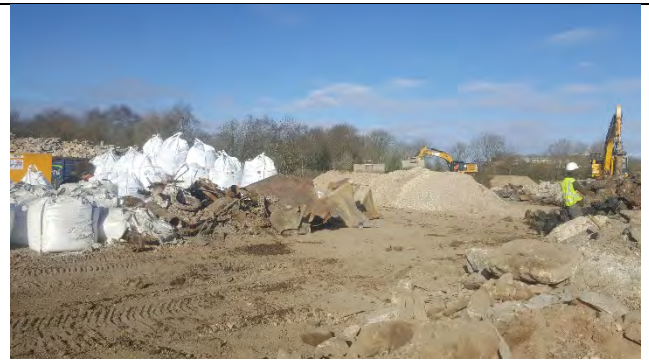
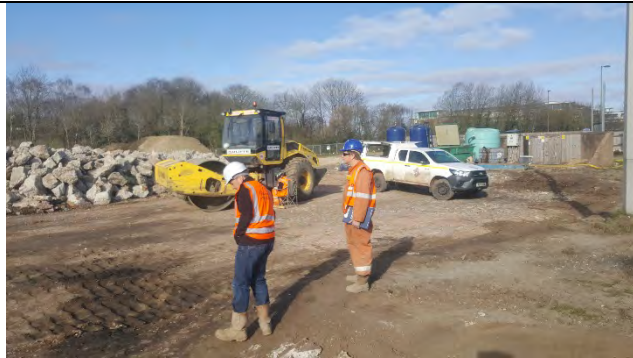
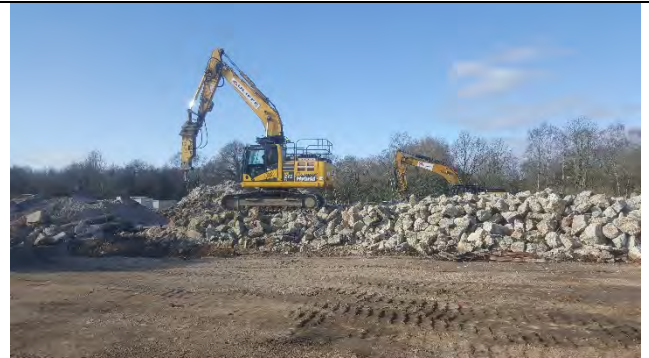
RECORD PHOTOGRAPHS:

- Covid19 precautions now in place.
- MG chaperoned by JC
- Site works have progressed in last 2 weeks.
- Structural soils on site doing plate load tests and plate CBRs.
- JC comments that 2no plate tests undertaken c2 weeks ago failed to meet backfill criteria. Exact location tbc – in north roughly inline with southern edge of wtp, c40m in from west boundary based on where JC indicated. This area is to be retested now cement has had additional time to set.
- Crushing of concrete stockpile due to commence Monday 6th April

JC stood appx at loc of test failure

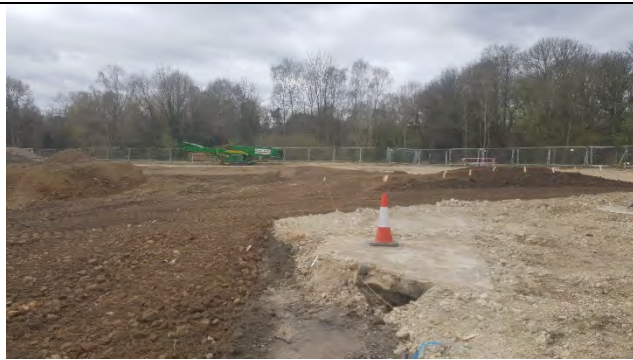
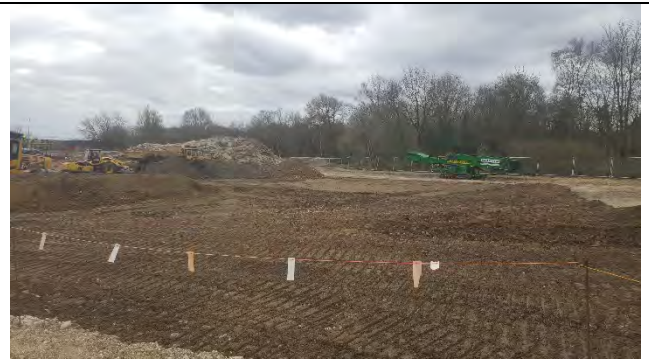
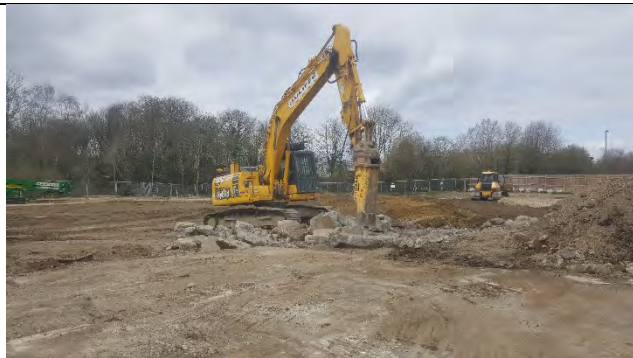
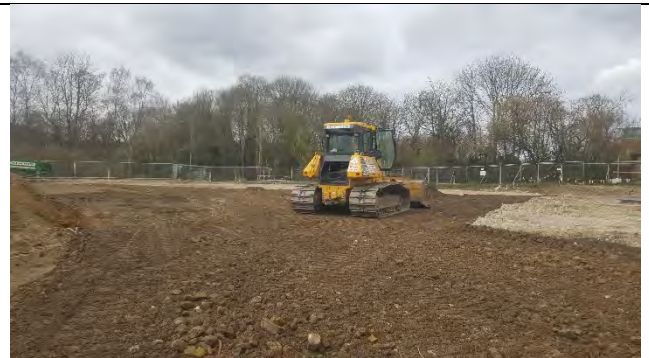
RECORD PHOTOGRAPHS:

- Concrete crusher due to arrive next week
- Stockpiles being moved and tidied up ahead of weekend
- Crushed brick and concrete layer being added with bulldozer to N car park area
- Conveyor for crusher set up ready for crusher arrival
- Concrete being broken out in centre of site for turnover next week

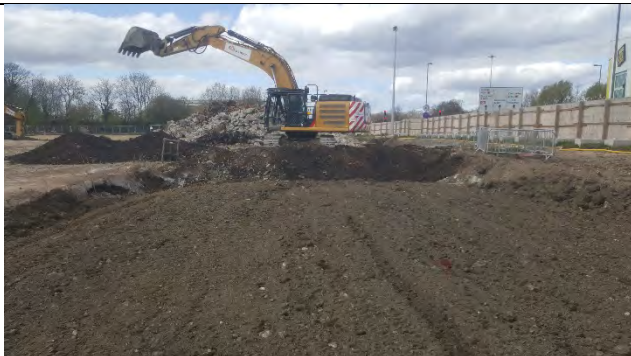
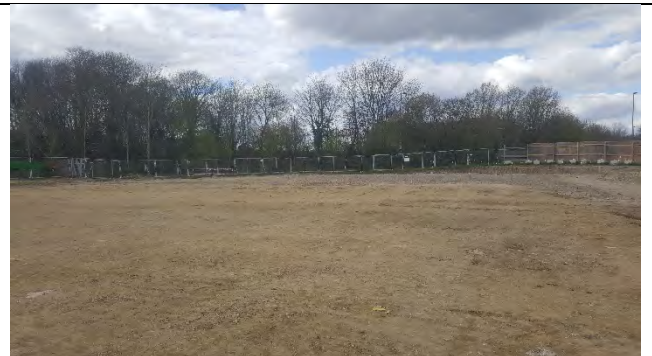
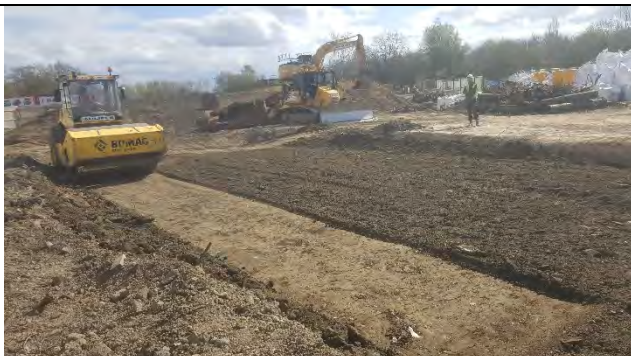
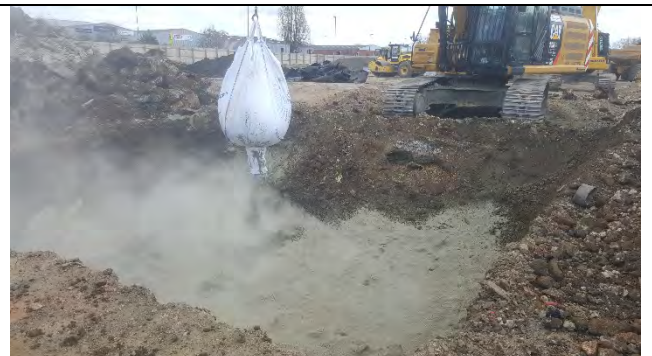
RECORD PHOTOGRAPHS:

- Sketch plan below.
- Loc 1 (to north of concrete stockpile) cement being added to arisings at base – c300mm layer left to cure and tamped with bucket, turnover continuing southwards in this pattern
- Loc 2 Concrete tank base uncovered – a lot of rebar. Breaking out required. Tank appx 2x6m in plan area filled with standing water
- Loc 3 – turned over last week. Backfilled with cement/soil mix and left to cure – c600mm below finished level. Vibro rolled 6 passes before additional layers added.

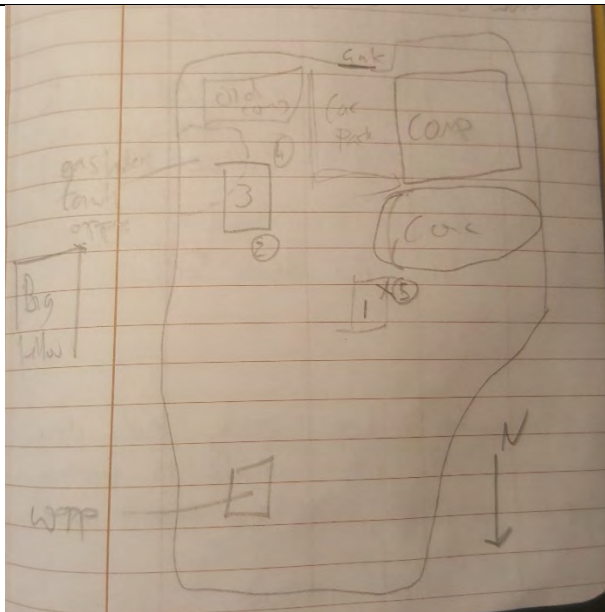
- Sketch plan below
- Loc2 now backfilled to 600mm below surface
- Loc 1 now backfilled to approximately 1m below finished level. Not observed by surface looks rolled. Bulldozer observed adding additional layers
- Location 5 now being turned over
- Loc 4 turned over, cement and slag added. 500mm of backfill added at base and tamped in
