Bat & Bird Appraisal at Beauchamps Cottage, Wyddial, Buntingford, SG9 0EP.

Mr. R. Forsyth

March 2020

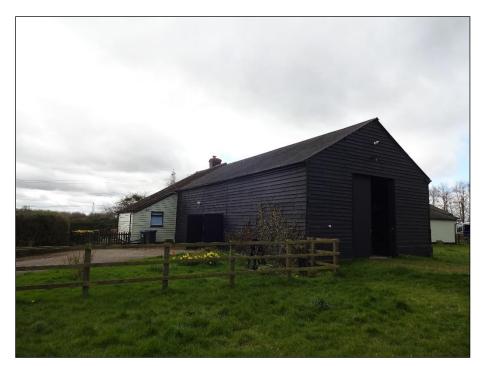
Photograph 1: Front of barn, looking south. 11th March 2020.

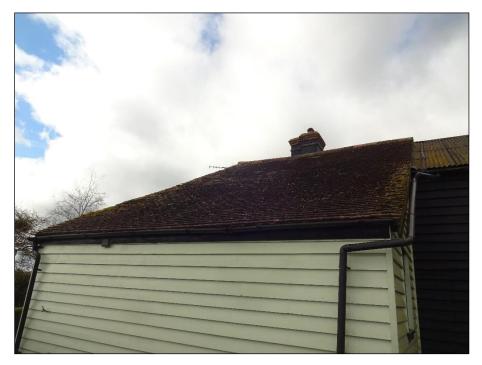
Photograph 2: Front of cottage, looking north. 11th March 2020.

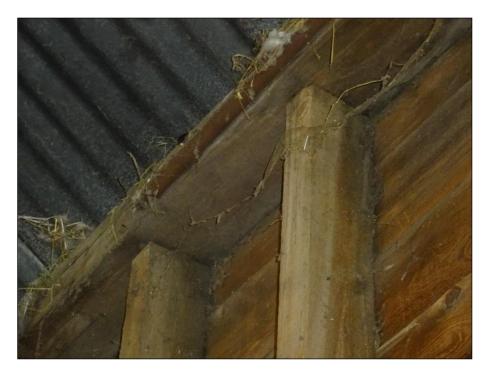
- 3.3.8 Externally, three main areas of house sparrow *Passer domesticus* activity were observed around the barn, where a moderate number of birds were observed entering and exiting the building. Historical dropping staining was evident beneath these areas.
- 3.3.9 Internally, house sparrow nesting was observed in various areas around the barn. Access or potential into the barn for larger birds such as barn owls was deemed negligible.
- 3.3.10 No other signs or evidence of other nesting or roosting by protected, priority or rare birds were observed.

Photograph 6: View of exterior evidence of house sparrow. 11th March 2020.

- 5.1.2 To compensate for loss in nesting habitat for house sparrows, three Vivara Pro WoodStone House Sparrow Nest Boxes should be installed into the northern elevation of the new dwelling. The boxes would be installed into the walls and form permanent features and last in perpetuity.
- 5.1.3 It is recommended that to prevent harm to nesting birds commencement of demolition/construction works should be undertaken outside of the main bird nesting season (March until the end of August). If this timescale is not possible then an ecologist should survey the site for active bird nests just prior to the commencement of works within the nesting season.
- 5.1.4 If an active bird nest was found, it would be necessary to protect the nest from harm or disturbance until the bird had finished nesting.
