HERITAGE NETWORK

Beauchamps Cottage, Wyddial, SG9 0EP

HN1564

HERITAGE STATEMENT

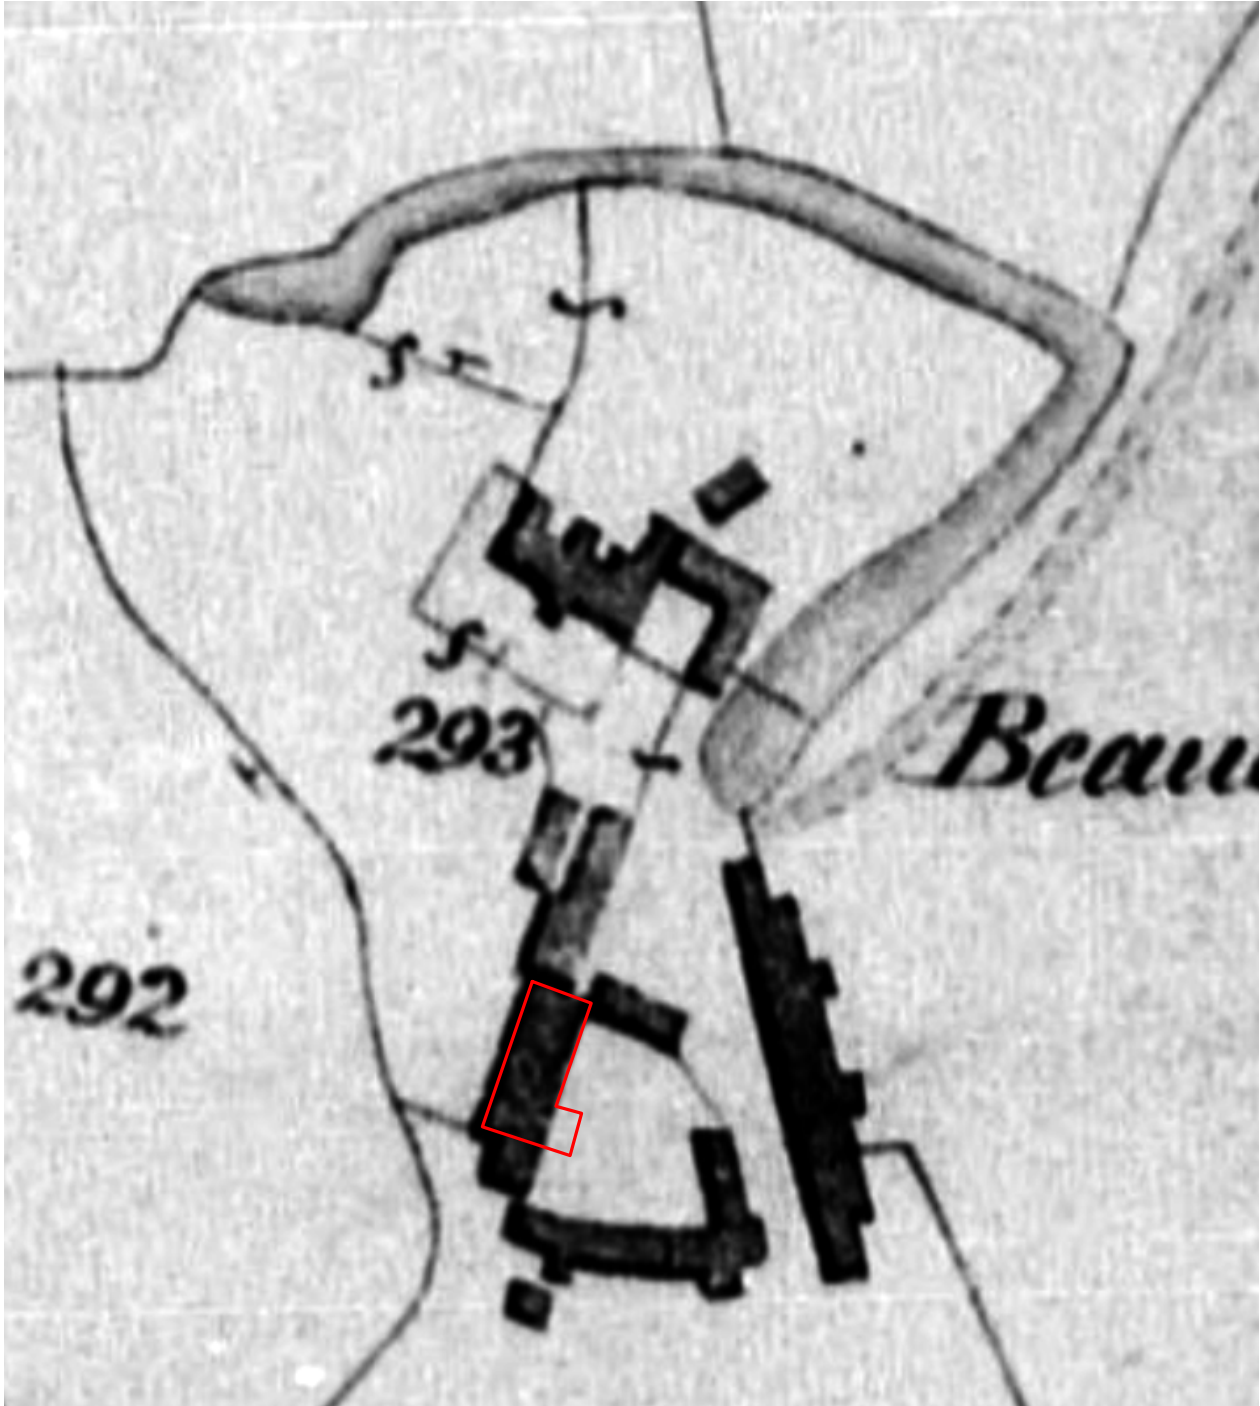
Figure 2

The 1842 Tithe map for the parish of Layston shows a triangular farmyard located to the south-east of the farmhouse, bounded by three ranges of buildings. The western range runs perpendicular to the axis of the farmhouse and is formed of a number of distinct structures. Careful overlaying of modern mapping over the Tithe map shows that the present structure occupies a similar footprint to the principal building in this range (Figure 2).

Extract from Tithe Map, 1842

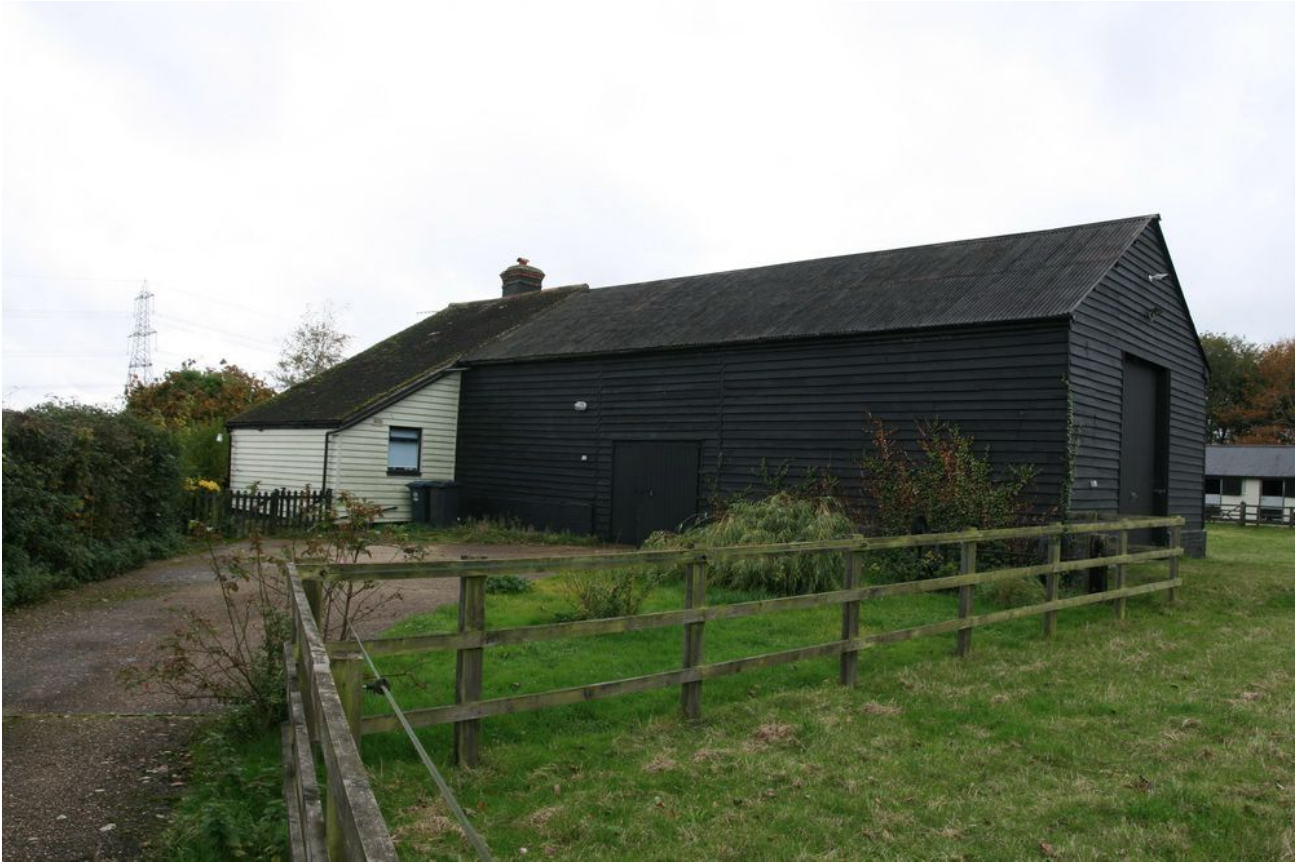
The building forms a timber-framed barn of five bays aligned north-south with two further bays to the south forming part of the same structure but built as domestic accommodation (Plate 1). It sits on a brick plinth with the framing clad on the exterior with modern softwood weatherboarding. Modern double doors in the middle of the eastern elevation of the barn give access to the interior and a further set of modern double doors have been inserted in the northern elevation. An opening in the middle of the western elevation has been blocked, although pintles for the earlier doors survive in the jambs (Plate 2).

Plate 01 - View of cottage and barn, looking SW

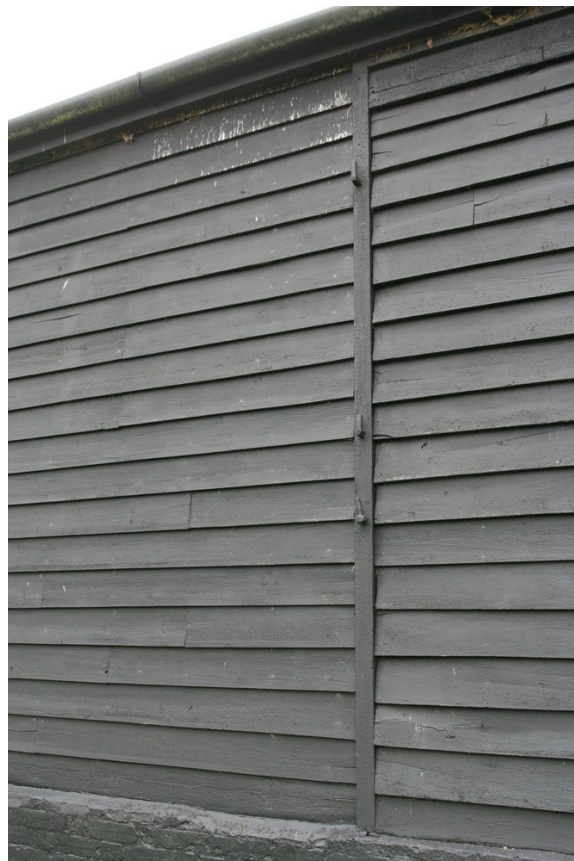
Plate 02 - Pintles in north jamb of blocked western doorway

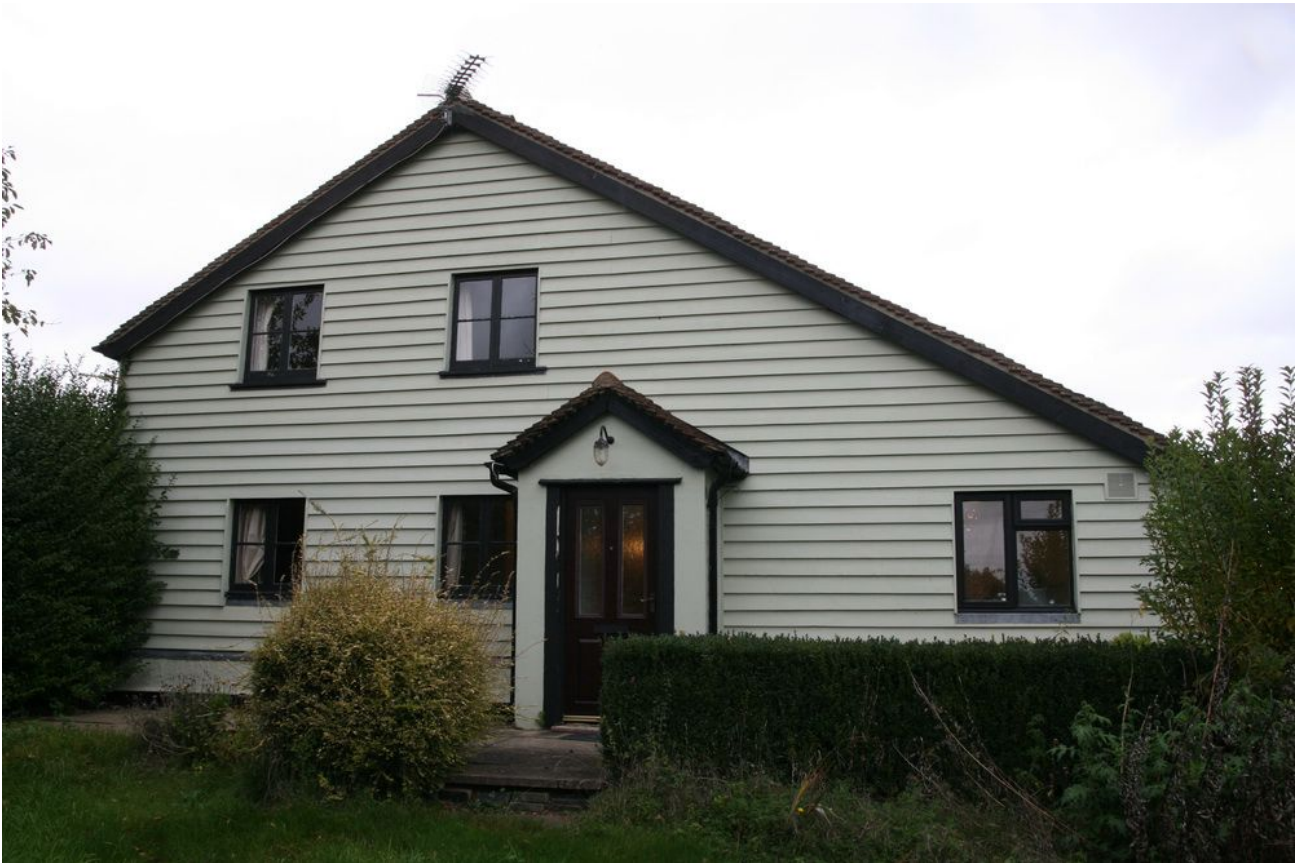
The domestic end of the building is entered through a door on the eastern side of the original southern elevation, now protected by a modern porch (Plate 3). Two windows sit to the west of the doorway, each window being a two-light casement, and each light being of two panes. An extension, housing kitchen and bathroom, has been added to the east of the doorway, beneath a catslide continuation of the main roof of the building. Two windows, serving the first floor, are aligned with the ground floor windows.

Plate 03 - Southern exterior elevation of cottage, looking N

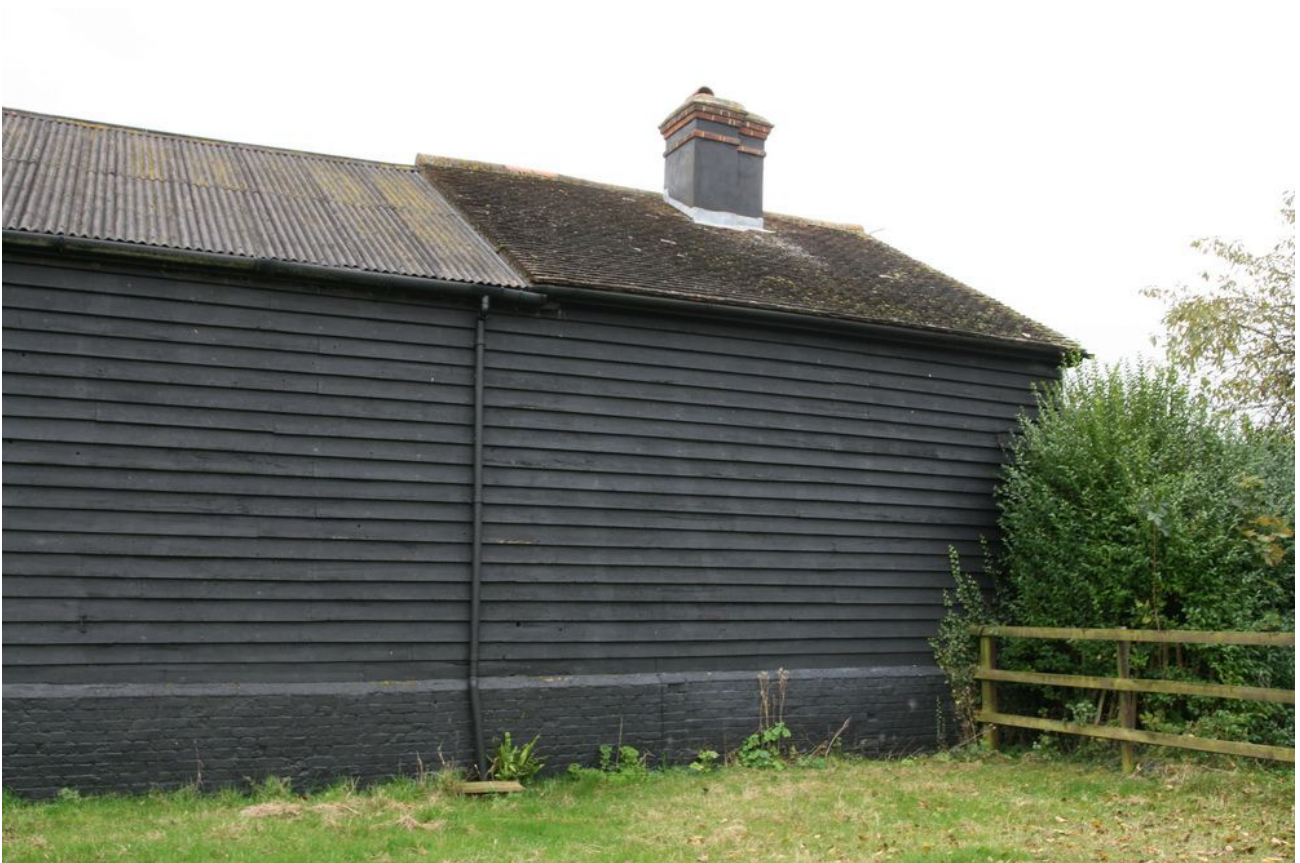
The barn is roofed in corrugated iron sheeting, and the cottage in clay tile (Plate 4). A partially rendered brick double chimney, with a T-shaped plan, rises through the roof to the west of the ridge of the cottage.

Plate 04 - Chimney and roof to cottage and barn, looking SE

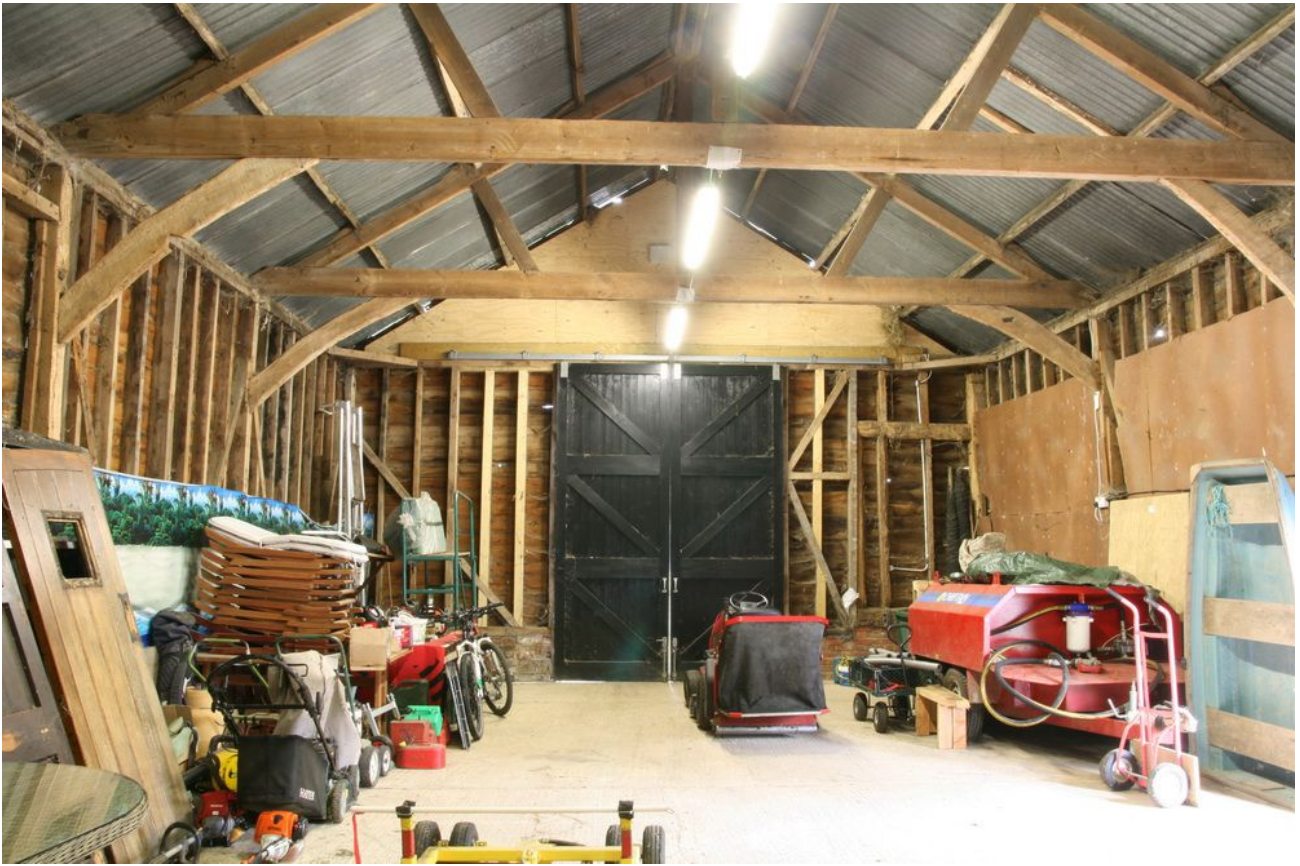
The framing throughout the barn is formed of a sawn softwood wall-plate, supported by principal posts with diagonal primary bracing, resting on a sawn softwood sole-plate and infilled with sawn softwood studs (Plate 5). The roof structure is formed of king post trusses, with sloping queen struts, resting on the wall-plate and braced to the principal posts. The trusses support four purlins in each slope within the main area of the barn, increasing to eight purlins in each slope supporting boarding, at the point that the roof transitions from corrugated sheeting to tile (Plate 6).

Plate 05 - Interior of barn, looking N

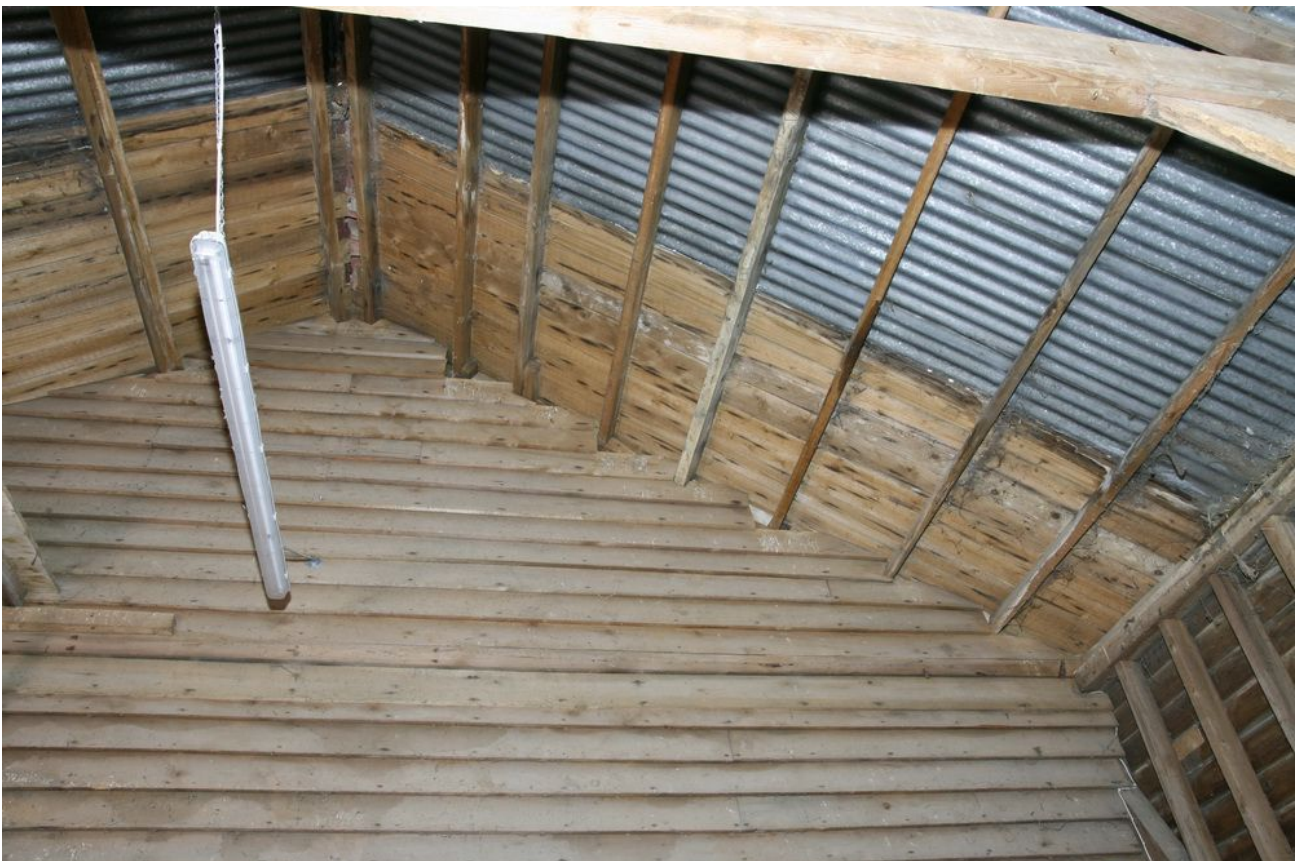
Plate 06 - Roof structure at junction between barn and cottage, looking S

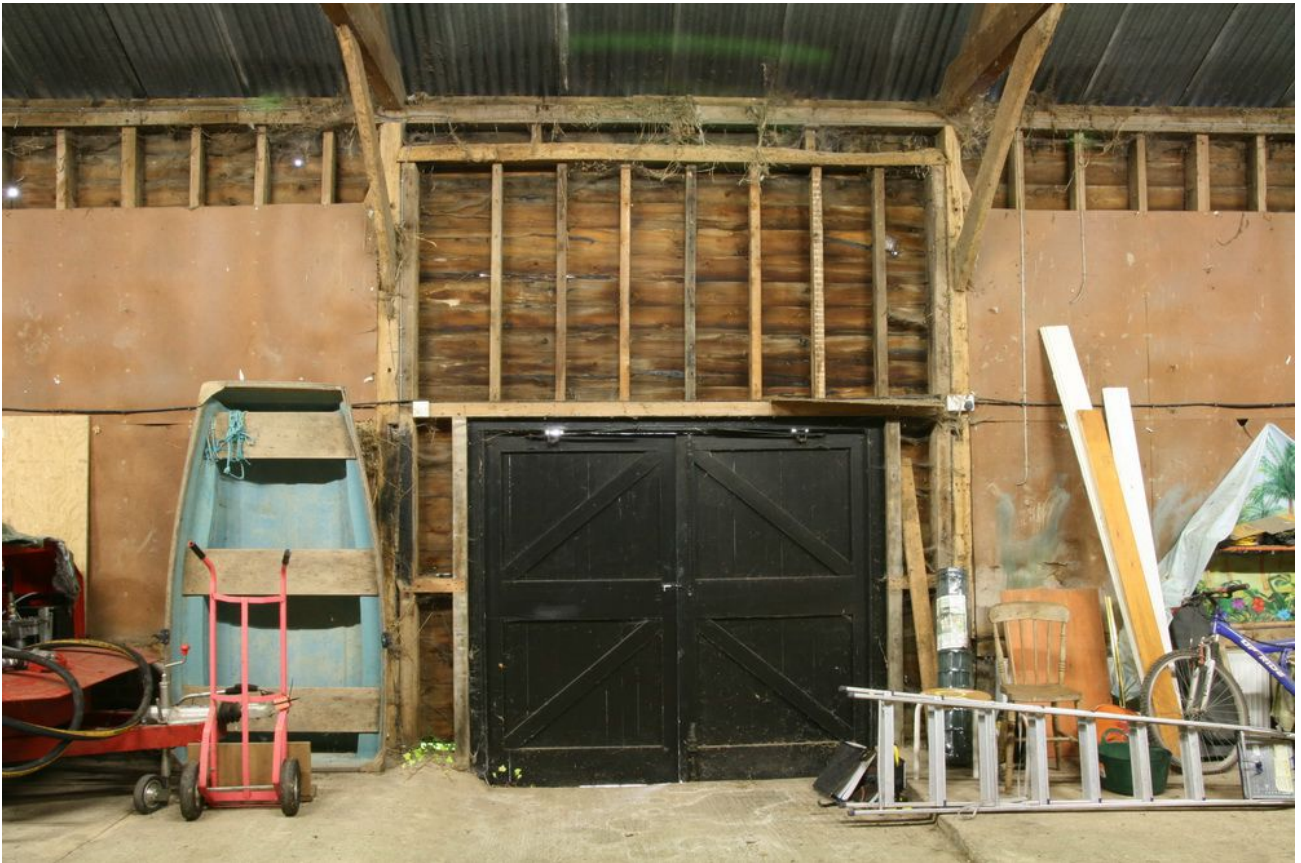
Bay 3 (from the north) has double door openings in the E and W elevations (Plates 7 & 8). The doorways are flanked by principal posts, which extend to the ground and could be from the earlier structure or reused from elsewhere. They are of quite narrow scantling.

Plate 07 - Eastern barn door opening, looking E

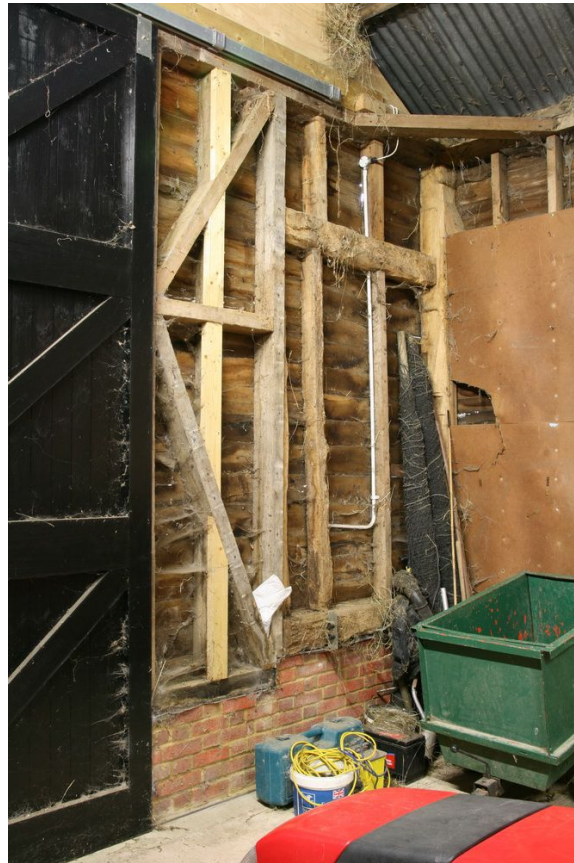
A small area of early framing survives in the NE corner of the barn and hints at an earlier building (Plate 9). A section of sole plate and mid-rail survive together with the truncated corner post indicating a much taller structure of uncertain date.

Plate 09 - Early framing in NE corner of barn, looking NE

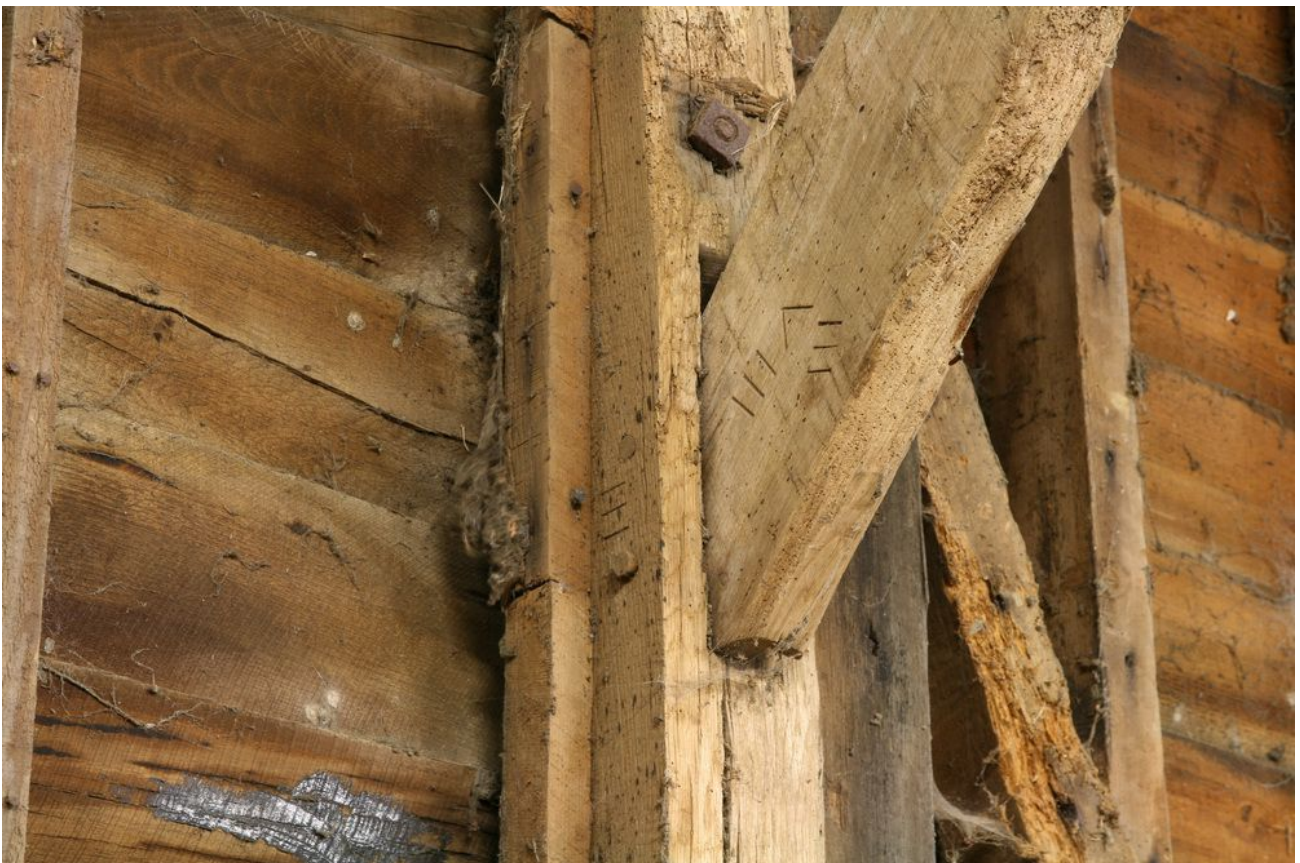
The braces between the tie-beams and principal posts also appear to be of earlier date, and could be derived from the earlier structure on the site or reused from elsewhere. A variety of carpenter's marks confirm reuse, particularly clearly demonstrated at the lower end of the brace on the west side of Bay 2/3, which includes both a III and a VIII (Plate 10).

Plate 10 - Bay 2-3, western brace, looking NW

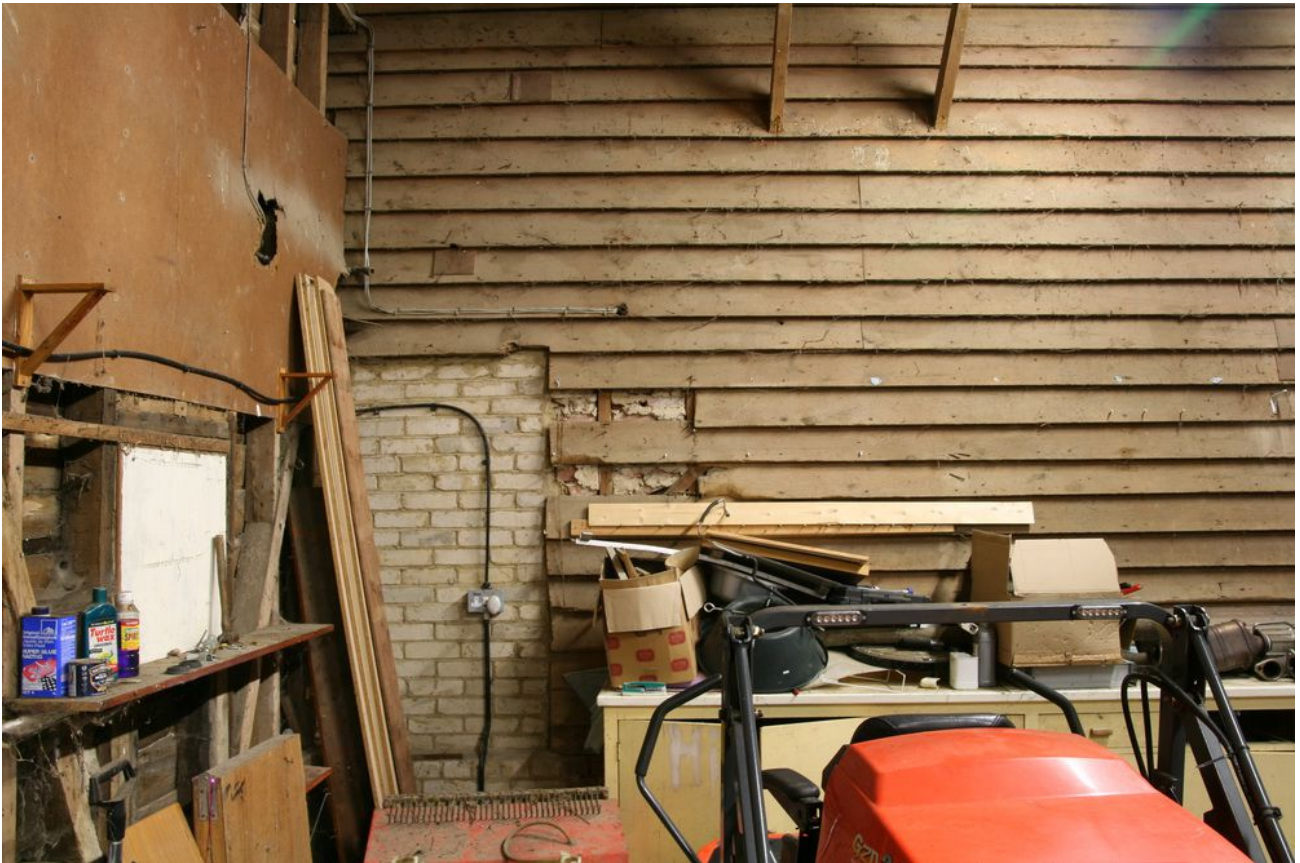
The partition between the barn and the dwelling, visible where the weatherboarding has been removed, is contemporary with the other softwood framing in the barn (Plate 11). A doorway from the cottage to the barn has been closed with modern bricks.

Plate 11 - Exposed framing and blocked door in S elevation, looking S

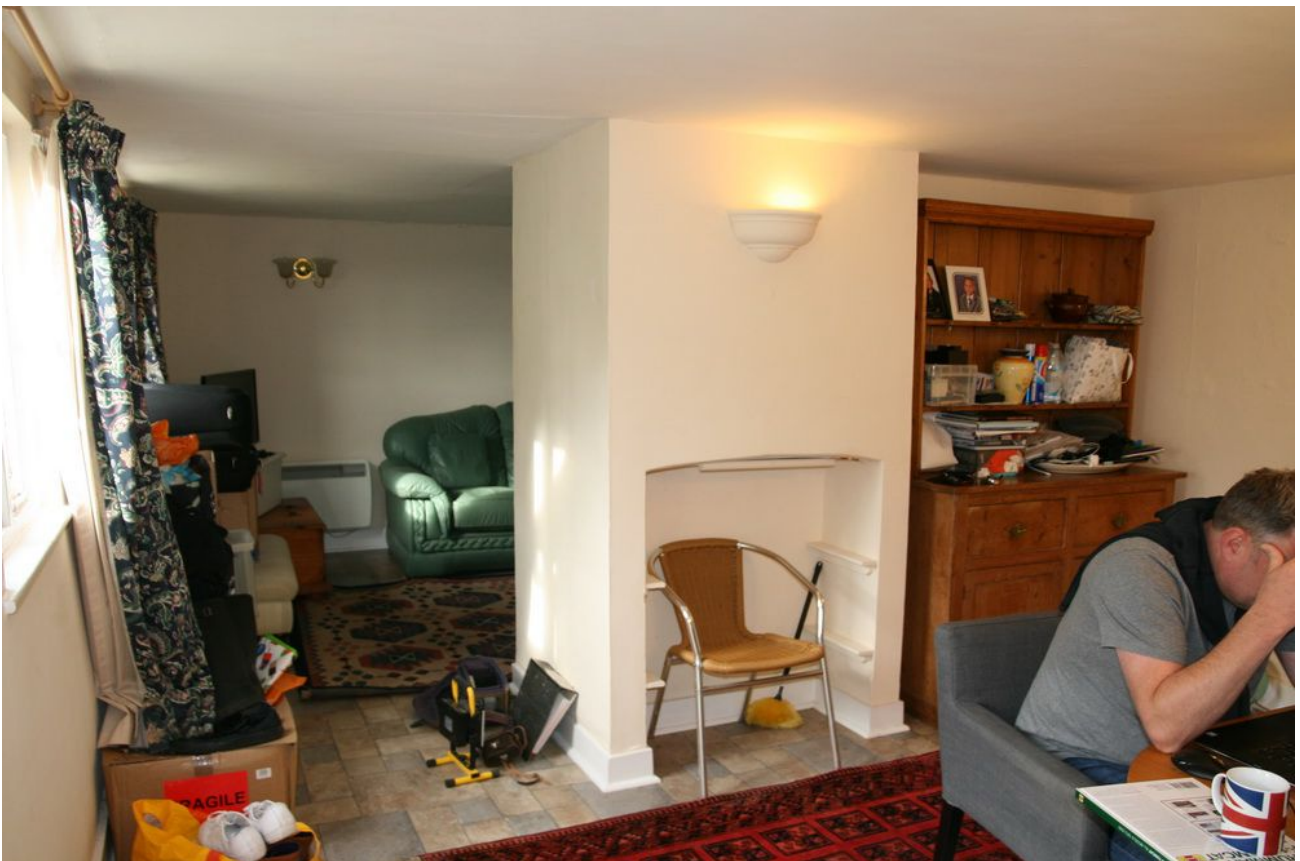
- The eastern ground floor room retains little of historic detail, though a wide fireplace opening in the west elevation hints at a former range (Plate 12), and an original boarded and ledged door at the north end of the east elevation opens onto the staircase leading to the first floor (Plate 13). No coving exists and the skirting is plain throughout.

Plate 12 - Fireplace, E ground floor, looking WNW

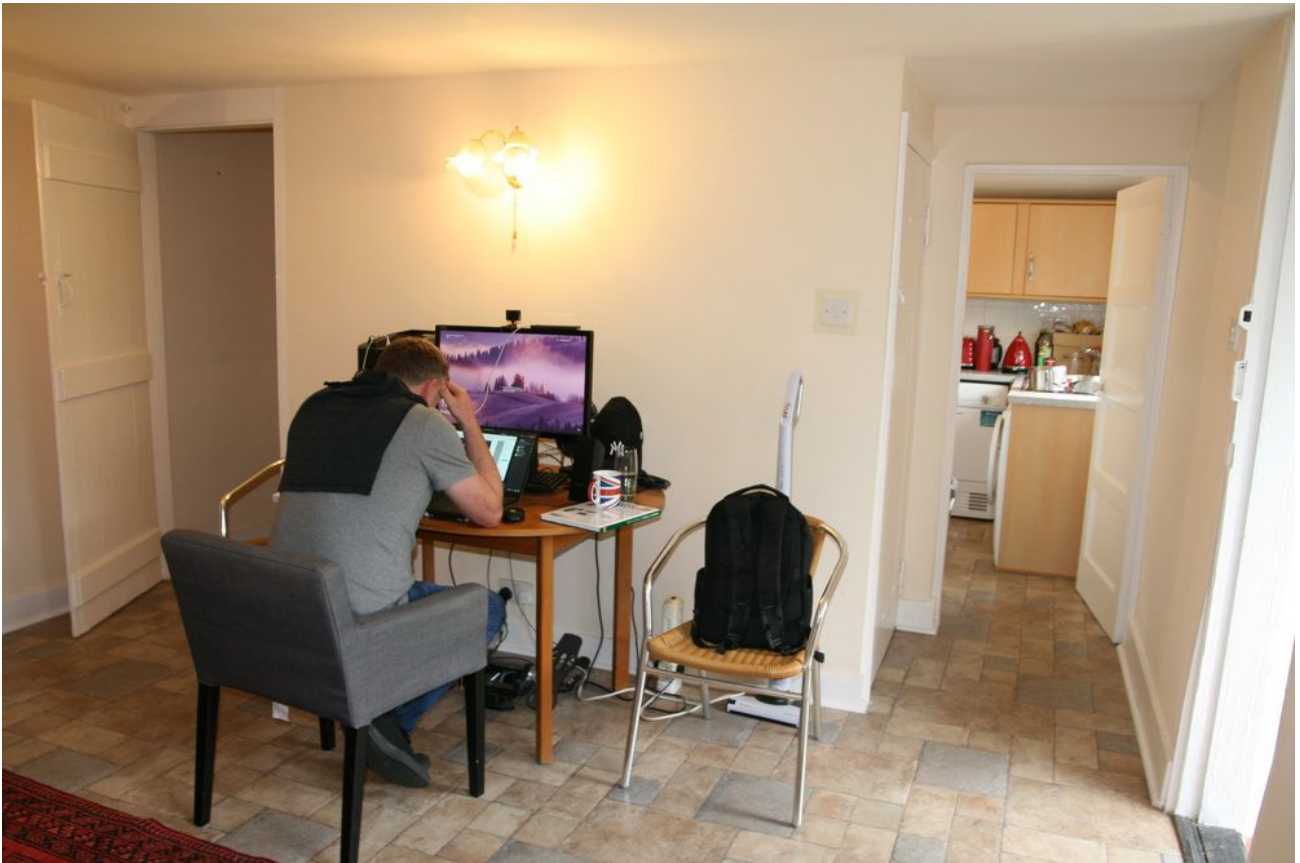
Plate 13 - Stair and kitchen access, E ground floor, looking ENE

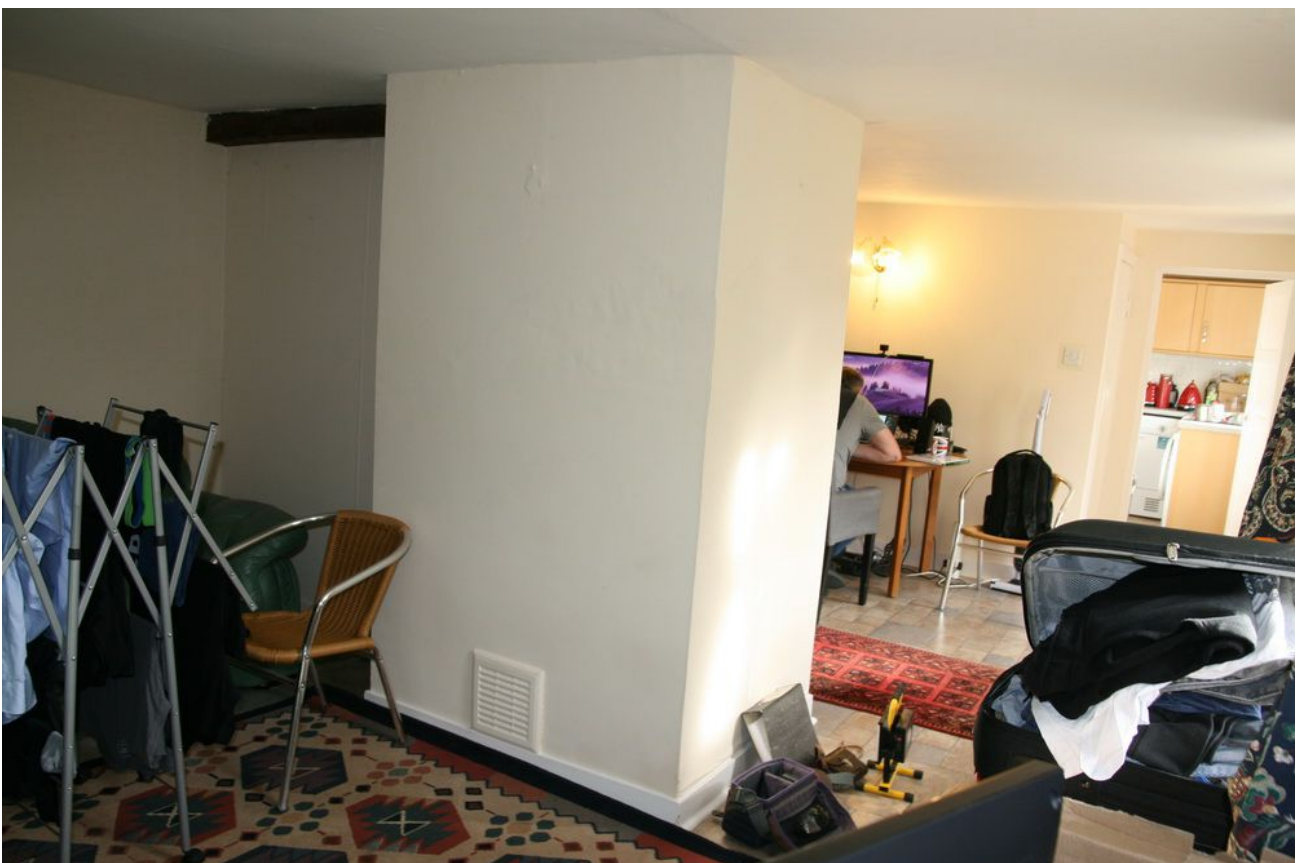
- The partition between the eastern and western rooms, to the south of the chimney, has been removed (Plate 14). The chimney breast in the east elevation of the western room has a modern ventilation grill indicating a blocked fireplace, and a short length of beam is exposed in the alcove to the north of the chimney.

Plate 14 - Chimney and alcove, W ground floor, looking NE

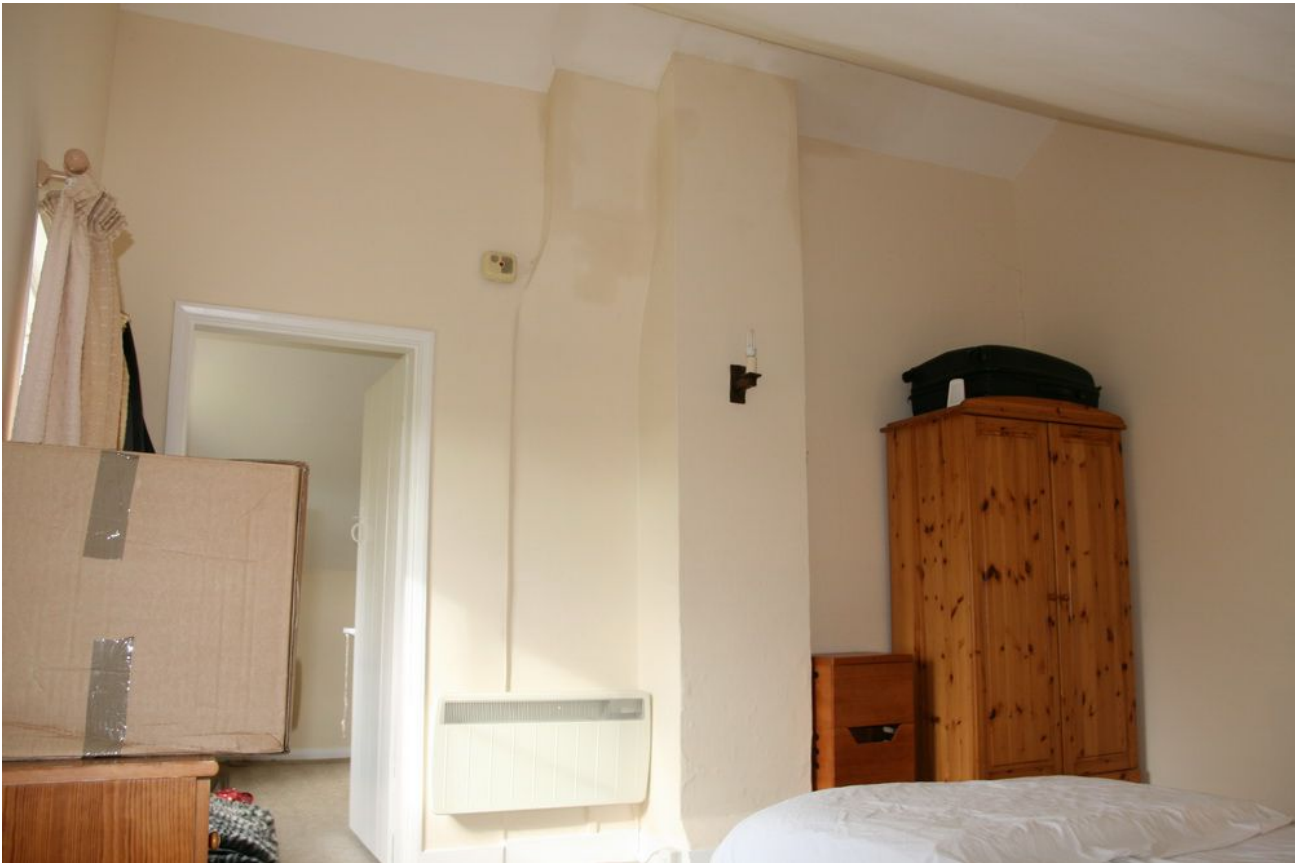
- The staircase rises directly into the eastern first floor room, which has little of historic detail other than the double chimney breast in the west elevation (Plate 15). A surviving partition to the south, which retains an original boarded and ledged door, leads into the western room.

- Discoloured patches on and adjacent to the chimney breasts in the upper rooms, suggest extensive hygroscopic salt contamination in the masonry of the chimney due to the burning of fossil fuels.

Plate 15 - Double chimney breast in W elevation, E 1st floor, looking WNW

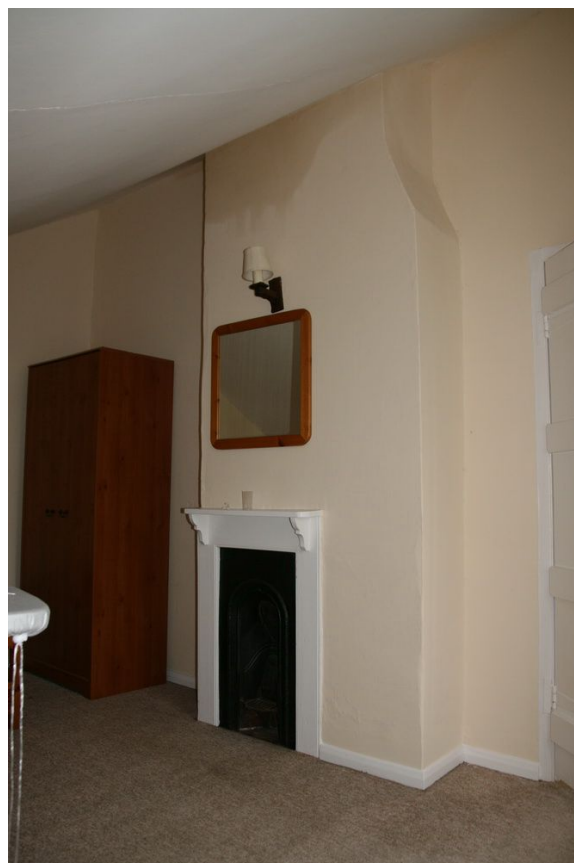
- The ceiling in the western room follows the roofline and a chimney breast occupies the east elevation (Plate 16). A fireplace sits at the northern end of this, with a small cast iron grate with fleur-de-lys decoration on the backplate (Plate 17).

Plate 16 - East elevation, W 1st floor, looking NE

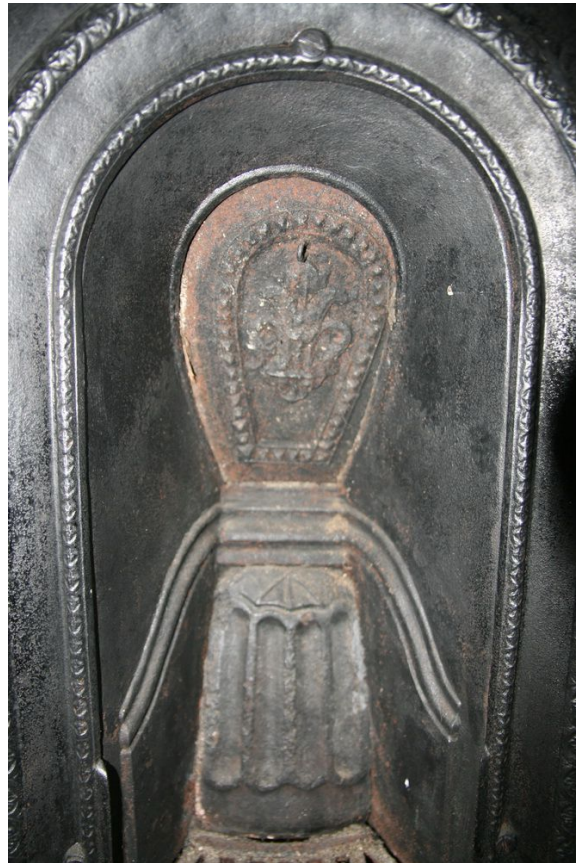
Plate 17 - Fleur-de-Lys detail on backplate, W 1st floor fireplace
