Geo-Environmental Desk Study

Preston Farm,
Shoreham Road,
Sevenoaks,
TN14 7UD

Rural Work Space Ltd

Ref: 3837 20 10 05 Rpt 01 Rev B RD RM

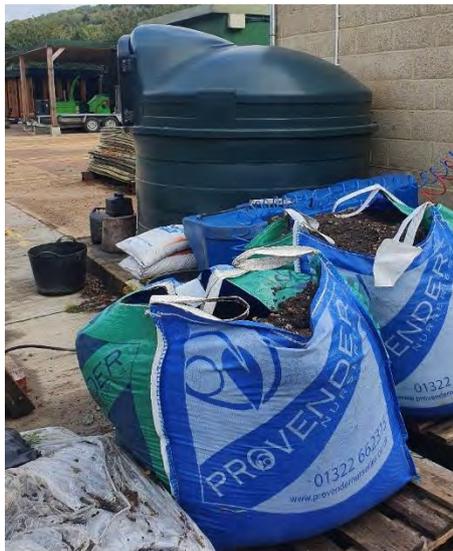
Photo 2 – View of the existing above ground level storage tank located immediately adjacent to the west of building No. 4.

- That a Preliminary Intrusive Geo-Environmental Site Investigation be conducted to clarify potential risks associated with the sources of contamination identified including; Made, previous / existing site use for agricultural purposes, vehicle parking, arboriculturalist yard, vehicle repairs, ground gas associated with infilled features and former mash land on site, existing and former fuel tanks and stockpiled manure. The site investigation include analysis of samples (soils, groundwater if encountered and surface water) for the contaminants of concern and should include a ground gas risk assessment in accordance with current CIRIA C665 guidance and;

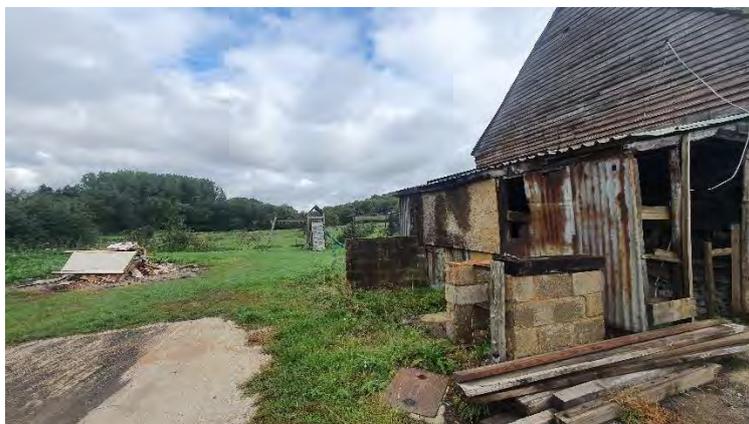
- Previous site use for agricultural purposes associated with Preston Farm farmyard including an oast house (Area B building No. 5), a workshop (Area B building No.6) with a potential vehicle inspection pit and localised oil staining to the ground slab, asbestos fragment debris to the ground surface around buildings 9 – 12 (Area D), a tree surgeons yard (Area A), vehicle parking including lorries and tractors (Areas A, B, D and E) and storage of small volume oil drums with localised oil staining to the slab of building 10 (Area D);

Photo 6 – View across the northern part of Area B showing the large burning ground and the plinth immediately adjacent to the west of building No. 6 indicative of a former above ground fuel storage tank at this location.

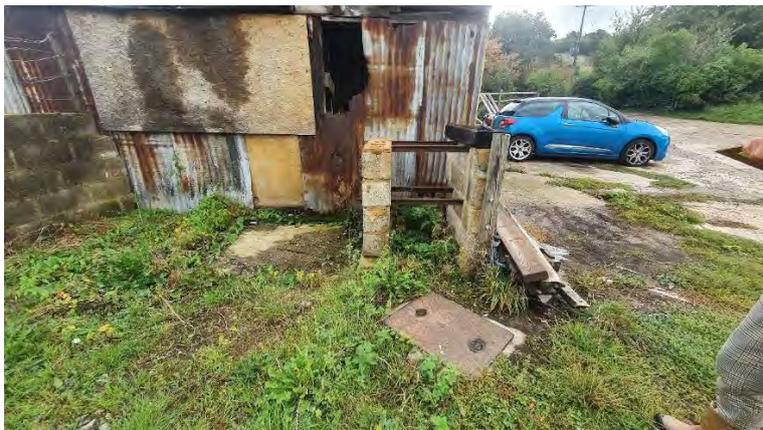
Photo 9 – Former fuel tank plinth with a manhole immediately beneath the former tanks position.

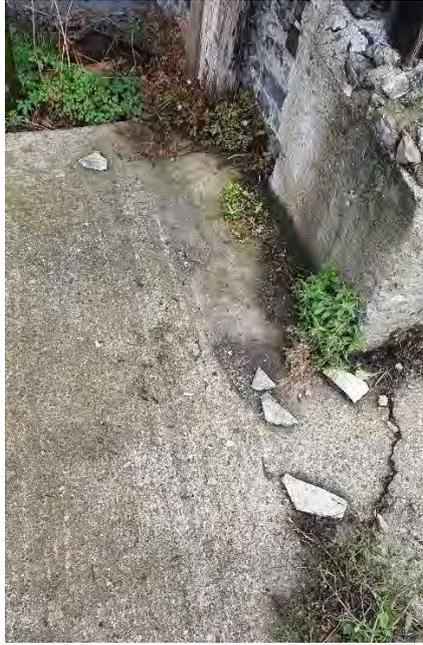
The barns were in part clad / roofed with suspected cement bonded asbestos sheeting and fragment debris were noted to the ground surrounding the barns.

Photo 10 – Example of cement bonded asbestos sheeting debris to the ground adjacent to the building No. 6.

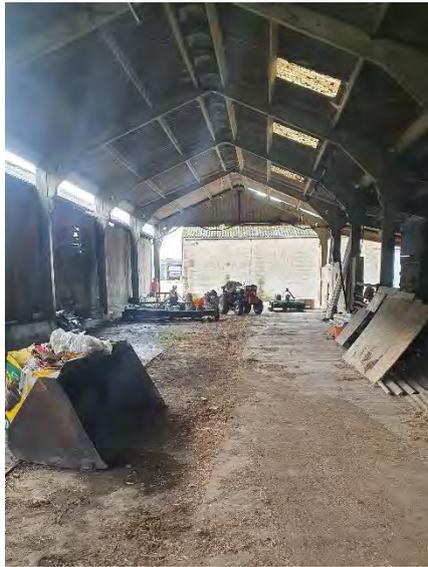
Photo 14 – View inside building No. 10 indicating use of the barn for parked agricultural vehicles and equipment with some localised oil staining to the concrete ground slab.

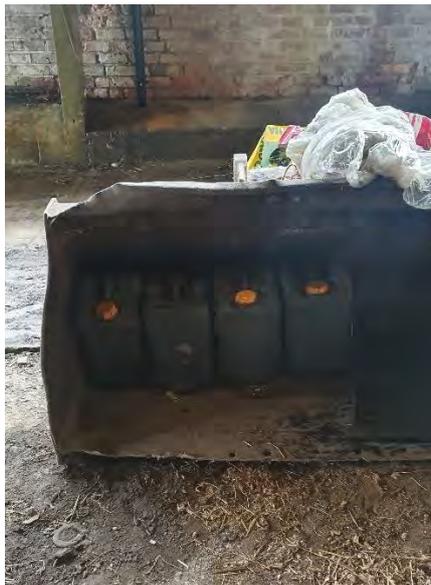
Photo 15 – Storage of oil/ fuel drums within barn No. 10 with localised oil staining.

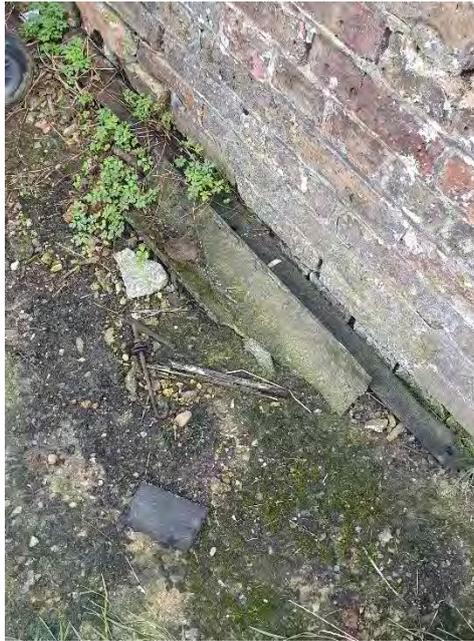
Photo 16 – Further evidence of cement bonded asbestos sheeting debris within Area D, adjacent to barns 9 – 12.

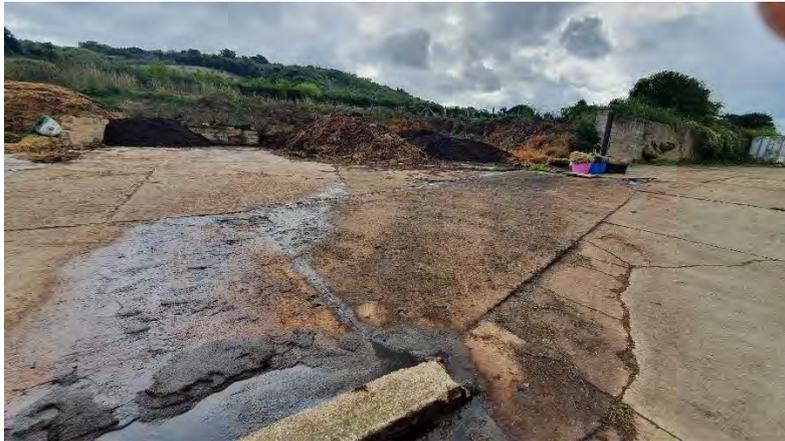
<p>On Site Source: Manure waste stockpiles with leachate run off flooding a catchpit to the south eastern corner of the site (Area E)</p>	<p>The proposed development Existing and future site users Groundworks and maintenance workers Neighbouring sites Controlled waters (Principal Aquifer) and Surface Waters (River Darent) Ecologically Sensitive Sites</p>	<p>Inhalation Ingestion Direct contact Permeable strata Percolation, infiltration and leaching Groundwater / surface water migration</p>	<p>Moderate</p>	<p>Medium</p>	<p>Further site investigation is recommended to clarify potential impact to the ground beneath the site associated with the leachate run off. Accordingly, analysis of soil, any groundwater encountered and surface water should include ammonia in addition to metals, hydrocarbons, speciated PAHs. It is also recommended that the existing surface water drainage system to be repaired to prevent unauthorised discharges and potential contamination to the adjacent River Darent.</p>

Photo 19 – View of the north east corner of Area E where manure is stockpiled and leachate runoff was noted.

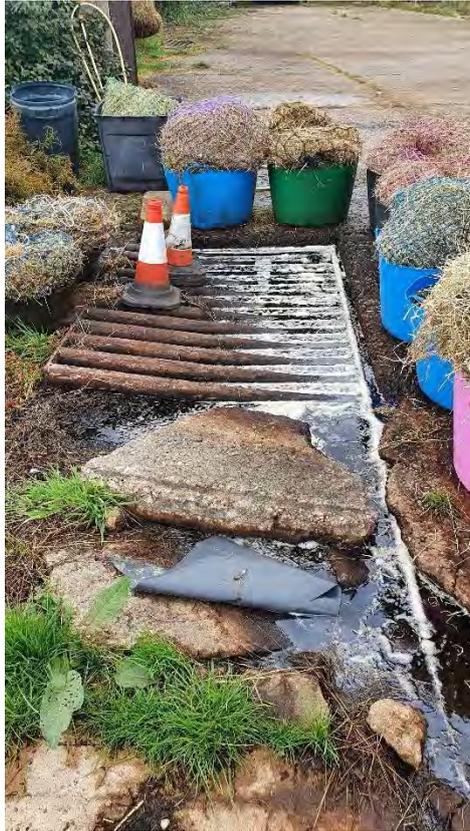
Area E was predominantly unoccupied by buildings and was in the most part laid to concrete hardstanding and used for the parking of horsebox lorries and trailers. A small portacabin (Building 14) was positioned in the north western corner of Area E which appeared to be used as a staff room. 2 No. metal freight containers were also positioned to the south east corner of Area E which were in a state of disrepair and previously appeared to have been used for office space. In addition stockpiles of manure were observed in this area of the site together with an overflowing surface water catchpit which appeared to receive surface water runoff from this area of hardstanding. The overflowing runoff of leachate from the manure heaps was noted to be discharging from the catchpit in a westerly / north westerly direction towards building 11.

Photo 20 – Surface water catchpit at the north east corner of Area E which was observed to be overflowing.
