# WINDLESHAM PLANT CENTRE, CHURCH ROAD, WINDLESHAM, SURREY

## HERITAGE STATEMENT

**PROJECT:** Windlesham Plant Centre, Church Road, Windlesham, Surrey

**DOCUMENT TITLE:** Heritage Statement

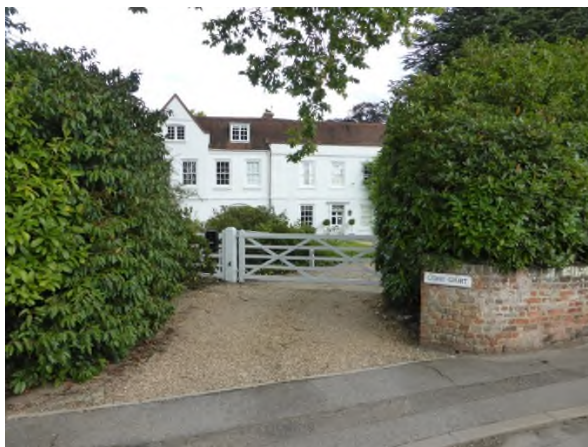
Figure 1: Cedars Court

- 3.2.1 Cedars House and Cedars Court (formerly listed as the Cedars) lies to the north-west of Windlesham Plant Centre. Cedars House and Cedars Court (formerly listed as the Cedars) was added to the statutory *List of Buildings of Architectural or Historic Interest* at Grade II on 23<sup>rd</sup> February 1973. The list description reads as follows:

*House. Early C18, extended to left in C19 and C20. Whitewashed brick with plain tiled roofs. Two storeys and attic to left under one flat roof casement dormer and in gable to left end. Brick plat band over ground floor and to base of parapet partly obscuring roof to centre and right and laid over former cornice. Rear ridge stack to left of centre, end ridge stack to right and end stack on rear range to left. 5 bays to original house with 12 pane glazing bar sash windows in regular arrangement. Panelled door to left of centre, top four panels glazed, in projecting surround with pseudo-pilasters flanking and transom light above (Cedars Court). Four bay extension slightly set back to left with gable to left end. 4 sash windows across first*

*floor with one tripartite sash window under segmental head to ground floor right. Half glazed door to left end in recessed porch with projecting surround, flanked by pseudo-pilasters and traceried transom light over (Cedar House) Single storey hipped roof extension to left end. Parallel range to rear.*

5.2.3 In both cases, the Windlesham Plant Centre site is of sufficient distance and well screened by green boundaries of mature trees and shrubs (**figures 1, 21, 23 and 24**). In the case of Birch Hall, Cedars Coach House is positioned between the listed building and Windlesham Plant Centre. There is negligible inter-visibility between these listed buildings and the proposed development site.

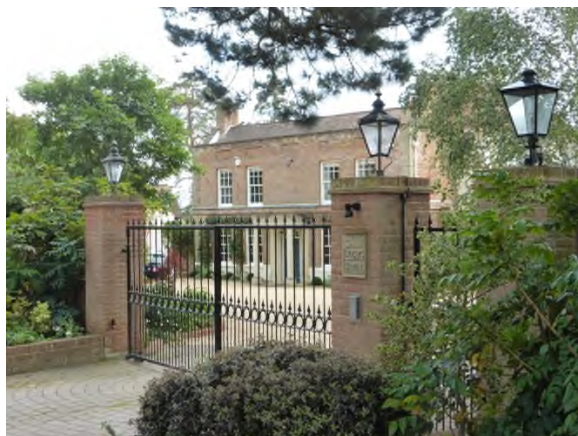
Figure 2: Birch Hall

- 3.2.2 Birch Hall lies to the south-west of Windlesham Plant Centre. Birch Hall was added to the statutory *List of Buildings of Architectural or Historic Interest* at Grade II on 19<sup>th</sup> July 1984. The list description reads as follows:

*House. Circa 1740 with large C20 extensions to rear right. Red and brown brick on rendered dado and plinth, stone rusticated quoins to ends; plain tiled roof. Extensions to rear rendered with hipped plain tiled roofs. Two storeys with plat band across ground floor and parapet partly obscuring roof; end stacks on raised gable ends. Four twelve pane glazing bar sash windows, renewed, across the first floor under cambered heads. Central panelled door in pilaster surround with open pediment over leaded fanlight. Extension to rear right taller. Two storeys with ridge stack. Four windows across.*

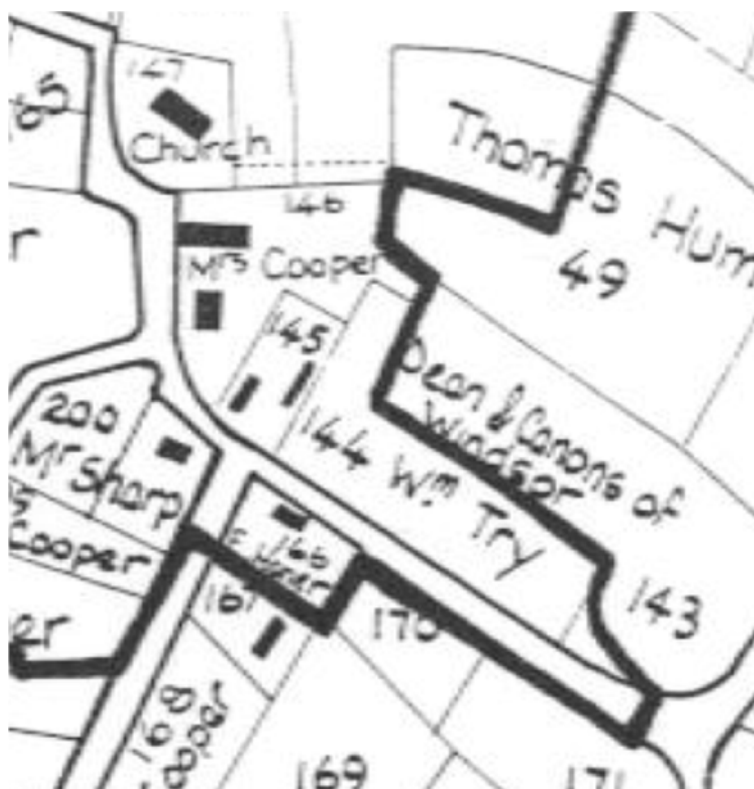
Figure 3: Extract from a copy of the Windlesham enclosure map (1813)

3.4.1 The Windlesham enclosure map (1813) demonstrates that the Windlesham Plant Centre site was under different ownership to the Cedars in the early 19<sup>th</sup> century. The Cedars was under the ownership of a certain Mrs Cooper while the Windlesham Plant Centre site was under the ownership of William Try.

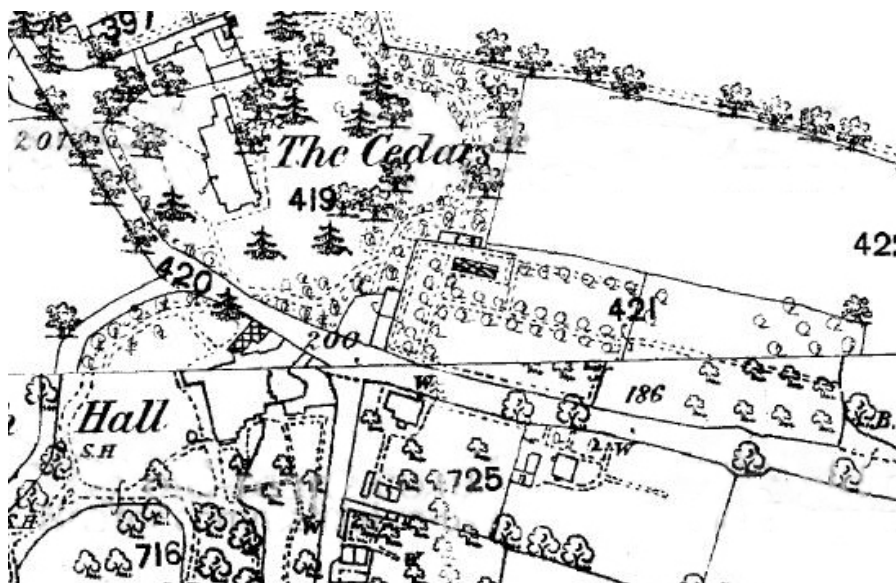
Figure 4: Extract from the 1<sup>st</sup> edition of the Ordnance Survey map (1872)

3.4.2 The 1<sup>st</sup> edition of the Ordnance Survey map (1872) shows The Cedars in its small parkland setting. To the south-east is Cedars Coach House and the Windlesham Plant Centre site. The western end of the Windlesham Plant centre site is shown with a formal layout of paths lined with trees and a greenhouse on the northern side. Unlike the current greenhouse it is positioned away from the boundary with The Cedars to the north. On the northern side of the north boundary to the Windlesham Plant Centre site there is a group of small attached structures.

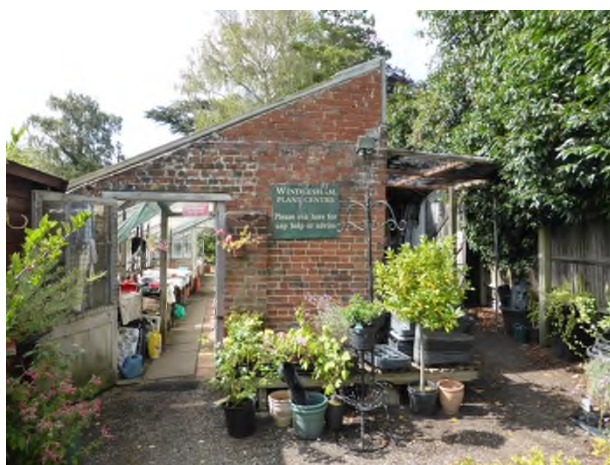
- 4.1.1 The east elevation of the glasshouse is of brick construction. The right hand section of brickwork incorporates part of a return to the northern brick boundary wall. This section of wall is characterised by Flemish bond bricks and a brick pilaster/buttress. The brick work above this is of different character and includes what appear to be machine made bricks as well as hand-made bricks. The brickwork on the left hand side matches the brick work of the plinth on the west elevation. Above these two phases of brickwork is a third phase of machine made bricks laid in stretcher bond.

Figure 8: East elevation of the glasshouse

- 4.1.2 There is door opening with a part-glazed panelled door on the left hand side of the east elevation.

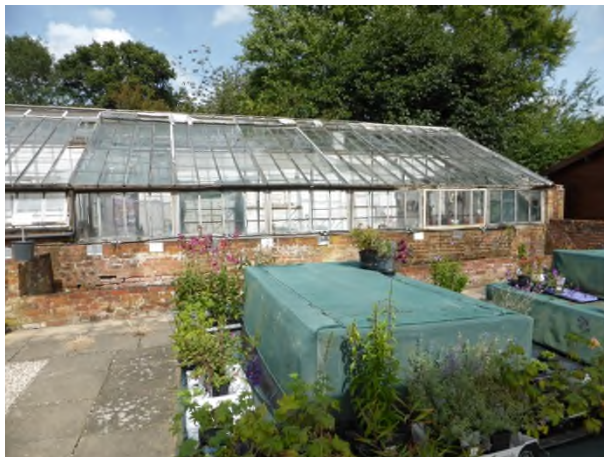
- 4.1.3 The south elevation includes a brick plinth laid in Flemish bond. This is only visible along the eastern two bays as the rest of the plinth is masked by a low brick wall to the rear of brickwork associated with modern cold frames (dismantled).
- 4.1.4 The brick plinth supports a slender frame of what appears to be softwood. The frame joints are dowelled. The front ventilators (or casement windows) are top hung and operated by iron winding gear (discussed below). Each ventilator includes 4 panes with square section glazing

bars. The roof is characterised by thicker section rafters which define the bays and narrow square section glazing bars between. The glazing is fixed to the glazing bars with panel pins. The glazing is straight cut rather than beaver-tail glass. Some of the panes has linear distortions which suggests drawn sheet glass, a machine-made glass characteristic of pre-1940. A large number of panes have been replaced.

Figure 9: Right hand side of the south elevation

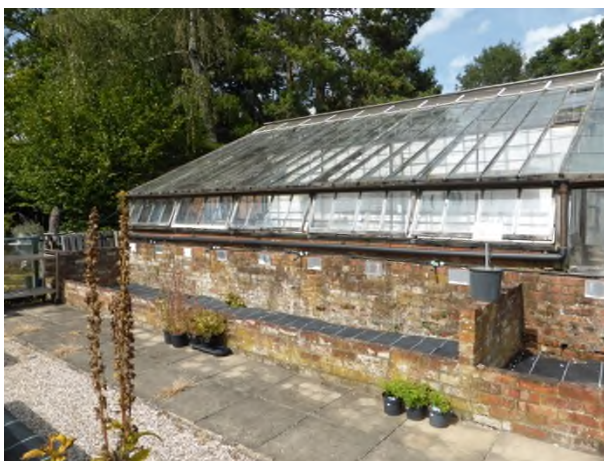
Figure 10: Left hand side of the south elevation

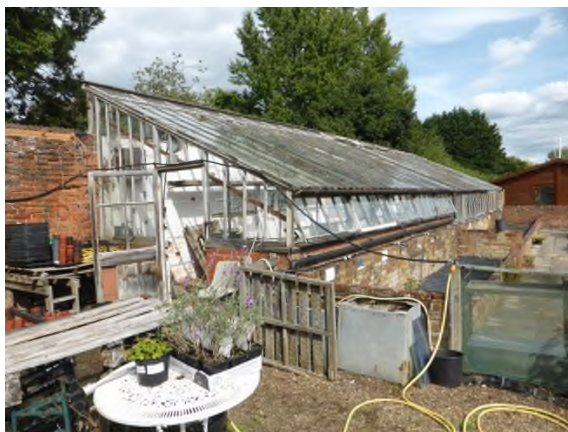
- 4.1.5 The west elevation includes a brick plinth of two phases of construction. The lower section of the plinth is laid in English bond while the upper sections and the jambs of the door opening are machine-made bricks laid in stretcher bond.
- 4.1.6 The door opening includes closer bricks in the earlier phase of brick work to the left. The door is part-glazed with three solid panels. This is of similar design to the door on the east elevation. The plinth wall supports and wooden frame with fixed glazing.

Figure 11: Oblique view of the glasshouse showing the west elevation

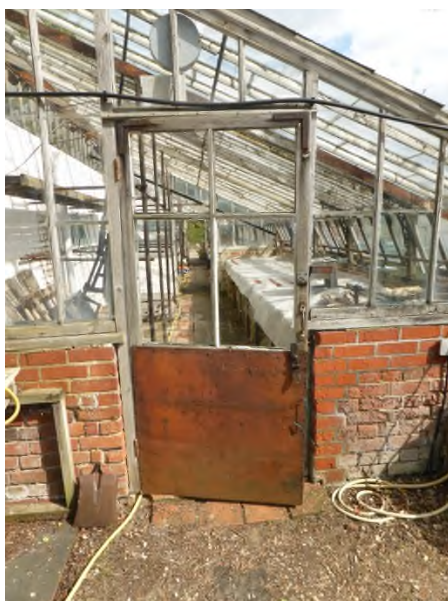
Figure 12: Detail of the west elevation showing two phases of brickwork

6.3.4 The additional courses of machine-made bricks on the western side of the glasshouse correlate with the position of the projecting element of the late Victorian glasshouse shown on historic maps.

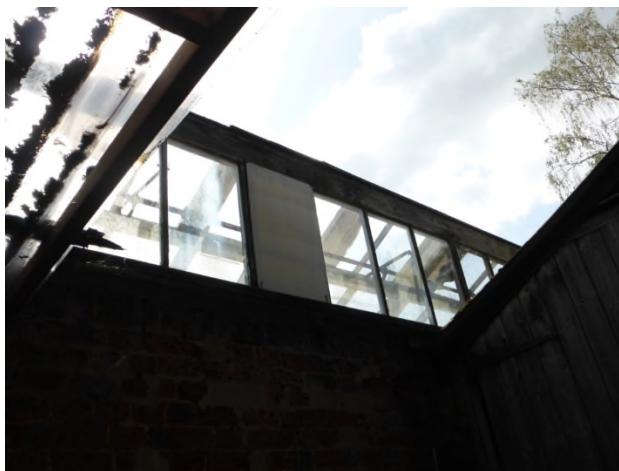
- 4.1.7 The north elevation is characterised by the original boundary wall on the north-eastern side of the Windlesham Plant Centre site (discussed below). The apex of the roof of the glasshouse projects above the wall and a series of fixed panes within a timber frame are supported on a longitudinal timber on top of the boundary wall.

Figure 13: Apex of the roof of the glasshouse viewed from the northern side of the brick boundary wall

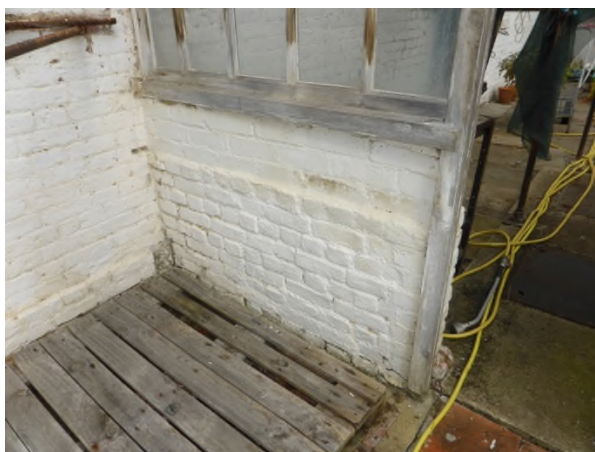
- 4.1.8 The interior is divided into two spaces by a low plinth wall with glazed frame above. Similar to the brickwork on the north elevation there are two clear phases of brickwork. There are three courses of what appear to be machine-made bricks in stretcher bond over hand-made bricks laid in English bond.

Figure 14: Plinth wall with two phases of brickwork at the centre of the glasshouse

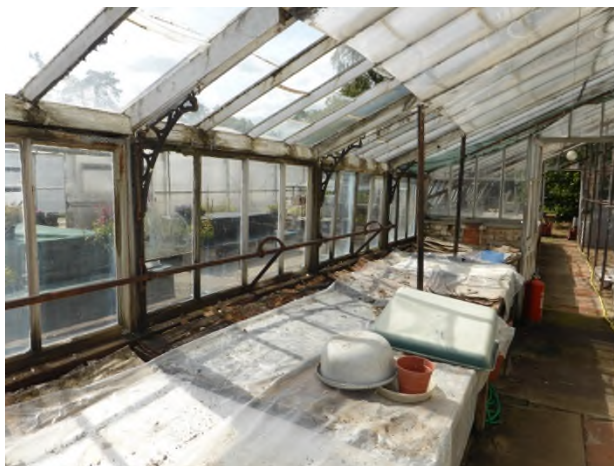
- 4.1.9 Internal fittings include winding gear for the front and roof lights. The winding gear is stamped with the following 'Taplow Bucks' and 'Wm Wood and Sons Ltd'. The ventilator opening system includes long rods connected to the opening lights with elbow levers which are rotated by the winding gear mentioned above. The roof ventilators are not connected to the ventilator opening system. There are decorative iron brackets at the junction between the wall frame and the principal rafters. The apex of the roof does not include any decorative ironmongery. The rafters are connected to a longitudinal timber along the top edge of the glazing which tops the boundary wall.

Figure 15: Decorative iron brackets and ventilator opening system

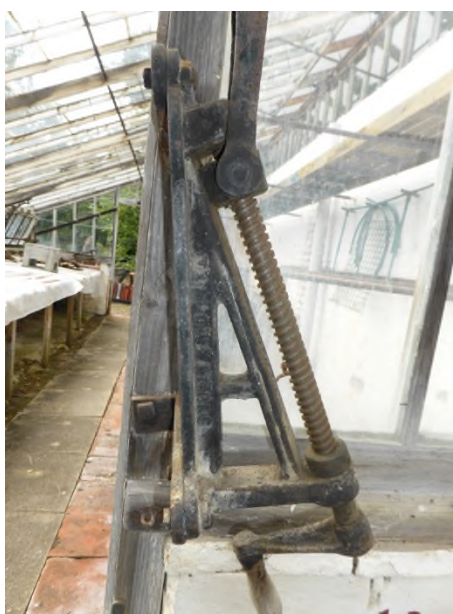
Figure 16: Detail of the winding gear

6.3.6 Internal fittings includes winding gear manufactured by William Wood and Son Ltd. Some of the winding gear includes the inscription 'Taplow. Bucks'. William Wood and Son were founded as coal merchants in 1850 and operated out of North British Wharf in Wood Green. By 1895 William Wood and Son were incorporated as a Limited Company. It was at this time that the company started to sell horticultural sundries in addition to coal and lime and by 1914 were operating on a grander scale as horticulturalists. In 1924 William Wood and Son Ltd moved from Wood Green to the Beechwood Works in Taplow, Buckinghamshire. This suggests that the winding gear in the glasshouse at Windlesham Plant Centre was inserted sometime after this date, i.e. after 1924.

The glasshouse includes limited internal features of merit. The winding gear manufactured by William Wood and Son Ltd are representative of mass produced horticultural fittings dating from the c. 1930s. These are considered to be of low significance.

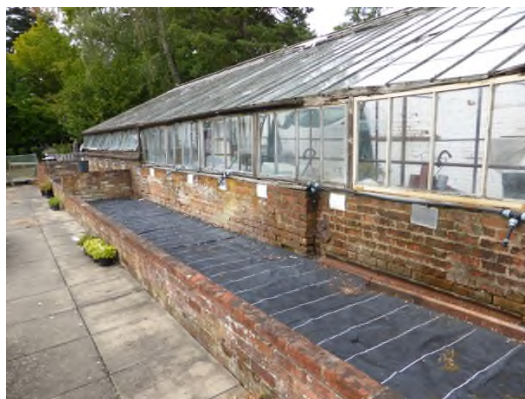
- 4.1.11 The low brick walls projecting from the south elevation of the glasshouse are laid in stretcher bond. These relate to a modern cold frame which has been dismantled.

Figure 17: Brick plinth walls to a dismantled cold frame

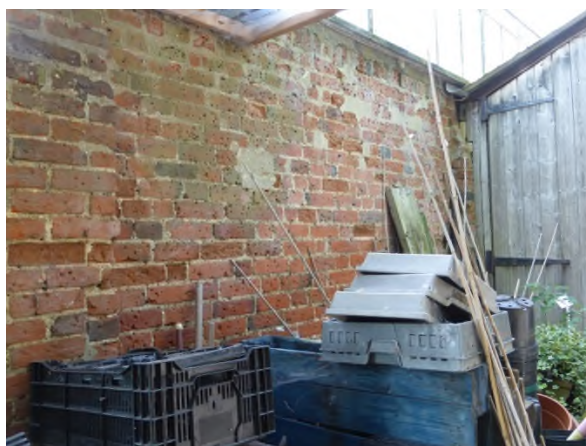
- 4.2.1 The boundary wall in the north-east corner of the Windlesham Plant Centre can be observed to the west of the glasshouse and from the store to the rear of the glasshouse. The brickwork is fairly random but is predominantly laid in monk bond. The top of the wall includes a brick on edge capping. The bricks are hand-made and their dimensions are approximately 230x112x62mm. The north facing elevation of this section of boundary wall includes shallow buttresses or pilasters. There is no clear evidence within the fabric of the wall for the former structures shown on the historic Ordnance Survey maps.

Figure 18: Boundary wall to the rear of the glasshouse

Based on this assessment, it is concluded that the north-east corner of the boundary at Windlesham Plant Centre should be regarded as curtilage listed. The section of wall to the rear of the greenhouse however appears to have been in separate ownership at the time of listing The Cedars and, although attached to the curtilage listed section, is considered to not be curtilage listed.

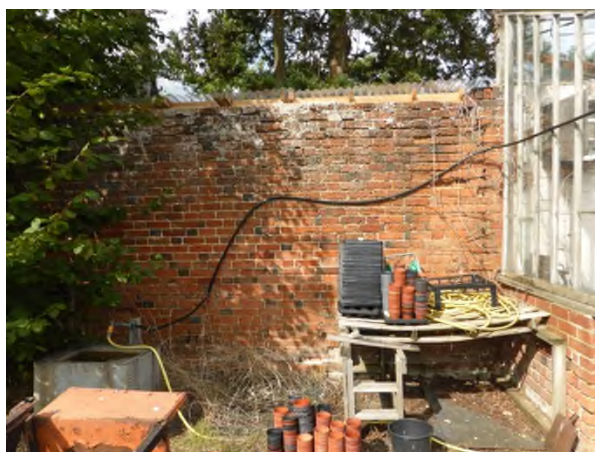
Figure 19: Section of boundary wall to the west of the glasshouse

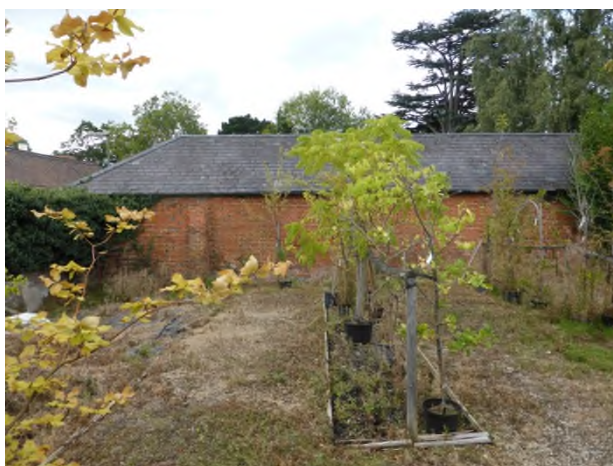
- 4.2.2 The boundary wall appears to return southwards along the western edge of the Windlesham Plant Centre and forms the rear wall of Cedars Coach House. This brickwork of this section is more clearly laid in monk bond. The boundary wall to Cedars Court then continues along Church Road and is of brick laid in monk bond. The character of the low wall directly in front of Cedars Court does change and appears to be laid in Flemish bond. The Windlesham Conservation Area Character Appraisal notes that this brick boundary wall along Church Road forms an attractive feature on the frontage of Cedar House, Cedar Court and Cedars Coach House.

Figure 20: Cedars Coach House on the western boundary of the Windlesham Plant Centre

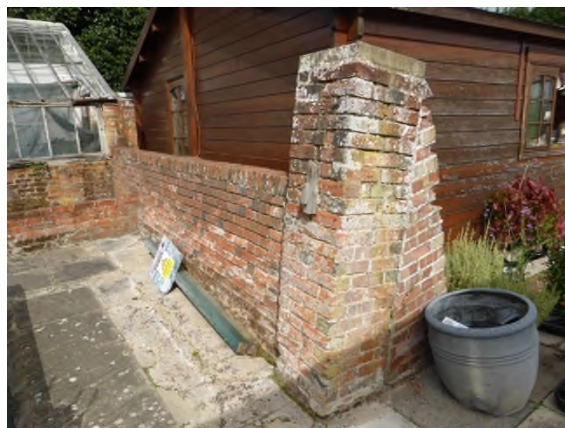
- 4.2.3 There is a low brick boundary wall which projects from the south-east corner of the glasshouse. The brickwork is laid in Flemish bond and includes lime mortar joints. The wall is capped with bricks on edge and terminates in a brick pier with a flat stone coping. The wall is leaning to the east and the brick pier is supported by a buttress of Fletton bricks.

Figure 22: Early 20<sup>th</sup> century brick wall on the south-east corner of the glasshouse

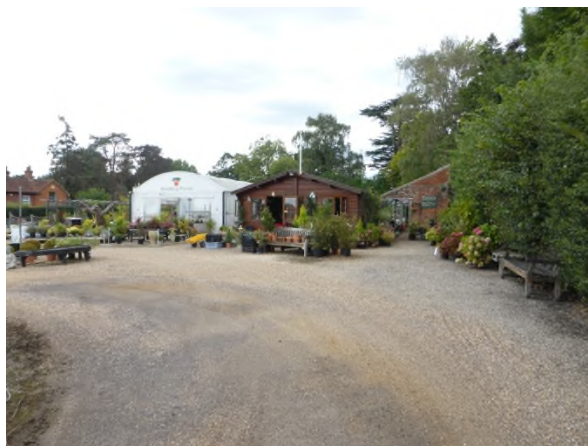
7.3.1 The plant centre structures include a shed on the north side of the old garden wall, a plant centre shop (shed) and a poly-tunnel. The poly-tunnel and shop are recent structures and of no interest. The shed on the northern side of the old garden wall includes a machine sawn softwood roof structure supported on battens attached to the old garden wall and a modern boundary wall. The roof finish is corrugated cement/asbestos. This structure relates to activities following the 1972 sale of the site. This building is not considered to be of interest.

Figure 25: Plant Centre shop and poly-tunnel

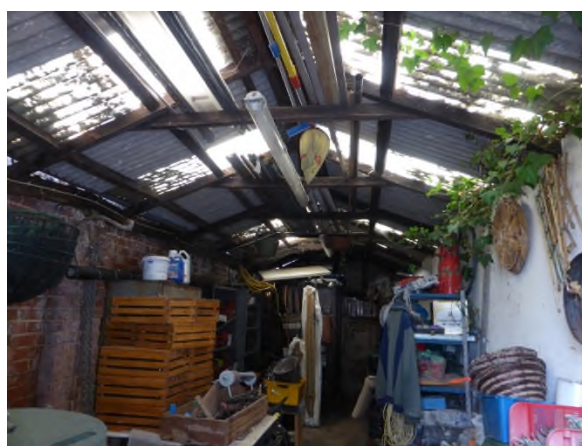
Figure 26: Shed on the north side of the garden wall/greenhouse

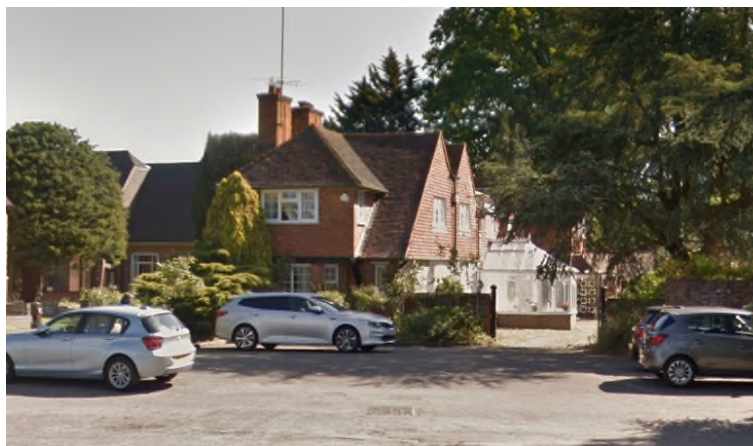
Figure 27: Cedars Lodge

- 7.4.4 The proposed dwelling would be 1 ½ storeys. Residential buildings along the eastern part of Church Road are predominantly 2 storeys, e.g. Birch Hall and Garboldisham (south side of Church Road opposite the site). The Cedars is 2 ½ storeys. Cedars Lodge to the north-west of The Cedars is 1 ½ storeys. The proposed dwelling would therefore be subservient in terms of height in relation to the majority houses in proximity to the site and would be similar to the scale of Cedars Lodge.
