**40 GROSVENOR GARDENS, SW1W 0EB**

Structural Engineer's Structural Methodology Statement for Planning

January 2021

Issue P2

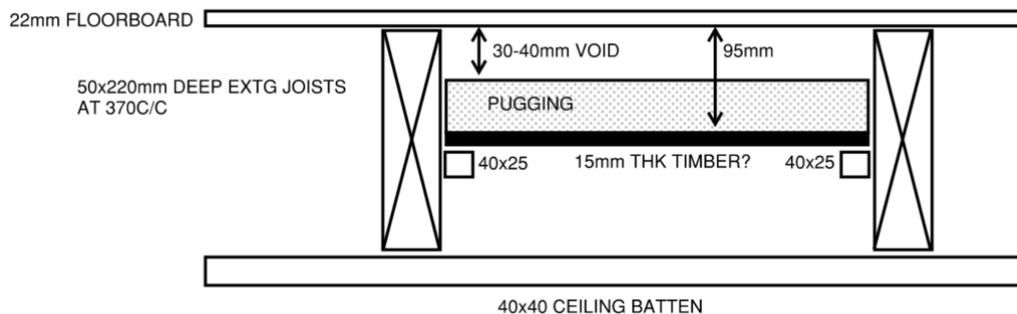
**Figure 2: Typical floor build-up at fifth floor level**

The opening up works at this level demonstrate that the existing floor joists span parallel to the main elevation of the building. The floor build-up consists of the following: carpet and lino tiles generally over 22mm thick floorboards over 220mm deep floor joists. There is approximately 30-40mm of void from the underside of the floorboards to the top of the pugging. The pugging is approximately 40-50mm and is suspended between the floor joists.

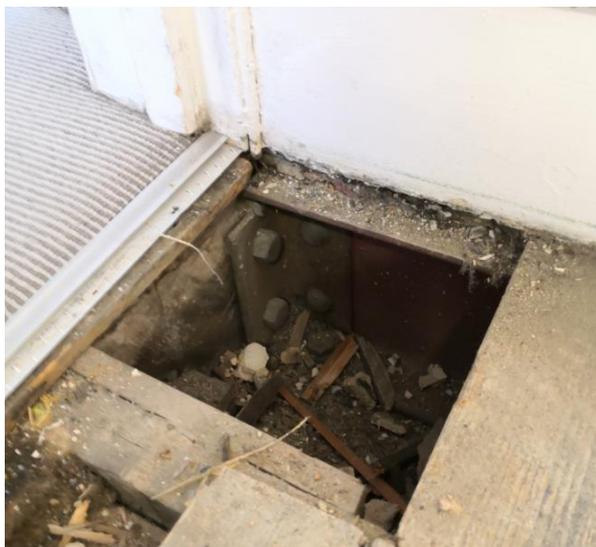
**Photo 1: Opening up at proposed riser location at fifth floor showing steel beam supporting lift shaft and span of joist**

A new service riser is proposed on the back wall surface of the existing lift shaft. The orientation of the riser is in the same direction as the span joists and therefore will have minimal disruption to the listed fabric. Investigations at the proposed riser location identifies a steel beam spanning beneath the lift shaft walls in the direction of the joists. The space between the first adjacent joist and the lift shaft is measured at 230mm width. The riser void can be achieved by trimming one or no joists, the cut joist will then be re-supported using a new trimmer joist.

A new fifth floor lift extension is proposed and can be constructed in a similar structural form as the levels below i.e. structural steel beams supporting shaft walls above. The new lift extension will be within the new roof structure and therefore creating minimal disruption to the existing retained roof structure.

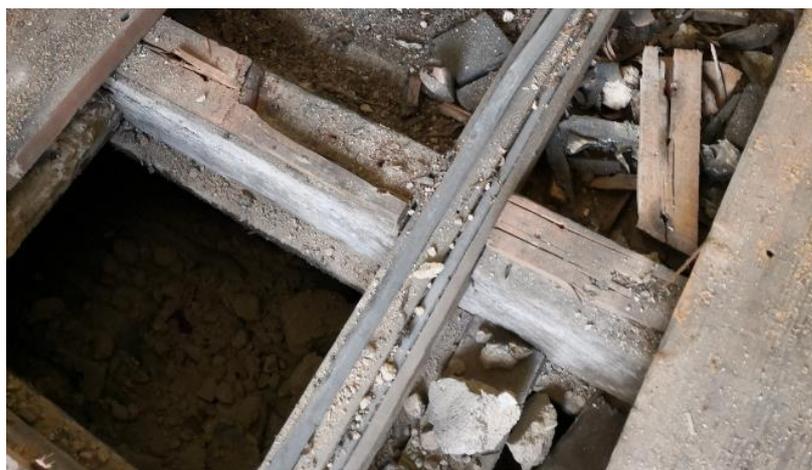
Photo 2: Opening up flooring at third floor level

The opening up works at this level demonstrate that the existing joist spans are parallel to the main elevation of the building. This establishes that the spine wall does not support any floor loadings and only supports the weight of itself and the spine wall above, all of which is constructed in timber. The proposed structural interventions will be sympathetic to the original construction of the wall i.e. using timber framing as illustrated below to create the proposed opening.

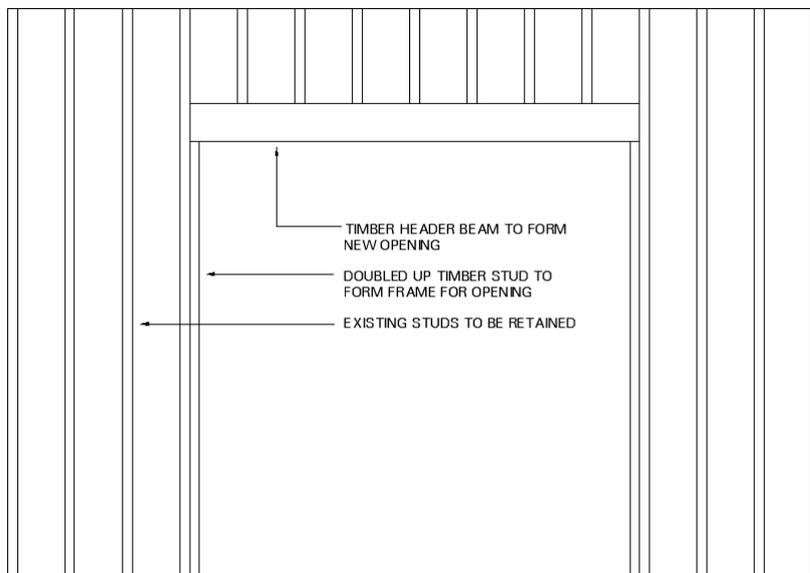
**Figure 3: Typical proposed opening formed in timber construction**

The existing joists span parallel to the main building elevation i.e. from party wall to party wall and is consistent with the structural philosophy of the floors described above. This demonstrates that the spine wall does not bear any floor loading and the proposed opening can be formed with minimal detriment to the originally intended

load-path, refer to Figure 3. Once again, the interventions will be sympathetic to the original construction i.e. using timber construction to match that of the existing.

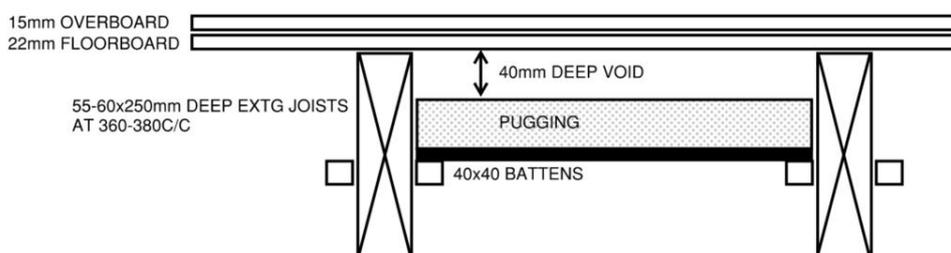
The third floor build-up consists of the following: carpet over lino tiles generally, approximately 15-18mm of over boarding, 22mm original floorboards, 40mm deep void between underside of board and pugging and 40-50mm of pugging suspended between joists. The existing joist width varies on this floor and are generally in a good condition. Overboarding is generally observed throughout the building with the exception of the fifth floor, fourth floor and mews house.

**Figure 4: Typical floor build-up at third floor level**

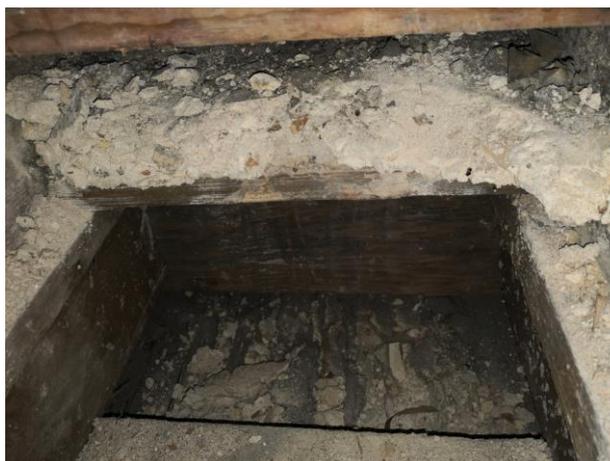
Photo 4: Primary timber beam below wall

The wall separating the front two offices which runs parallel to the Party Wall may be load-bearing. The investigative work has identified the presence of an original timber beam measured at 200x290mm deep which runs under this wall. The opening up also establishes the absence of a kingpost and diagonal bracing members and therefore this wall is unlikely to perform as truss wall at this level. Refer to Photos 4 and 5.

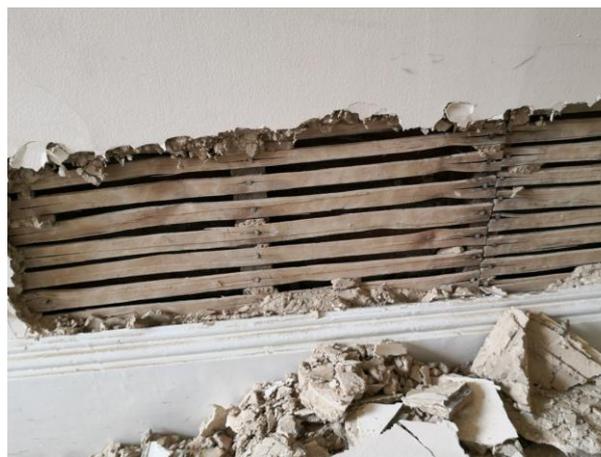
Photo 5: Removal of finishes to expose structure in wall

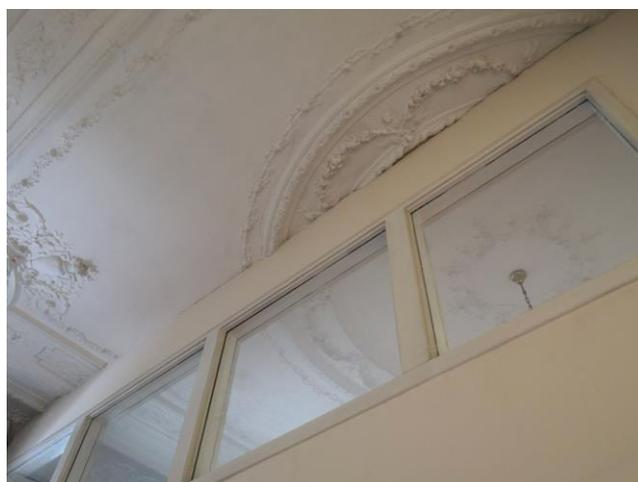
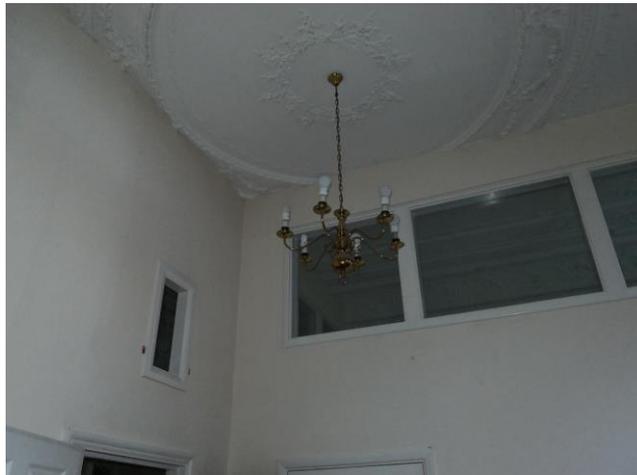
Photo 6: Internal partition separating front offices at first floor level

Photo 7: Internal partition separating front offices at first floor level

The proposals at this level are to remove the internal partitions separating the existing front offices. As can be seen from the photos below, these walls are clearly non-structural given that they divide what appears to be an original single front room, refer to photos 6 and 7.

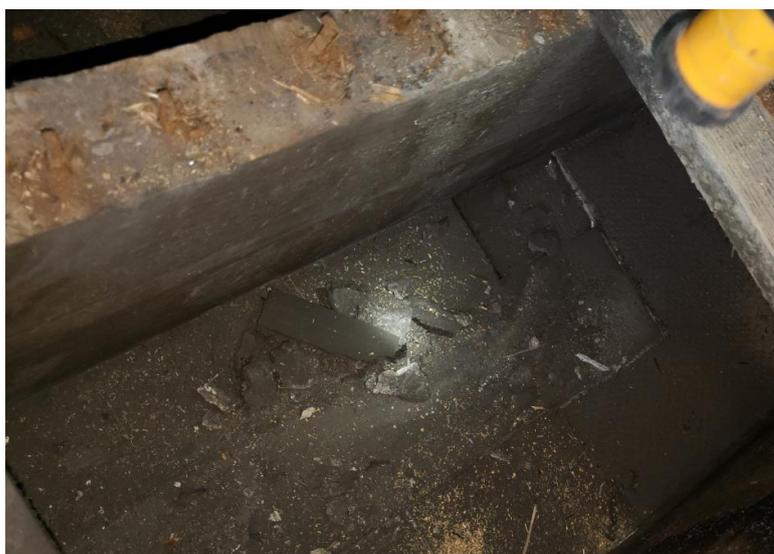
Photo 8: Local opening up at first floor level in Mews

Local opening up of the mews at first floor identifies existing timber joists to span back to front. The joist depths are generally 250mm deep with traditional herringbone strutting to provide lateral restraint, refer to Photo 8. On investigation the roof is formed of a series of trusses which span from the back wall to the front wall, see Photo 9. It can be assumed that the two central walls are only providing support to the stair and stair void. In the proposals, the stair void will be infilled using matching timber joists and the loads will be taken back to the main load-bearing lines i.e. front and back walls. The removal of the staircase walls will generally not affect the roof structure.

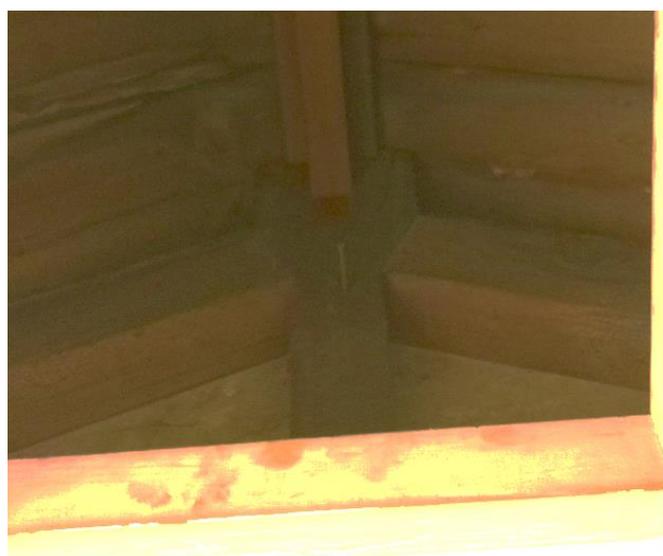
Photo 9: Photograph of truss roof in loft spanning back to front

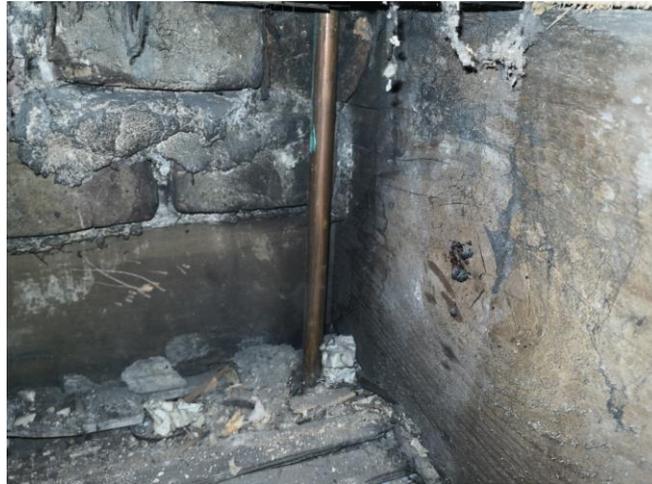
Photo 10: Opening up of junction between first floor joists and rear timber beam lintel

A large timber beam is identified over the top of the ground floor rear opening. The first floor level joists are supported onto this beam, see Photo 10. This existing beam is proposed to be retained and if required repairs or strengthening will be carried out on the element insitu.

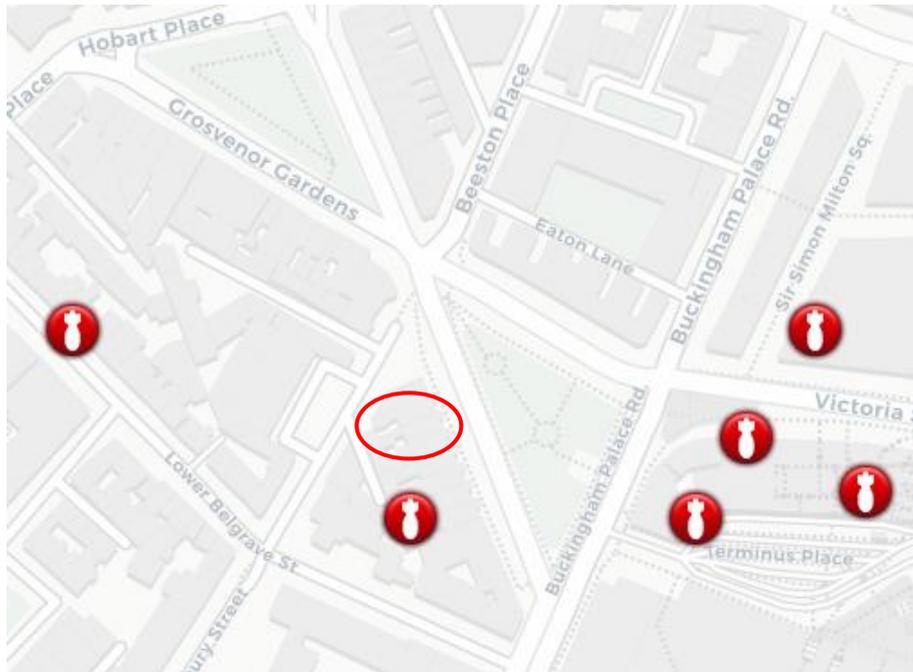
Figure 6: WWII bomb census map, <http://www.bombsight.org/>

The information provided on this map suggests that no industrial contamination is expected to be found on site. The map below, Figure 6, extract from the *WWII Census Map* (<http://www.bombsight.org/>), shows one major bombing in the locality of No 40, albeit at a distance from our property. The map suggests that significant structural bomb damage at No 40 is unlikely.

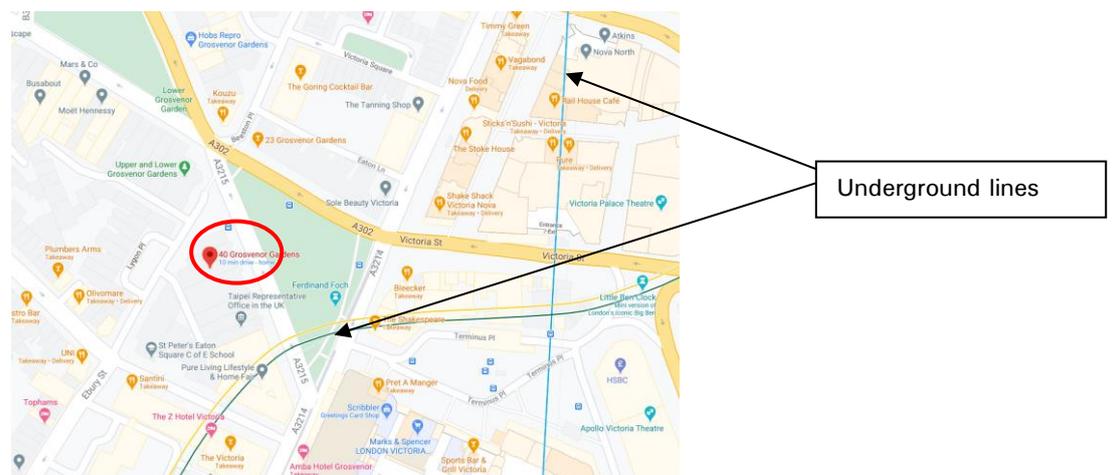
The map below, Figure 8, shows the site being far enough from any London Underground tunnels. No impact from the underground lines is therefore expected on both the proposed works and vibration issues to the property at 40 Grosvenor Gardens.

Figure 8: London Underground Lines

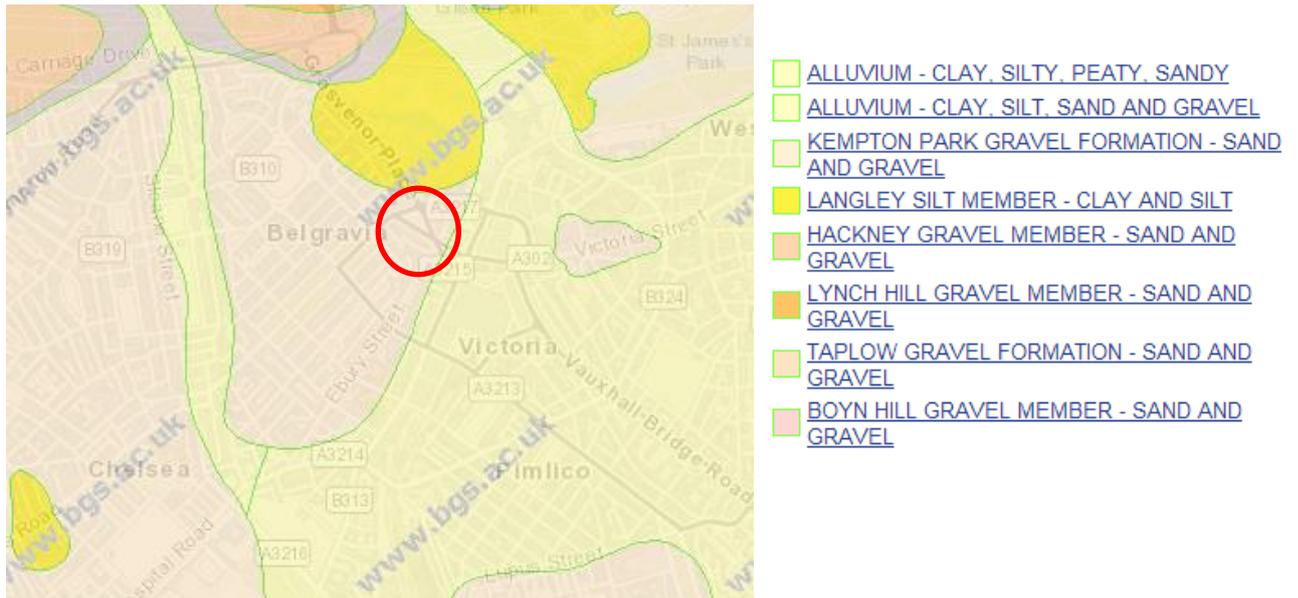
British Geological survey map indicates underlying strata in the area to be Kempton Gravel Formation. The lower boundary of the strata rests with sharp base on bedrock geology, i.e. London Clay. Typical thickness is 8m, can extend locally to 10m. Figure 9 is an extract of the local geology map.

**Figure 9: Extract from Geology of Britain viewer**

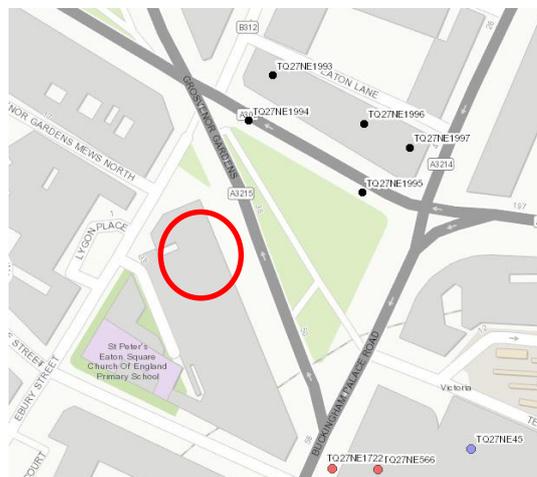
The British Geological Survey has records of several boreholes in the area, although some are restricted. MBP also have records available for sites in Chester Square, Belgrave Square, Eaton Square and Eaton Place.

**Figure 10: Boreholes location- Extract from BGS website**

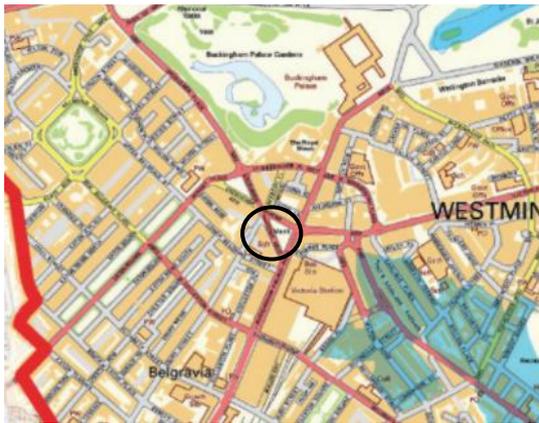
Figure 11: Overtopping and breach inundation

The *Westminster City Councils Residential Basement Report* prepared by Alan Baxter & Associates LLP Consulting Engineer for and on behalf of the Westminster City Council provides initial guidance for the identification of areas subject to flood risk from overtopping and breach inundation (Figure 11) and local surface water (Figure 12), together with an indication of the areas with a significant risk of drains surcharge during heavy rainfall periods (Figure 13).
