Acton Gardens, Phase 8

Phase 2 Ground Investigation Report

Curtins Ref: 073270-CUR-00-XX-RP-GE-002

Site Address: Acton Gardens | Acton | London | W3 8TJ

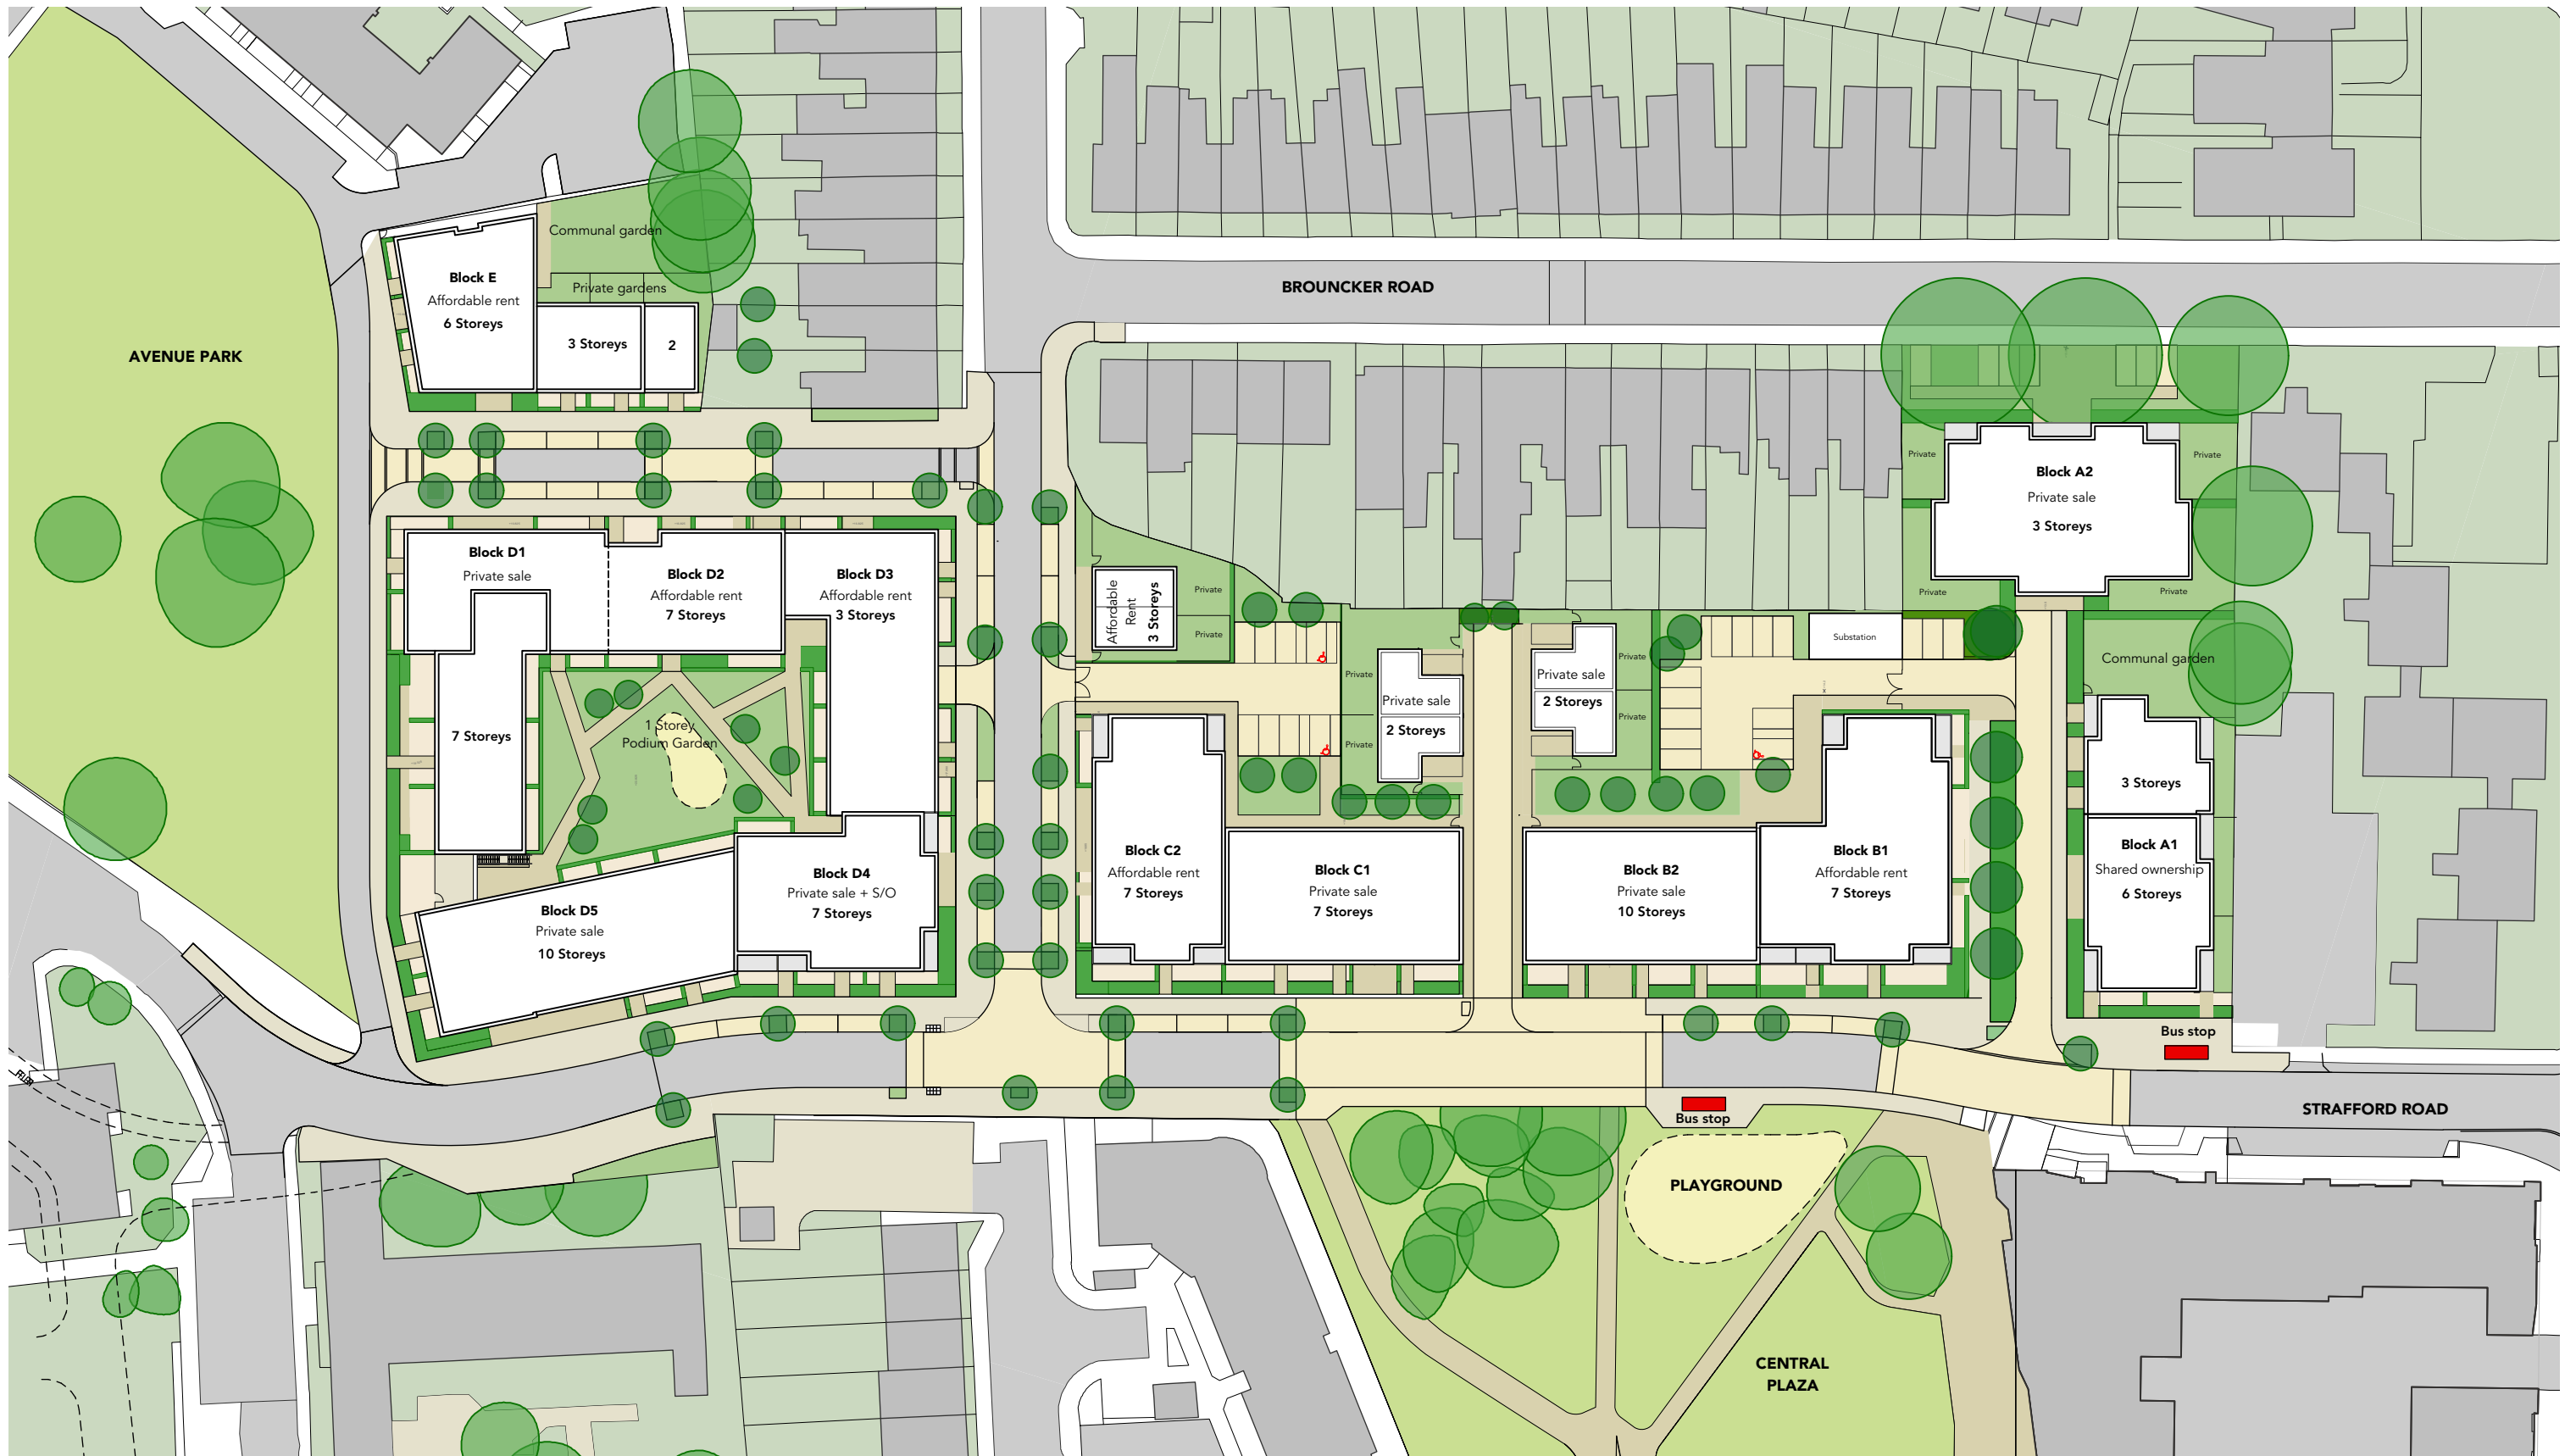
- Proposed Development Plan; and,
- Exploratory Hole Location Plan.

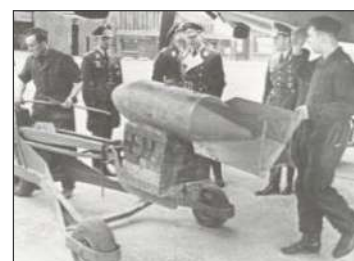
SC 250kg High Explosive Bomb

Bomb Weight	245-256kg (540-564lb)
Explosive Weight	125-130kg (276-287lb)
Fuze Type	Electrical impact/mechanical time delay fuze.
Bomb Dimensions	1640 x 512mm (64.57 x 20.16in)
Body Diameter	368mm (14.5in)
Use	Against railway installations, embankments, flyovers, underpasses, large buildings and below-ground installations.
Remarks	It could be carried by almost all German bomber aircraft, and was used to notable effect by the Junkers Ju-87 Stuka (Sturzkampfflugzeug or dive-bomber).

SC250 bomb being loaded onto German bomber

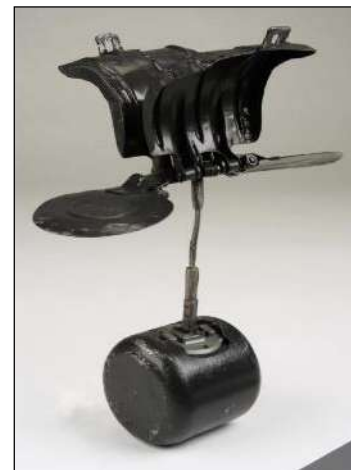
SD2 Anti-Personnel 'Butterfly Bomb'

Bomb Weight	Approx. 2kg (4.41lb)
Explosive Weight	Approx. 7.5oz (225 grams) of Amatol surrounded by a layer of bituminous composition.
Fuze Type	41 fuze (time) , 67 fuze (clockwork time delay) or 70 fuze (anti-handling device)
Body Diameter	3in (7.62 cm) diameter, 3.1in (7.874) long
Use	Designed as an anti-personnel/ fragmentation weapon. They were delivered by air, being dropped in containers of 23-144 sub-munitions that opened at a predetermined height, thus scattering the bombs.
Remarks	Very rare. First used against Ipswich in 1940, but were also dropped on Kingston upon Hull, Grimsby and Cleethorpes in June 1943, amongst various other targets in UK. As the bombs fell the outer case flicked open by springs which caused four light metal drogues with a protruding 5 inch steel cable to deploy in the form of a parachute & wind vane which armed the device as it span.

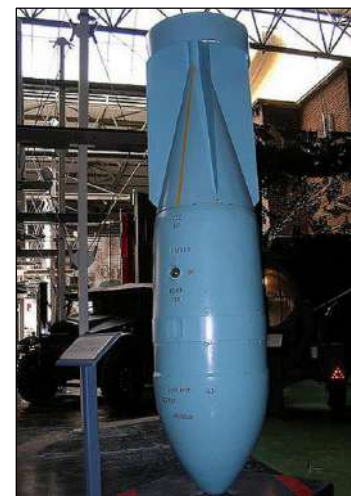
SC 1000kg

Bomb Weight	Approx. 993-1027kg (2,189-2,264lb)
Explosive Weight	Approx. 530-620kg (1168-1367lb)
Fuze Type	Electrical impact/mechanical time delay fuze.
Filling	Mixture of 40% amatol and 60% TNT, but when used as an anti-shipping bomb it was filled with Trialen 105, a mixture of 15% RDX, 70% TNT and 15% aluminium powder.
Bomb Dimensions	2800 x 654mm (110 x 25.8in)
Body Diameter	654mm (18.5in)
Use	SC type bombs are General Purpose Bombs used primarily for general demolition work. Constructed of parallel walls with comparatively heavy noses. They are usually of three piece welded construction

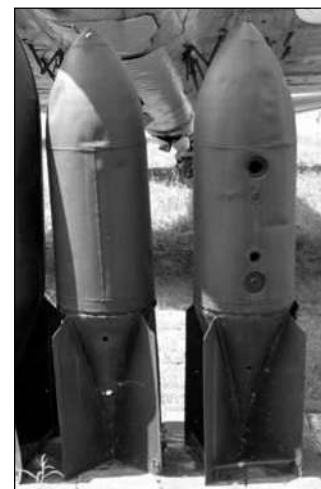
Flam C-250 Oil Bomb

Bomb Weight	Approx. 125kg (276lb)
Explosive Weight	Approx. 1kg (2.2lb)
Fuze Type	Super-fast electrical impact fuze
Filling	Mixture of 30% petrol and 70% crude oil
Bomb Dimensions	1,650 x 512.2mm (65 x 20.2in)
Body Diameter	368mm (14.5in)
Use	Often used for surprise attacks on ground troops, against troop barracks and industrial installations. Thin casing – not designed for ground penetration

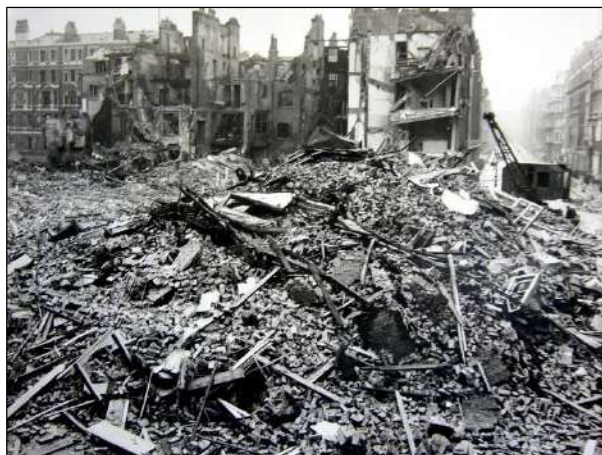
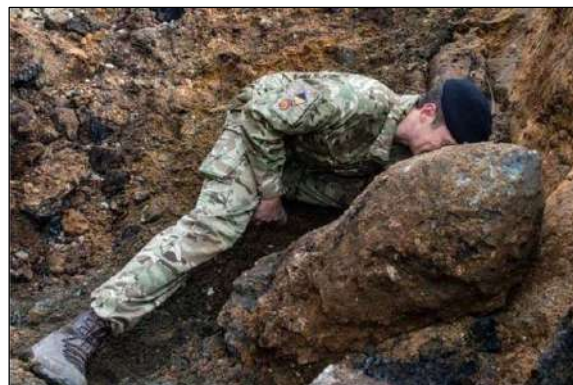
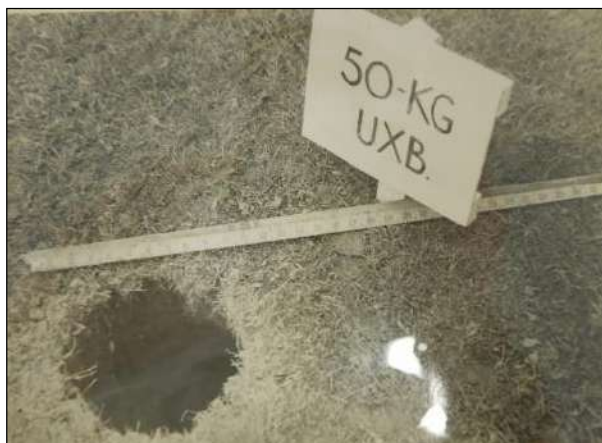
'J-Curve' Effect

Top: J-curve Effect - Due to angle of entry, unexploded bombs would often end their trajectory at a lateral offset from point of entry, often ending up beneath adjacent extant structures/sites. The photograph above shows 250kg bomb found in Bermondsey pointing upwards, demonstrating 'J-curve'

One of the most common scenarios for UXO going unnoticed was when a UXB fell into a 'bomb site' (such as the area shown **Top Left**), the entry hole of the bomb obscured by any debris and rubble present. Note that the entry hole of a 50kg UXB could be as little as 20cm in diameter (**Left**).

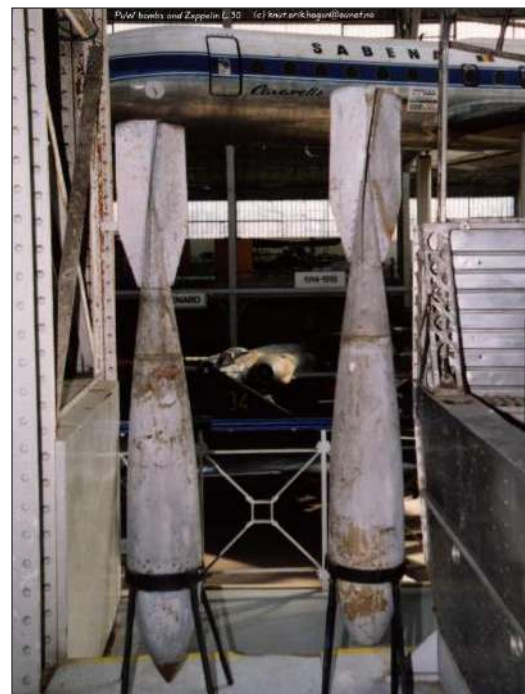
Examples of 50 and 100kg German WWI bombs

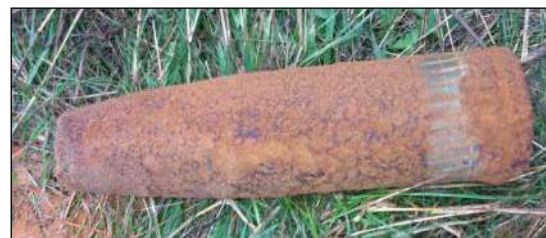
3.7 Inch QF Anti-Aircraft Projectile

Projectile Weight	28lb (12.6 kg)
Explosive Weight	2.52lbs
Fuze Type	Mechanical Time Fuze
Dimensions	3.7in x 14.7in (94mm x 360mm)
Rate of Fire	10 to 20 rounds per minute
Use	The 3.7in AA Mks 1-3 were the standard Heavy Anti-Aircraft guns of the British Army.
Ceiling	30,000ft to 59,000ft

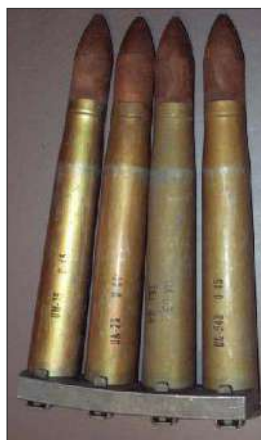
40mm Bofors Projectile

Projectile Weight	1.96lb (0.86kg)
Explosive Weight	300g (0.6lb)
Fuze Type	Impact Fuze
Rate of Fire	120 rounds per minute
Projectile Dimensions	40 x 180mm
Ceiling	23,000ft (7000m)
Remarks	Light quick fire high explosive anti-aircraft projectile. Each projectile fitted with small tracer element. If no target hit, shell would explode when tracer burnt out. Designed to engage aircraft flying below 2,000ft

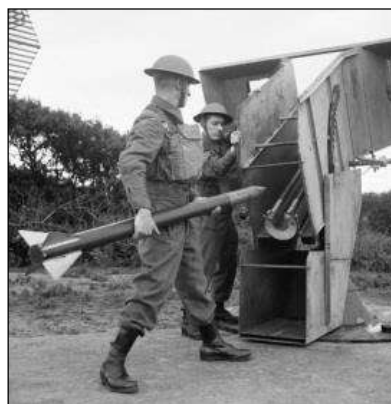
3in Unrotated Projectile (UP) Anti-Aircraft Rocket ("Z" Battery)

HE Projectile Weight	3.4kg (7.6lb)
Explosive Weight	0.96kg (2.13lb)
Filling	High Explosive – TNT. Fitted with aerial burst fuzing
Dimensions of projectile	236 x 83mm (9.29 x 3.25in)
Remarks	As a short range rocket-firing anti-aircraft weapon developed for the Royal Navy. It was used extensively by British ships during the early days of World War II. The UP was also used in ground-based single and 128-round launchers known as Z Batteries. Shell consists of a steel cylinder reduced in diameter at the base and threaded externally to screw into the shell ring of the rocket motor
