## HERITAGE STATEMENT

### THE REAL ALE TAVERN

**67, Load Street, Bewdley, Worcestershire. DY12 2AW.**

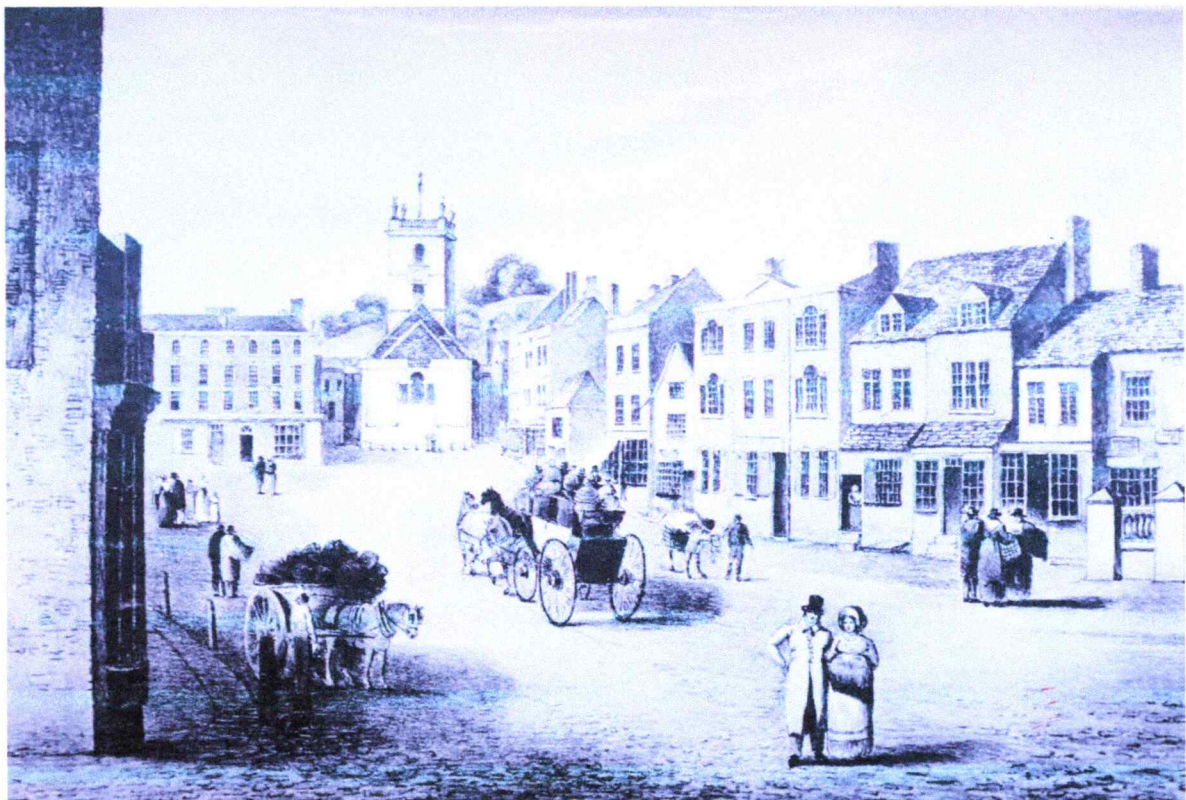
*A small single storey structure with twin pitched roof is shown next to the present 67 Load Street in this late 18<sup>th</sup> Century engraving - the artist has compressed the upper part of the street making No 67 appear closer to the church than it actually is (image courtesy of Stephen Price)*
