**TAYLOR WIMPEY WEST
MIDLANDS**

**CONISTON CRESCENT
STOURPORT-ON-SEVERN**

SITE INVESTIGATION REPORT

Job number: **20088**

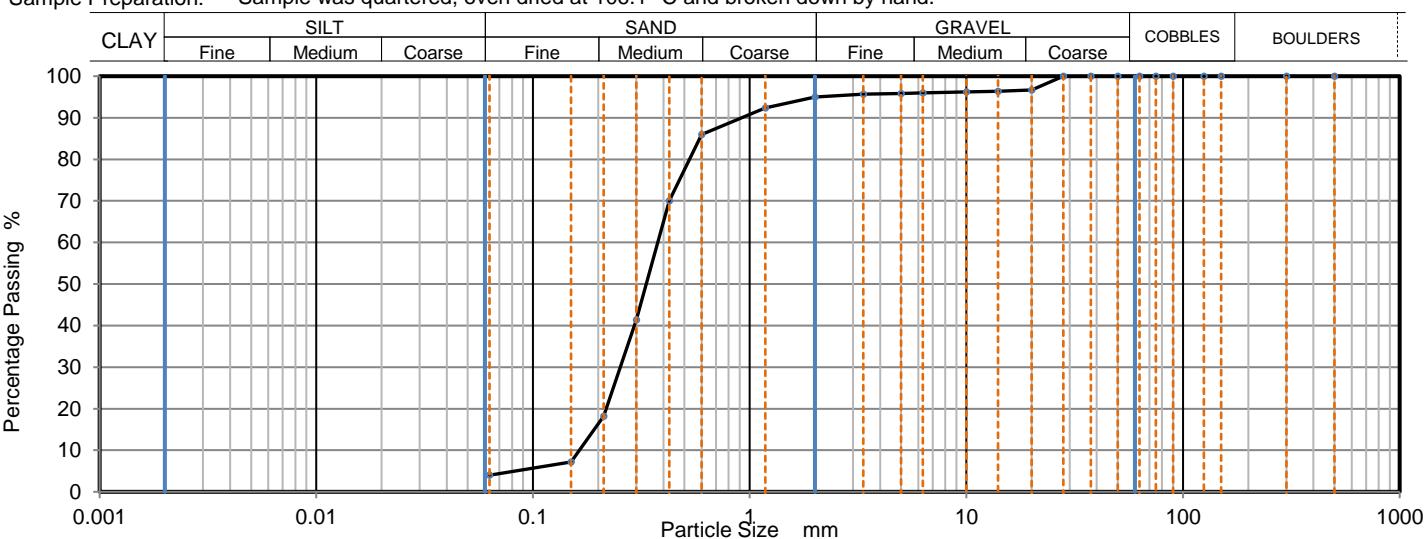
Laboratory Reference: 1643215
Hole No.: TP02
Sample Reference: Not Given
Sample Description: Brown slightly gravelly slightly clayey SAND
Sample Preparation: Sample was quartered, oven dried at 106.1 °C and broken down by hand.

Sieving		Sedimentation	
Particle Size mm	% Passing	Particle Size mm	% Passing
500	100		
300	100		
150	100		
125	100		
90	100		
75	100		
63	100		
50	100		
37.5	100		
28	100		
20	97		
14	96		
10	96		
6.3	96		
5	96		
3.35	96		
2	95		
1.18	92		
0.6	86		
0.425	70		
0.3	41		
0.212	18		
0.15	7		
0.063	4

Sample Proportions	% dry mass
Very coarse	0.00
Gravel	5.00
Sand	91.00
Fines <0.063mm	4.00

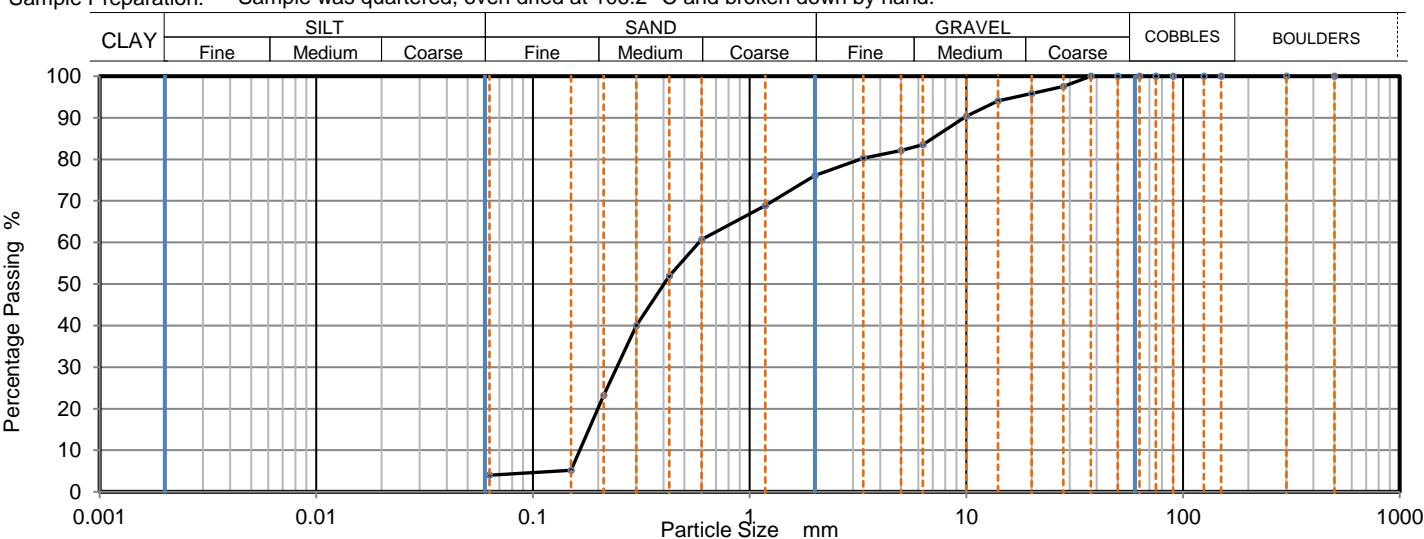
Laboratory Reference: 1643216
Hole No.: TP05
Sample Reference: Not Given
Sample Description: Brown slightly clayey gravelly SAND
Sample Preparation: Sample was quartered, oven dried at 106.2 °C and broken down by hand.

Sieving		Sedimentation	
Particle Size mm	% Passing	Particle Size mm	% Passing
500	100		
300	100		
150	100		
125	100		
90	100		
75	100		
63	100		
50	100		
37.5	100		
28	98		
20	96		
14	94		
10	90		
6.3	84		
5	82		
3.35	80		
2	76		
1.18	69		
0.6	61		
0.425	52		
0.3	40		
0.212	23		
0.15	5		
0.063	5

Sample Proportions	% dry mass
Very coarse	0.00
Gravel	23.90
Sand	71.50
Fines <0.063mm	4.60

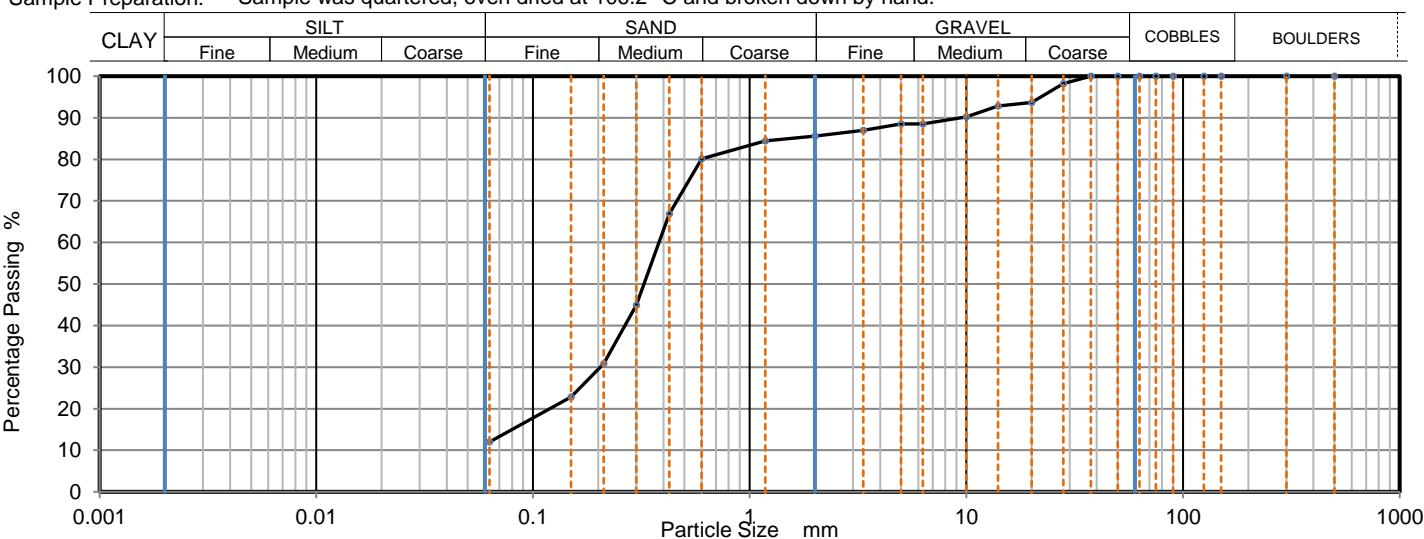
Laboratory Reference: 1643217
Hole No.: TP6
Sample Reference: Not Given
Sample Description: Brown gravelly clayey SAND
Sample Preparation: Sample was quartered, oven dried at 106.2 °C and broken down by hand.

Sieving		Sedimentation	
Particle Size mm	% Passing	Particle Size mm	% Passing
500	100		
300	100		
150	100		
125	100		
90	100		
75	100		
63	100		
50	100		
37.5	100		
28	98		
20	94		
14	93		
10	90		
6.3	89		
5	89		
3.35	87		
2	86		
1.18	84		
0.6	80		
0.425	67		
0.3	45		
0.212	31		
0.15	23		
0.063	13

Sample Proportions	% dry mass
Very coarse	0.00
Gravel	14.40
Sand	73.00
Fines <0.063mm	12.60

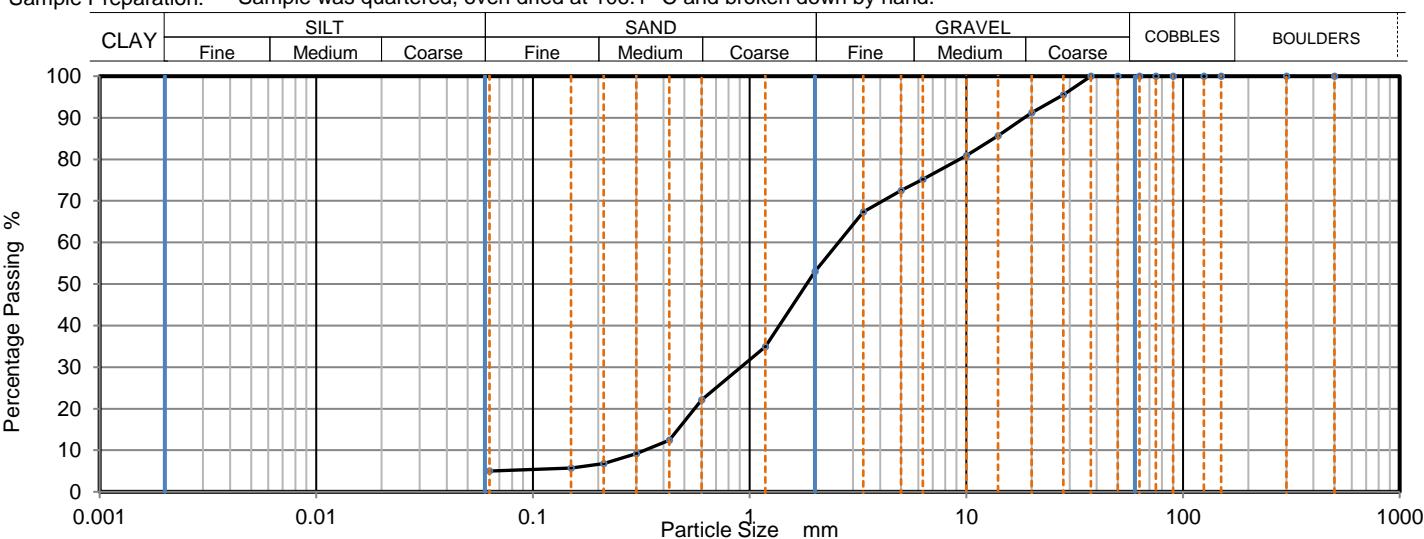
Laboratory Reference: 1643218
Hole No.: TP07
Sample Reference: Not Given
Sample Description: Brown slightly clayey GRAVEL and SAND
Sample Preparation: Sample was quartered, oven dried at 106.1 °C and broken down by hand.

Sieving		Sedimentation	
Particle Size mm	% Passing	Particle Size mm	% Passing
500	100		
300	100		
150	100		
125	100		
90	100		
75	100		
63	100		
50	100		
37.5	100		
28	96		
20	91		
14	86		
10	81		
6.3	75		
5	73		
3.35	67		
2	53		
1.18	35		
0.6	22		
0.425	12		
0.3	9		
0.212	7		
0.15	6		
0.063	5

Sample Proportions	% dry mass
Very coarse	0.00
Gravel	47.00
Sand	47.60
Fines <0.063mm	5.40

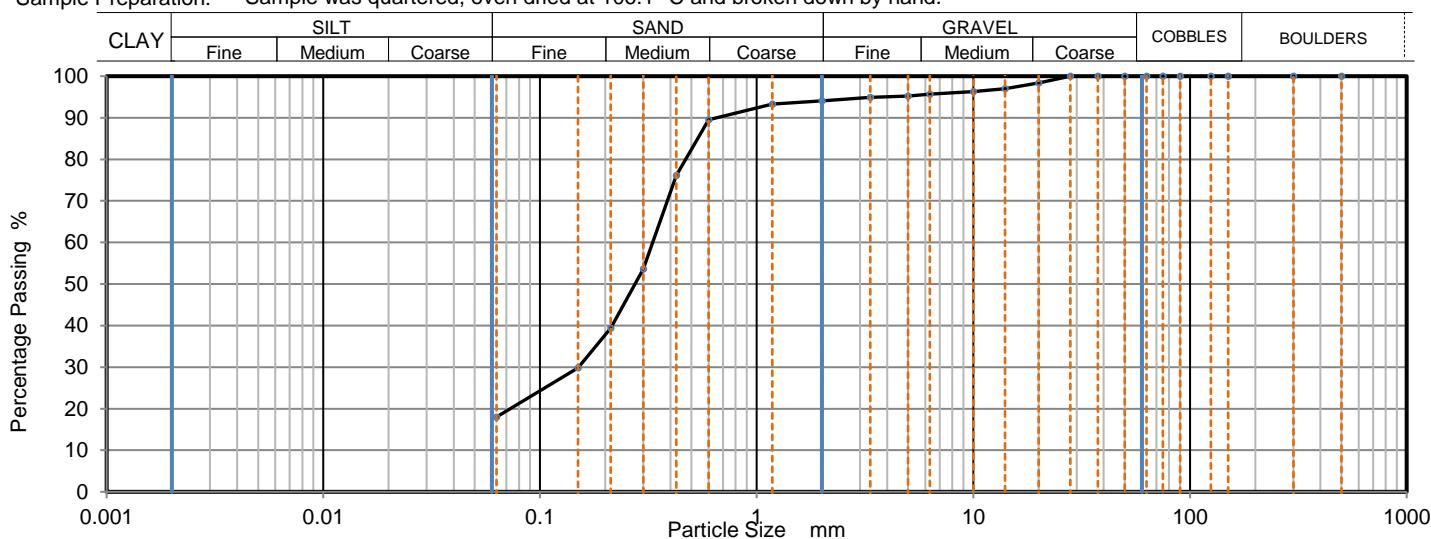
Laboratory Reference: 1643219
Hole No.: TP08
Sample Reference: Not Given
Sample Description: Brown slightly gravelly clayey SAND
Sample Preparation: Sample was quartered, oven dried at 106.1 °C and broken down by hand.

Sieving		Sedimentation	
Particle Size mm	% Passing	Particle Size mm	% Passing
500	100		
300	100		
150	100		
125	100		
90	100		
75	100		
63	100		
50	100		
37.5	100		
28	100		
20	98		
14	97		
10	96		
6.3	96		
5	95		
3.35	95		
2	94		
1.18	93		
0.6	90		
0.425	76		
0.3	54		
0.212	39		
0.15	30		
0.063	18

Sample Proportions	% dry mass
Very coarse	0.00
Gravel	5.90
Sand	76.10
Fines <0.063mm	18.00

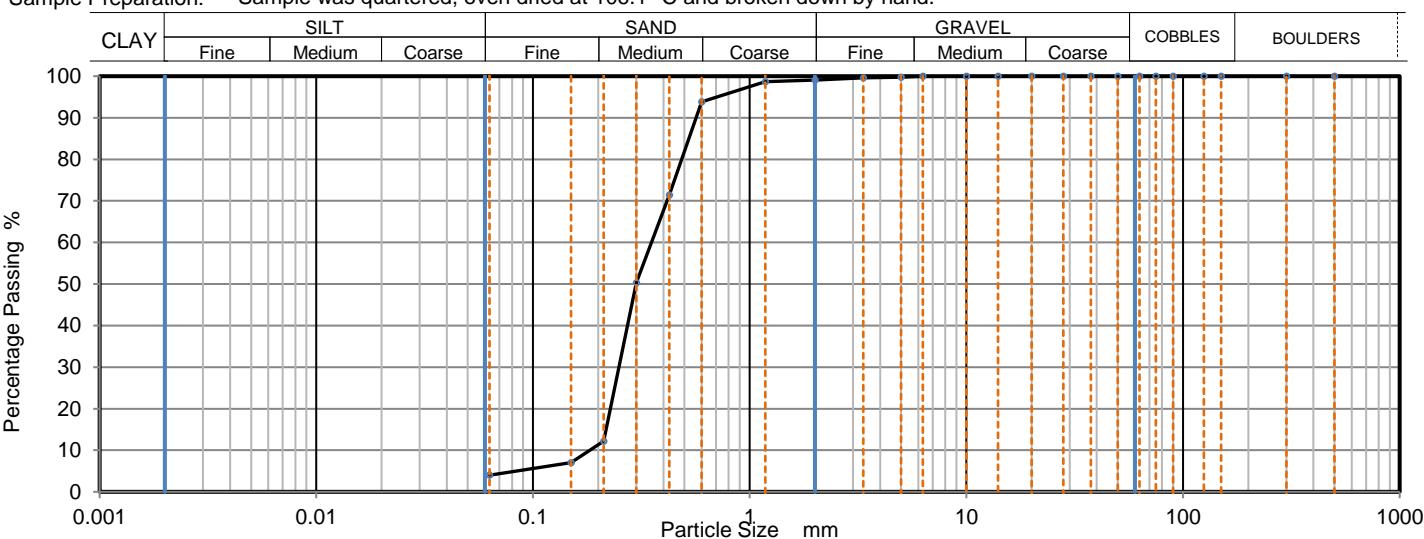
Laboratory Reference: 1643220
Hole No.: DS02
Sample Reference: Not Given
Sample Description: Brown slightly clayey SAND
Sample Preparation: Sample was quartered, oven dried at 106.1 °C and broken down by hand.

Sieving		Sedimentation	
Particle Size mm	% Passing	Particle Size mm	% Passing
500	100		
300	100		
150	100		
125	100		
90	100		
75	100		
63	100		
50	100		
37.5	100		
28	100		
20	100		
14	100		
10	100		
6.3	100		
5	100		
3.35	100		
2	99		
1.18	99		
0.6	94		
0.425	71		
0.3	50		
0.212	12		
0.15	7		
0.063	4

Sample Proportions	% dry mass
Very coarse	0.00
Gravel	0.90
Sand	95.00
Fines <0.063mm	4.10

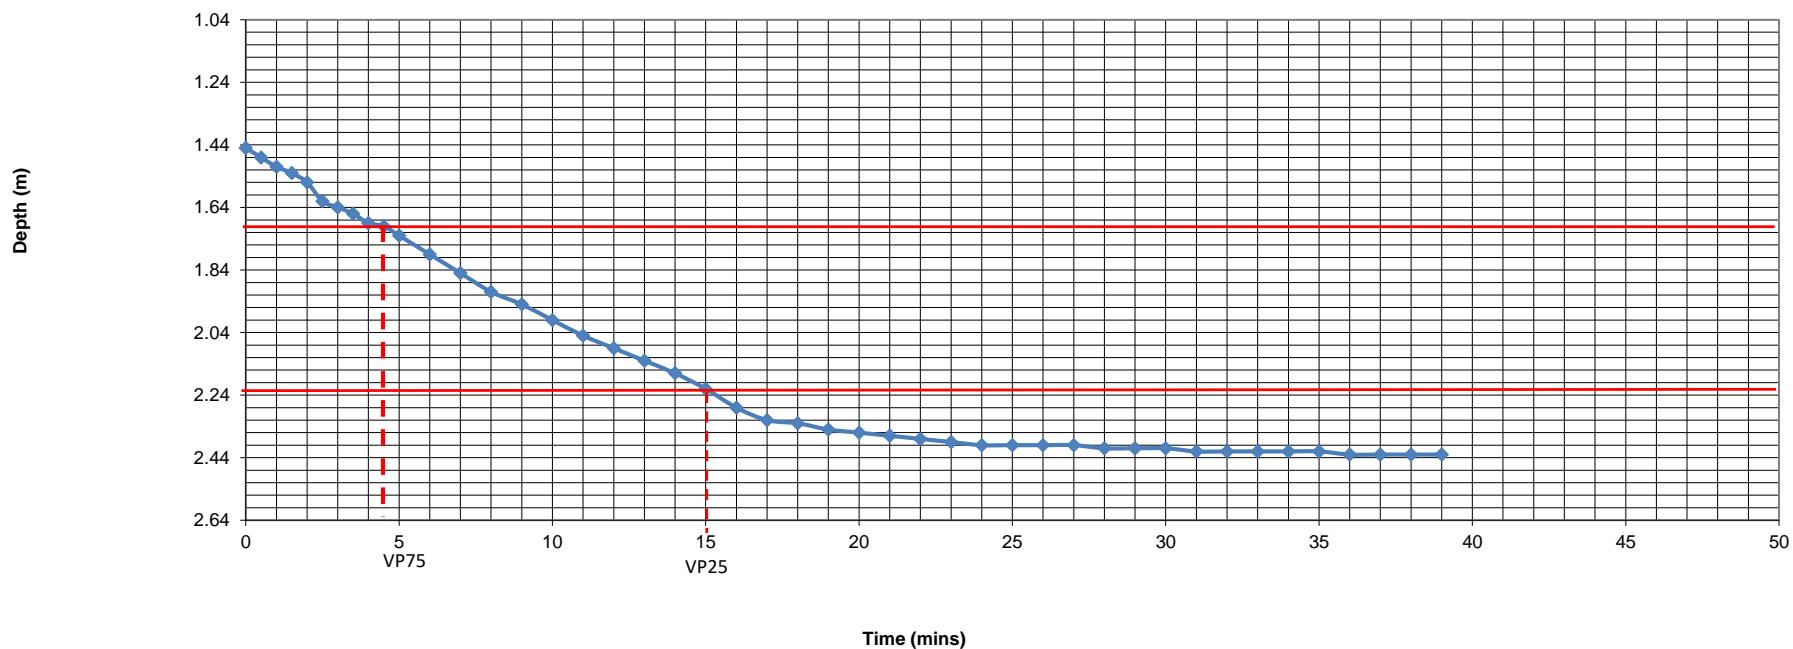
Coniston Crescent, Stourport - SA1 - Test 1

Time (mins)	Time (secs)	Depth (mbgl)
0	0	1.45
0.5	30	1.48
1	60	1.5
1.5	90	1.52
2	120	1.54
2.5	150	1.56
3	180	1.58
3.5	210	1.6
4	240	1.61
4.5	270	1.63
5	300	1.64
6	360	1.68
7	420	1.7
8	480	1.73
9	540	1.76
10	600	1.79
11	660	1.82
12	720	1.86
13	780	1.88
14	840	1.91
15	900	1.93
16	960	1.96
17	1020	1.99
18	1080	2.03
19	1140	2.05
20	1200	2.07
21	1260	2.08
22	1320	2.11
23	1380	2.13
24	1440	2.14
25	1500	2.16

- 4.8.4 To provide an approximation of the soil infiltration rate for the natural materials for each location we have plotted the results of the soakaway tests graphically to determine the times that the water levels reached 25% and 75% of the effective depth. In accordance with BRE 365, we have used the following formula to determine the approximate permeability rate:

- 4.8.5 The results of the four soakaway tests undertaken at each location, calculation summary sheets and associated graphs are included as Appendix 8. For ease of reference, a summary of calculated soil infiltration rates is presented within Table 7 overleaf.
- 4.8.6 BRE 365 indicates that the lowest soil infiltration rate should be used to assess the suitability of the soils, these are identified in bold in Table 7. Based on the soakaway tests undertaken at the location of the proposed infiltration feature location, the calculated soil infiltration rates indicate the materials tested to exhibit a medium permeability.

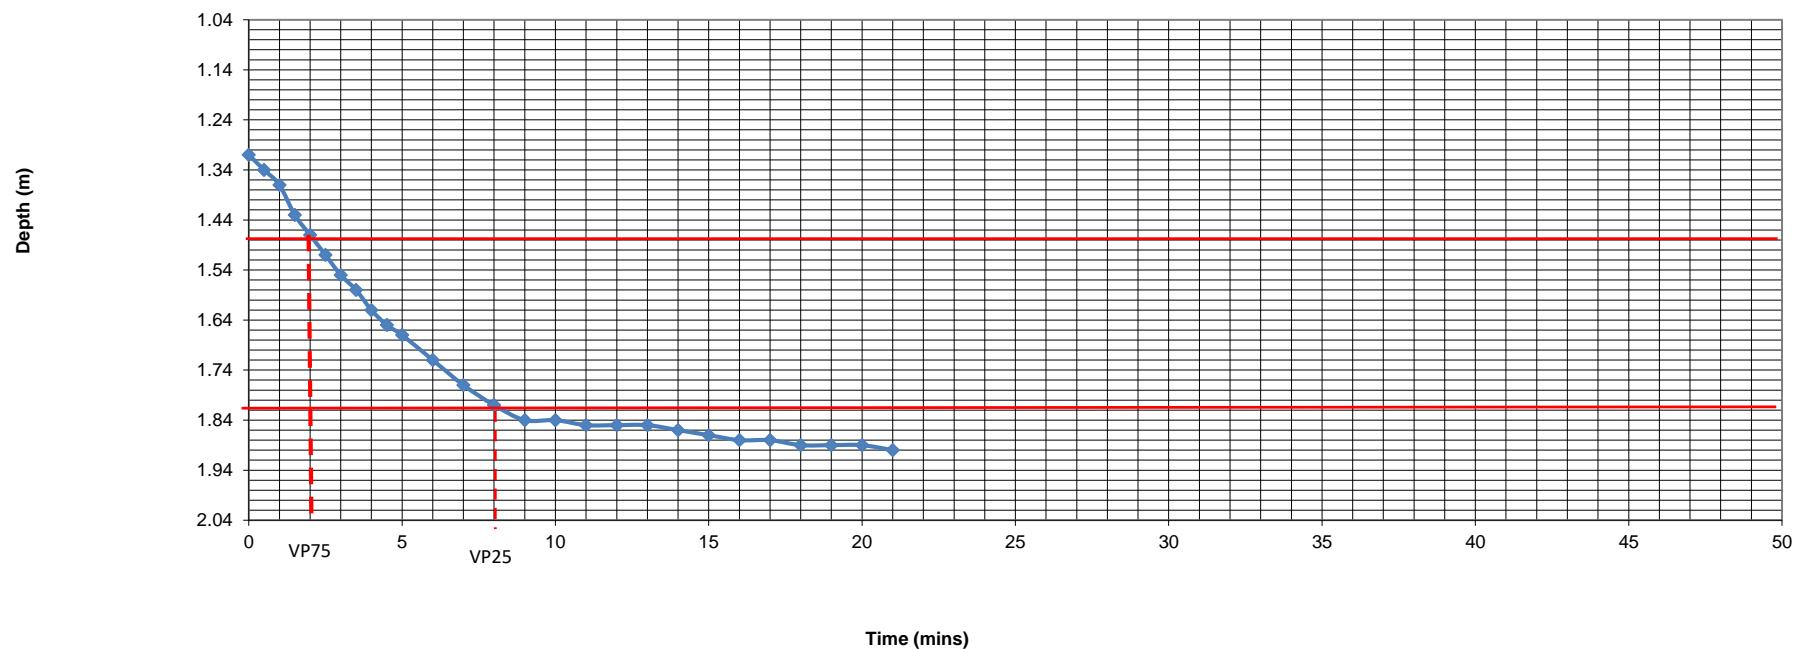
Coniston Crescent, Stourport - SA3 - Test 1

Soakaway 3 test 1
Width (m): 0.65
Length (m): 2.50
Depth (m): 2.00
Natural depth (m): 0.00
Depth (m) of Water at T = 0 1.31

Effective depth (m) 0.69
Vp25 (m) 0.173
Depth (mbgl) at Vp25 1.828
Vp75 (m) 0.518
Depth (mbgl) at Vp75 1.483
Vp50 (m) 0.35
Vp75/Vp25 (m^3) 0.561
Vp75/Vp25 (m^3) $\times 0.3$ 0.207
 $a50 (m^3)$ 3.80
 t between vp75 to vp25(secs) 360
Soil infiltration (m/s) 1.52E-04

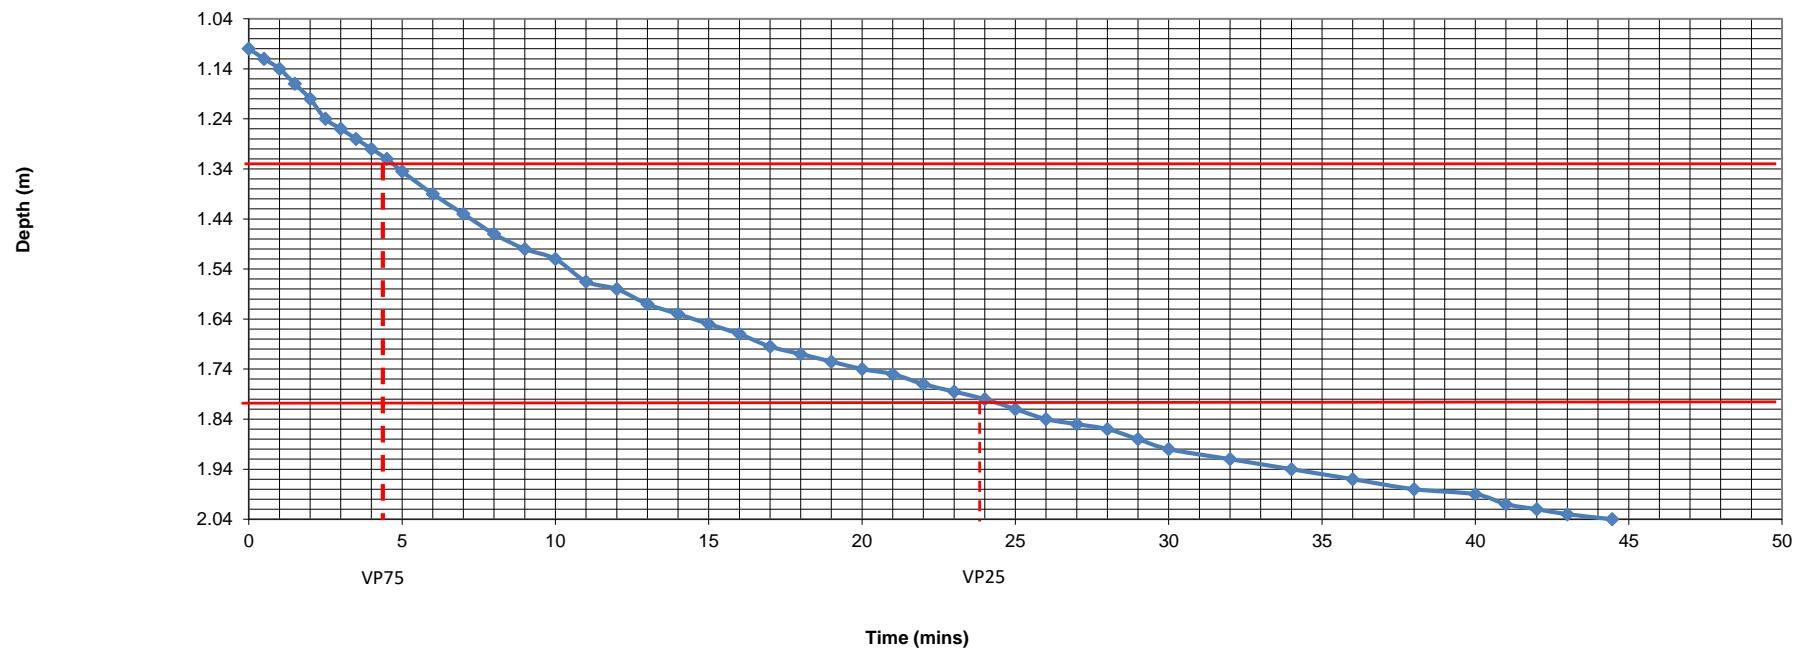
Coniston Crescent, Stourport - SA4 - Test 1

Soakaway 4 test 1

Width (m):	0.70
Length (m):	2.10
Depth (m):	2.04
Natural depth (m):	0.00
Depth (m) of Water at T = 0	1.10

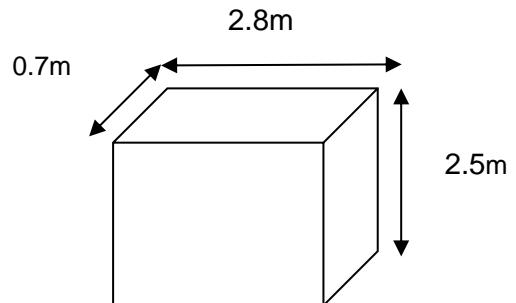
In-situ Soakaway Test Record – Test No: SA1 – Test 1

SITE	Coniston Crescent, Stourport		DATE	12/10/2020
CLIENT	Taylor Wimpey West Midlands		JOB NO.	20088
Type of Test:	Pit	NOTES: Light showers/overcast weather conditions Spalling of trial pit walls Pit was dry during excavation		
Width of pit:	0.7m			
Length of pit:	2.8m			
Depth of pit:	2.5m			
Standing Water Level Prior to Test:	None			
Depth of Water at T = 0 (below ground level):	1.45m			
Infilled with gravel? (Y/N)	Y

Depth (mbgl)	Strata
0 – 0.45	Topsoil.
0.45 – 0.85	Light brown slightly gravelly SAND.
0.85 – 1.5	Red- brown gravelly SAND.
1.50 – 2.50	Light orange- brown slightly gravelly SAND
