NS/C4380/9728

24th November 2020

Re: Lathom Pastures (Phase 2), Skelmersdale – Mineral Assessment Report

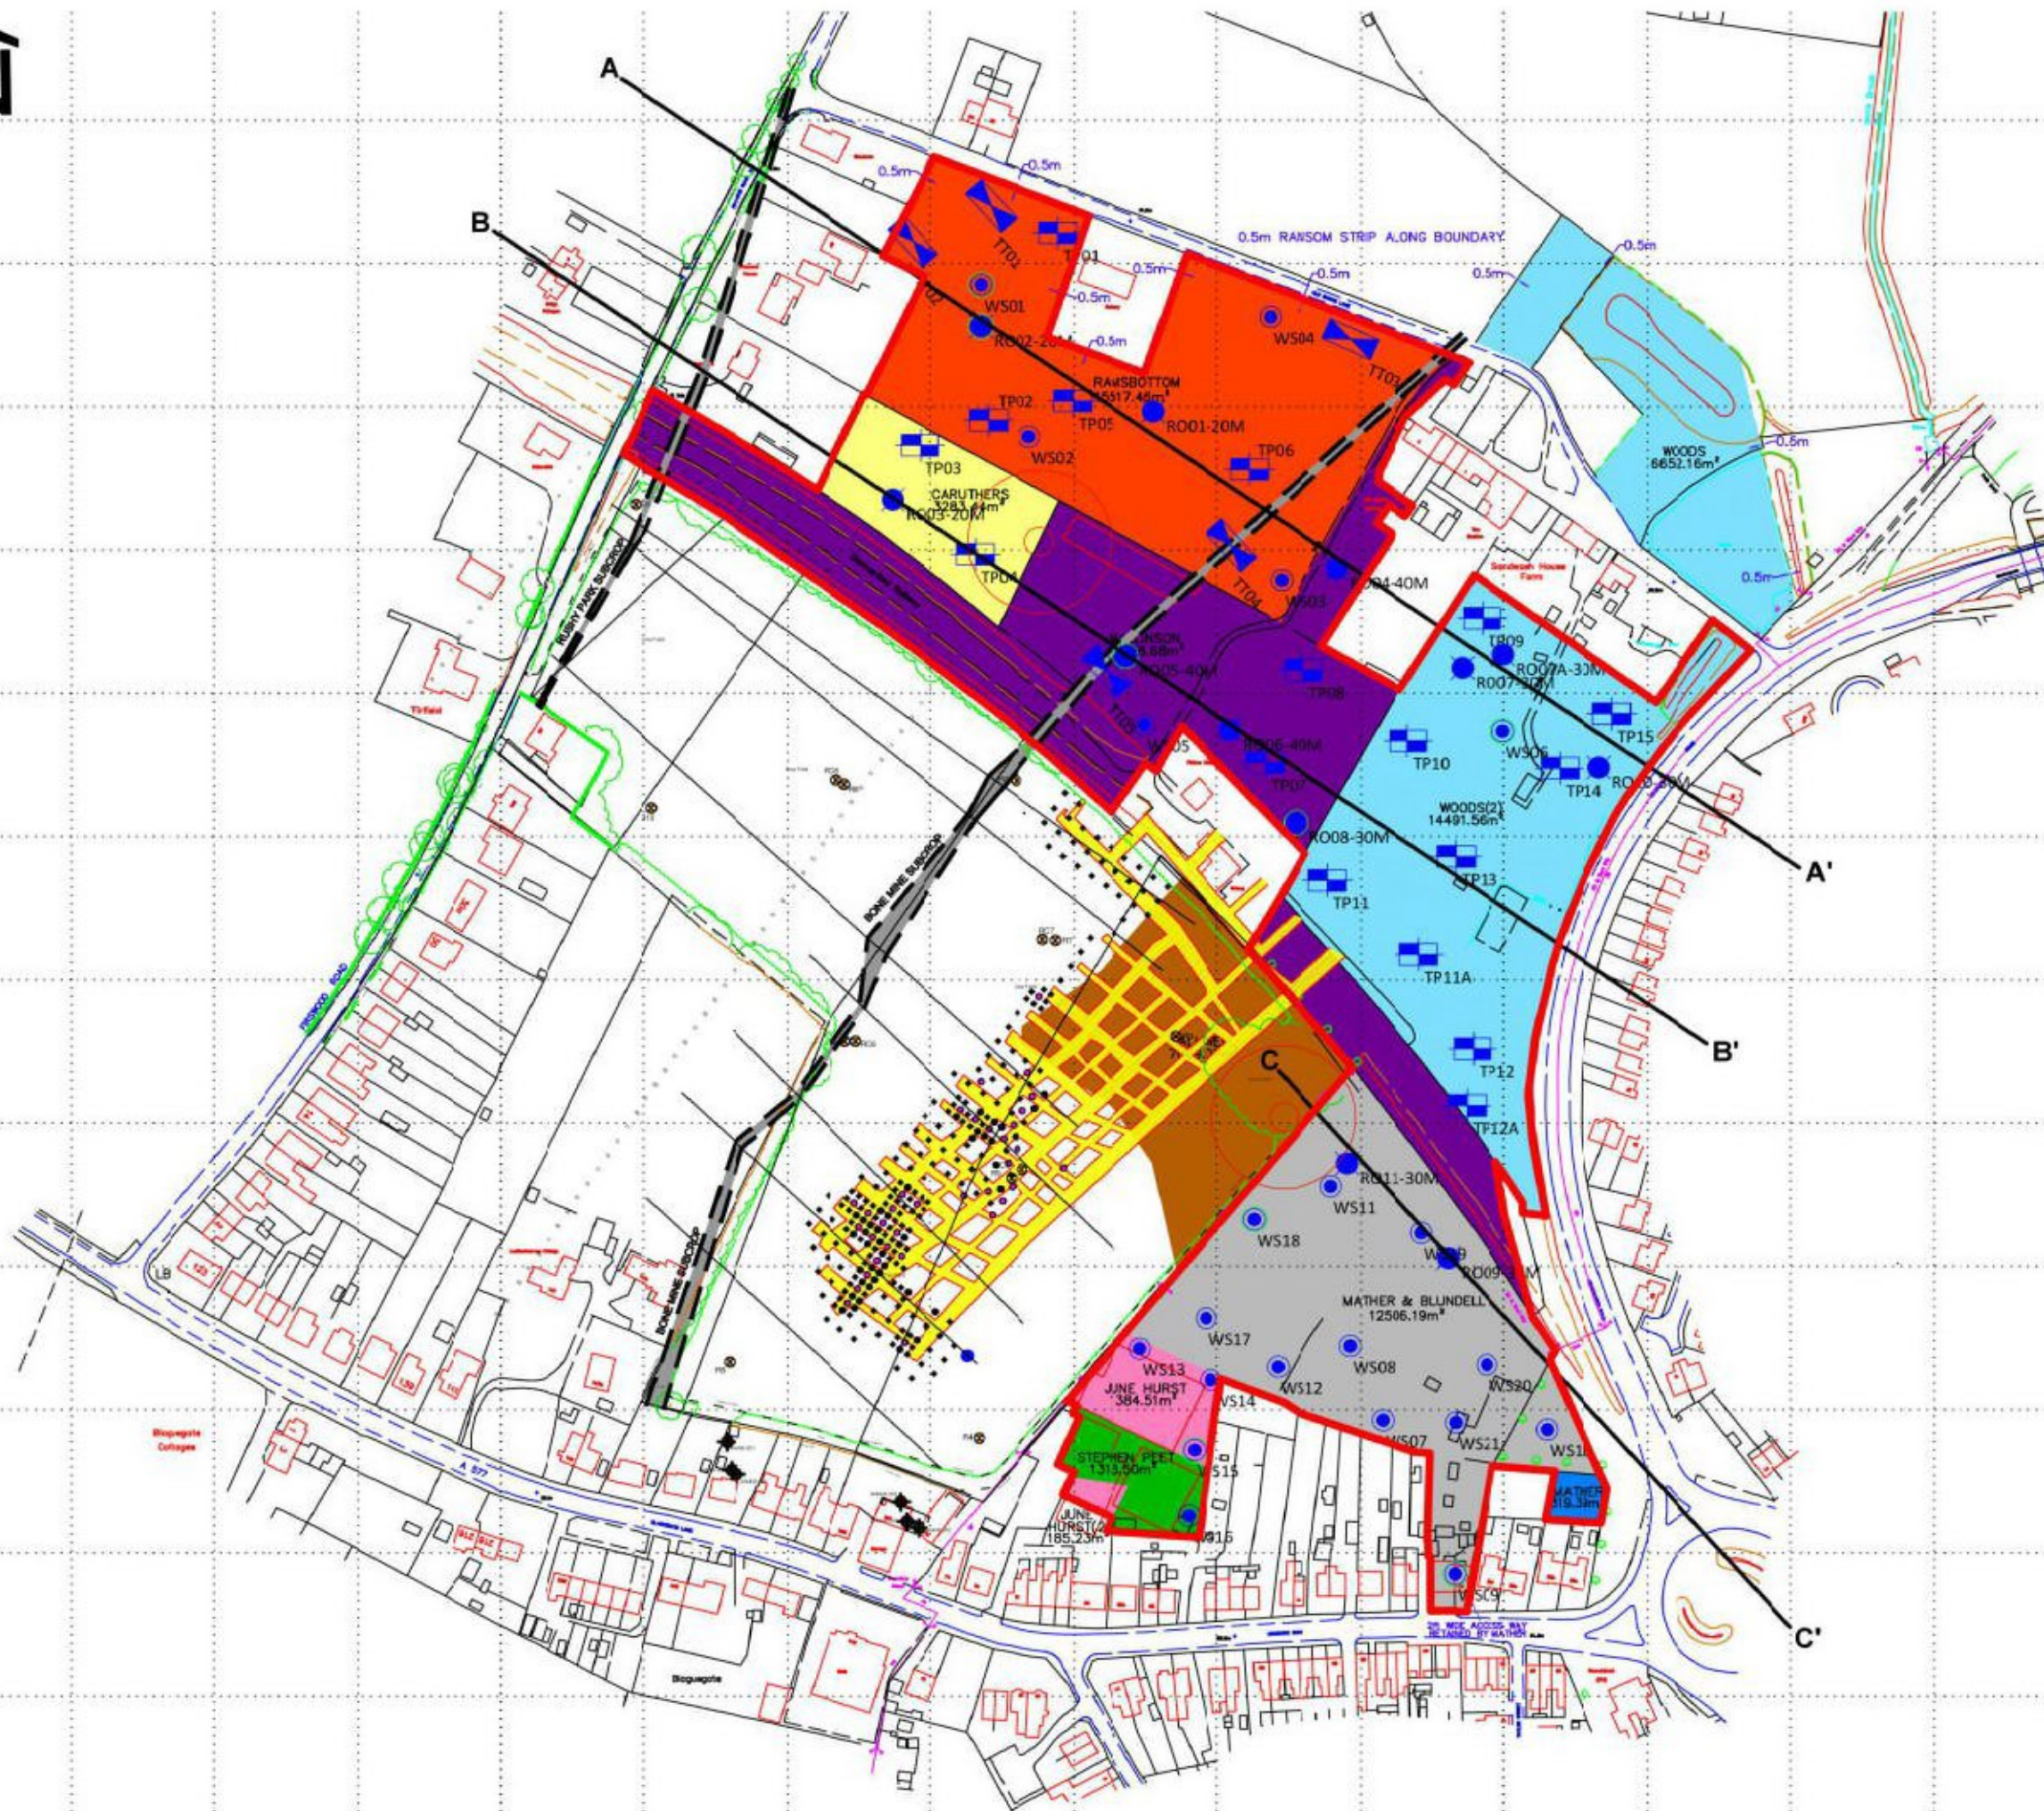
DRAWING TITLE
EXPLORATORY HOLE LOCATION PLAN

Based on the exploratory hole location plan, four locations were undertaken within the Mineral Safeguarding Area in the north of the site (WS04, TT03, TP06, RO01). Sand was encountered within TT03 and TP06 at depths from 0.35m bgl to 0.95m bgl and on average 0.425m in thickness. The sand in these exploratory holes were noted to be clayey fine to coarse sand. WS04 encountered a fine to medium sand between 0.50m and 0.70m bgl. Sand was not encountered within RO01.
