Preliminary Roost Assessment

**2 Salmon Hall Cottages
Howden-le-Wear
County Durham
Christian Salisbury**

FE-089-001-400-R-01-V1

January 2021

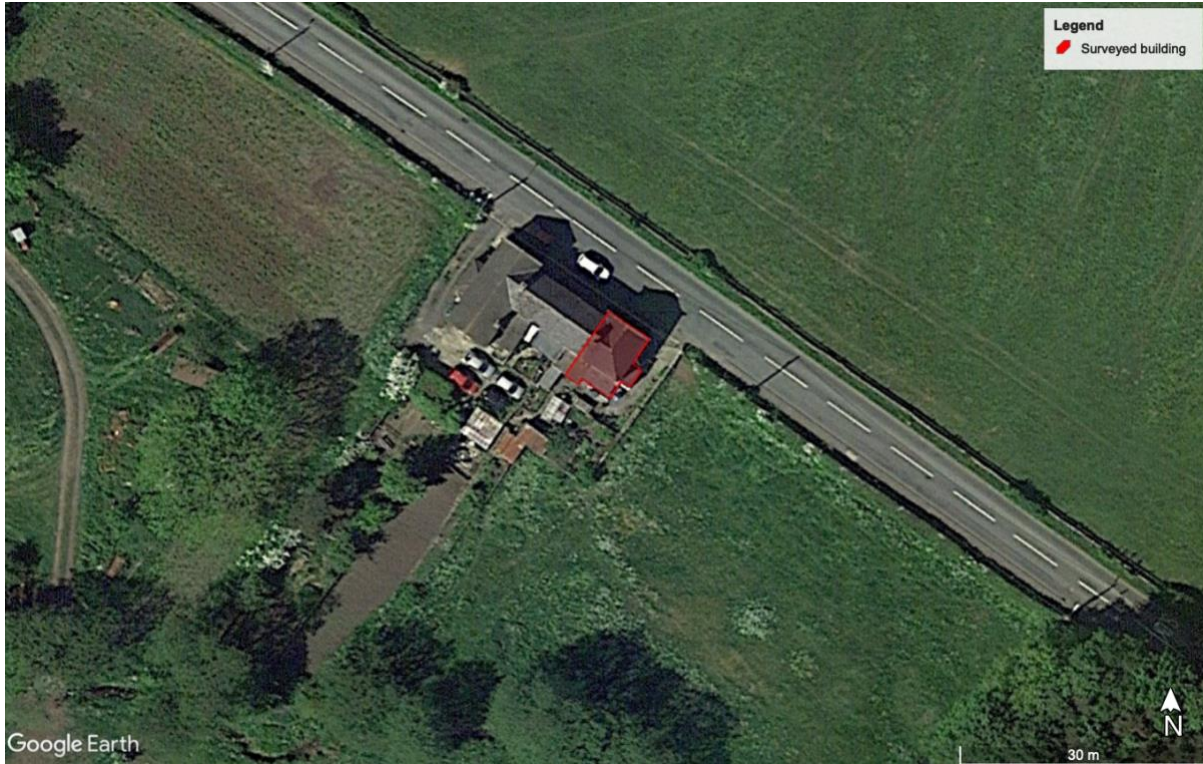
Figure 1: Surveyed building.

- 2.2.2 The address of the surveyed building was 2 Salmon Hall Cottages, Howden-le-Wear, County Durham, DL15 8DH. The central Ordnance Survey grid reference for the surveyed building was NZ 15714 33729 and was ~130m above sea level. The location of the surveyed building is shown in Figure 1 (page 4).

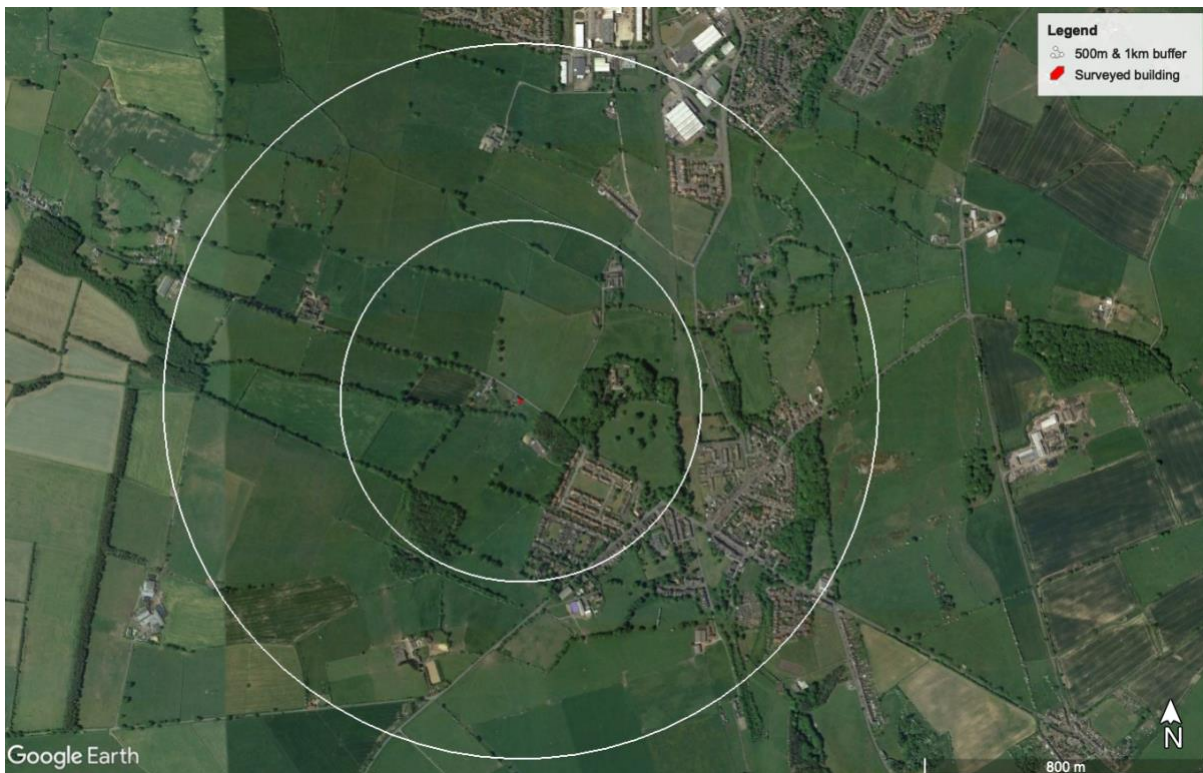
Figure 2: Surrounding habitats.

- 2.2.3 The surrounding habitats of the surveyed building was dominated by pasture farmland, woodland blocks, and sub-urban area of Howden-le-Wear. Howden Beck runs ~45m downslope from the surveyed building and this beck is lined with mature Alder trees. The surrounding area of the surveyed building with a 500m and 1km buffer are shown in Figure 2 (page 4).

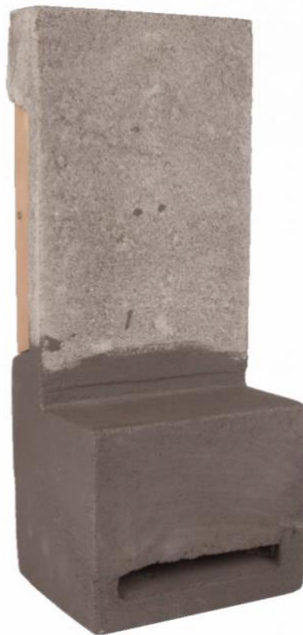
Figure 3: Example of an integrated bat box²

7.1.1 In order to fulfil the latest National Planning Policy Framework which includes biodiversity net gain, it is recommended that an integrated bat box, such as a Build-in WoodStone as shown in Figure 3 or similar, is built into the wall of the proposed development. The front of the box can be rendered or painted to match the surrounding wall. If rendered, then the entrance hole dimensions must remain the same (height and width). The bat box should be situated near the wall top on the rear aspect of the proposed development, as shown in Figure 4, and be approximately 3m or higher above ground level.

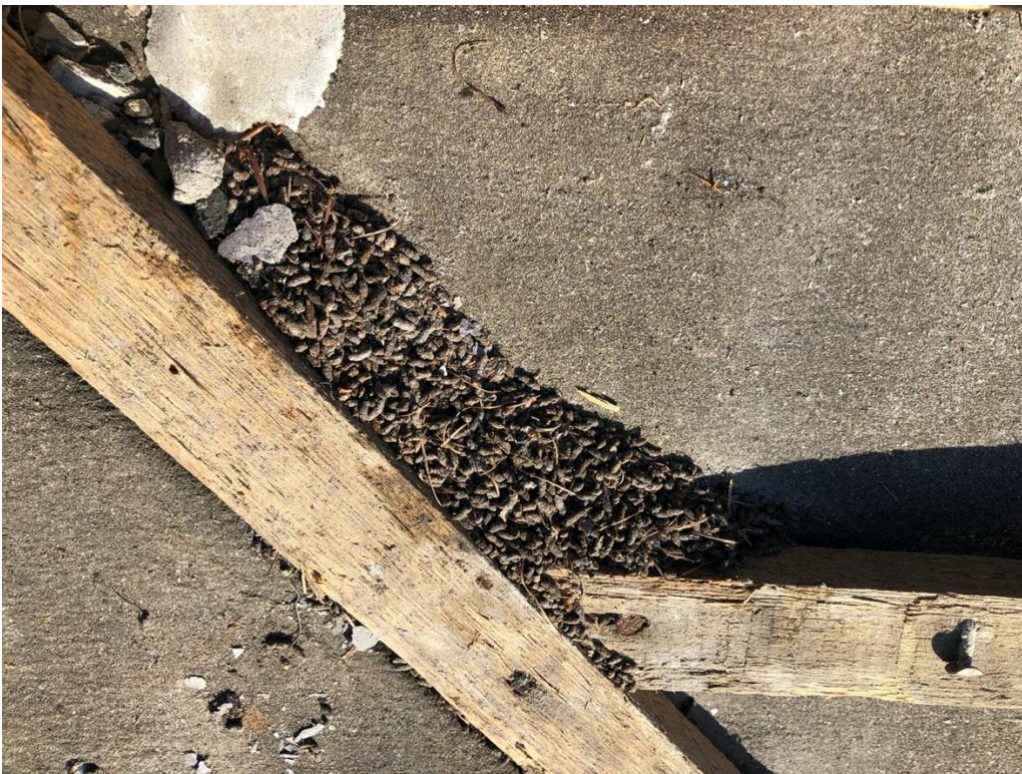
Figure 6: Example of bat droppings between slates (removed) and roof underlay, next to a roof valley.

8.1.6 Figure 6 and Figure 7 (page 18) show examples of bat droppings which indicates the presence of a bat roost location. Bat droppings, which will crumble to dust when rubbed between fingers, can be easily identified from mouse droppings, which are hard and generally do not crumble easily. Bat droppings are generally 1.5-2mm wide by 7-9mm long.

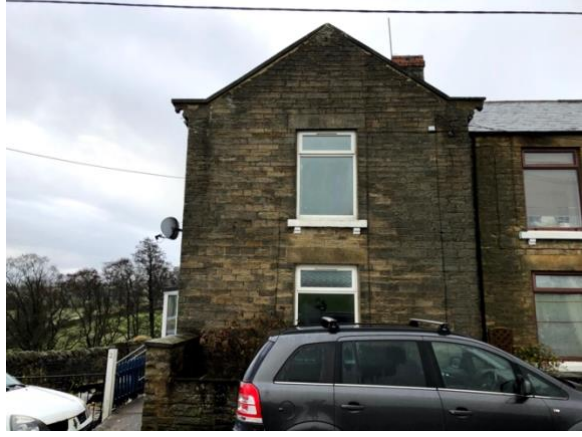
Ref.	Description	Photo
1	Front aspect

4.2.2 The surveyed building was constructed with sandstone brick on the front aspect. The side and rear aspect walls were rendered. The exterior walls were presumed to be solid given the depth of them and the age of the property. Furthermore, it is presumed that the exterior walls had a rubble infill. Gaps in the brick mortar were recorded on the front aspect wall within the gable apex, which provided PAPs for roosting bats.

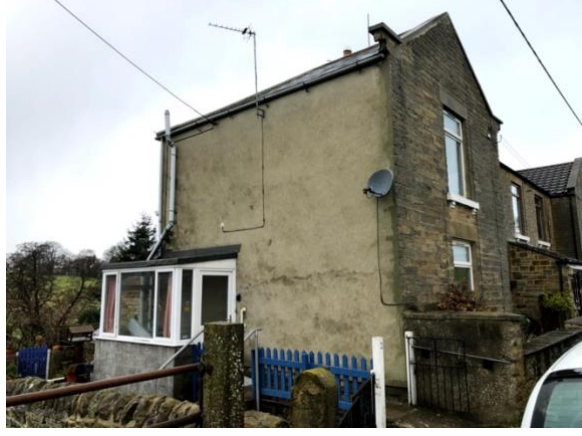
2	Side aspect

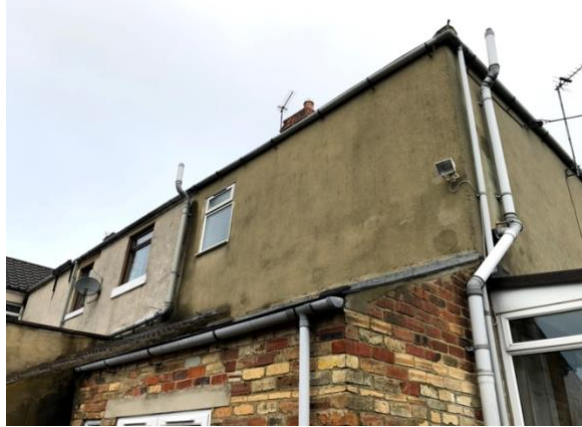
3	Rear aspect

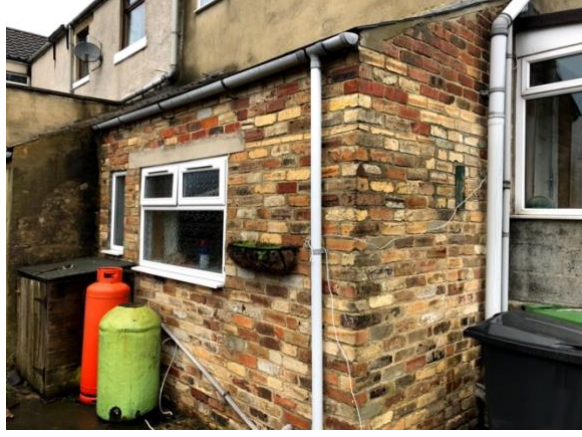
4.2.5 A single storey extension which formed the kitchen was present on the rear aspect. This was constructed with brick and a few gaps in the brick mortar was recorded; however, an inspection with the endoscope confirmed that the gaps did not form or lead to cavities within the wall.

Ref.	Description	Photo
4	Single storey extension on rear aspect

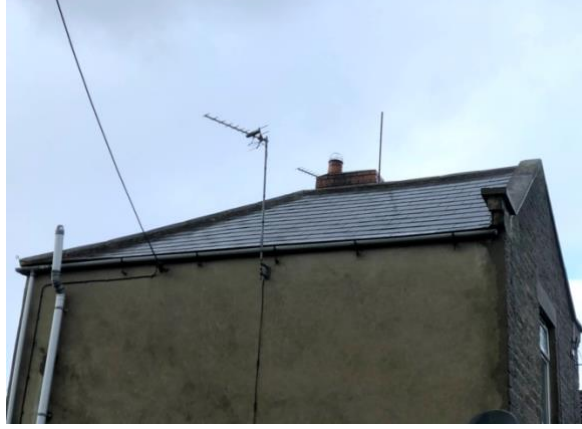
4.2.1 The surveyed building had a hip and valley roof type with a gable end on the front (northeast) aspect. The roof had synthetic roof tiles and a wet ridge with clay ridge tiles. The roof tiles appeared to be tight and no mortar appeared to be missing around the ridge tiles. The brick chimney had a lead apron which appeared to be tight fitting; however, the base on the neighbouring side of the shared chimney had various different materials from multiple repair jobs. Several gaps in the chimney brick mortar were recorded and these provided PAPs for roosting bats. The watershed stones on the front gable had renewed mortar with no visible gaps.

A photograph showing a side aspect of a porch. The porch is built on a concrete base and has a white frame with glass panels. The wall above the porch is made of red and yellow bricks. A white gutter runs along the roofline. In the foreground, there are black and green bins.
6	Synthetic roof tiles and wet ridge with clay ridge tiles

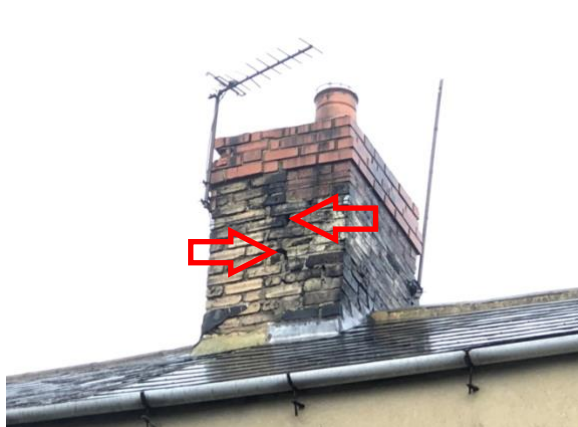
Ref.	Description	Photo
7	<p>Shared chimney</p> <p>PAPs</p> <ul style="list-style-type: none">• Gaps within the brick mortar

It is the responsibility of the Client to ensure that any building contractor are aware that potential roost features (within the gaps of the brick mortar on the front aspect gable wall and the rear aspect of the shared chimney) which are present within the surveyed building.

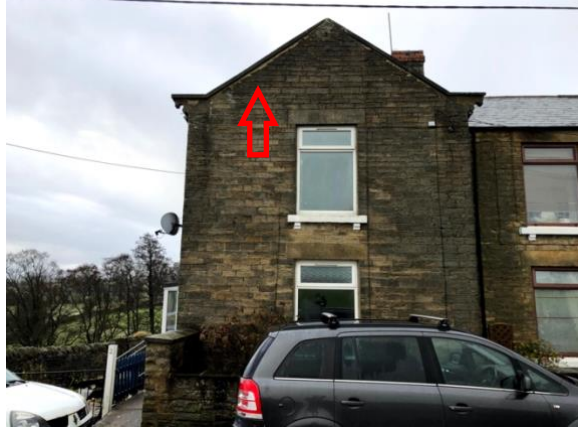
8	<p>Front aspect gable wall</p> <p>PAPs</p> <ul style="list-style-type: none">• Gaps within the brick mortar

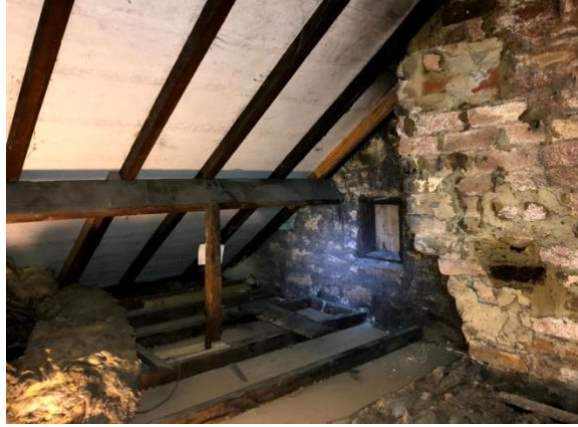
9	<p>Roof void with new first floor ceiling and breathable roofing membrane</p>

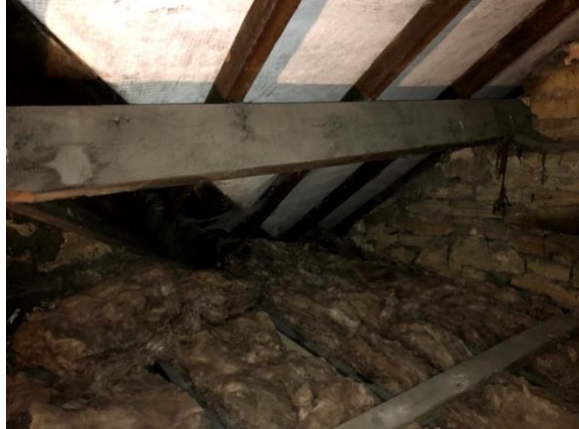
Ref.	Description	Photo
10	Newly installed loft insulation

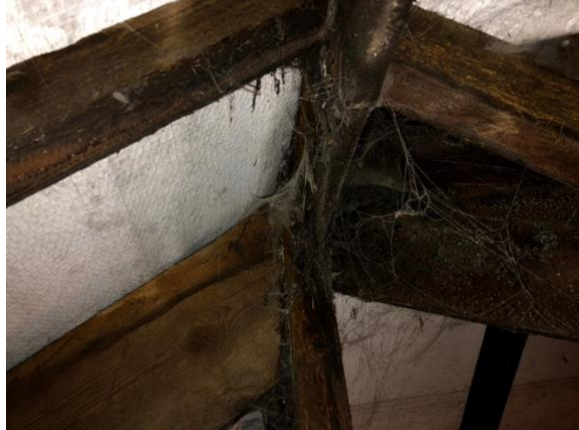
4.2.7 No bats or recent evidence of roosting bats, such as droppings were recorded within the roof void of the surveyed building. The ridge beam appeared to have claw marks in it; however, the ridge beam was covered in cob webs which appeared to have been present for many years. Furthermore, the roof tiles had been renewed at some point in the past and breathable roofing membrane (BRM) was present. No damage was recorded to the BRM, such as from clawing, was recorded during the survey. The old loft insulation was piled to one side of the roof void and this was checked for evidence of bat droppings, although none were found. Dust was present on the purlins and hip post supports and no bat droppings were recorded on these either.

11	Hanging cobwebs from single ridge beam

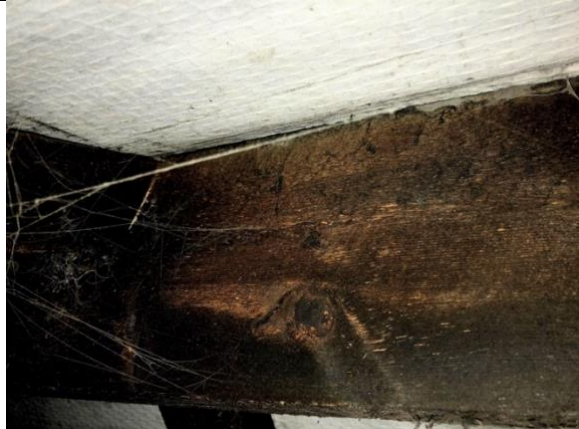
12	Potential historic claw marks on the ridge beam; however, no damage/snagging on the adjacent BRM. No droppings were recorded within the cobwebs or on the pile of old loft insulation.

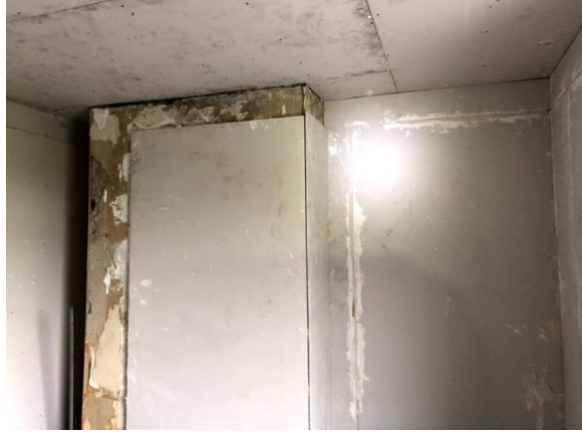
Ref.	Description	Photo
13	Front bedroom renovation with new insulated plasterboard
