Desk Top Land Contamination Report

Proposal: Outline Application for Up To 3 Dwellings

Site: Land North of Windmill Rise

Wetherden IP14 3LE

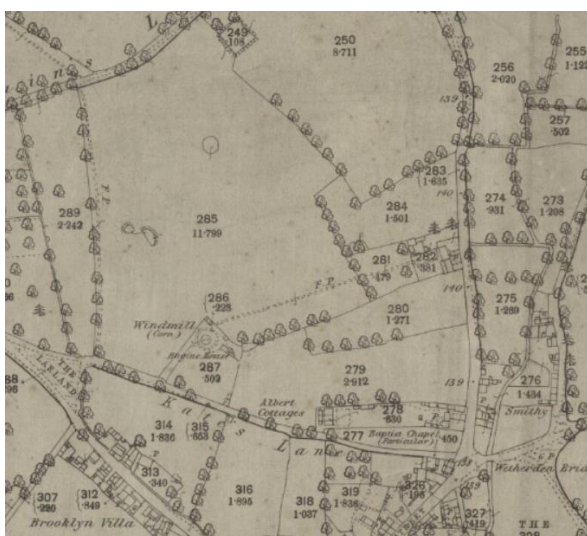
Figure 3: First Ordnance Survey Map (1884)

1. **19th Century** – The site was open agricultural land in 1884 as seen below it was part of a wider field enclosure as shown in the first Ordnance Survey map of in the 19th Century. This does indicate that south west of the site there was a saw pit.

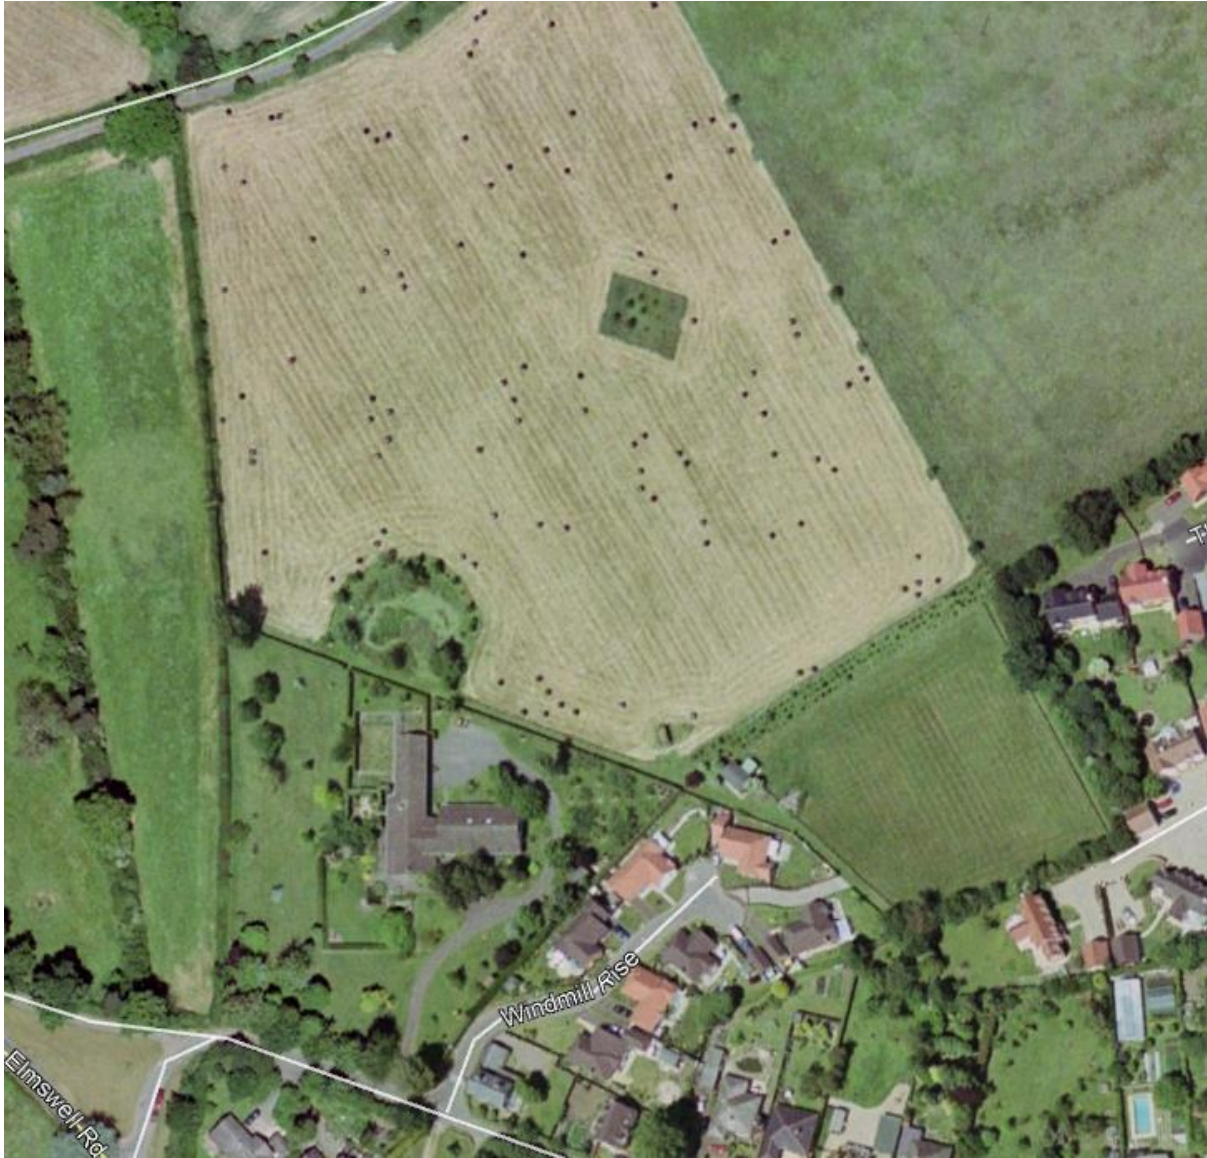
Figure 6: 2000 Aerial View

4. **2000** - See aerial view from 2000, the application site is still part of the wider agricultural holding and in control of our client. Residential development on windmill rise has been constructed to the south.

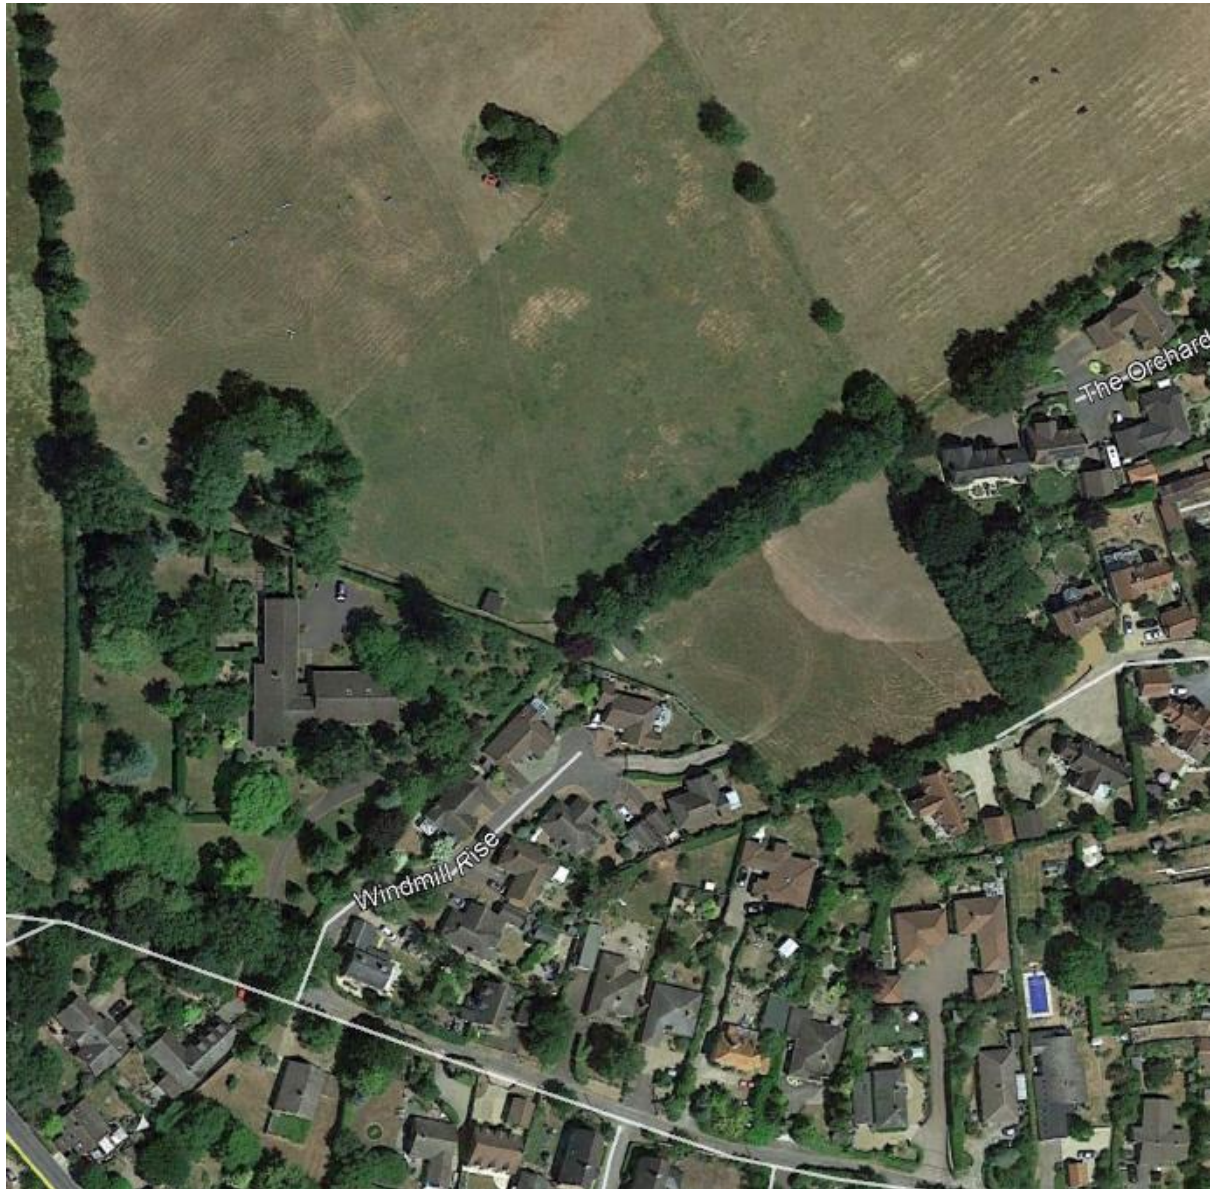
Figure 7: Present Day

- 5. Present Day** - See aerial view from 2019, the application site is still part of the wider agricultural holding and in control of our client. However boundary planting which can be seen in aerial image of 2000 has created a physical boundary between the wider agricultural holding. Further residential development in this area has been constructed adjacent the application site.
