STOCKPORT INTERCHANGE

Mersey Bank Survey Report

PROJECT NO. 70031899

DATE: FEBRUARY 2019

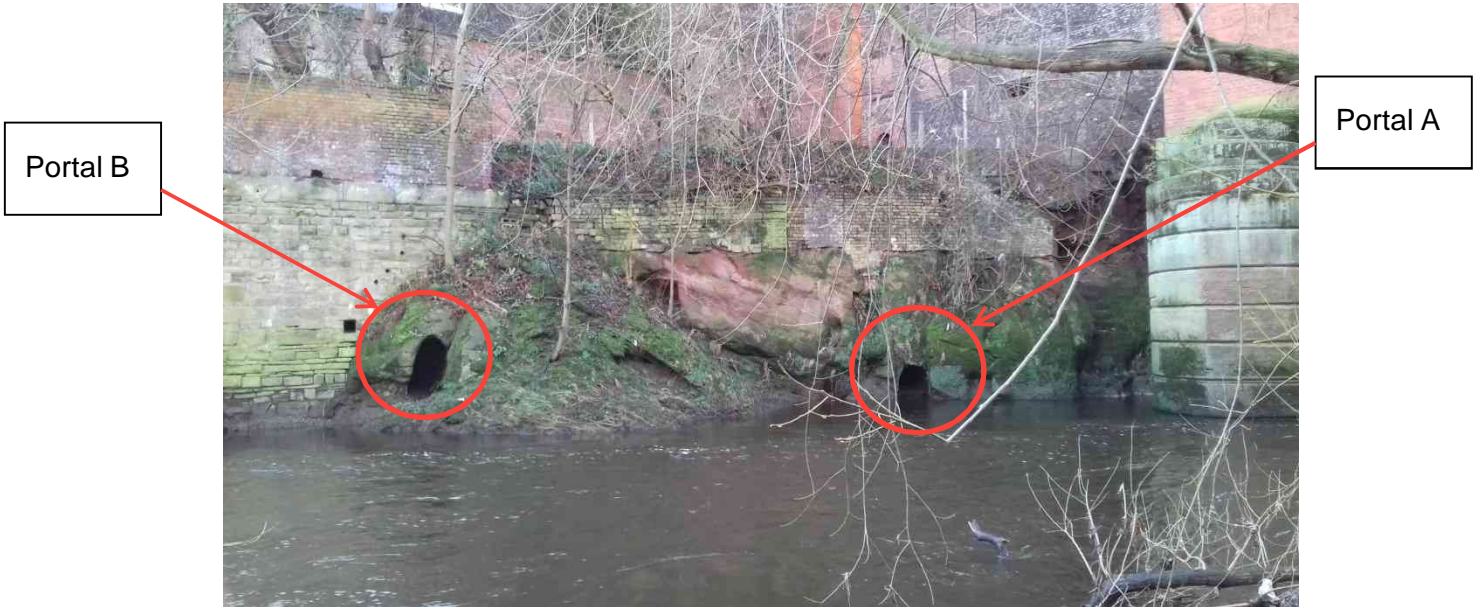
Photograph 1: Portals A & B from the northern bank of the River Mersey

Portals A and B are unlined and cut directly into the sandstone and are located immediately to the east of the viaduct.

Based on its shape, Portal A appears to have been partially submerged beneath the river at the time of the laser scan survey. During the UAV survey of Portal A, the tunnel was observed to be silted up approximately 3.0m into the tunnel.

The UAV penetrated approximately 25m into Portal B where it encountered a blockage comprised of brick rubble. The tunnel was inclined upwards at a slight gradient.

- Portals A and B, fall outside the site boundary and, based on their indicated orientation, are not considered to be of further interest.
- Portal C was encountered by Osborne during a trial pitting exercise undertaken for the Swaine Street bridge abutment. The trial pitting encountered a three-way junction between the tunnel extending from Portal C and two additional tunnels. This needs further investigation.

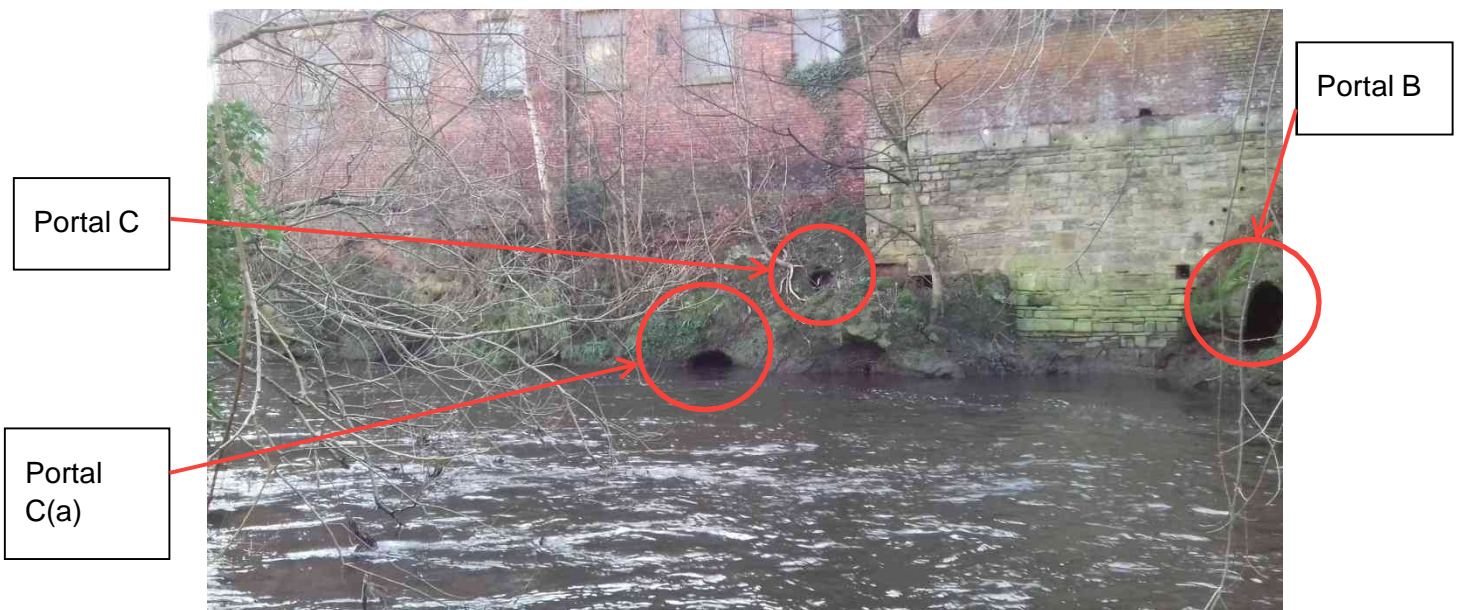
Photograph 2: Portal C and C(a) from the northern bank of the River Mersey

Portal C(a) appears to be unlined and is located beneath a red brick warehouse building approximately 22m east of the viaduct. Based on its shape the portal appeared to be partially submerged at the time of the survey. A UAV survey of the tunnel was not possible.

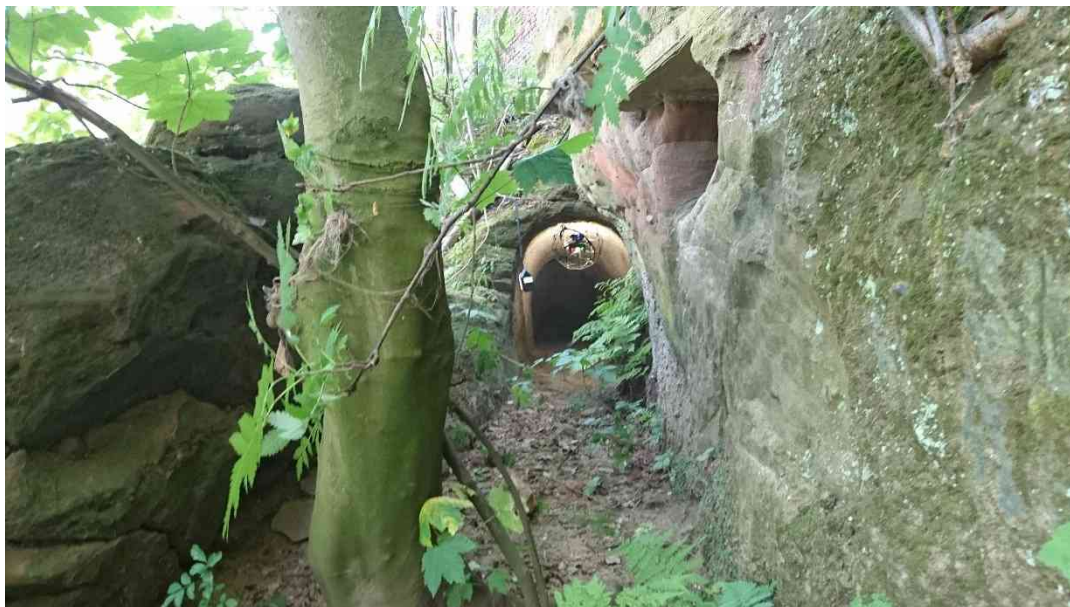
Photograph 3 - Portal C

Portal C is cut into the sandstone at a higher elevation. The UAV survey encountered two smaller tunnels, which off shoot from the main tunnel. The first tunnel offshoot is orientated approximately south and comprises steps which lead to a brick lined shaft. The second tunnel offshoot is also aligned approximately south but, due to poor signal, the UAV could not further investigate its extent. The UAV encountered a blockage in the main tunnel extending from Portal C.

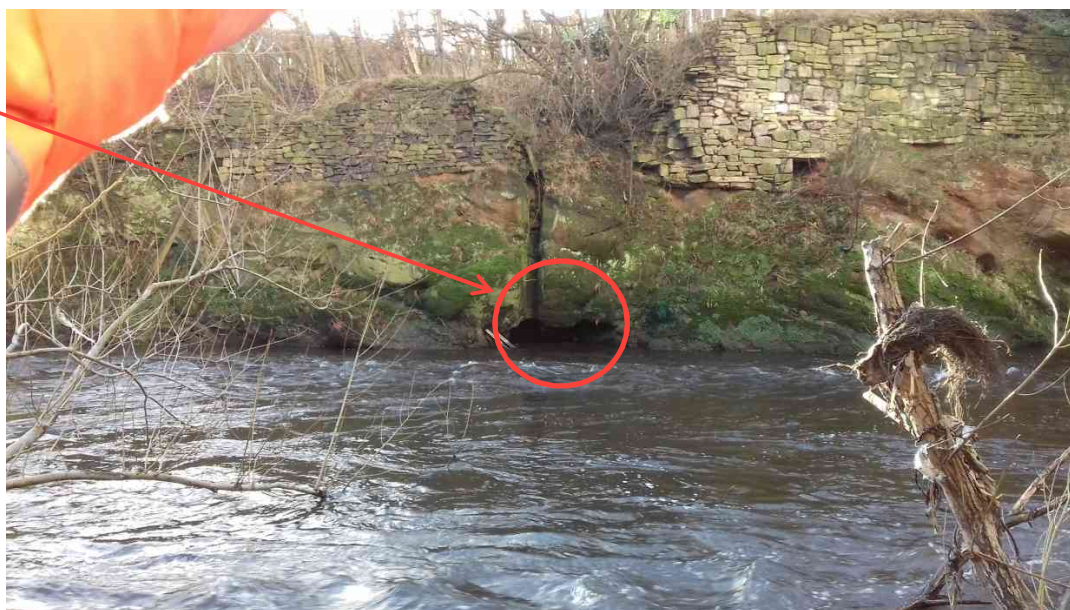
Photograph 5 – Portal E from the northern bank of the River Mersey

Portal E appears to be an unlined, rock cut and again appears partially submerged. At the crest of the tunnel, there appears to be a vertical channel cut into the rock, possibly leading from a historical structure above. The UAV survey observed that this Portal was heavily silted up.

- The orientation measured from Portal E indicates that if it projects any significant distance back into the site, then it may intersect with Binns' Deep, to the east of the indicated sewer connection. However, such an intersection was not recorded by Emma Brown, which suggests that either;
 - I. The tunnel is of limited length.
 - II. Its orientation is different to that indicated from the current survey.
 Further investigation is required.
- Portal G (Fernley Gully) is also indicated to likely extend beneath the site and again requires further investigation.

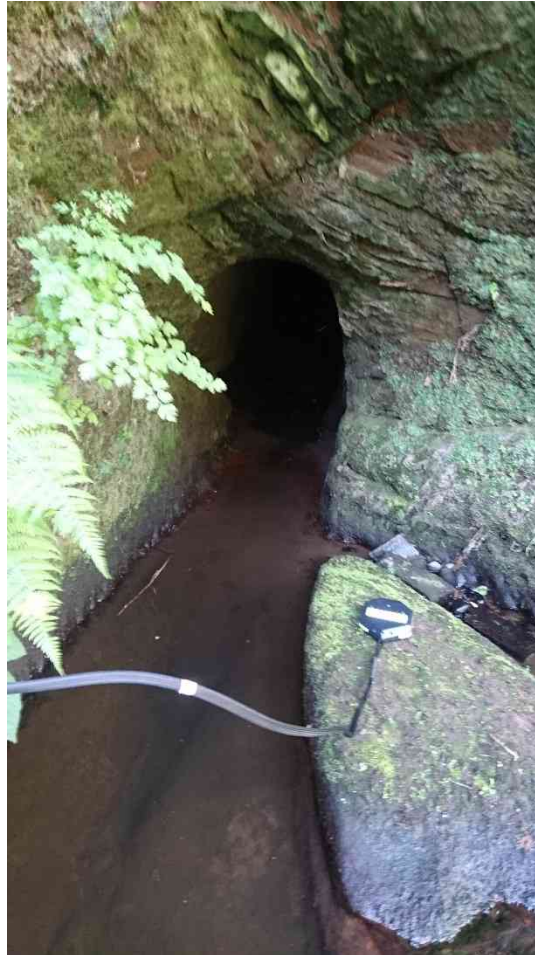
Photograph 6 - Portal F (Binns' Deep)

Portal F is the unlined tunnel referred to as '*Binns' Deep*' in the Tunnel Assessment. The tunnel portal appeared to be partially submerged at the time of the laser scan survey. The UAV survey could not fully explore the extent of the tunnel.

- Further desk based investigation has been made into Portal F (Binns' Deep). Information provided by WSP's drainage team indicates that Binns' Deep is in part connected to an existing 300mm diameter public surface water sewer, which crosses the site from south to north. Dye placed into a manhole on site (MH38) as part of a drainage survey was observed to emanate from Binns' Deep (See DWG 70031899-D-001 from "*Stockport Interchange Stage 1 – Drainage and Flood Risk*" report (WSP, 2017) presented in Appendix B). It is assumed that the sewer is the clayware pipe shown projecting from a brick headwall, as observed by Emma Brown (Photograph 8).

Based on the suggested orientation, it appears that the course of Binns' Deep is almost parallel to the river and it may have been a head race carrying water to one of the former industrial concerns (the inlet faces up stream). If this assumption is correct, it seems unlikely that the feature extends any significant distance back into the site. However, it would also seem likely that the structure continues beyond the headwall and, in theory, there would be expected to be an associated outlet back into the river (tail race). Based on a review of historical photographs presented in our Tunnel Assessment report (and reproduced as Photograph 9 in this report), it is possible that the flowing water seen may be the tail race. Further investigation of Binns' deep is required.

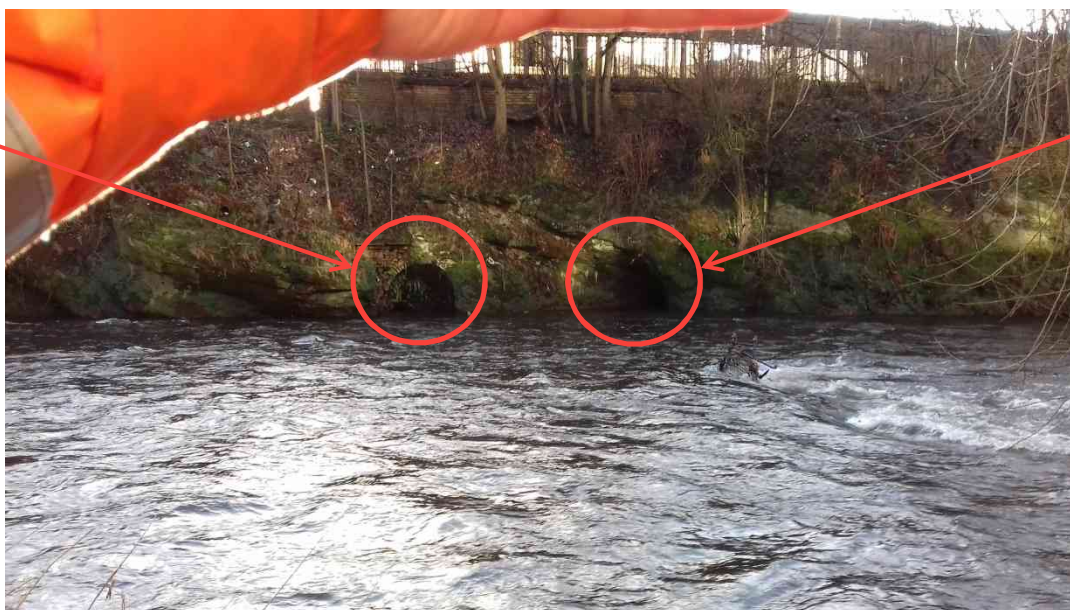
Photograph 7 – Portal F (Binns' Deep) and Portal G (Fernley Gully) from the northern bank of the River Mersey

Portal G is a brick lined tunnel entrance referred to as '*Fernley Gully*' in the Tunnel Assessment and lies approximately 6m to the east of Portal F. The majority of the tunnel portal appeared to be above the river level at the time of the laser scan survey, although it was noted during the UAV survey that the tunnel brick arch (Photograph 7) is significantly larger than the tunnel itself (Photograph 8). The UAV survey observed that the brick arch portal was partially collapsed and the tunnel was heavily silted up.

Boreholes proposed to investigate Portal G are located on the existing public footpath and will require its closure.
