STOCKPORT INTERCHANGE

Environmental Screening Report

14113-WSP-SKZ-ZZ-RP-Y-0040 MAY 2018

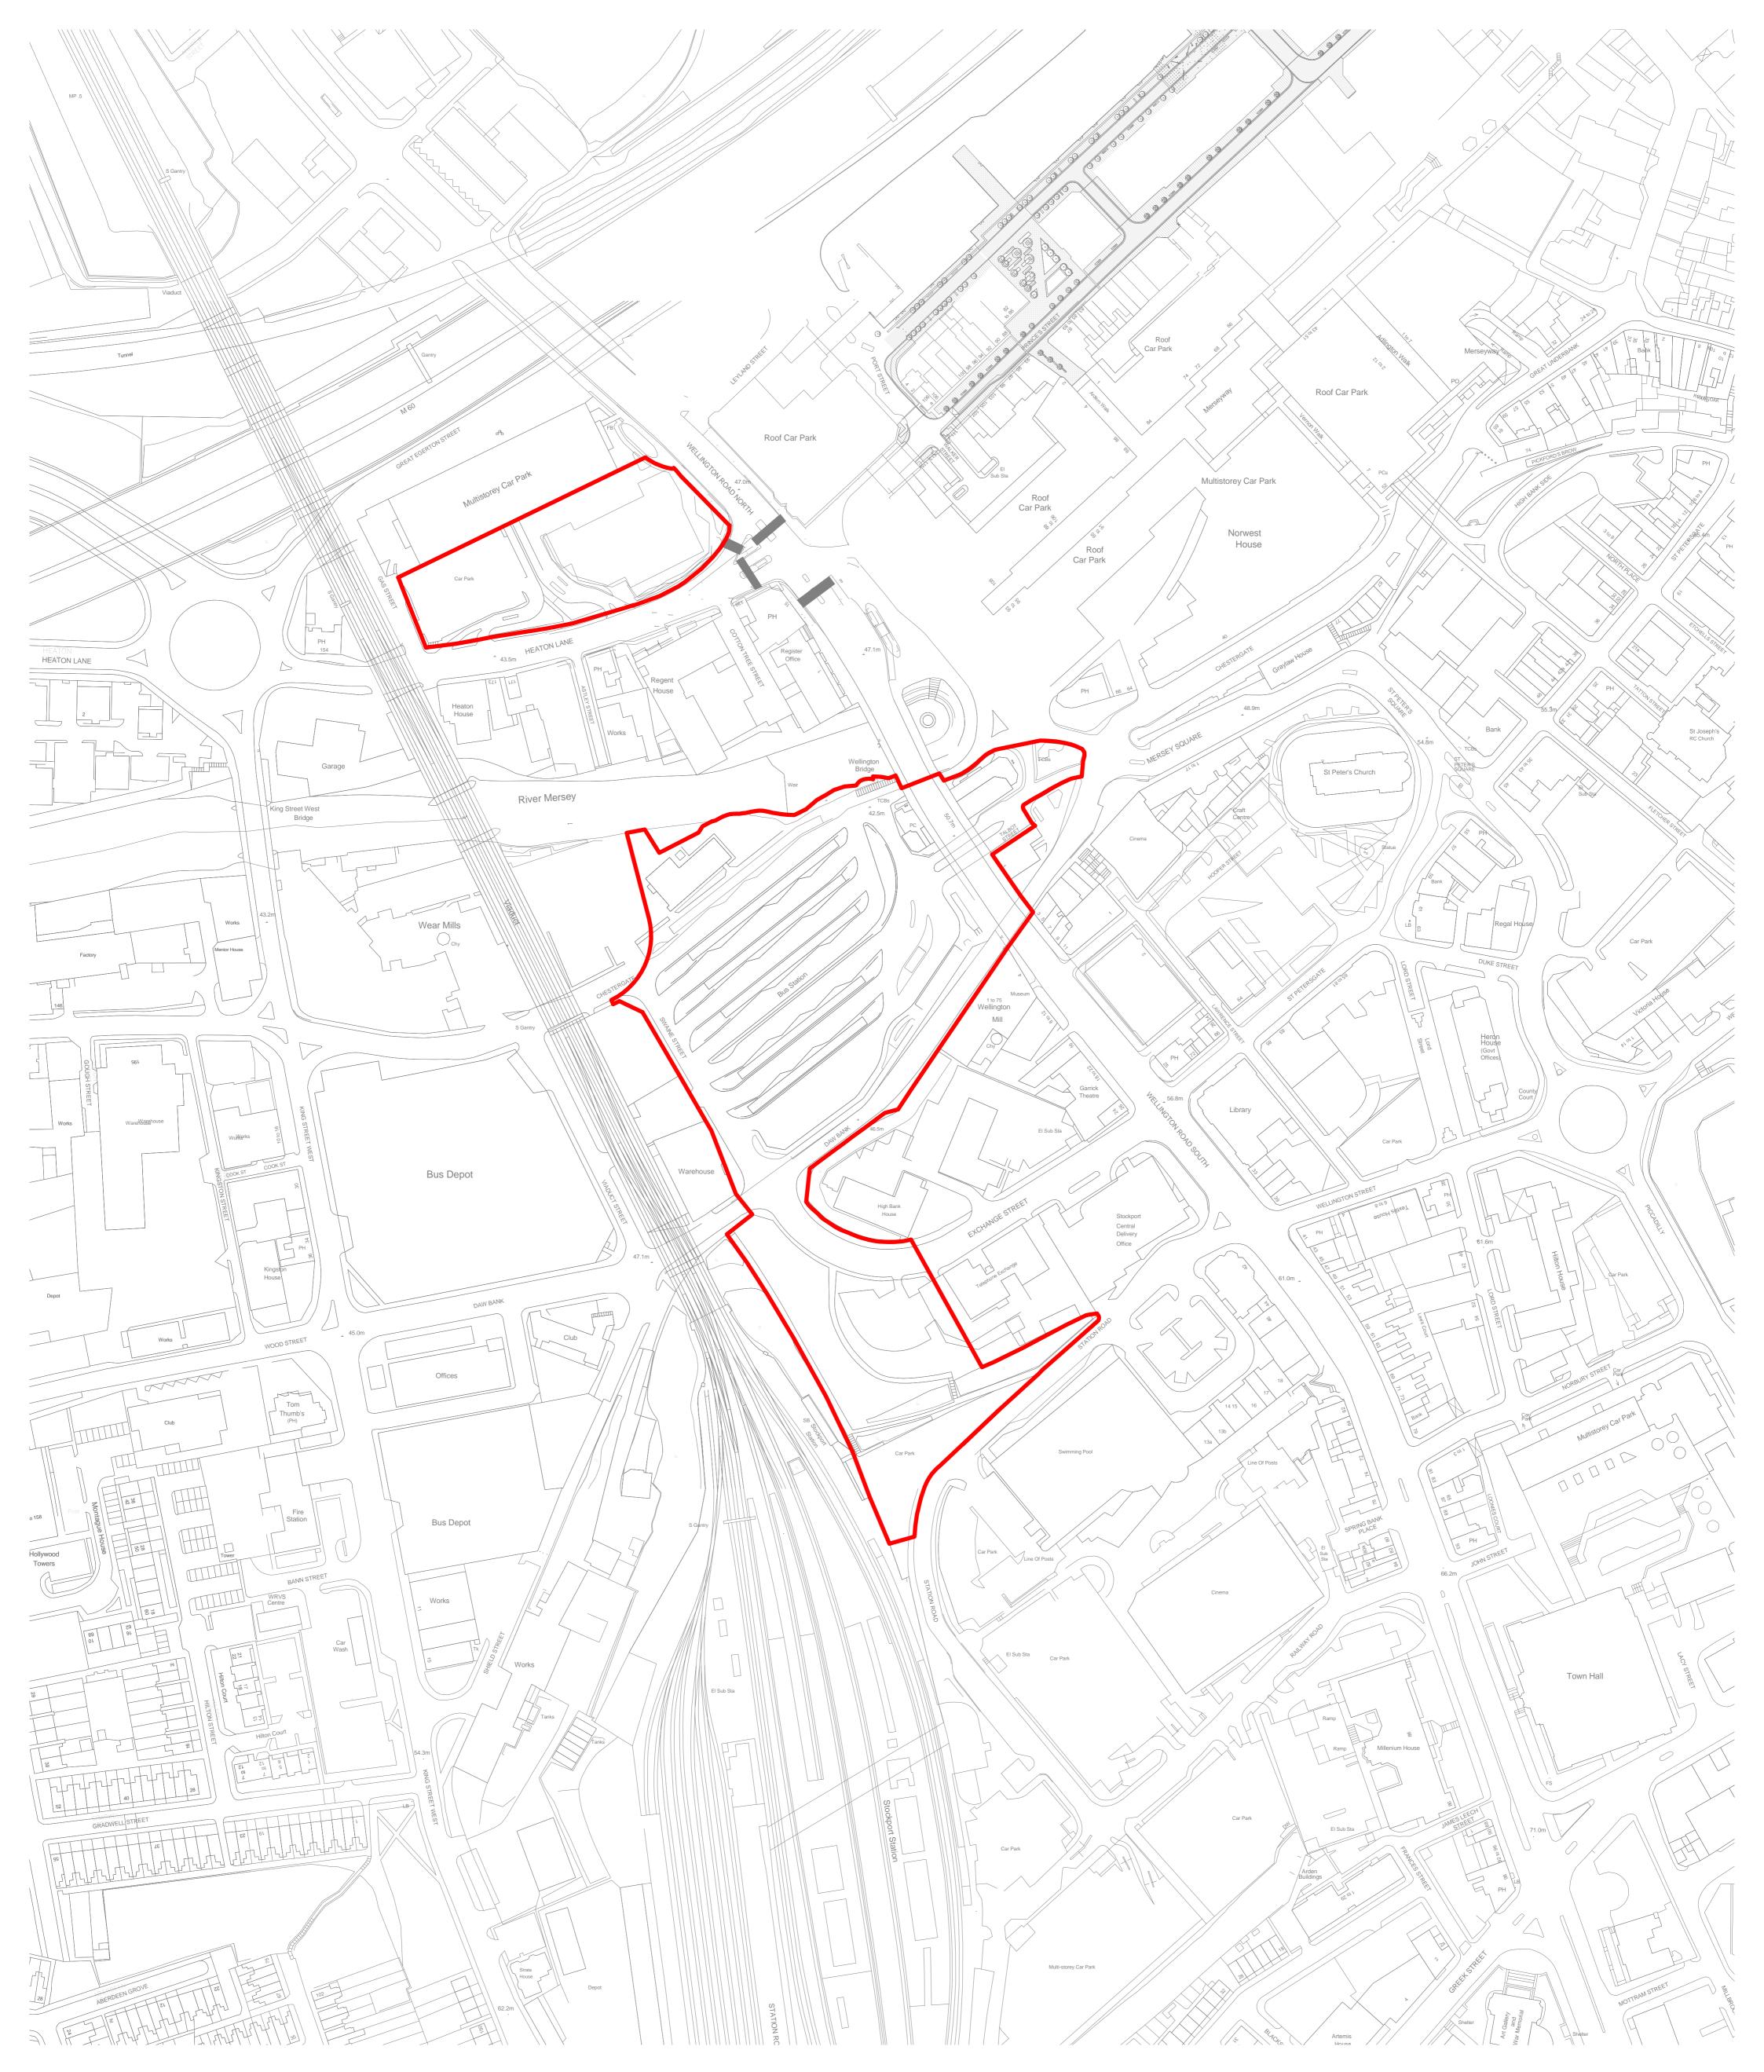
Drawing No.: STPT-BDP-RB-ZZ-SK-A-PM_40_40_79-0005_P01 Sketch Drawing of Residential Block

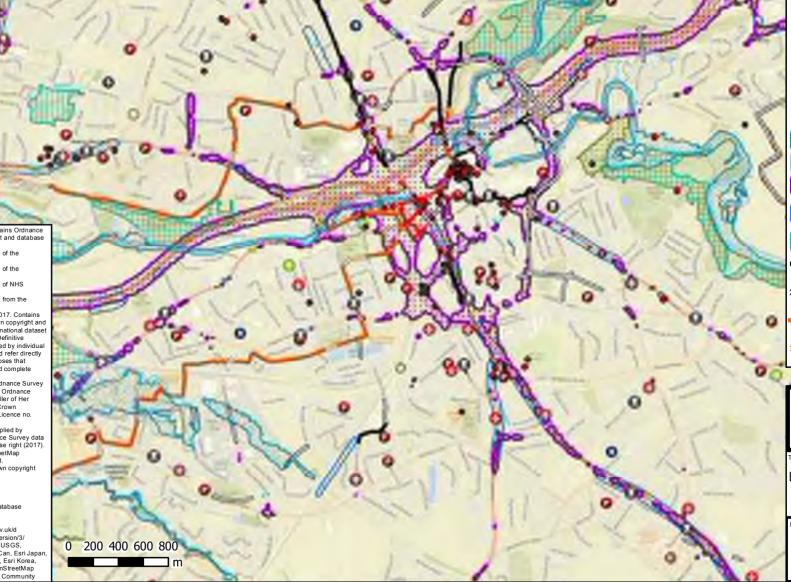
Figure 1: Environmental Constraints Map

-- Heaton Lane Site Boundary Main Site (Stockport Interchange) Boundary Listed Building Hospitals GP Practice Dentists Secondary Schools Primary Schools 1 Nursery Schools Flood Zone 3 Flood Zone 2 Air Quality Management Area 2017 Noise Action Planning Important Areas (NIA) Local Nature Reserve Sustrans Local Cycle Route (On Road) Sustrans Local Cycle Route (Off Road) Sustrans National Cycle Route (On Road) Sustrans National Cycle Route (Off Road) -TITLE: Environmental Constraints Map for Stockport Interchange FIGURE No: Figure 1

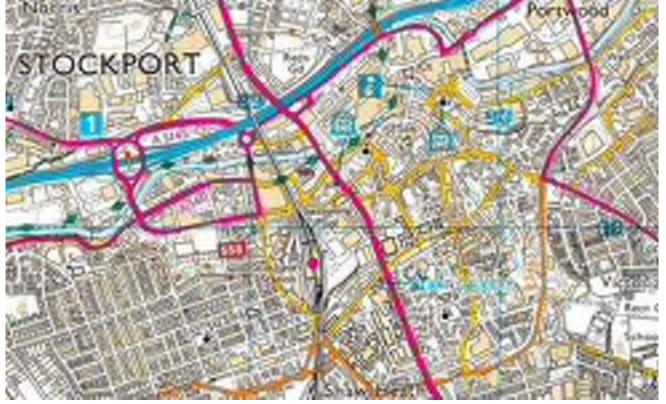
Figure 3: Public Right of Way

Screenshot of PRoW (green line), taken from Bing Maps, OS Layer [Online at: https://www.bing.com/maps?osid=08a02ff3-10af-46af-ba8f-38813269a76c&cp=53.407987~-2.162668&lvl=16&style=s&v=2&sV=2&form=S00027]
