STOCKPORT INTERCHANGE

TUNNEL ASSESSMENT

14113-WSP-SKX-XX-RP-G-0006

DATE: OCTOBER 2018

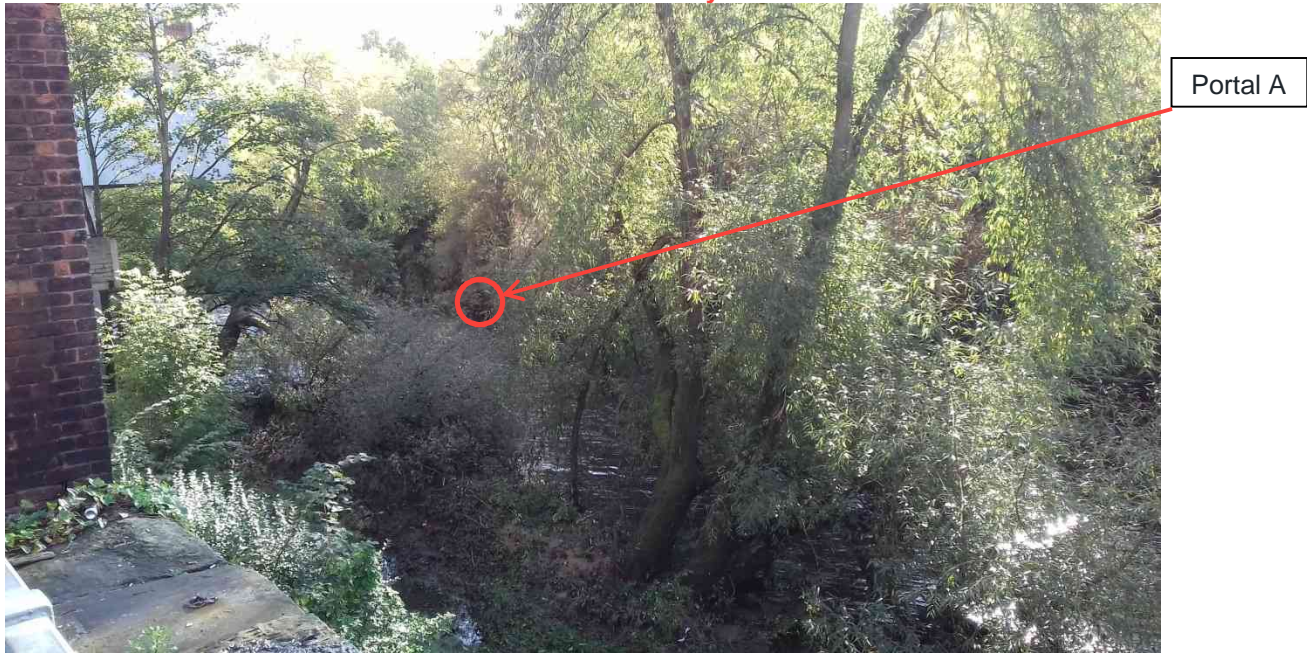
Plate 1: Portal A from Astley Street

Portal A appears to be an unlined tunnel entrance cut directly into the sandstone bedrock (see Plates 1 and 2). The portal appears to be partially submerged beneath the river.

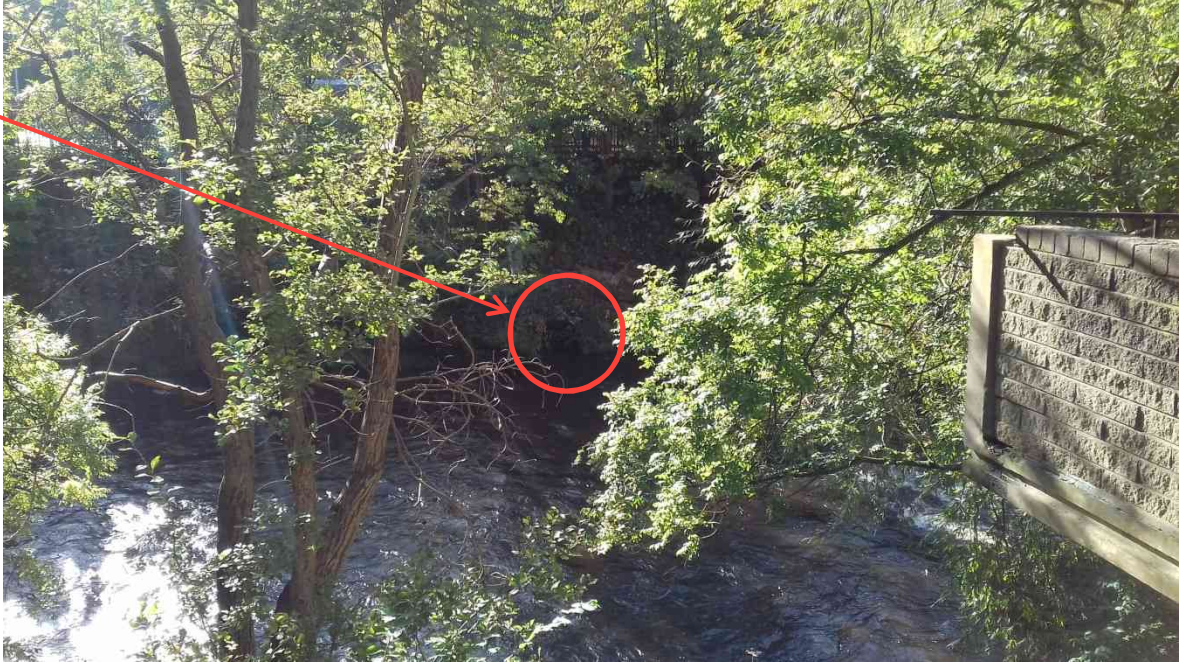
Plate 3: Portal B from Cotton Tree Street

Portal B appears to be semi-circular brick lined tunnel entrance positioned mostly above the water level of the river.

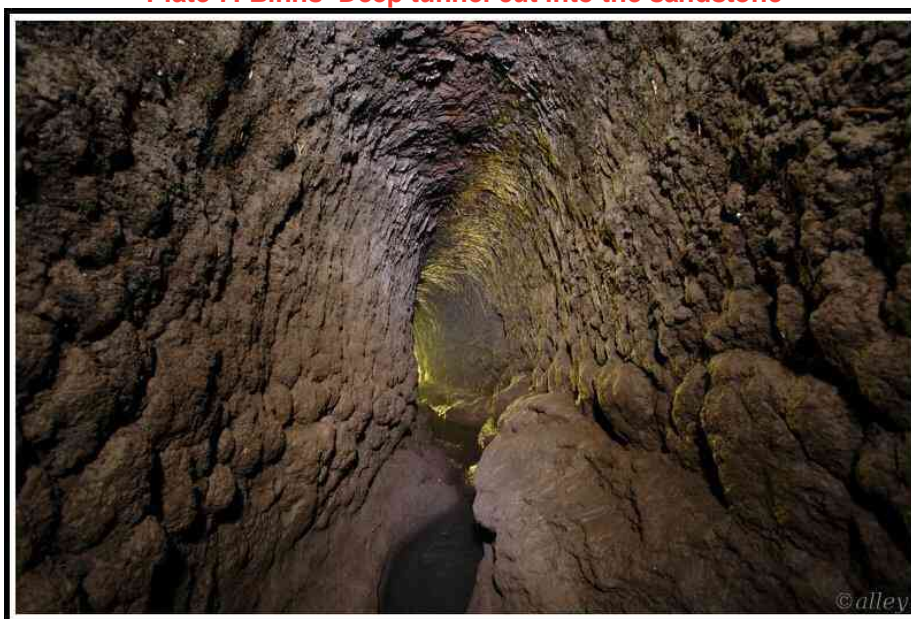
Plate 7: Binns' Deep tunnel cut into the sandstone

The second tunnel, named as ‘*Binns’ Deep*’, is described as being located just to the west of Fernley Gully and is described as an approximately 2m high, 1m wide tunnel cut into the sandstone.. Emma Brown describes exploring the tunnel for an unspecified distance until her progress was halted by the tunnel being bricked up. At this point she could evidently “*hear buses above*”. Binns’ Deep was not viewed during the recent walkover and was likely obscured by vegetation on the bank. Plates 7 and 8 were taken within Binns’ Deep.

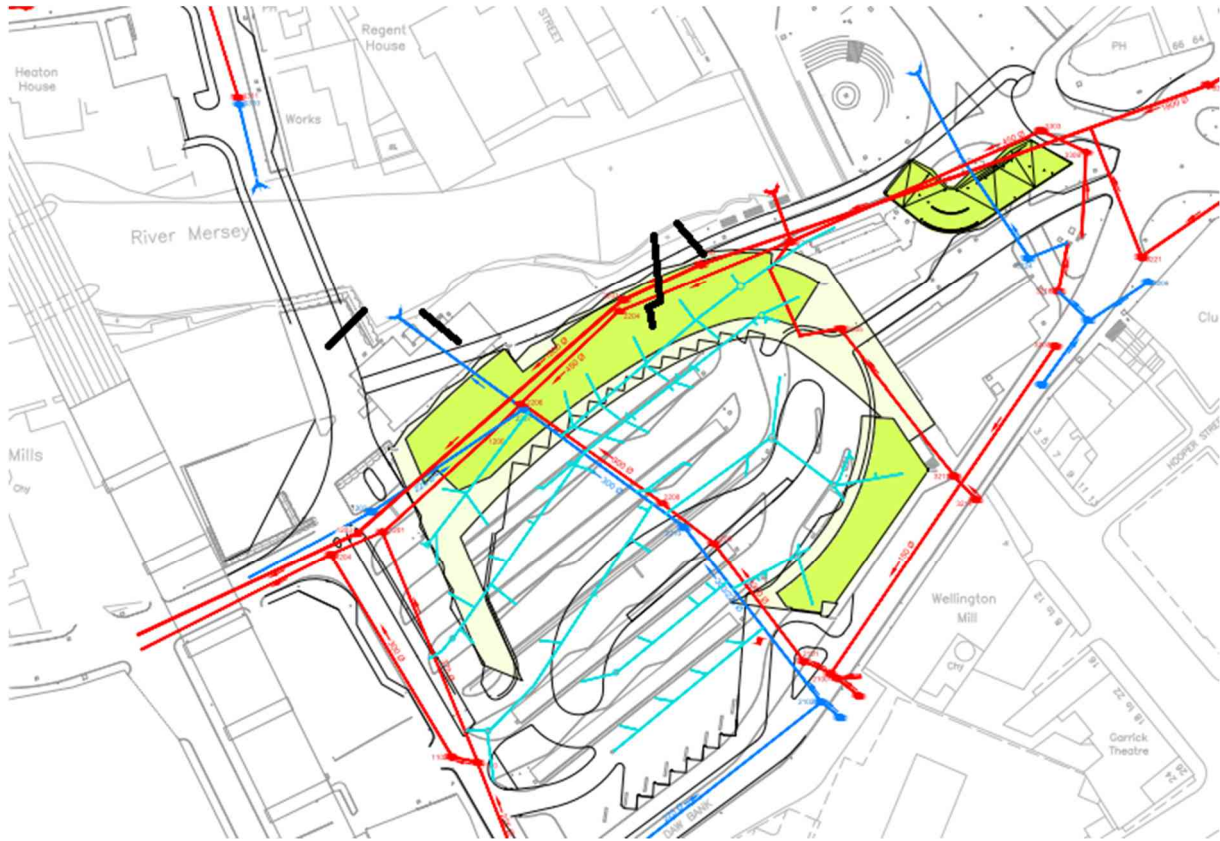
Plan provided by Emma Brown showing approximate location of known tunnel entrances

Emma Brown also provided a marked up a plan indicating the approximate location of the tunnels she is aware of and these have been transposed onto the development layout below.

It can be seen that there are two tunnels (not included in her book) close to the outfall shown on the historical photographs in the west of the site. It is noted that one of these seems to correspond well with the position of a surface water sewer. The other is indicated to outfall below the location of the proposed new bridge. She did not annotate Portal A on her plan but, when questioned, indicated that she was aware of it.
