Stockport Bus Station, Mersey Square, Stockport, SK1 1NU

STOCKPORT INTERCHANGE -
GROUND INVESTIGATION REPORT -
AECOM - 2016

Stockport Interchange - Ground Investigation Report

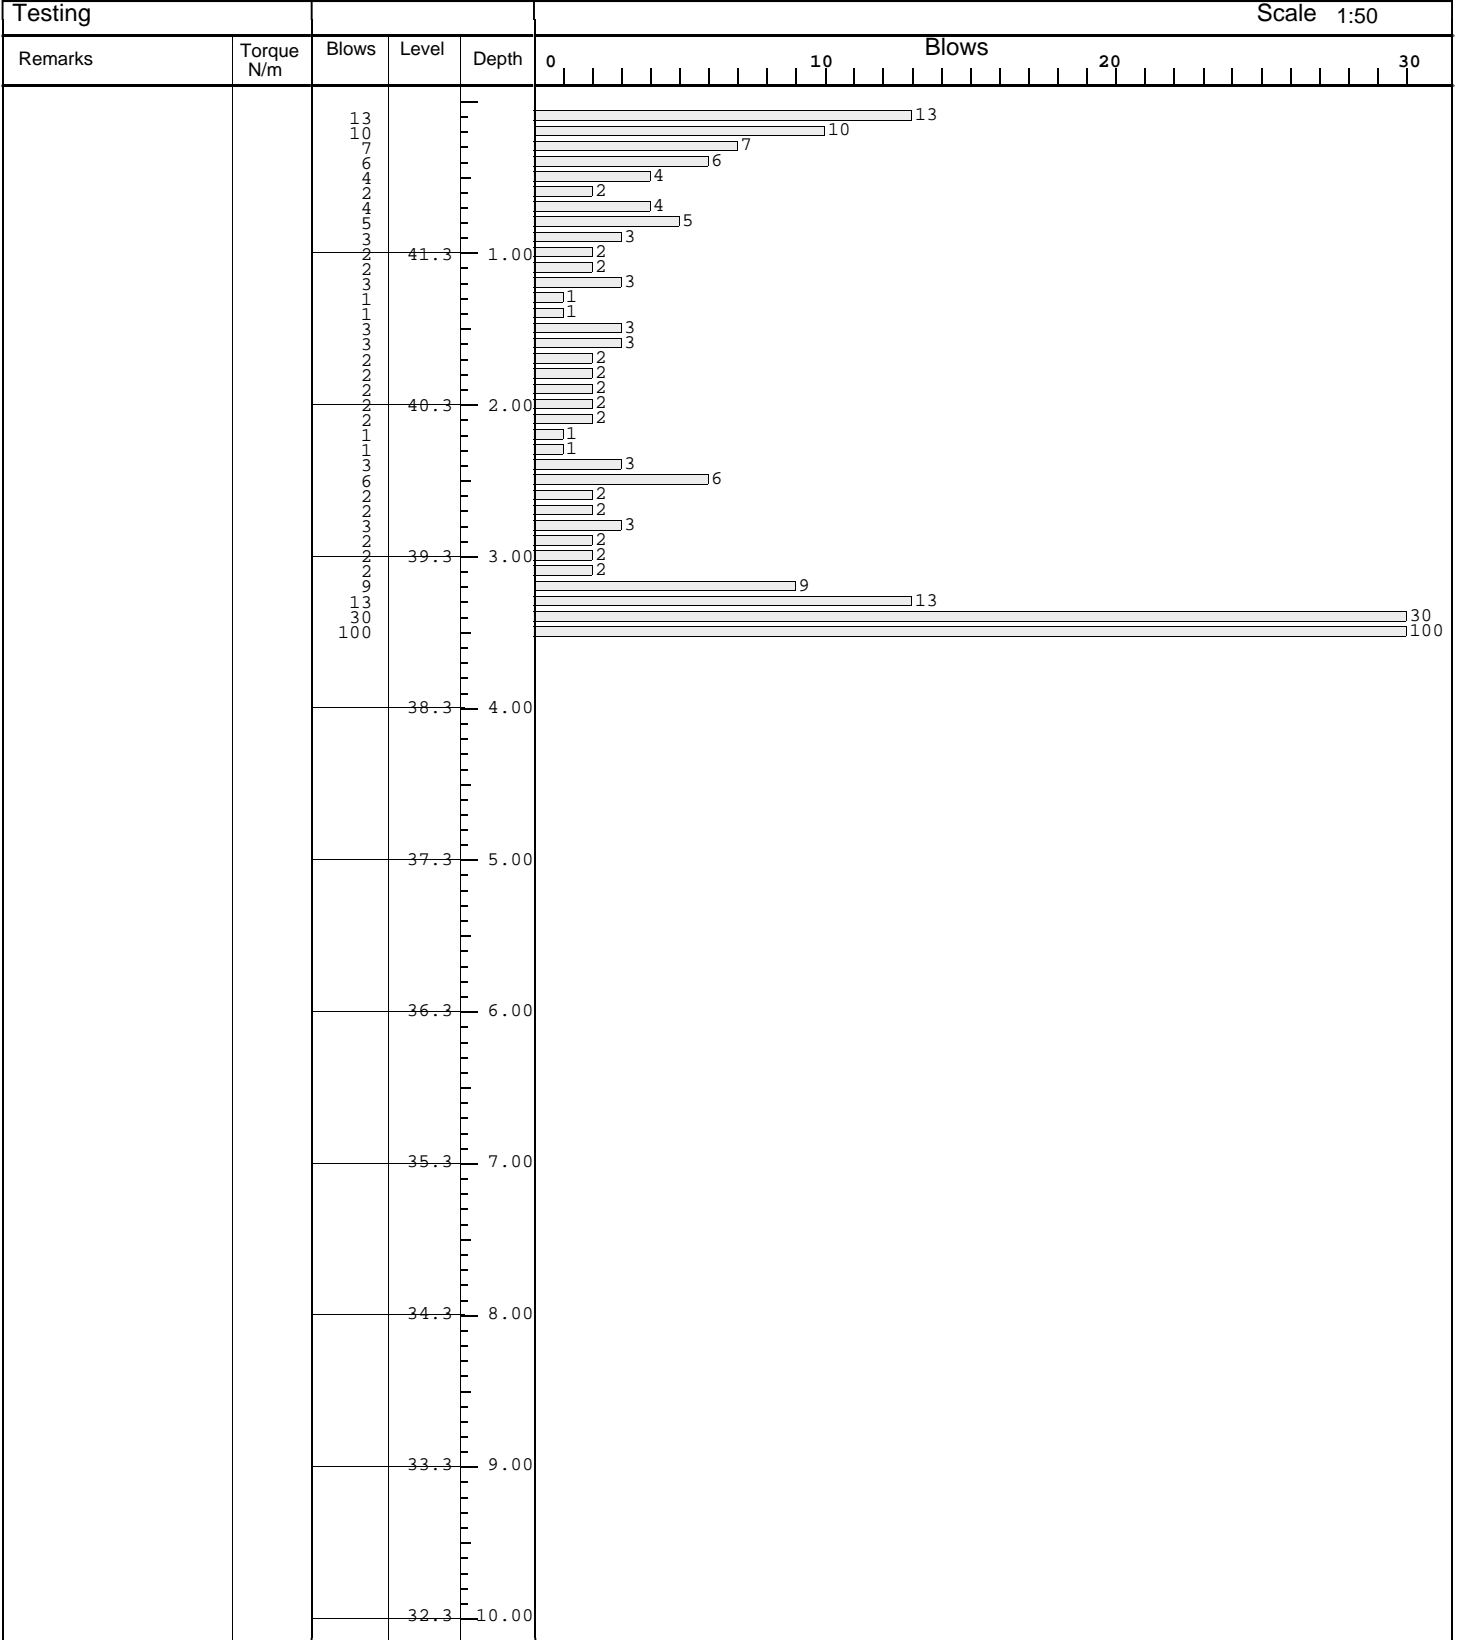
Project **STOCKPORT BUS STATION** Engineer **AECOM** Borehole **DP1**
 Client **TRANSPORT FOR GREATER MANCHESTER** National Grid Coordinates **389135.6 E**
390312.5 N Project No **PN153428** Ground Level **42.30 m OD**

Probing				Progress					Groundwater					
Depth	Dia	Technique	Crew	Depth of Hole	Depth Cased	Depth to Water	Date	Time	Depth Struck	Depth Cased	Rose to	in Mins	Depth Sealed	Remarks on Groundwater
3.45	0.05	Dynamic Probe	AT	G.I. 3.45		DRY	17/12/15	08:00						None encountered.

Remarks Probe equipment checked and test carried out in accordance with BS EN ISO 22476-2:2005.

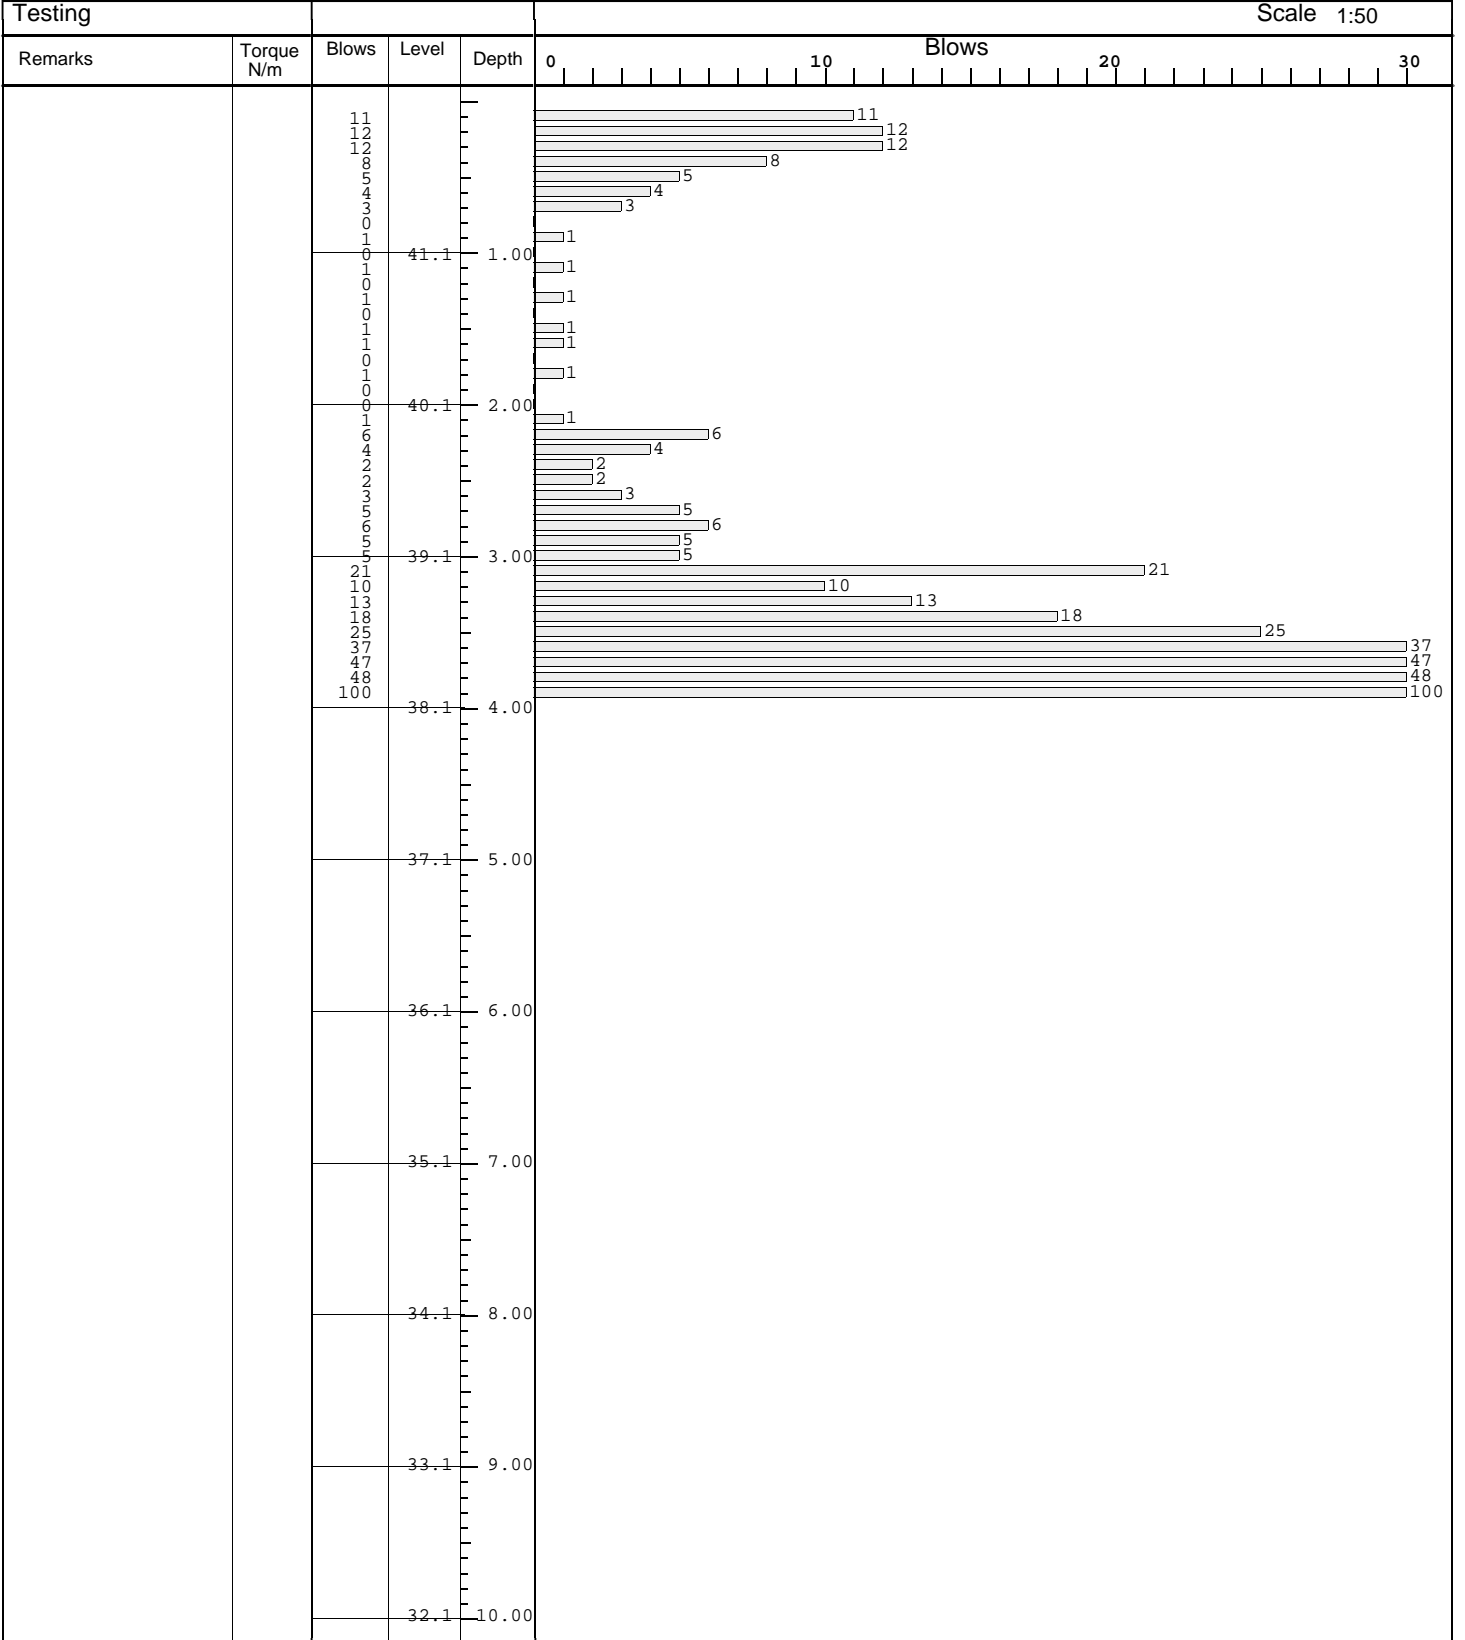
Project **STOCKPORT BUS STATION** Engineer **AECOM** Borehole **DP2**
 Client **TRANSPORT FOR GREATER MANCHESTER** National Grid Coordinates **389141.1 E**
390310.4 N Project No **PN153428** Ground Level **42.13 m OD**

Probing				Progress					Groundwater					
Depth	Dia	Technique	Crew	Depth of Hole	Depth Cased	Depth to Water	Date	Time	Depth Struck	Depth Cased	Rose to	in Mins	Depth Sealed	Remarks on Groundwater
3.87	0.05	Dynamic Probe	AT	G.I. 3.87		DRY	17/12/15	08:00						None encountered.

Remarks Probe equipment checked and test carried out in accordance with BS EN ISO 22476-2:2005.

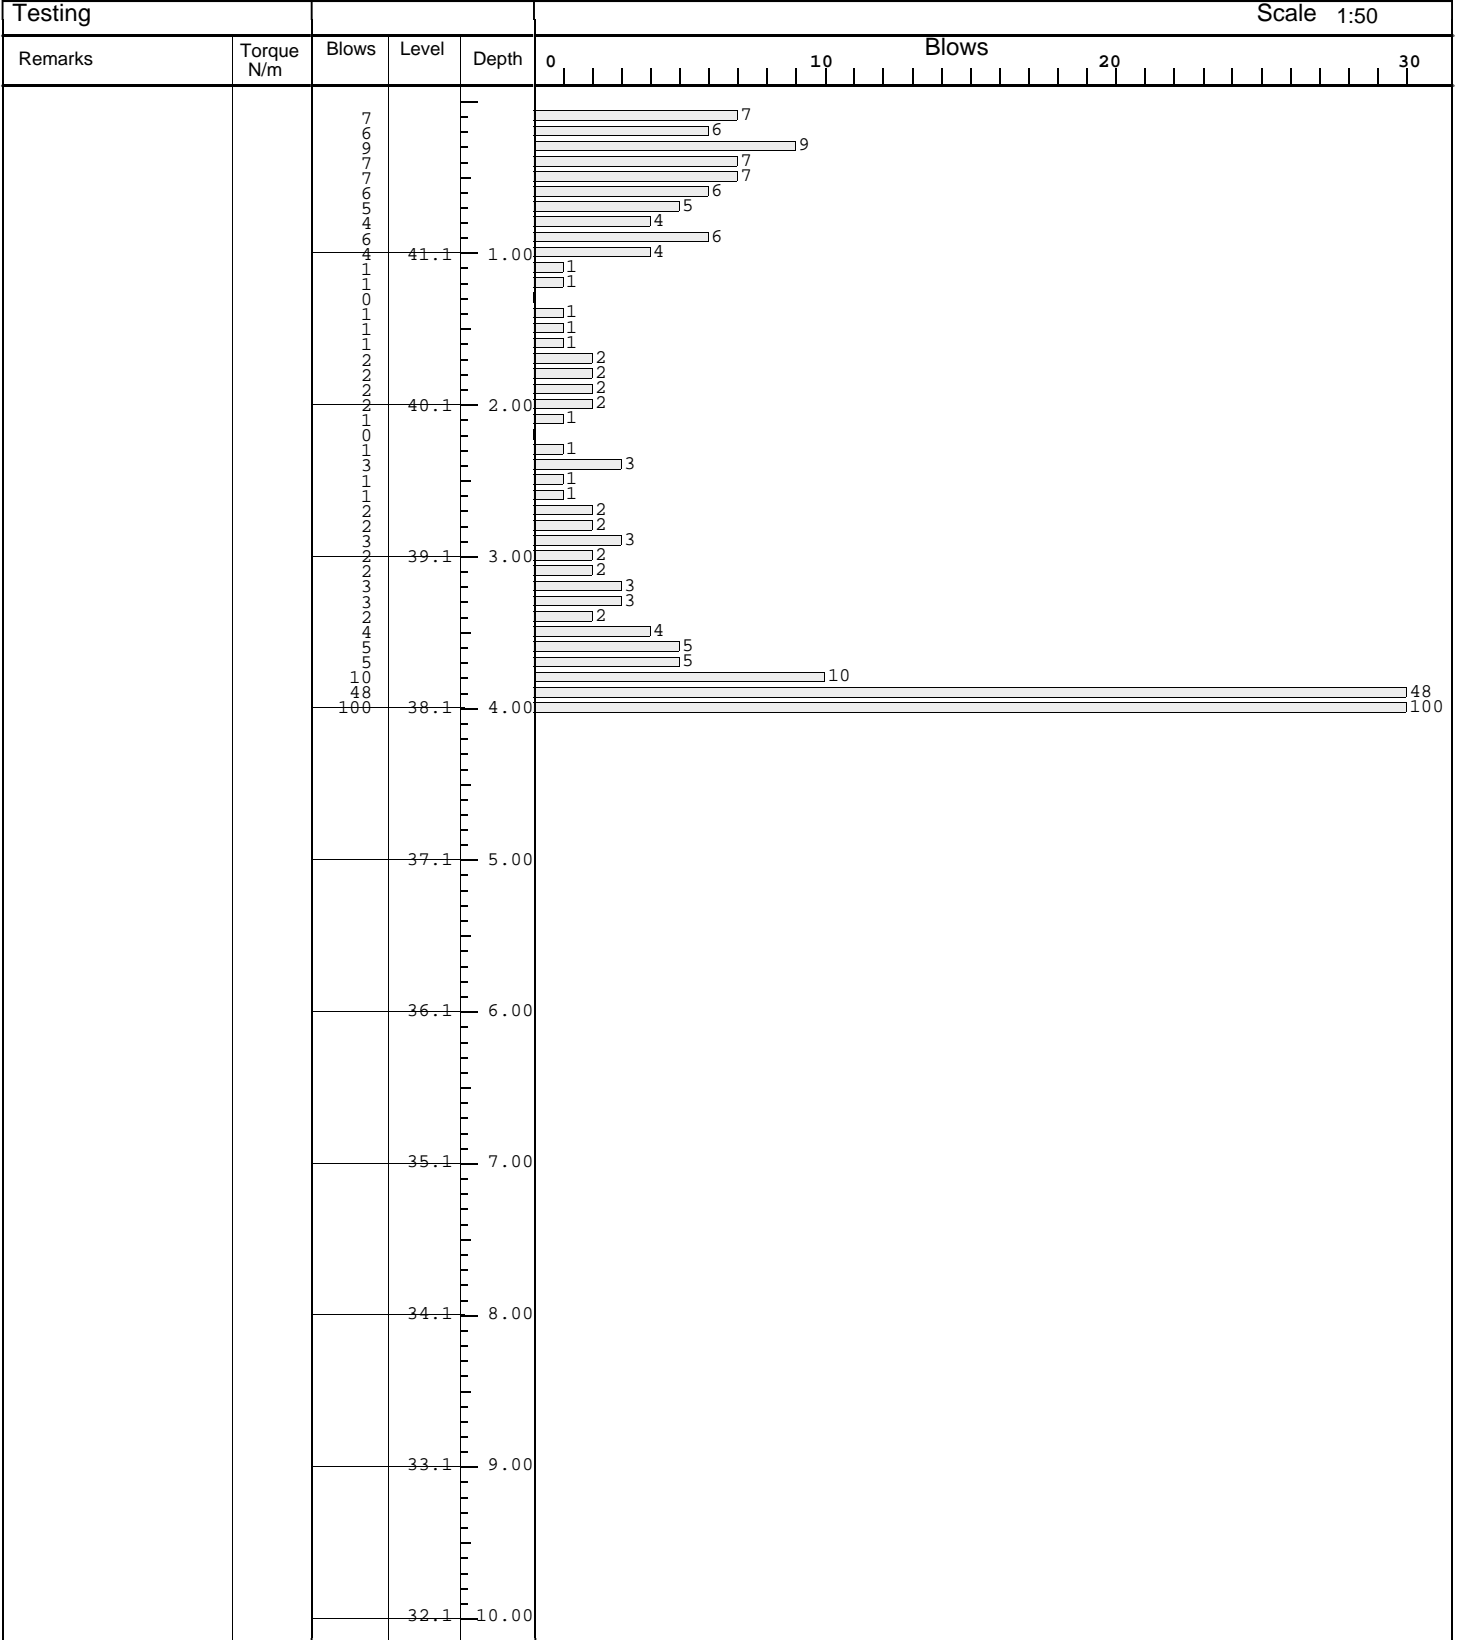
Project **STOCKPORT BUS STATION** Engineer **AECOM** Borehole **DP3**
 Client **TRANSPORT FOR GREATER MANCHESTER** National Grid Coordinates **389138.1 E** Project No **PN153428**
390305.6 N Ground Level **42.13 m OD**

Probing				Progress					Groundwater					
Depth	Dia	Technique	Crew	Depth of Hole	Depth Cased	Depth to Water	Date	Time	Depth Struck	Depth Cased	Rose to	in Mins	Depth Sealed	Remarks on Groundwater
3.95	0.05	Inspection Pit	AT	G.I. 3.95		DRY	17/12/15 17/12/15	08:00 18:00						None encountered.

Remarks Probe equipment checked and test carried out in accordance with BS EN ISO 22476-2:2005.

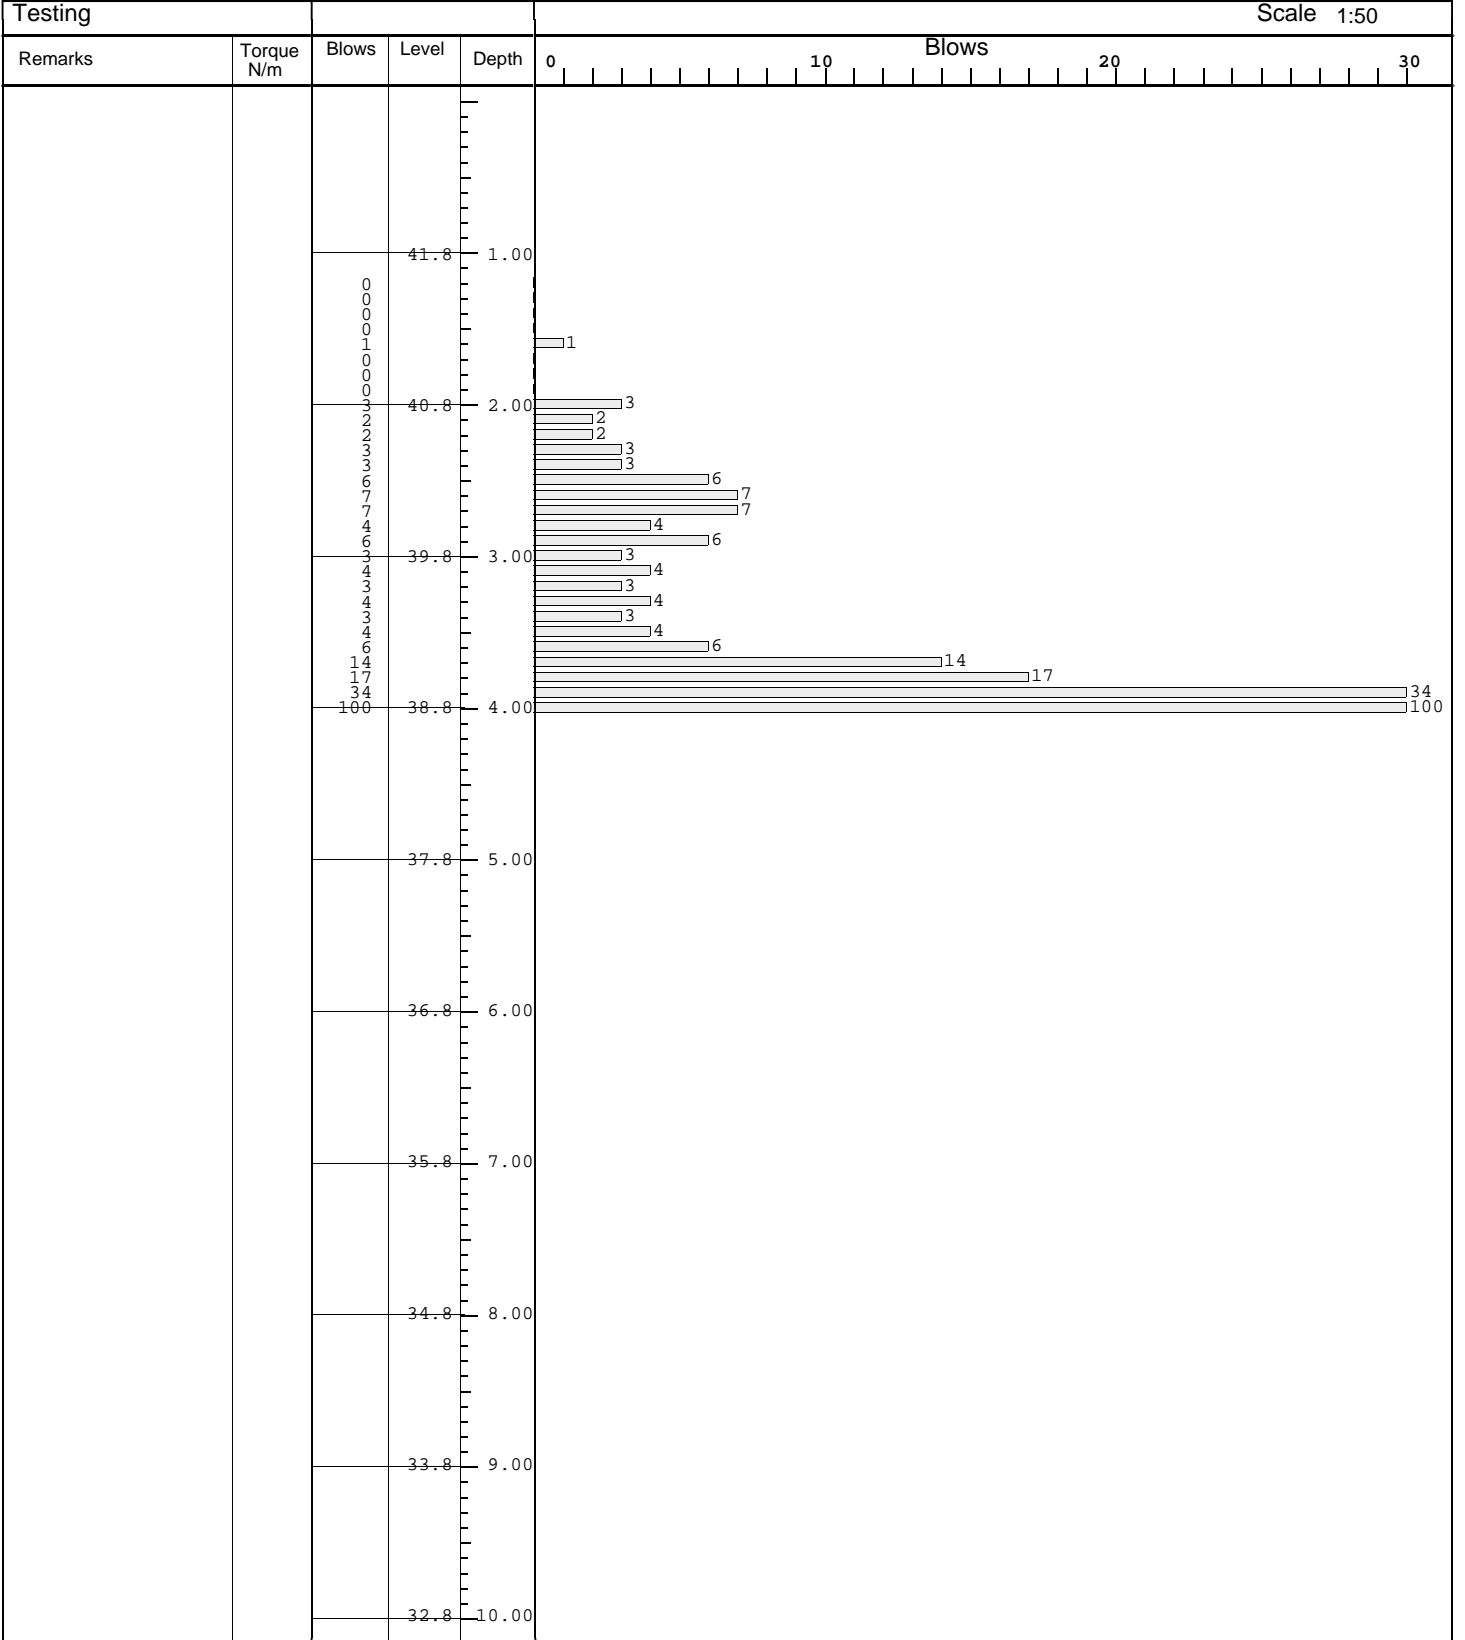
Project **STOCKPORT BUS STATION** Engineer **AECOM** Borehole **DP8**
 Client **TRANSPORT FOR GREATER MANCHESTER** National Grid Coordinates **389152.9 E**
390260.0 N Project No **PN153428** Ground Level **42.85 m OD**

Probing				Progress					Groundwater					
Depth	Dia	Technique	Crew	Depth of Hole	Depth Cased	Depth to Water	Date	Time	Depth Struck	Depth Cased	Rose to	in Mins	Depth Sealed	Remarks on Groundwater
1.20	0.40	Inspection Pit	AT	G.L.			16/12/15	08:00						None encountered.
4.07	0.05	Dynamic Probe	AT	4.07		DRY	16/12/15	18:00

Remarks Probe equipment checked and test carried out in accordance with BS EN ISO 22476-2:2005.

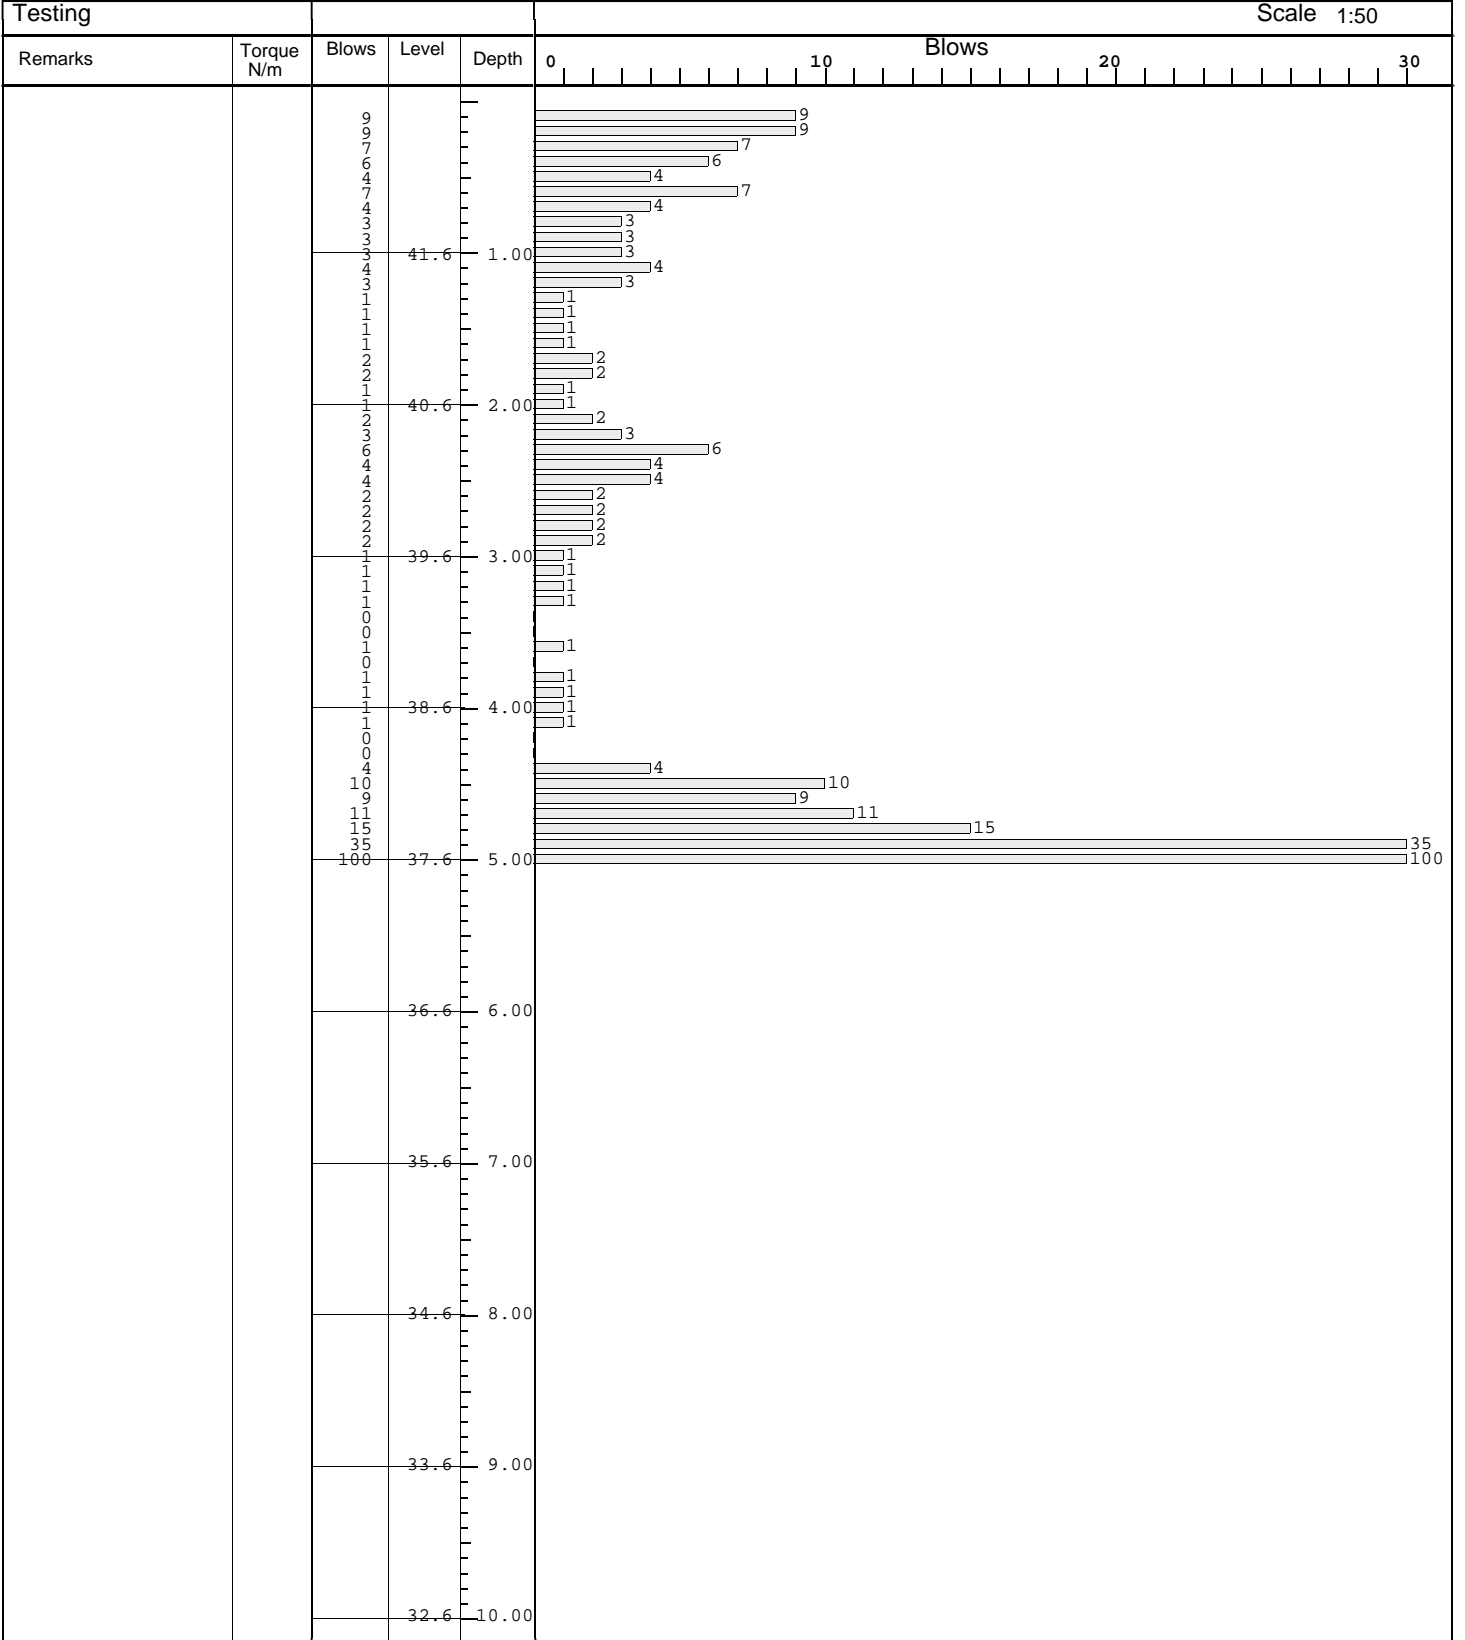
Project **STOCKPORT BUS STATION** Engineer **AECOM** Borehole **DP10**
 Client **TRANSPORT FOR GREATER MANCHESTER** National Grid Coordinates **389164.1 E**
390266.9 N Project No **PN153428** Ground Level **42.65 m OD**

Probing				Progress					Groundwater					
Depth	Dia	Technique	Crew	Depth of Hole	Depth Cased	Depth to Water	Date	Time	Depth Struck	Depth Cased	Rose to	in Mins	Depth Sealed	Remarks on Groundwater
4.98	0.05	Dynamic Probe	AT	G.L. 5.98		DRY	16/12/15 16/12/15	08:00 18:00						None encountered.

Remarks Probe equipment checked and test carried out in accordance with BS EN ISO 22476-2:2005.

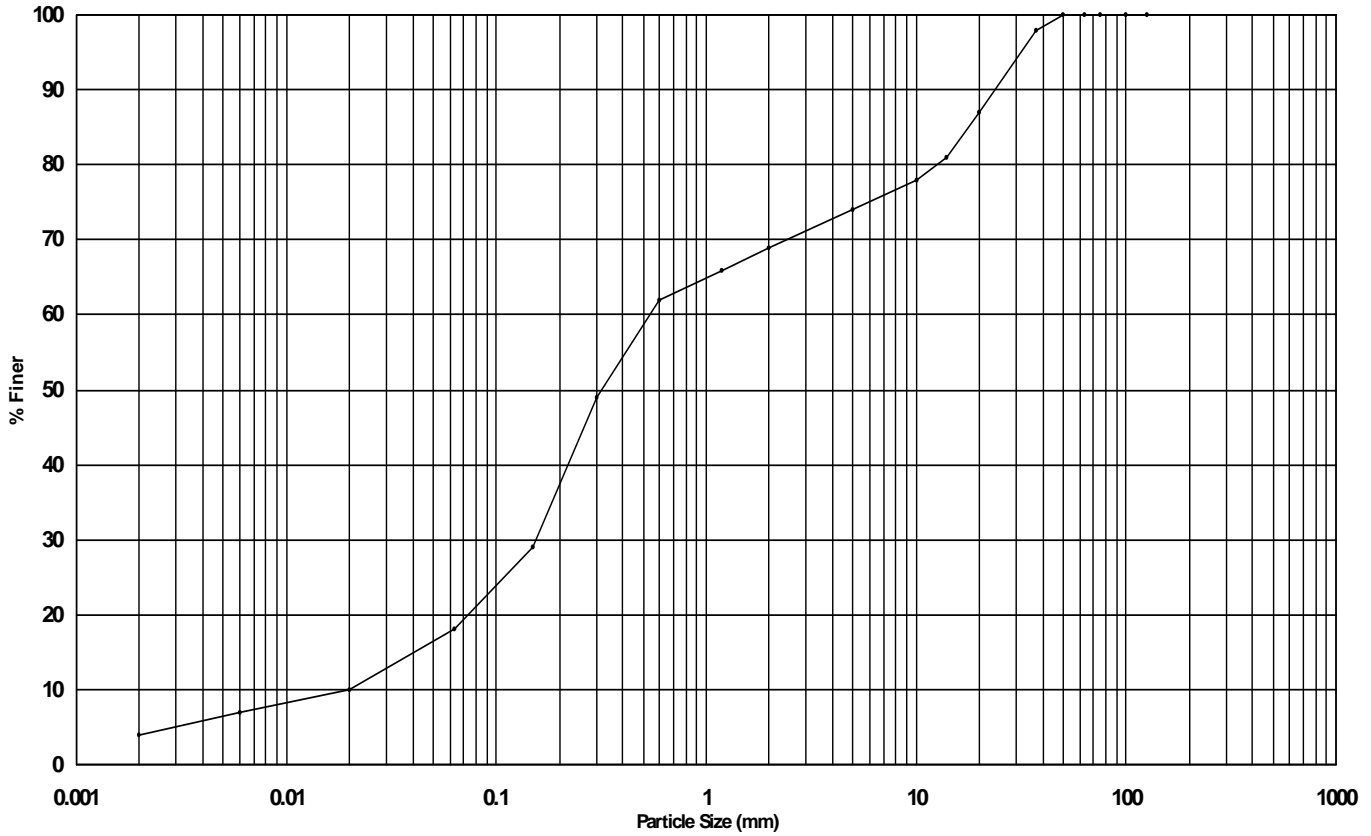
Yellowish brown clayey very gravelly fine to coarse SAND.

Classification	% of each
CLAY	4
SILT	14
SAND	51
GRAVEL	31
COBBLES	0
BOULDERS	0
