STOCKPORT INTERCHANGE - SUPPLEMENTARY GROUND INVESTIGATION

Factual Report

for
Willmott Dixon Construction
Limited

Project Number PN204140

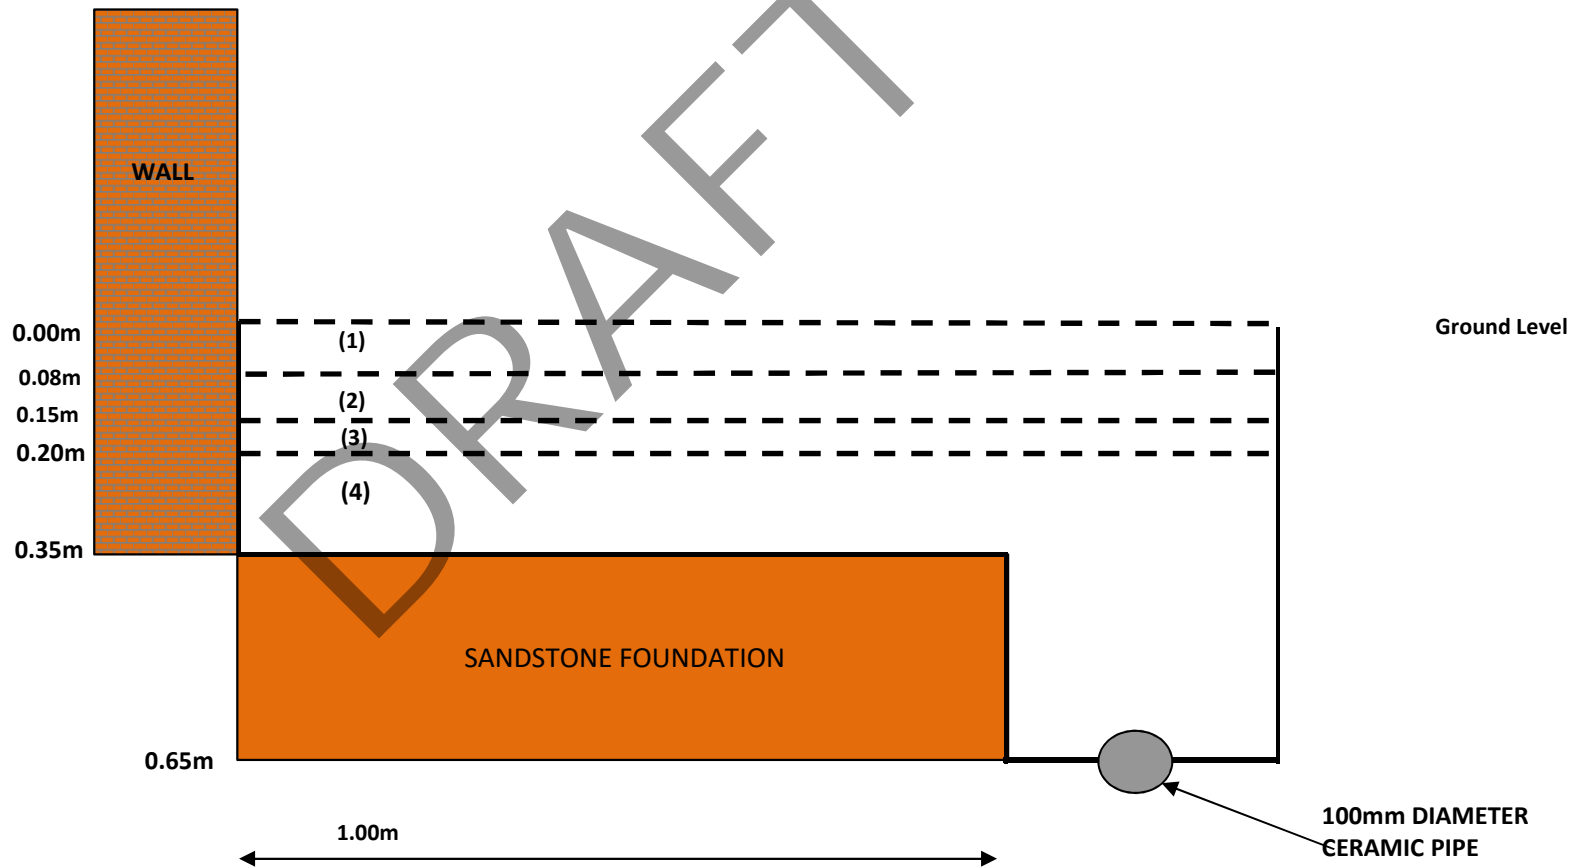
Inspection pit hand excavated to 0.60m depth.
 Sandstone foundation outstand noted at 0.35m depth, extending 1.00m from base of wall.
 The Inspection pit was terminated at 0.65m depth on encountering a 100mm diameter ceramic pipe at 0.60m depth.

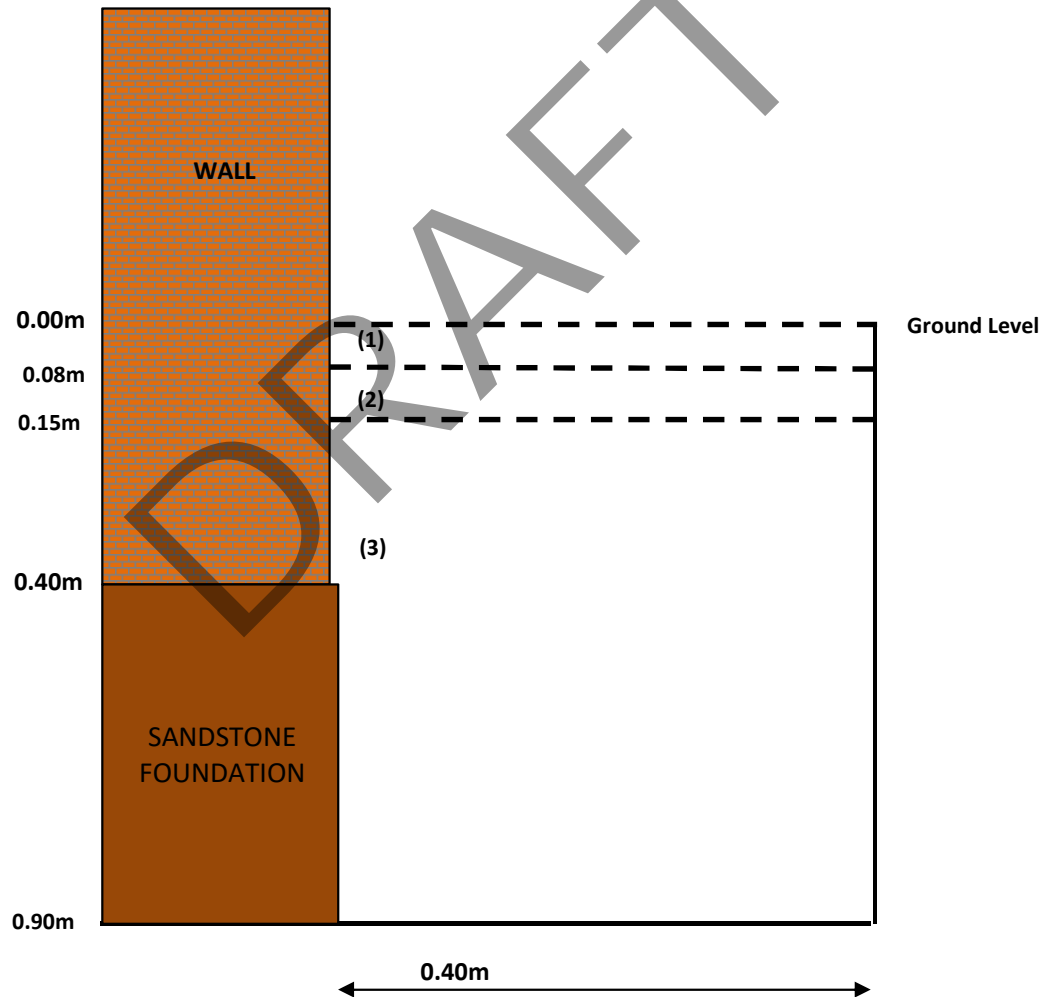
Sandstone foundation outstand noted between 0.40-0.90m depth with no outstand.

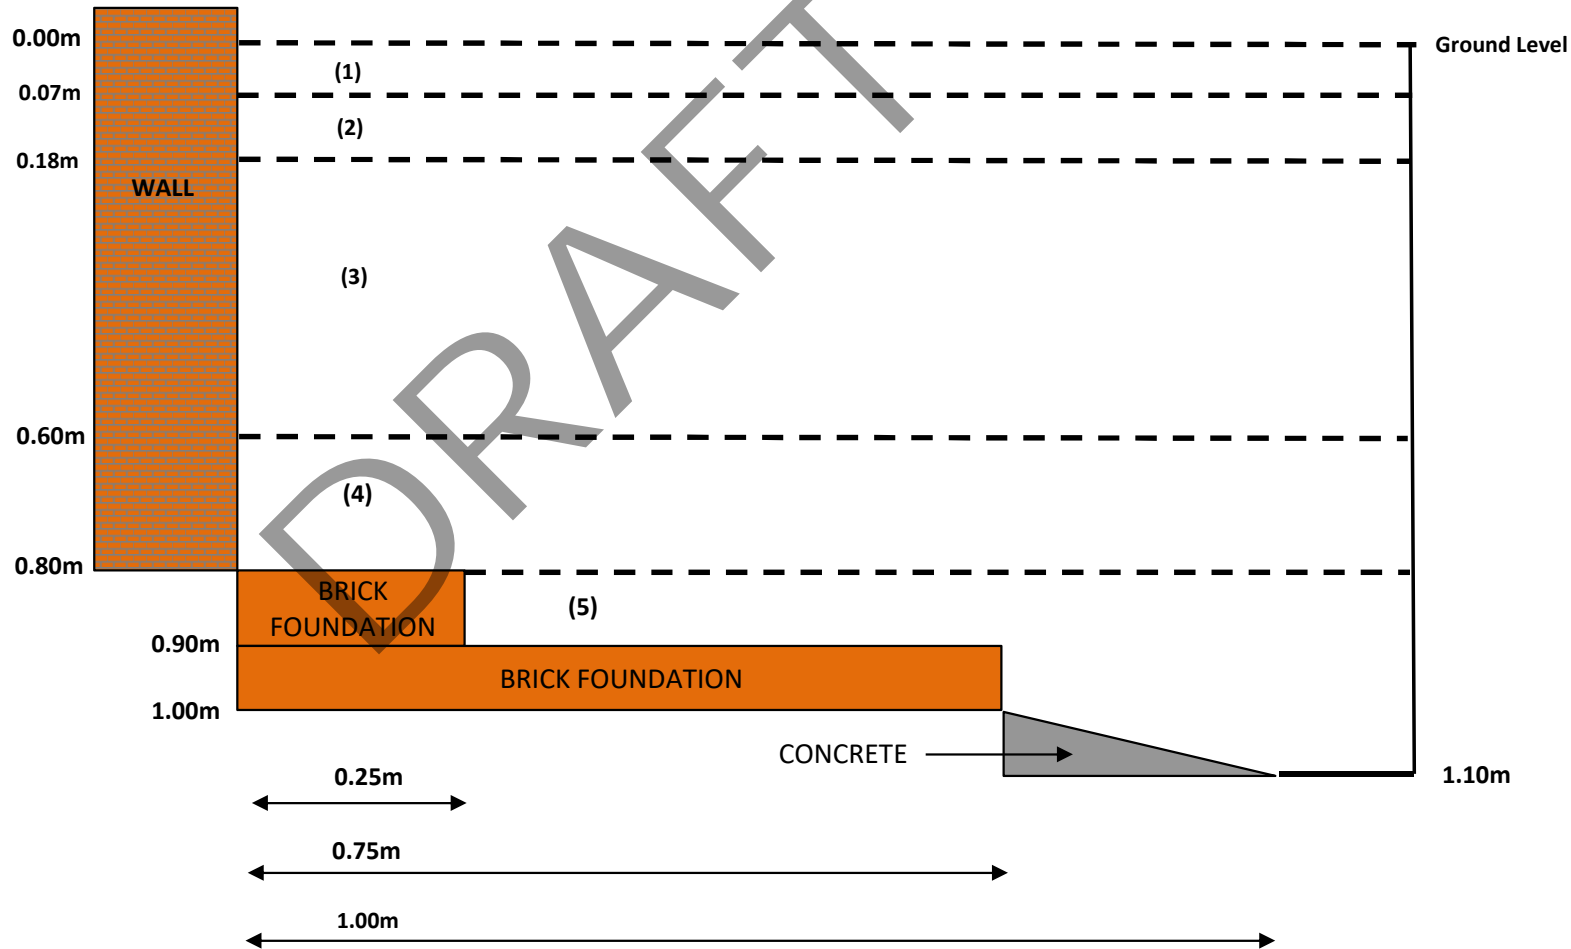
Inspection pit hand excavated to 1.10m depth.
 Brick foundation outstand noted at 0.80m depth, stepping down to 0.90m depth, extending 0.75m from base of wall. Sloping rough concrete noted beyond brick foundation between 1.00-1.10m depth, extending 1.00m from base of wall.

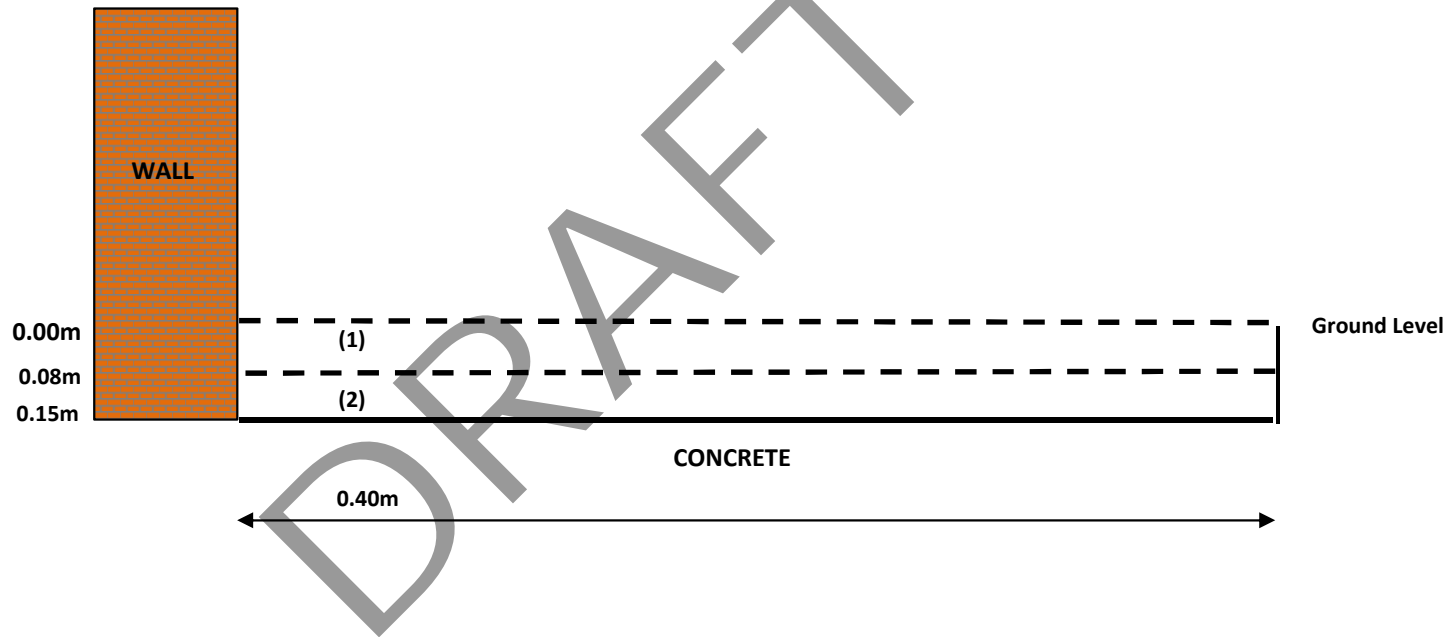
Inspection pit hand excavated to 0.15m depth and no services were found.

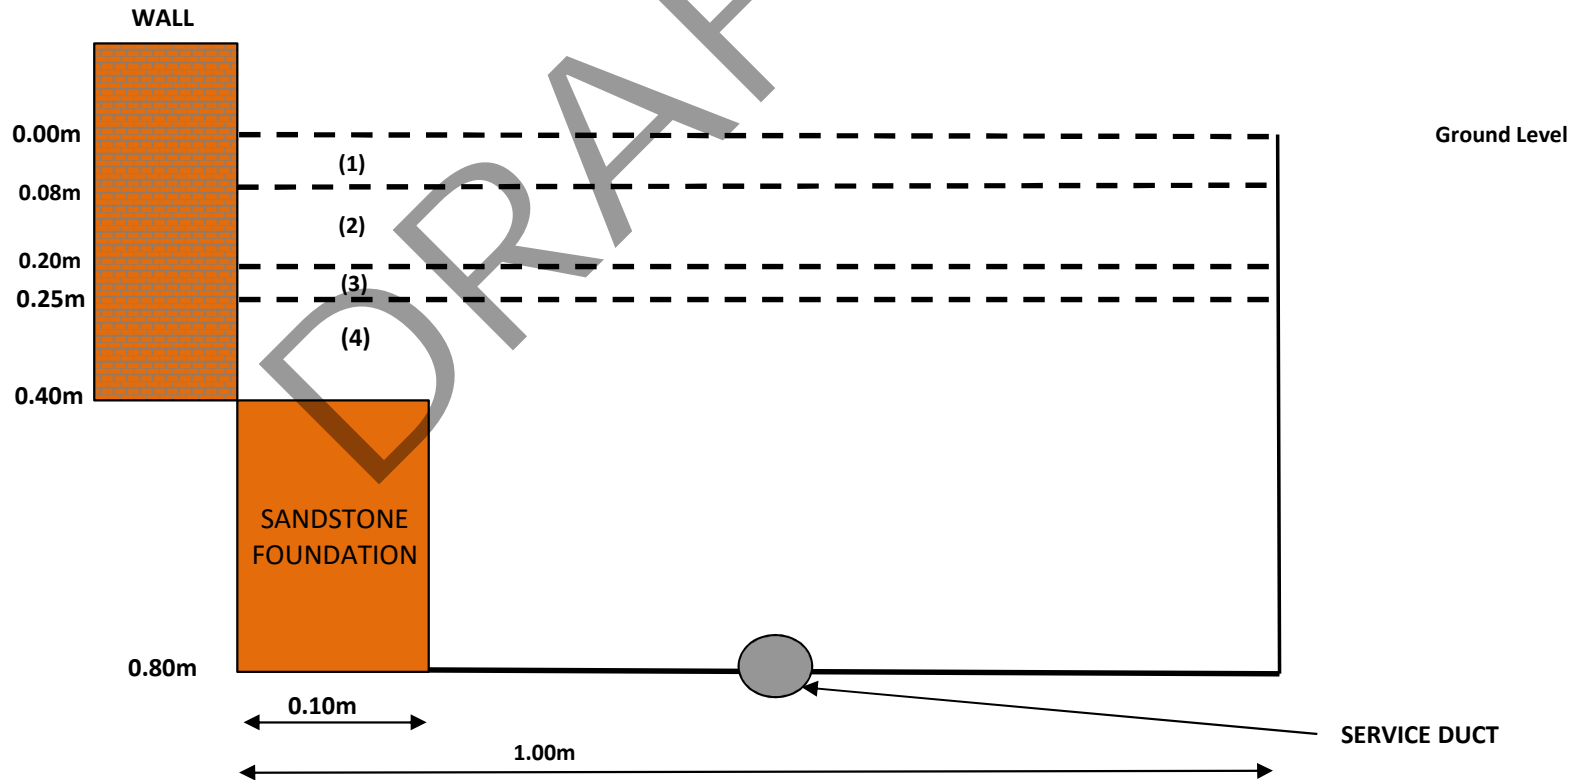
Inspection pit hand excavated to 0.80m depth.
 Sandstone foundation outstand noted at 0.40m depth, extending 0.10m from base of wall.
 The Inspection pit was terminated at 0.80m depth on encountering a service duct.

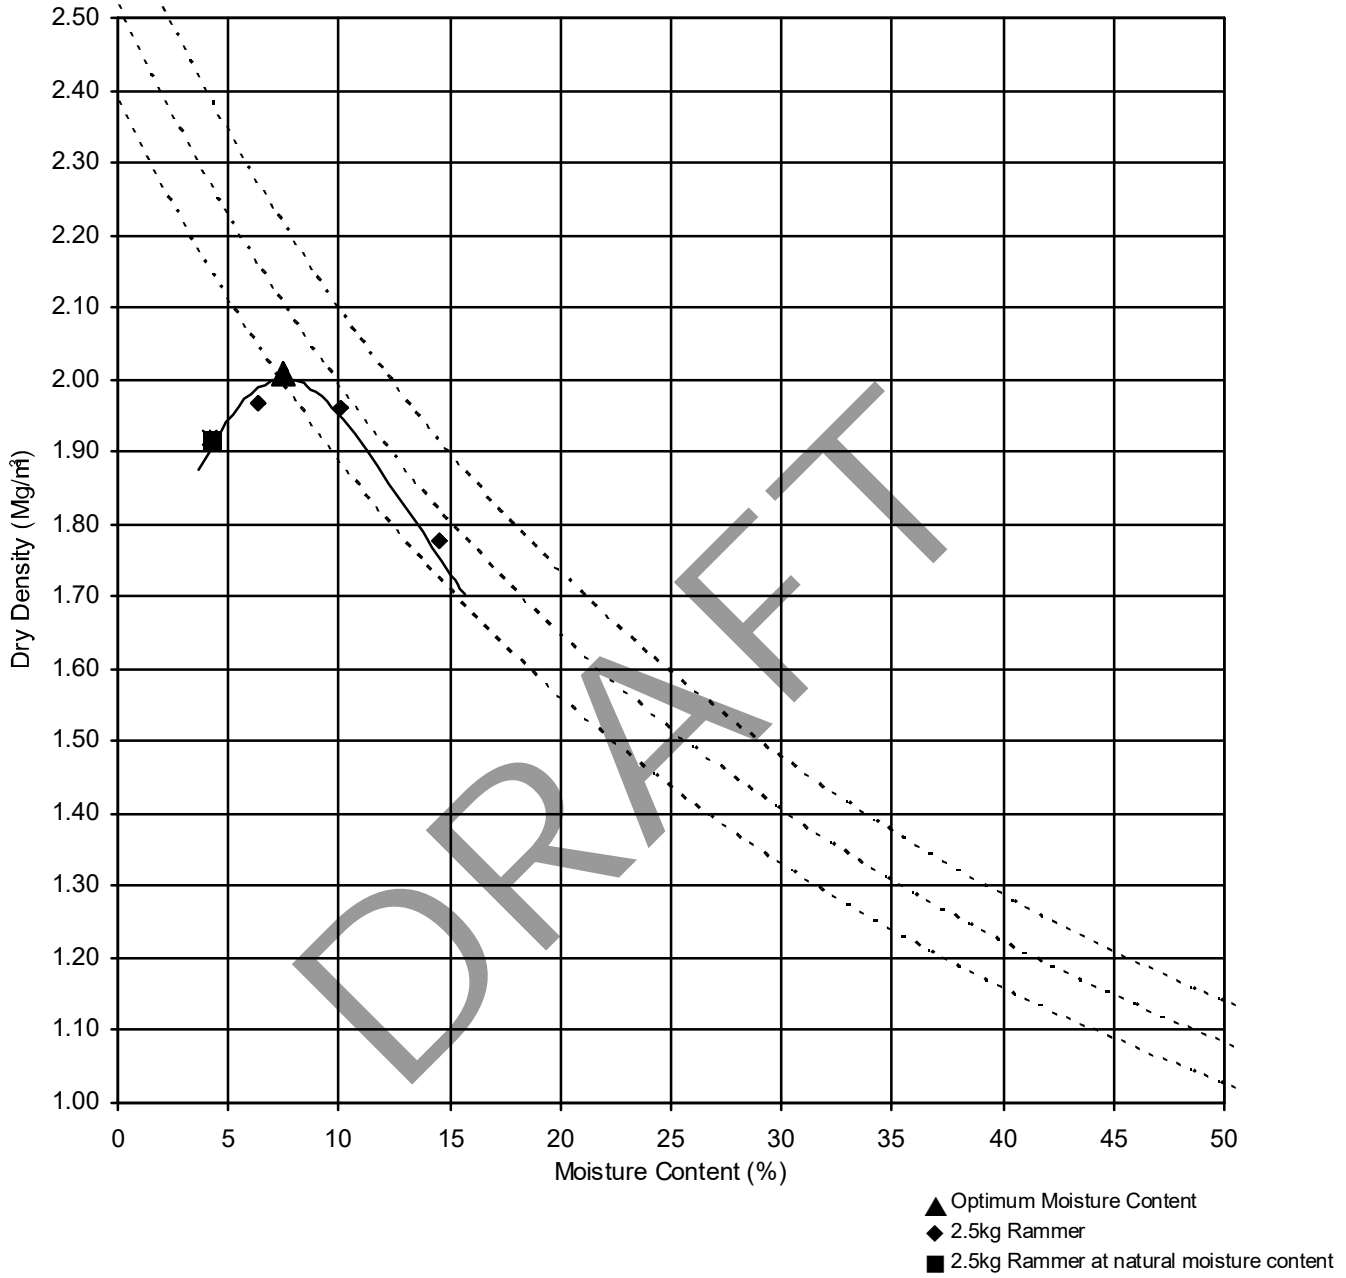
Optimum Moisture Content 7.5
Maximum Dry Density 2.01 Mg/m³

Particles retained on 37.5mm sieve 3 %
 20mm sieve 16 %

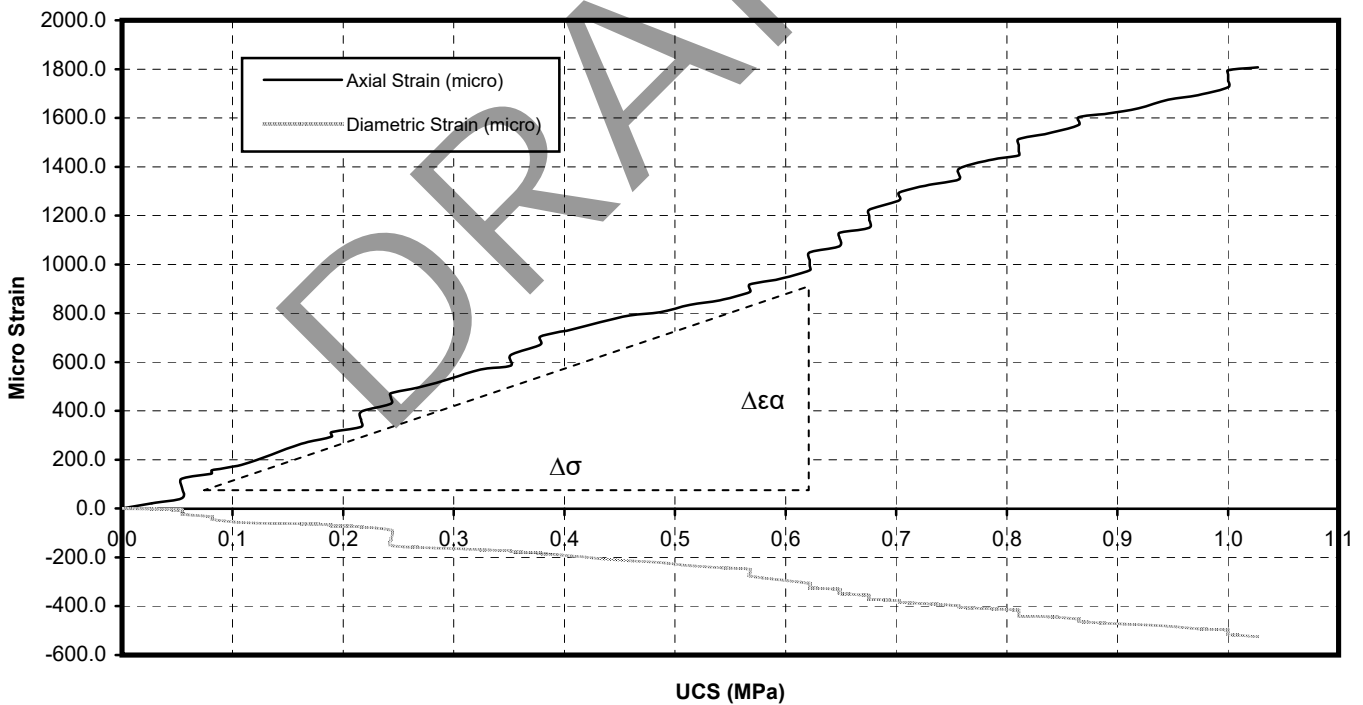
Method of Young's modulus determination - Average Modulus of Linear Portion of Axial Stress-Strain Curve
 Method of Poisson's ratio determination - slope of axial curve / slope of lateral curve
 Young's modulus and poisson's ratio calculated between stress levels of 0.1MPa and 0.6MPa
 Test specimen does not meet specified length / diameter ratio requirements

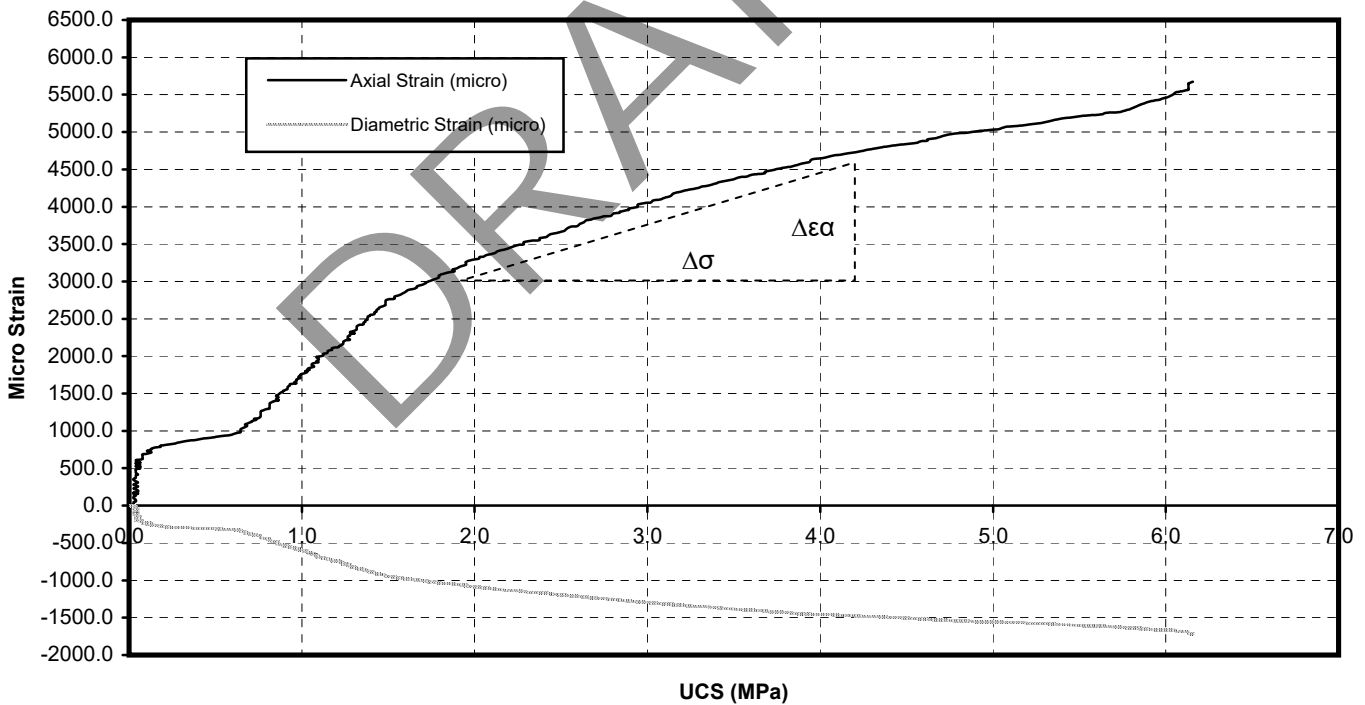
Method of Young's modulus determination - Average Modulus of Linear Portion of Axial Stress-Strain Curve
 Method of Poisson's ratio determination - slope of axial curve / slope of lateral curve
 Young's modulus and poisson's ratio calculated between stress levels of 1.8MPa and 4.2MPa
 Test specimen does not meet specified length / diameter ratio requirements

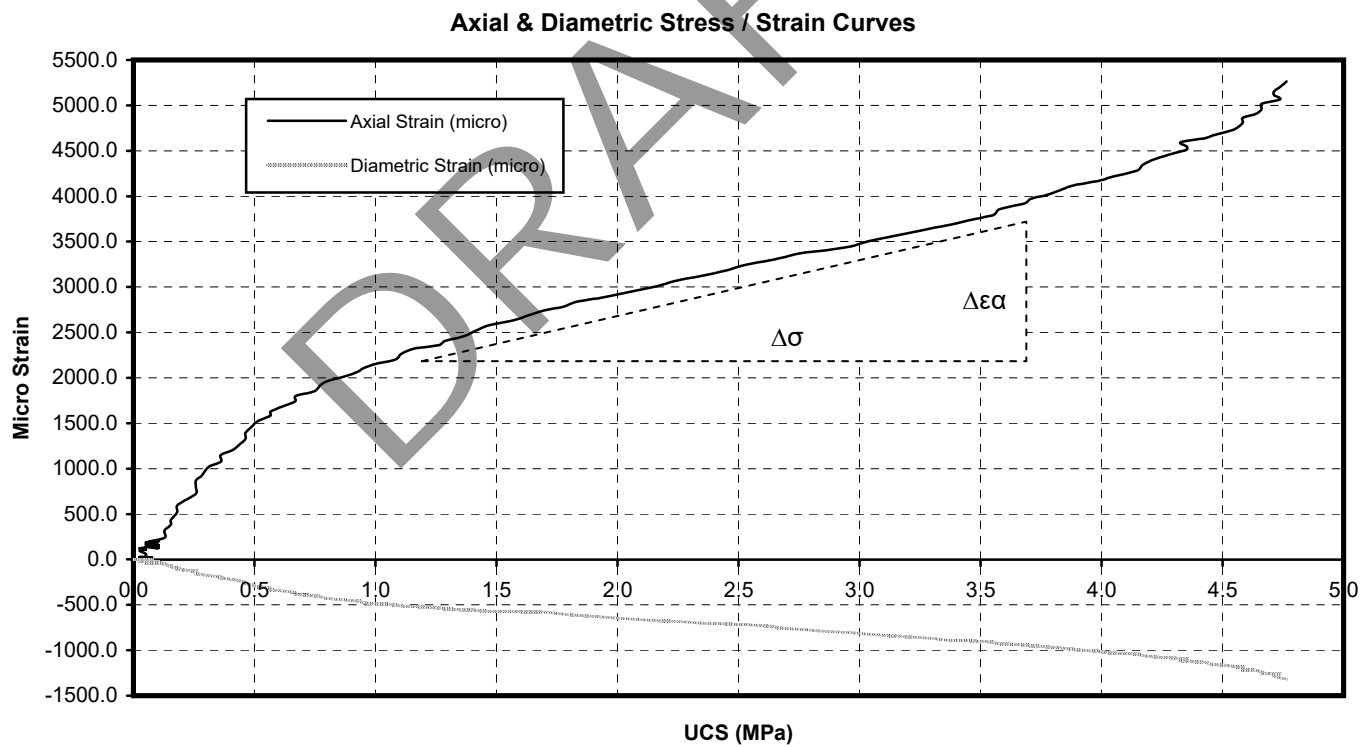
Method of Young's modulus determination - Average Modulus of Linear Portion of Axial Stress-Strain Curve
 Method of Poisson's ratio determination - slope of axial curve / slope of lateral curve
 Young's modulus and poisson's ratio calculated between stress levels of 1.1MPa and 3.7MPa
 Test specimen does not meet specified length / diameter ratio requirements

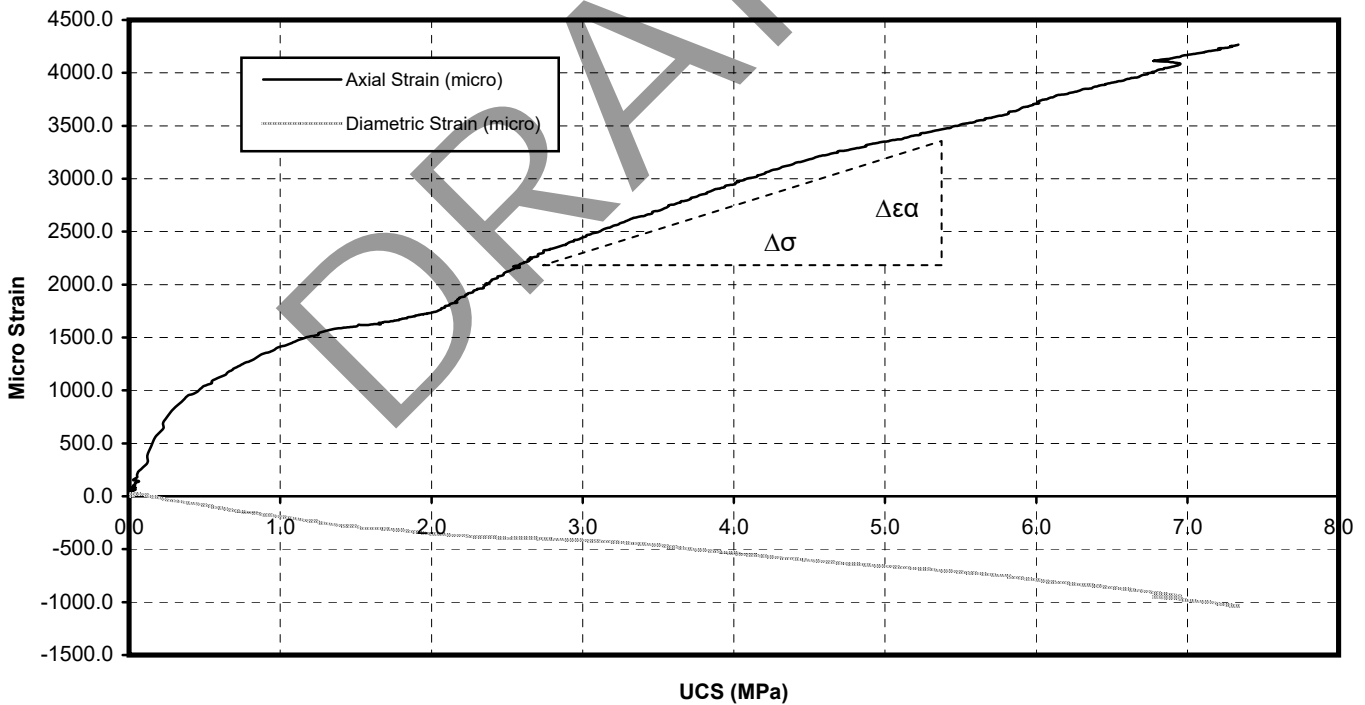
Method of Young's modulus determination - Average Modulus of Linear Portion of Axial Stress-Strain Curve
 Method of Poisson's ratio determination - slope of axial curve / slope of lateral curve
 Young's modulus and poisson's ratio calculated between stress levels of 2.7MPa and 5.4MPa
 Test specimen does not meet specified length / diameter ratio requirements
