STOCKPORT INTERCHANGE, BUS INTERCHANGE

Phase II Geo-Environmental Site Investigation
Report

PROJECT NO. 70031899/11568

DATE: MARCH 2020

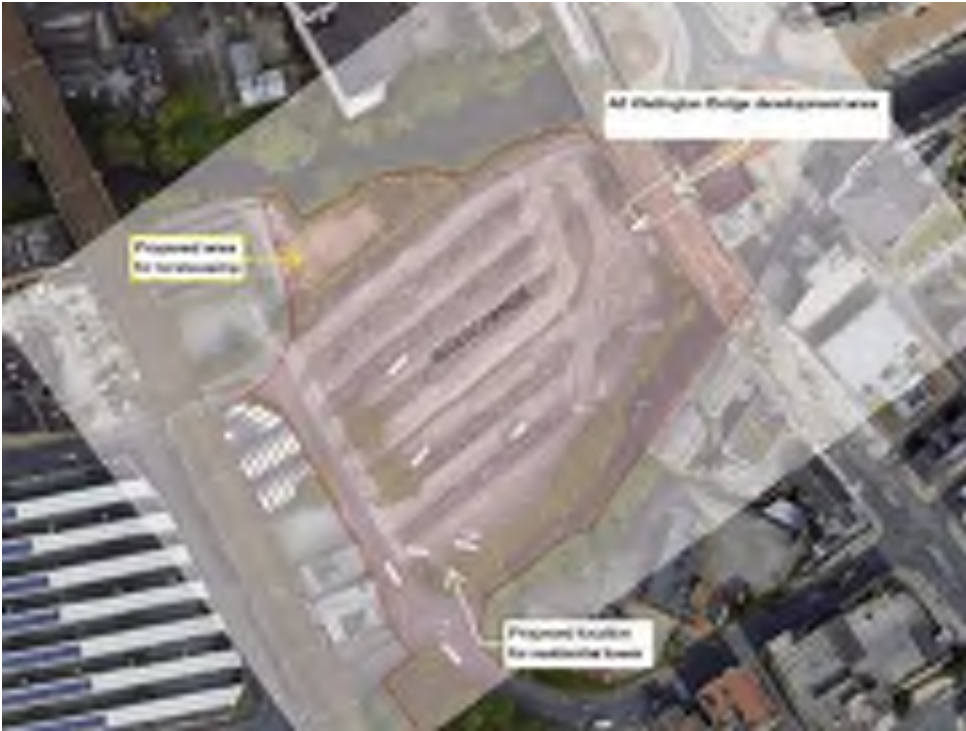
Detail	Comment
Name and Address	Land off Swaine Street, Stockport, SK3 0EH (closest postcode).
Site Description and Current Use	<p>The Stockport Interchange site comprises a bus terminal, two surface car parks and associated infrastructure, including the Stockport Viaduct located adjacent to the west. The proposed landscaped area is an undeveloped parcel of land located within the north of the wider Interchange site, as indicated by the yellow dashed polygon in the extract below. The A6 Wellington Bridge is present in the east which trends in a north – south trajectory over the bus terminal. The current layout is shown in Figure 2, an extract of which is presented below.</p> <p>Extract 1 – Layout</p>

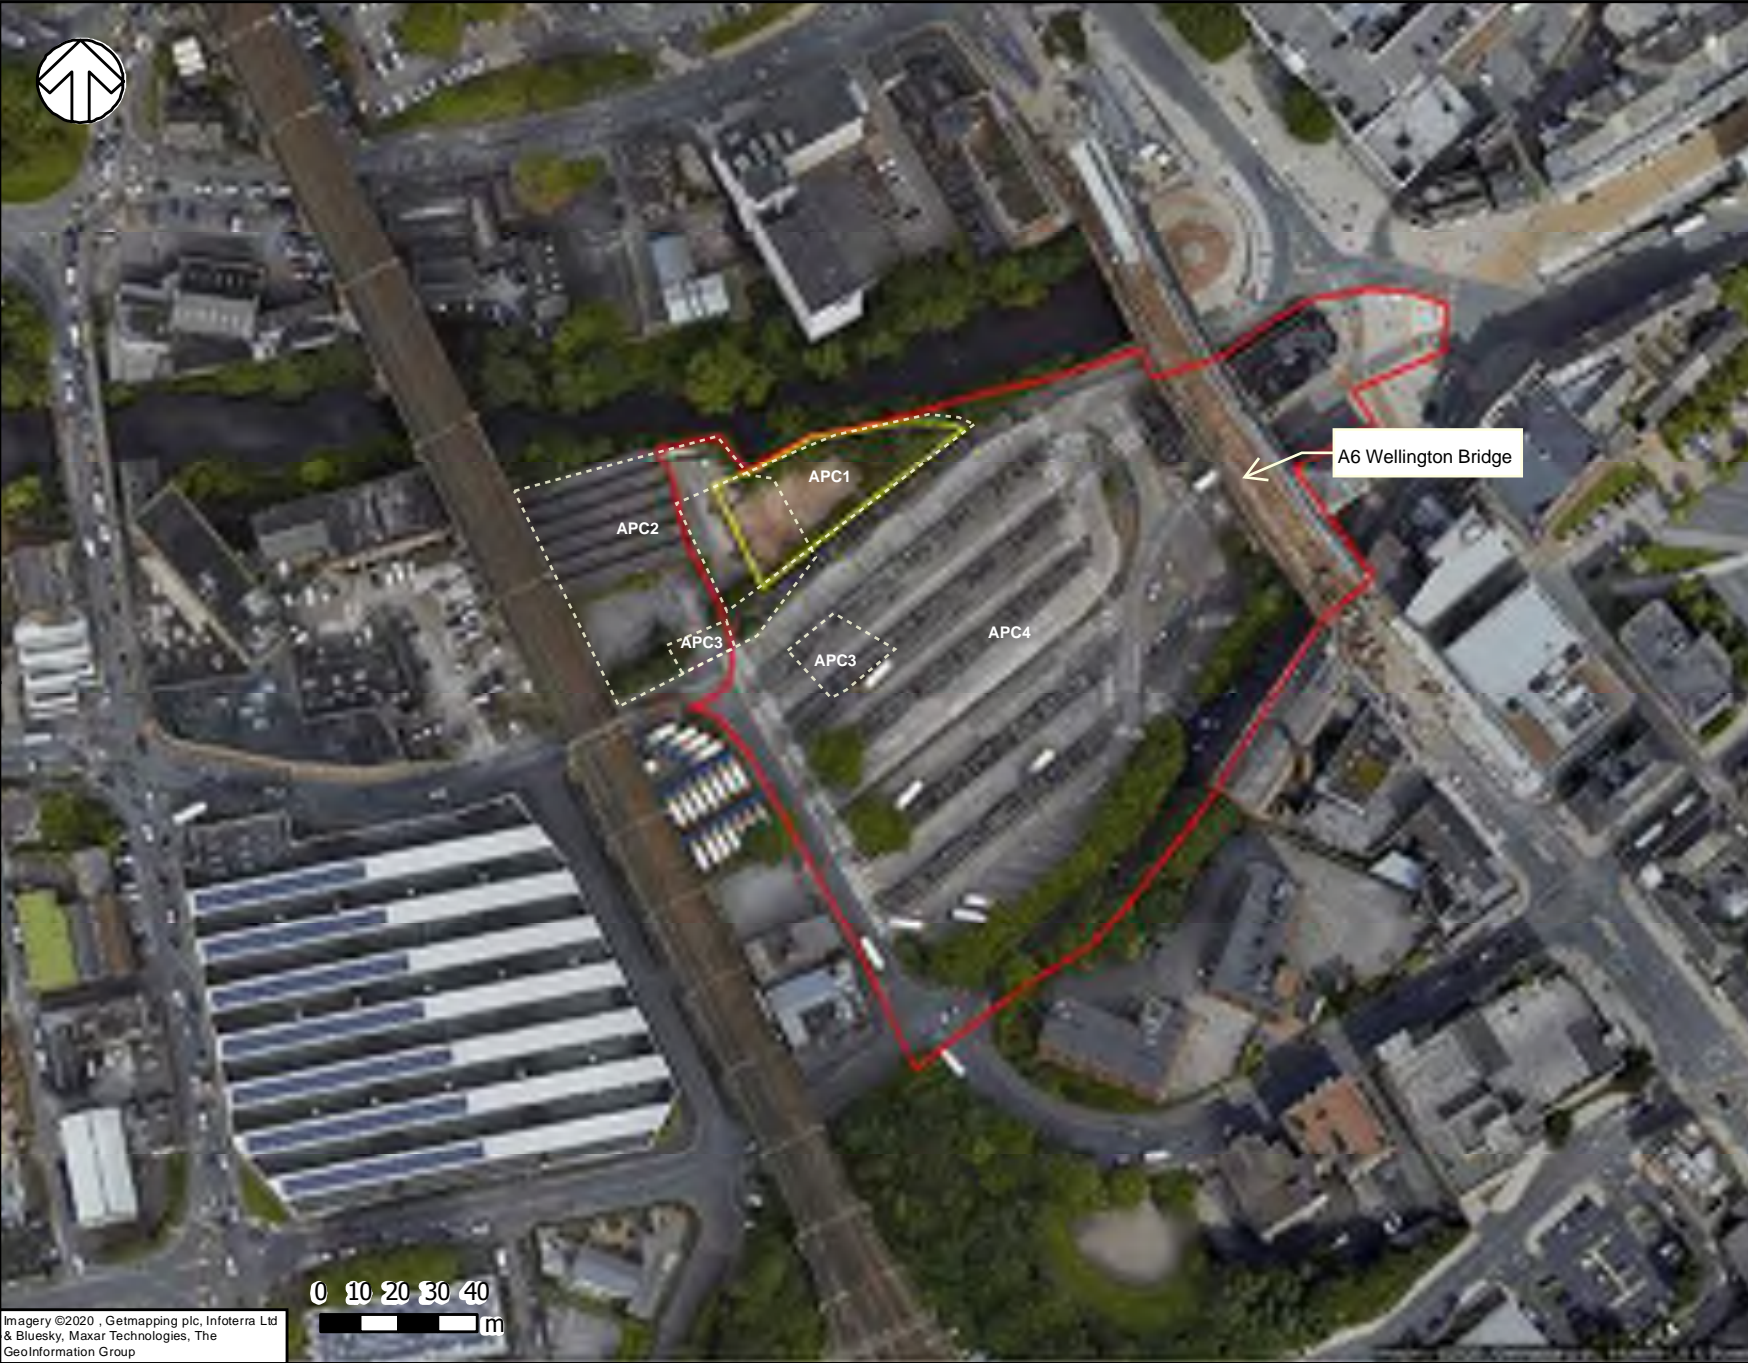
FIGURE No:
Figure 3 - Areas of Potential Concern

- Approximate Stockport Interchange Site Boundary
- Proposed Landscaped Area

Area of Potential Concern / Area	APC	Exploratory Hole Location	Rationale
Former industrial use (including print works and chemical works)	APC1, APC2	WS301 - WS304	To assess potential impacts to soil and groundwater conditions in area formerly used for industry.
Former surrounding industrial use	APC3	WS303	To identify potential contamination migrating from historical offsite sources.
Current operational bus terminal	APC4	-	No additional exploratory hole location was deemed necessary given potential impacts associated with this APC have been addressed in the previous site investigation (AECOM, 2016).
A6 Wellington Bridge	-	TP301 – TP304	To assess likely suitability of the excavated soils for storage and re-use and obtain sufficient geotechnical site data to assess geotechnical risk of the development.
Proposed residential area in the south	-	BH301 – BH302	To obtain deep geotechnical information to support pile design.

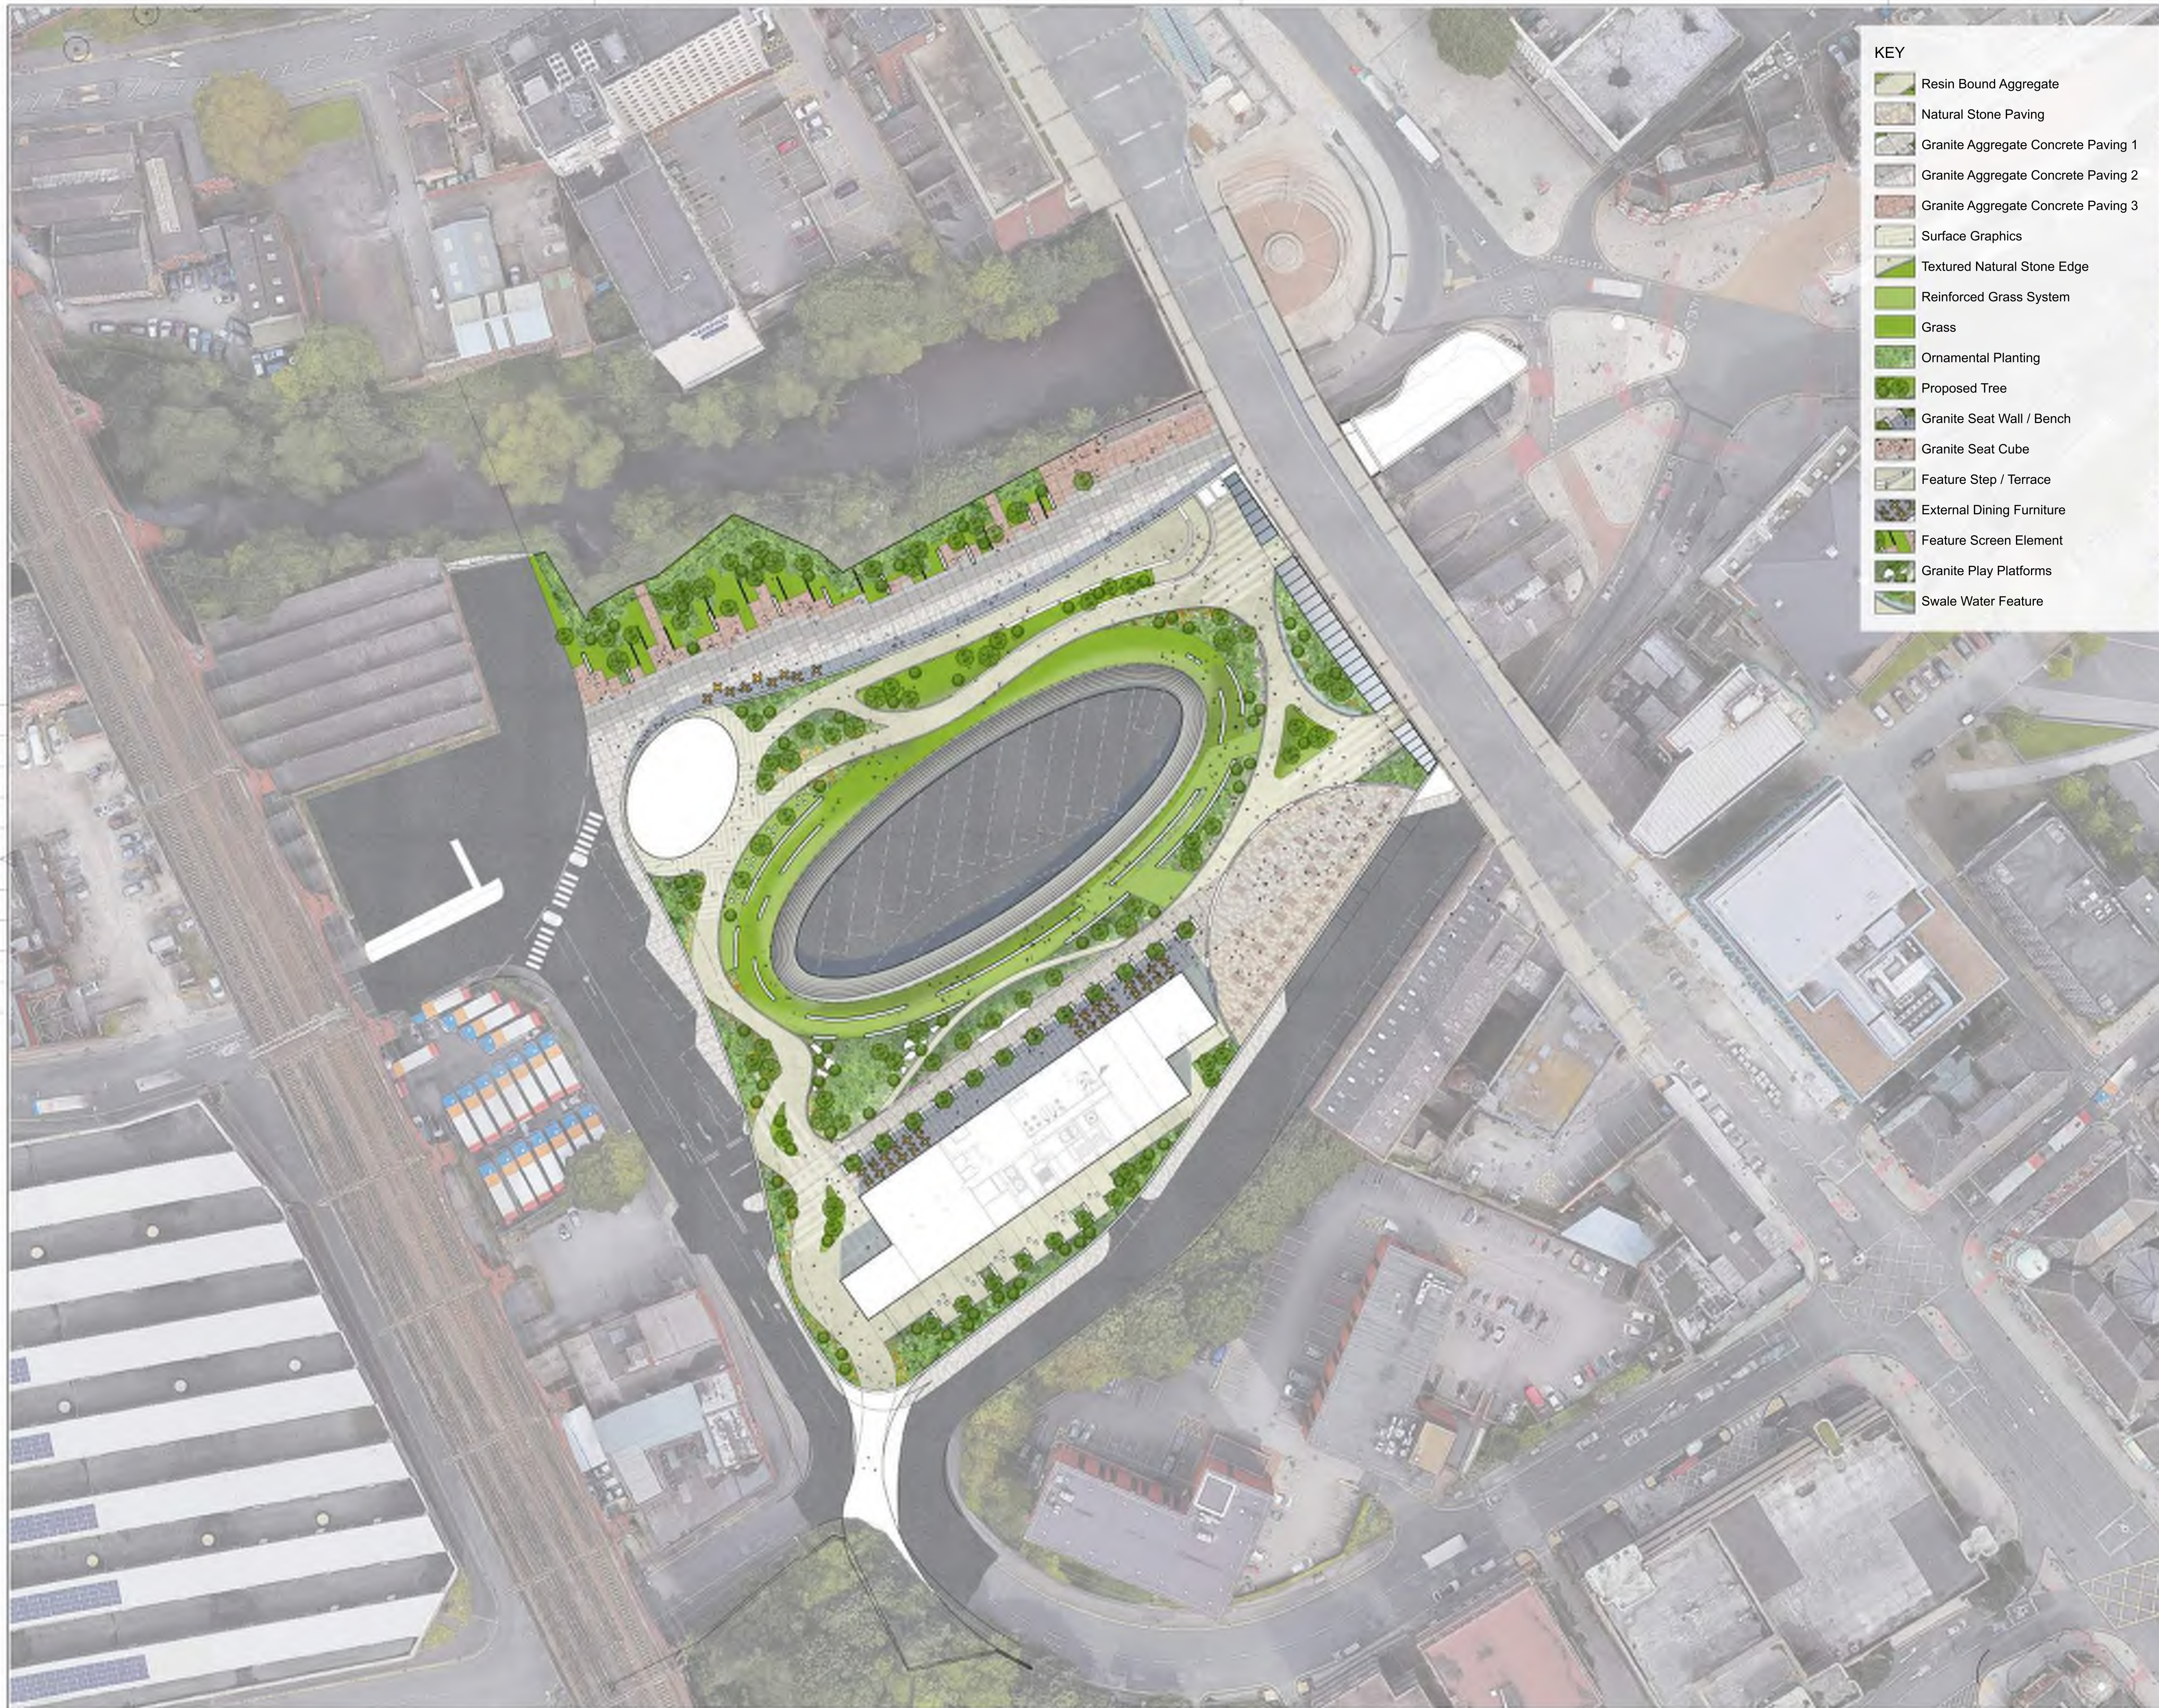
Stockport Bus Interchange	
Landscape Masterplan	@ A1 1:500
	July '18
P2007822	5111-2007-22-004-22_70_00-001

- KEY**
- Resin Bound Aggregate
 - Natural Stone Paving
 - Granite Aggregate Concrete Paving 1
 - Granite Aggregate Concrete Paving 2
 - Granite Aggregate Concrete Paving 3
 - Surface Graphics
 - Textured Natural Stone Edge
 - Reinforced Grass System
 - Grass
 - Ornamental Planting
 - Proposed Tree
 - Granite Seat Wall / Bench
 - Granite Seat Cube
 - Feature Step / Terrace
 - External Dining Furniture
 - Feature Screen Element
 - Granite Play Platforms
 - Swale Water Feature

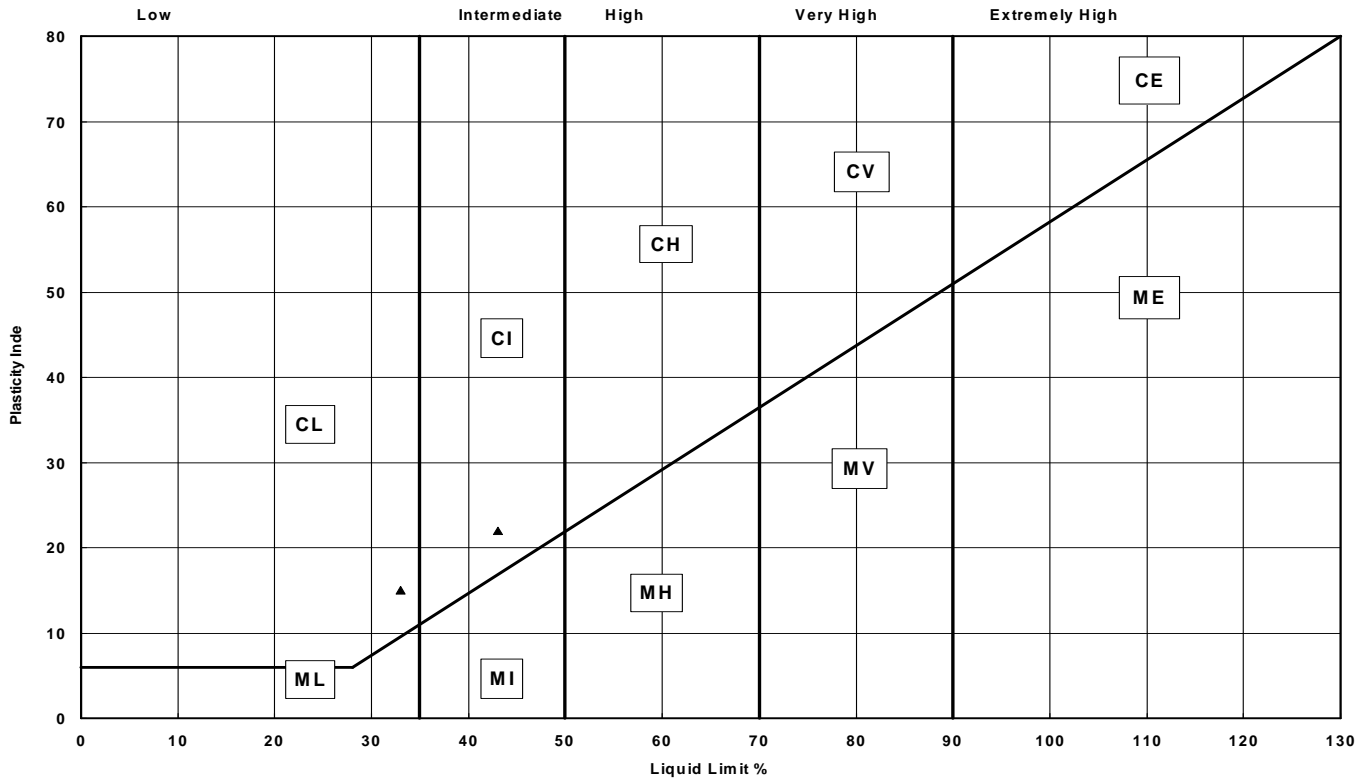
PLOT OF PLASTICITY INDEX AGAINST LIQUID LIMIT for all items tested

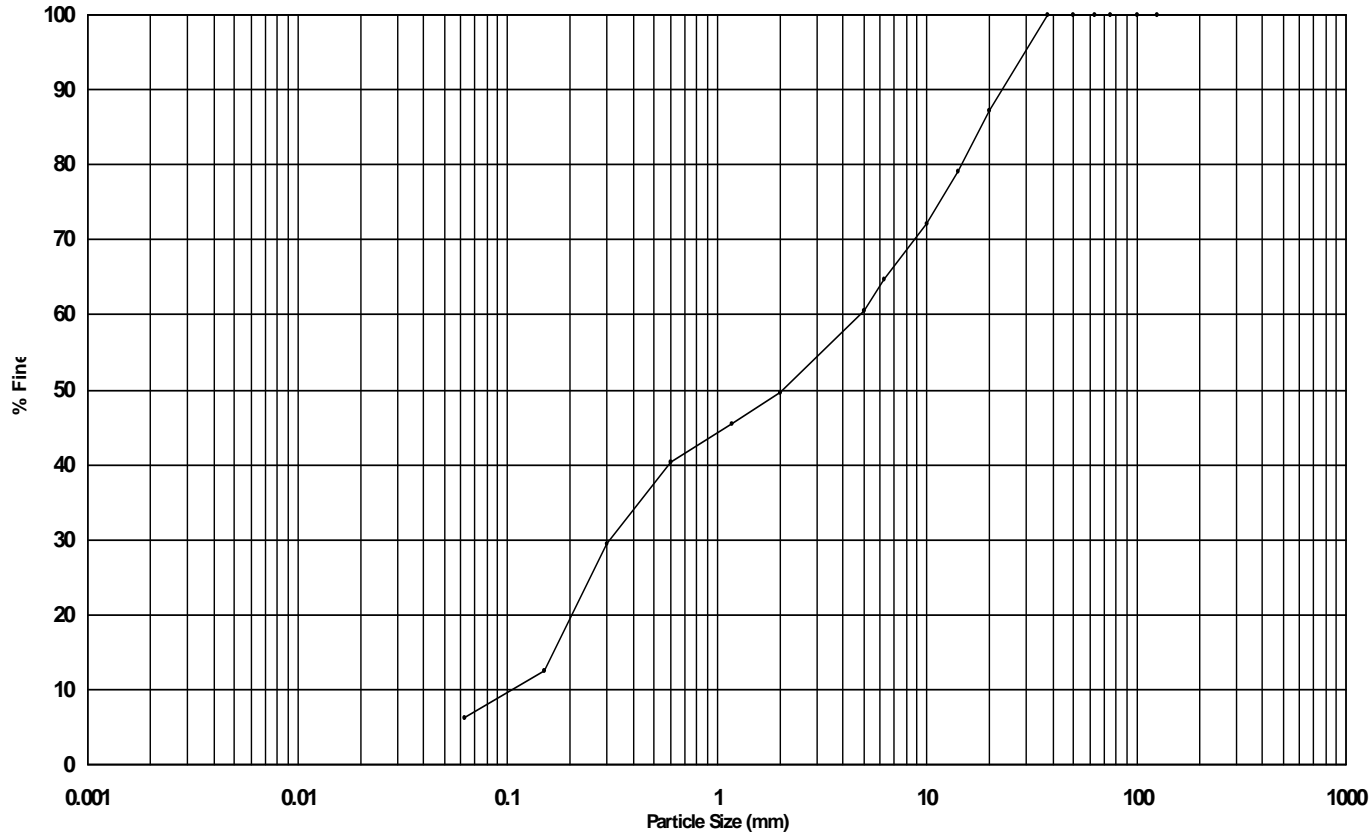
MADE GROUND: Black clayey sand and gravel.

Classification	% of each
SILT (including CLAY)	6
SAND	44
GRAVEL	50
COBBLES	0
BOULDERS	0

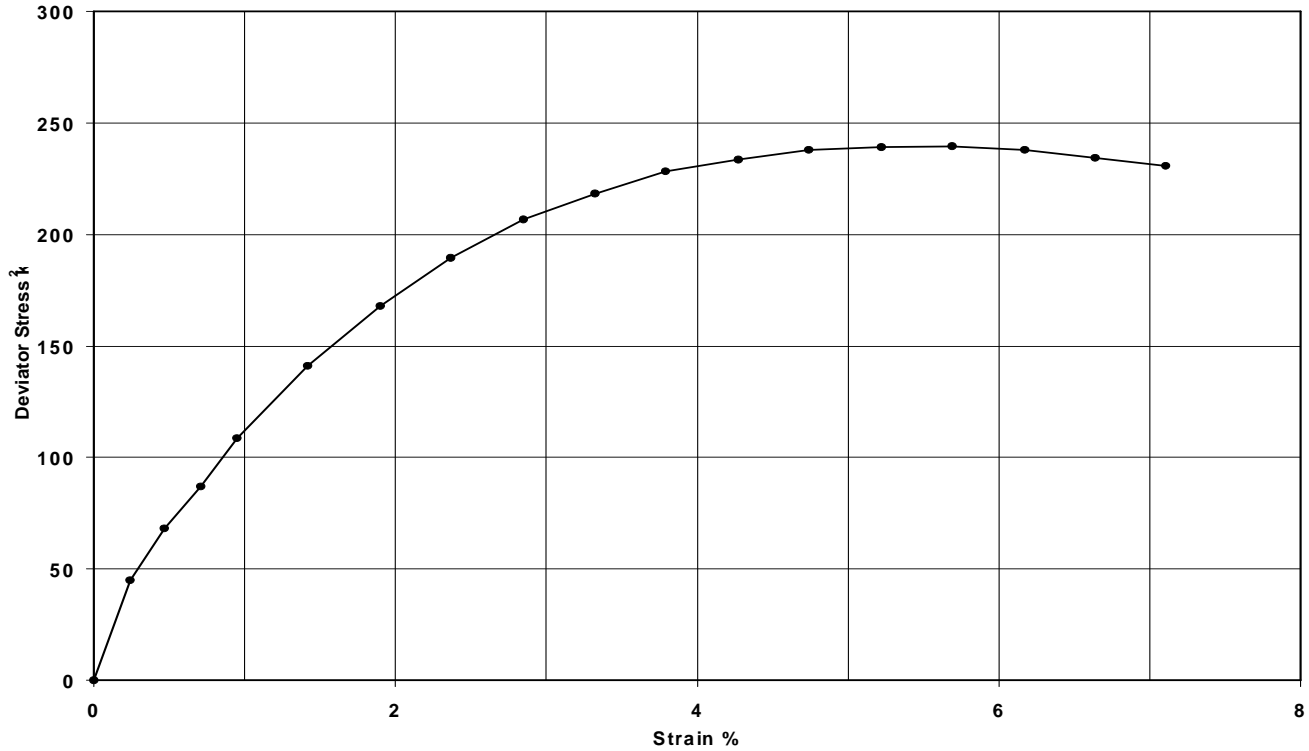
Stage 1	Stage 2	Stage 3	Strain %	Corrected Deviator Stress kN/m ²	Strain %	Corrected Deviator Stress kN/m ²
Sample Condition	Undisturbed			0.2	44.9		
Orientation of sample	Vertical			0.5	68.2		
Initial Diameter (mm)	102.70			0.7	87.0		
Initial Length (mm)	210.86			0.9	108.6		
Initial Water Content (%)	21.4			1.4	141.1		
Initial Bulk Density (Mg/m ³)	1.82			1.9	167.7		
Initial Dry Density (Mg/m ³)	1.50			2.4	189.4		
Particle Density (Mg/m ³)	2.65 Assumed			2.8	206.6		
Cell Pressure (kPa)	60			3.3	218.2		
'Specimen Height' at start of Shearing Stage (mm)	210.26			3.8	228.5		
Membrane Thickness/Correction (mm/kPa)				4.3	233.5		
Rate of Strain (%/min)	2.0			4.7	237.9		
Corrected Deviator Stress (kPa)	239			5.2	239.1		
Undrained Shear Strength (kPa)	120			5.7	239.5		
Strain at Failure (%)	5.7			6.2	237.8		
Failure Zone Water Content (%)	10.9			6.6	234.4		
Water Content (after test) (%)				7.1	230.8		
Mode of Failure	Brittle

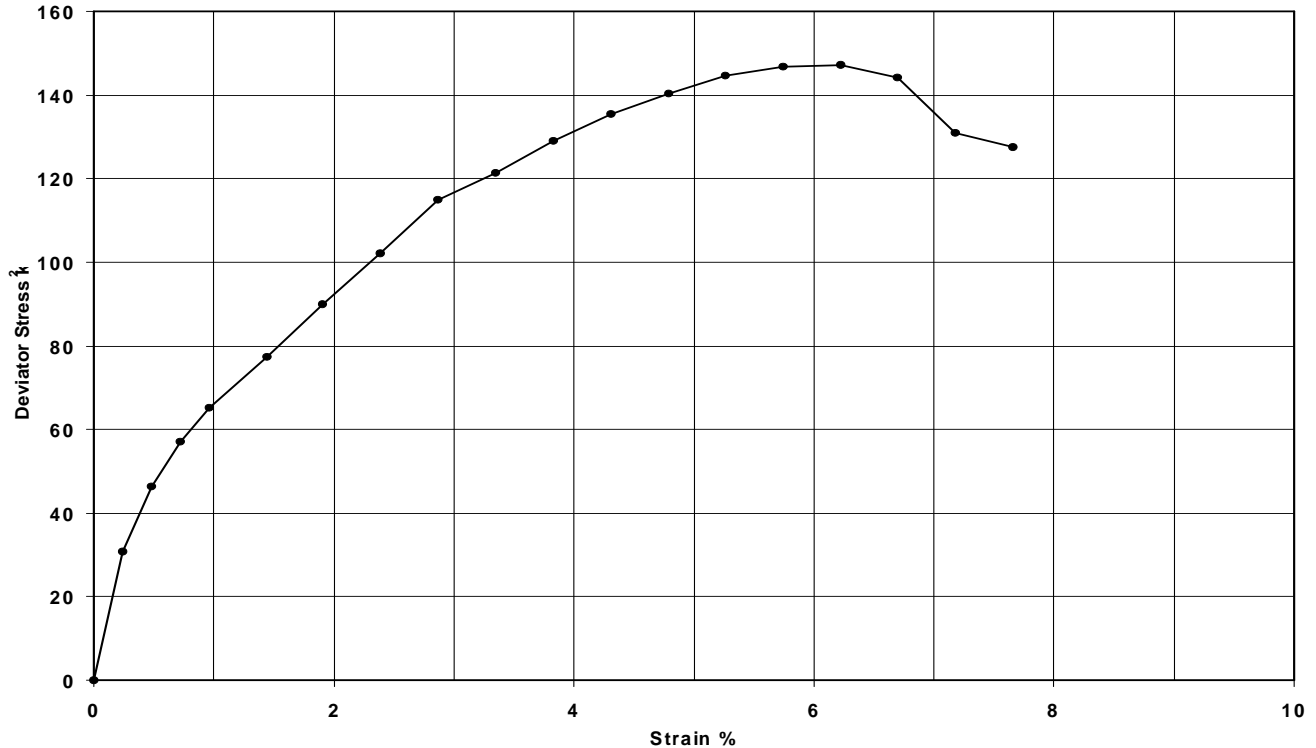
Stage 1	Stage 2	Stage 3	Strain %	Corrected Deviator Stress kN/m ²	Strain %	Corrected Deviator Stress kN/m ²
Sample Condition	Undisturbed			0.2	30.7		
Orientation of sample	Vertical			0.5	46.4		
Initial Diameter (mm)	102.01			0.7	57.1		
Initial Length (mm)	208.95			1.0	65.1		
Initial Water Content (%)	8.6			1.4	77.3		
Initial Bulk Density (Mg/m ³)	1.94			1.9	90.0		
Initial Dry Density (Mg/m ³)	1.79			2.4	102.2		
Particle Density (Mg/m ³)	2.65 Assumed			2.9	115.0		
Cell Pressure (kPa)	40			3.4	121.4		
'Specimen Height' at start of Shearing Stage (mm)	208.66			3.8	129.0		
Membrane Thickness/Correction (mm/kPa)				4.3	135.3		
Rate of Strain (%/min)	2.0			4.8	140.3		
Corrected Deviator Stress (kPa)	147			5.3	144.7		
Undrained Shear Strength (kPa)	74			5.7	146.9		
Strain at Failure (%)	6.2			6.2	147.2		
Failure Zone Water Content (%)	7.8			6.7	144.3		
Water Content (after test) (%)				7.2	131.0		
Mode of Failure	Brittle			7.7	127.6

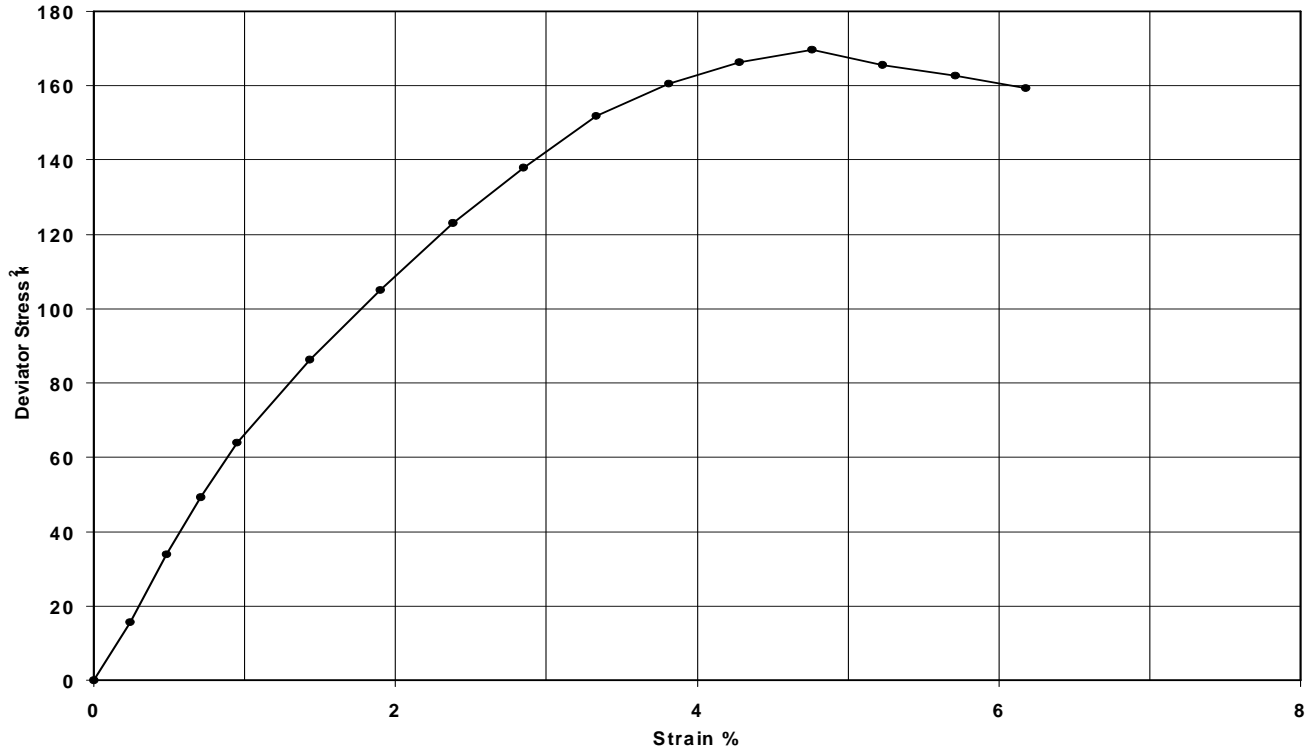
Stage 1	Stage 2	Stage 3	Strain %	Corrected Deviator Stress kN/m ²	Strain %	Corrected Deviator Stress kN/m ²
Sample Condition	Undisturbed			0.2	15.6		
Orientation of sample	Vertical			0.5	33.9		
Initial Diameter (mm)	103.08			0.7	49.2		
Initial Length (mm)	210.21			1.0	63.9		
Initial Water Content (%)	11.8			1.4	86.3		
Initial Bulk Density (Mg/m ³)	1.92			1.9	105.0		
Initial Dry Density (Mg/m ³)	1.72			2.4	123.1		
Particle Density (Mg/m ³)	2.65 Assumed			2.9	137.8		
Cell Pressure (kPa)	40			3.3	151.9		
'Specimen Height' at start of Shearing Stage (mm)	210.13			3.8	160.4		
Membrane Thickness/Correction (mm/kPa)				4.3	166.3		
Rate of Strain (%/min)	2.0			4.8	169.6		
Corrected Deviator Stress (kPa)	170			5.2	165.6		
Undrained Shear Strength (kPa)	85			5.7	162.6		
Strain at Failure (%)	4.8			6.2	159.4		
Failure Zone Water Content (%)	8.6						
Water Content (after test) (%)							
Mode of Failure	Brittle

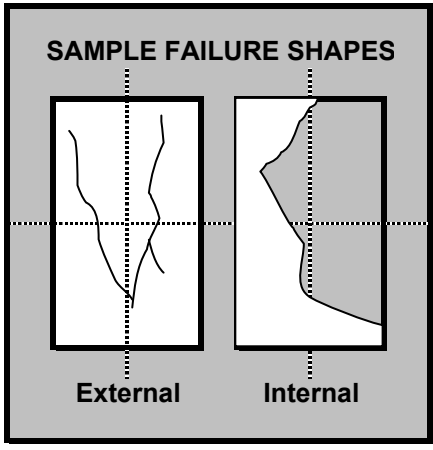
BOREHOLE		BH301

SAMPLE		C	
DEPTH	m	10.97-11.06	
SAMPLE DIAMETER	mm	84.44	
SAMPLE HEIGHT	mm	151.40	
TEST CONDITION		As Received	
RATE OF LOADING	kN/s	0.1	
TEST DURATION	min.sec	8.01	
DATE OF TESTING		31/01/2020	
LOAD FRAME USED		2000kN	
LOAD DIRECTION WITH RESPECT TO LITHOLOGY		Unknown	
FAILURE LOAD	kN	38.5	
UNCONFINED COMPRESSIVE STRENGTH	MPa	6.9	
WATER CONTENT (ISRM Suggested Methods)	%	14.3	
BULK DENSITY (ISRM Suggested Methods)	Mg/m ³	2.18	
DRY DENSITY (ISRM Suggested Methods)	Mg/m ³	1.91

Test specimen does not meet specified length / diameter ratio requirements

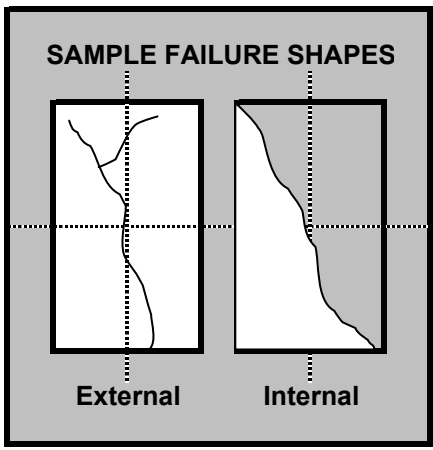
BOREHOLE		BH301

SAMPLE		C	
DEPTH	m	12.50-12.80	
SAMPLE DIAMETER	mm	85.81	
SAMPLE HEIGHT	mm	154.39	
TEST CONDITION		As Received	
RATE OF LOADING	kN/s	0.1	
TEST DURATION	min.sec	7.33	
DATE OF TESTING		31/01/2020	
LOAD FRAME USED		2000kN	
LOAD DIRECTION WITH RESPECT TO LITHOLOGY		Unknown	
FAILURE LOAD	kN	41.0	
UNCONFINED COMPRESSIVE STRENGTH	MPa	7.1	
WATER CONTENT (ISRM Suggested Methods)	%	11.9	
BULK DENSITY (ISRM Suggested Methods)	Mg/m ³	2.17	
DRY DENSITY (ISRM Suggested Methods)	Mg/m ³	1.94

Test specimen does not meet specified length / diameter ratio requirements

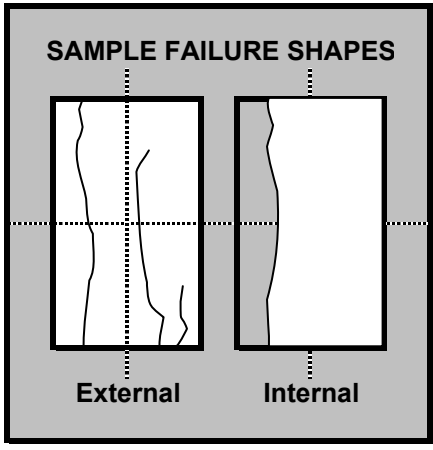
BOREHOLE		BH302B

SAMPLE		C	
DEPTH	m	11.00-11.28	
SAMPLE DIAMETER	mm	100.42	
SAMPLE HEIGHT	mm	160.17	
TEST CONDITION		As Received	
RATE OF LOADING	kN/s	0.1	
TEST DURATION	min.sec	8.31	
DATE OF TESTING		31/01/2020	
LOAD FRAME USED		2000kN	
LOAD DIRECTION WITH RESPECT TO LITHOLOGY		Unknown	
FAILURE LOAD	kN	38.9	
UNCONFINED COMPRESSIVE STRENGTH	MPa	4.9	
WATER CONTENT (ISRM Suggested Methods)	%	12.3	
BULK DENSITY (ISRM Suggested Methods)	Mg/m ³	2.11	
DRY DENSITY (ISRM Suggested Methods)	Mg/m ³	1.88

Test specimen does not meet specified length / diameter ratio requirements

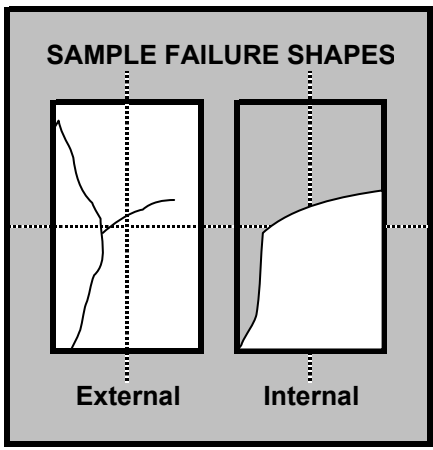
BOREHOLE		BH302B

SAMPLE		C	
DEPTH	m	13.52-13.74	
SAMPLE DIAMETER	mm	100.49	
SAMPLE HEIGHT	mm	127.94	
TEST CONDITION		As Received	
RATE OF LOADING	kN/s	0.1	
TEST DURATION	min.sec	7.12	
DATE OF TESTING		31/01/2020	
LOAD FRAME USED		2000kN	
LOAD DIRECTION WITH RESPECT TO LITHOLOGY		Unknown	
FAILURE LOAD	kN	39.0	
UNCONFINED COMPRESSIVE STRENGTH	MPa	4.9	
WATER CONTENT (ISRM Suggested Methods)	%	16.4	
BULK DENSITY (ISRM Suggested Methods)	Mg/m ³	2.10	
DRY DENSITY (ISRM Suggested Methods)	Mg/m ³	1.80

Test specimen does not meet specified length / diameter ratio requirements

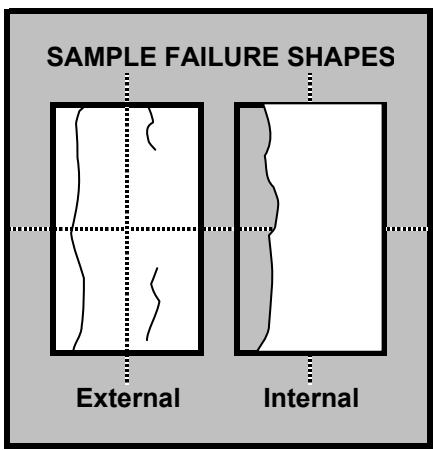
BOREHOLE		BH302B

SAMPLE		C	
DEPTH	m	24.37-24.54	
SAMPLE DIAMETER	mm	100.06	
SAMPLE HEIGHT	mm	97.77	
TEST CONDITION		As Received	
RATE OF LOADING	kN/s	0.1	
TEST DURATION	min.sec	6.07	
DATE OF TESTING		31/01/2020	
LOAD FRAME USED		2000kN	
LOAD DIRECTION WITH RESPECT TO LITHOLOGY		Unknown	
FAILURE LOAD	kN	40.3	
UNCONFINED COMPRESSIVE STRENGTH	MPa	5.1	
WATER CONTENT (ISRM Suggested Methods)	%	13.7	
BULK DENSITY (ISRM Suggested Methods)	Mg/m ³	2.11	
DRY DENSITY (ISRM Suggested Methods)	Mg/m ³	1.85

Test specimen does not meet specified length / diameter ratio requirements
