**Nick
Tomlinson
Ecology**

**Manor Farmhouse, Godmanstone
Protected Species (bats) Report
*September 2020***

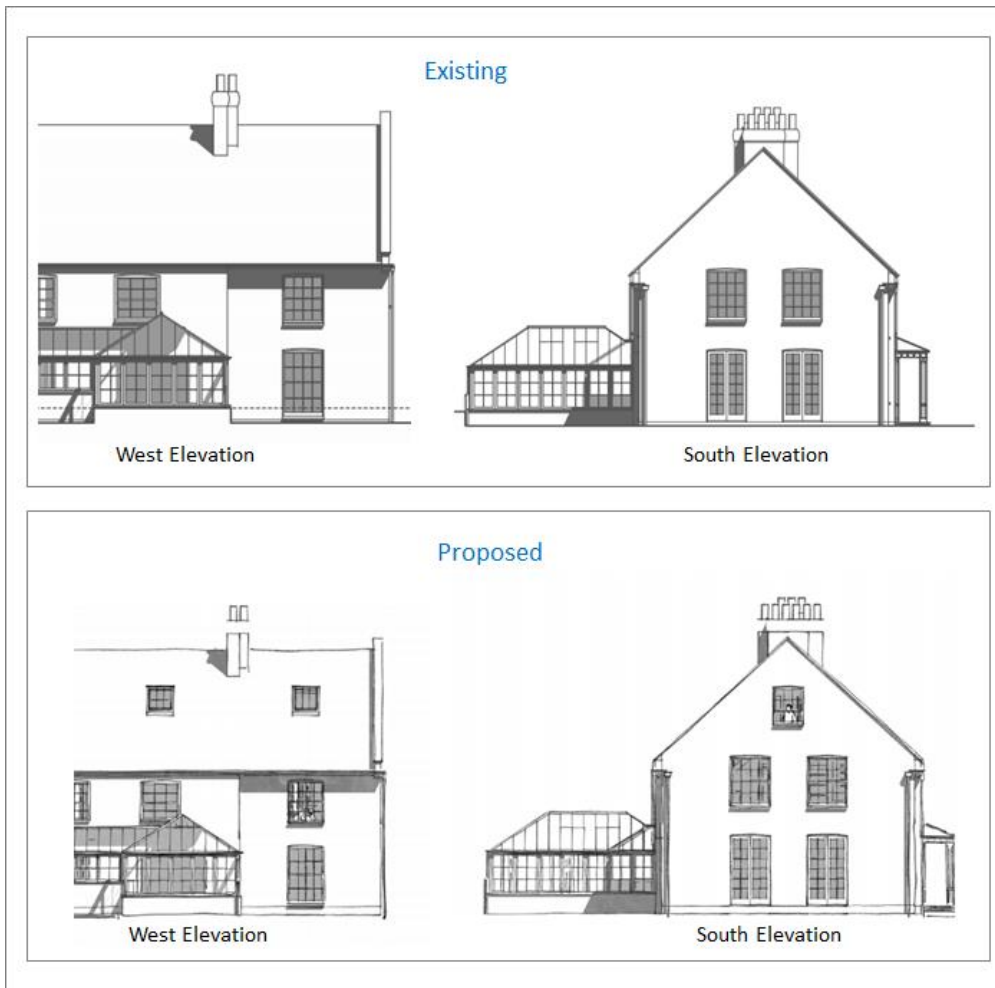
1.2. The owners wish to convert the roof void at the southern end to residential accommodation (Please see figure below)

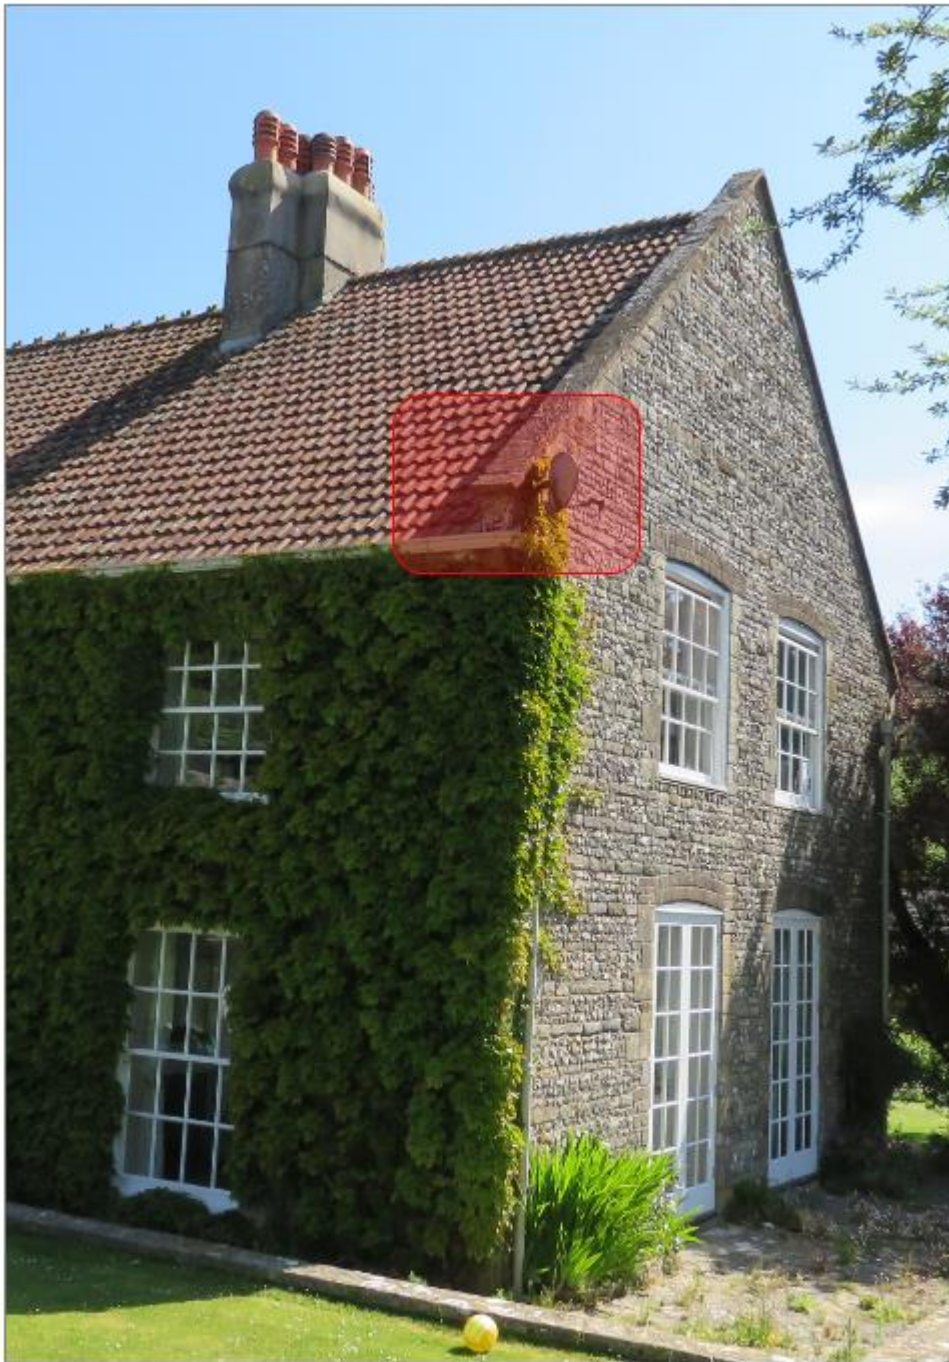
Figure B: Focus of brown long-eared bats swarming during dawn return survey on 3rd July 2020

- 4.3.7.2. Four long-eared bats (assumed, based on prior work, to be brown long-eared) were seen swarming around the southern end of the building, with a focus on the south-western gable end between 03:51 and 04:32 (*Please see Figure B, in Appendix B*).

- 4.3.7.3. At the end of this period of time the bats were seen to leave the area and were not seen to return, so are assumed to have roosted elsewhere on that occasion.

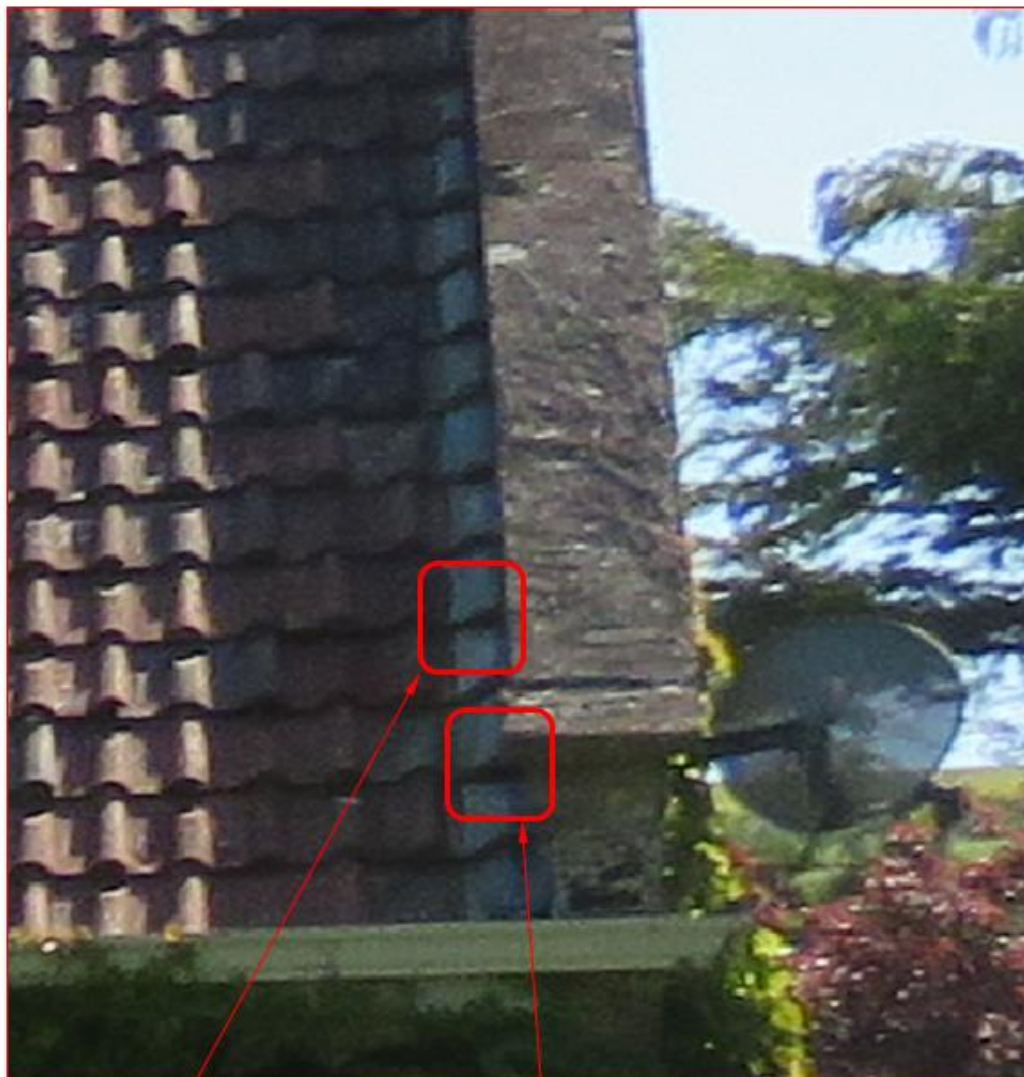
One bat emerged at 22:05:22

Bats emerged at
21:51:36,
22:08:47
22:08:55
