PHASE I GEO-ENVIRONMENTAL APPRAISAL AT SEAFIRE CLOSE, CLIFTON MOOR INDUSTRIAL ESTATE, YORK

IPIF CO FOX LLOYD JONES LIMITED

Project Reference JS/BAD/43366-Rp-002

Date: 9th December 2019

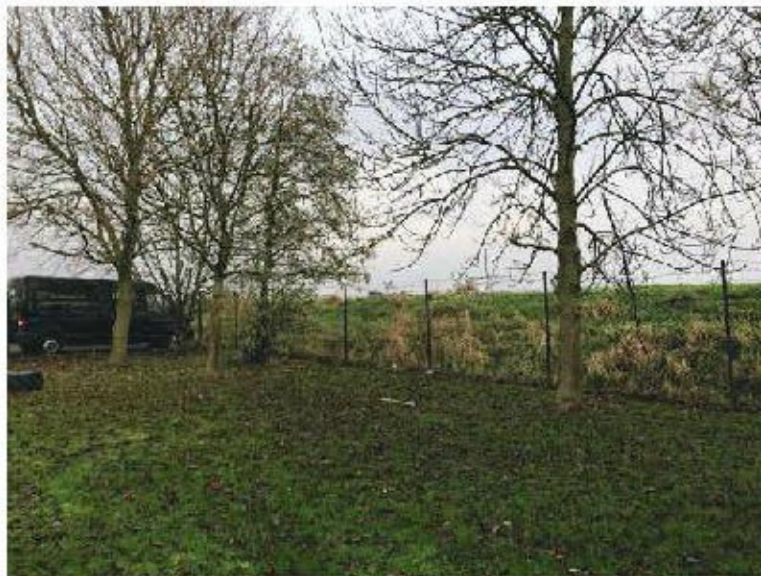
Photograph No. 2

To the rear of the building is a small bund. View to the north-east.

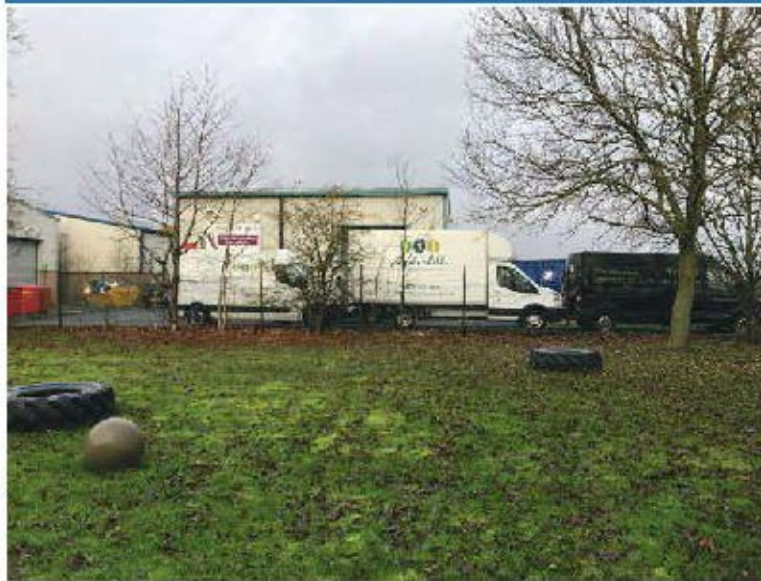
Photograph No. 3

Metal fence down northern boundary of site. Stops adjacent to the front of the building (former Atlanta Gym). View to the north.

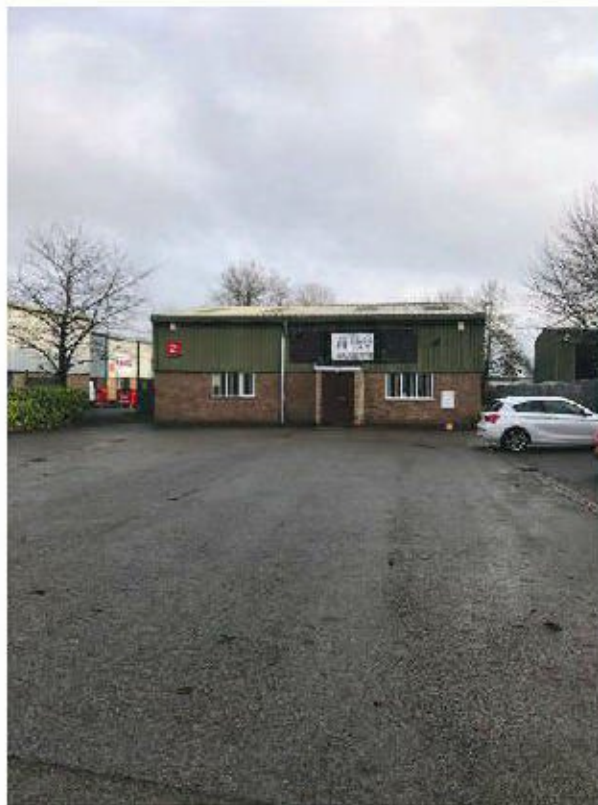
Photograph No. 4

Disused building on the site is a former Atlanta Gym. View to the east.

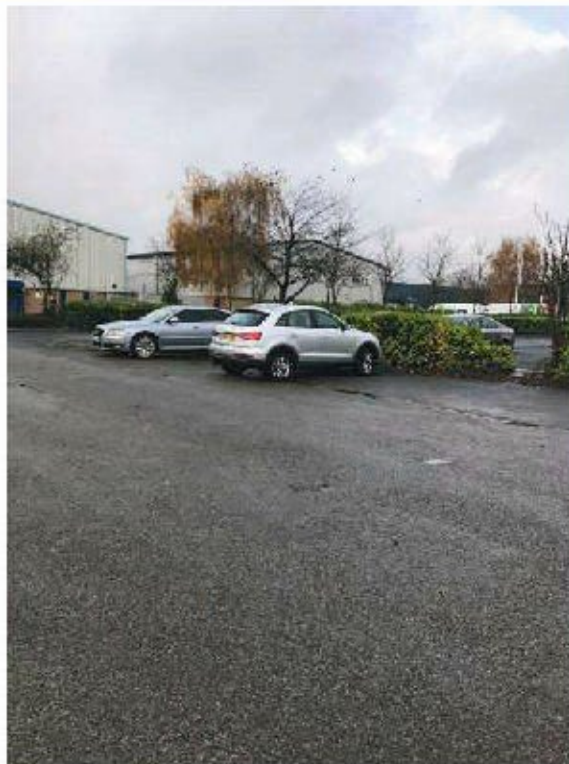
Photograph No. 5

Hedge down the northern boundary of the site. A number of cars park on the car park. View to the north-west.

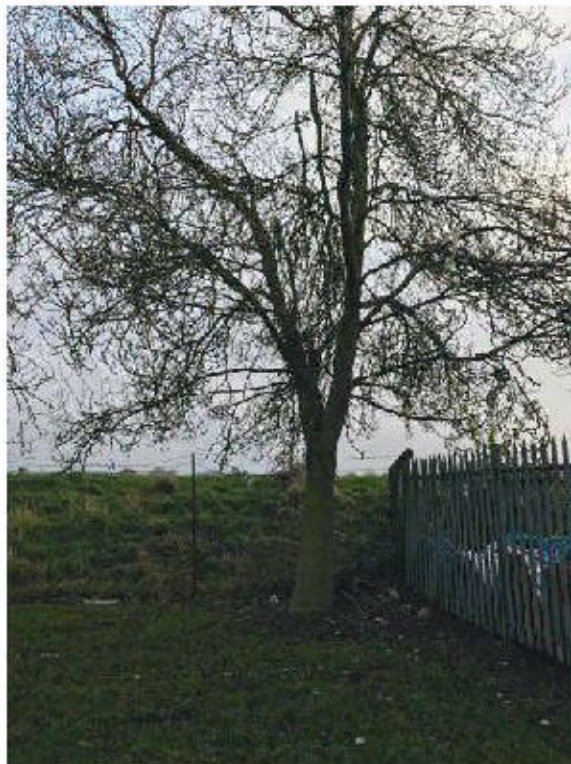
Photograph No. 7

Large Alder tree in the south-eastern corner of the site. View to the east.

4.4.3 There are some trees around the boundaries to the site, so precautions may be required should structures lie within influencing distance when in clay. In addition, precautions may be required where trees are to be removed or where new planting is proposed. All foundations should be constructed in accordance with current guidelines (e.g. NHBC Standards, Chapter 4.2). If foundations are built off competent bedrock, no precautions are likely to be required.

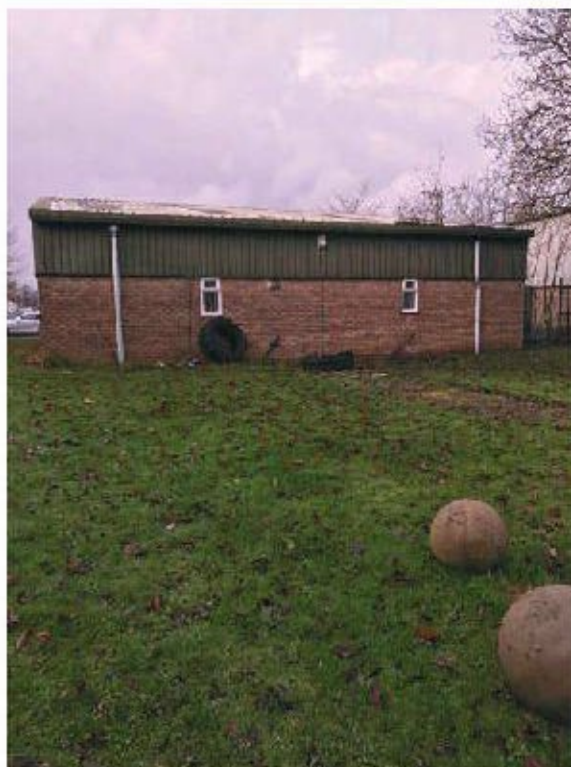
Photograph No. 8

2.2.9 A number of tyres and stone balls were noted to the rear of the building, thought to have been used when the site was active as a gym.

Rear of the building. View to the west.
