### **88-94 CHURCH STREET & 1-3 ABINGDON STREET, BLACKPOOL**

Ecology Solutions was commissioned by Newsteer in January 2021 to assess the buildings at 88 - 94 Church Street and 1 - 3 Abingdon Street, Blackpool for their potential for roosting bats.

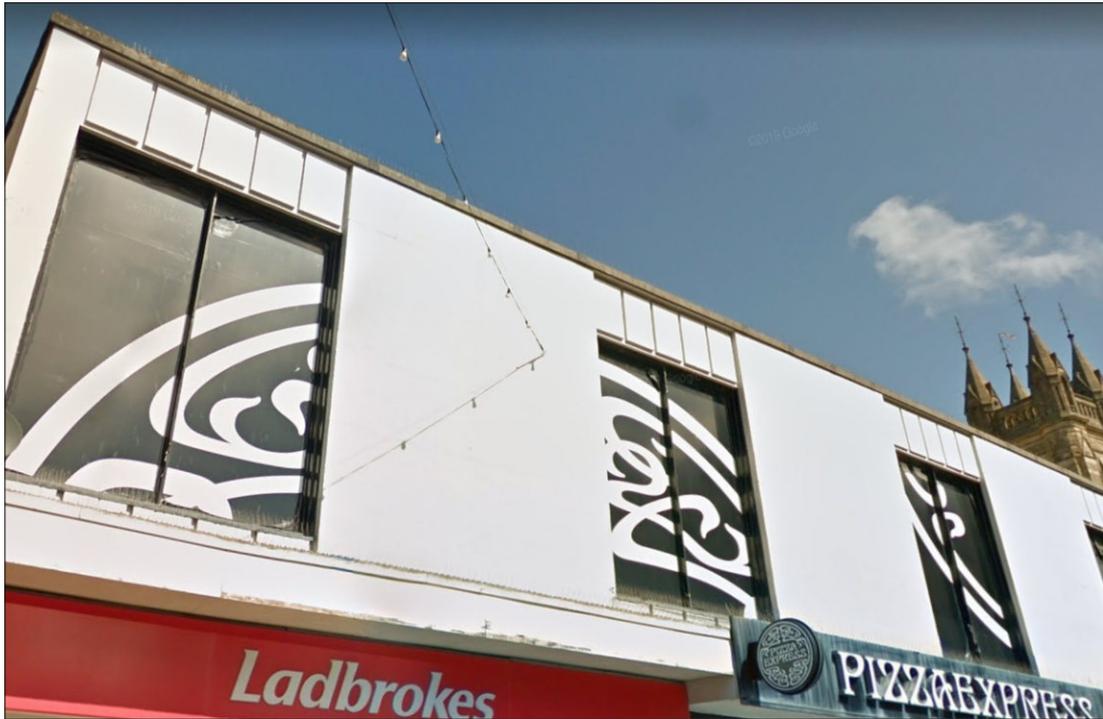
PHOTOGRAPH 1: 88 - 94 Church Street

The building at 88 – 94 Church Street is a two-storey brick-built retail building with a flat roof (see Photograph 1). The building is currently in use by Pizza Express and Ladbrokes. The flat roof design is typically unfavoured by roosting bats with a lack of potential roosting features.

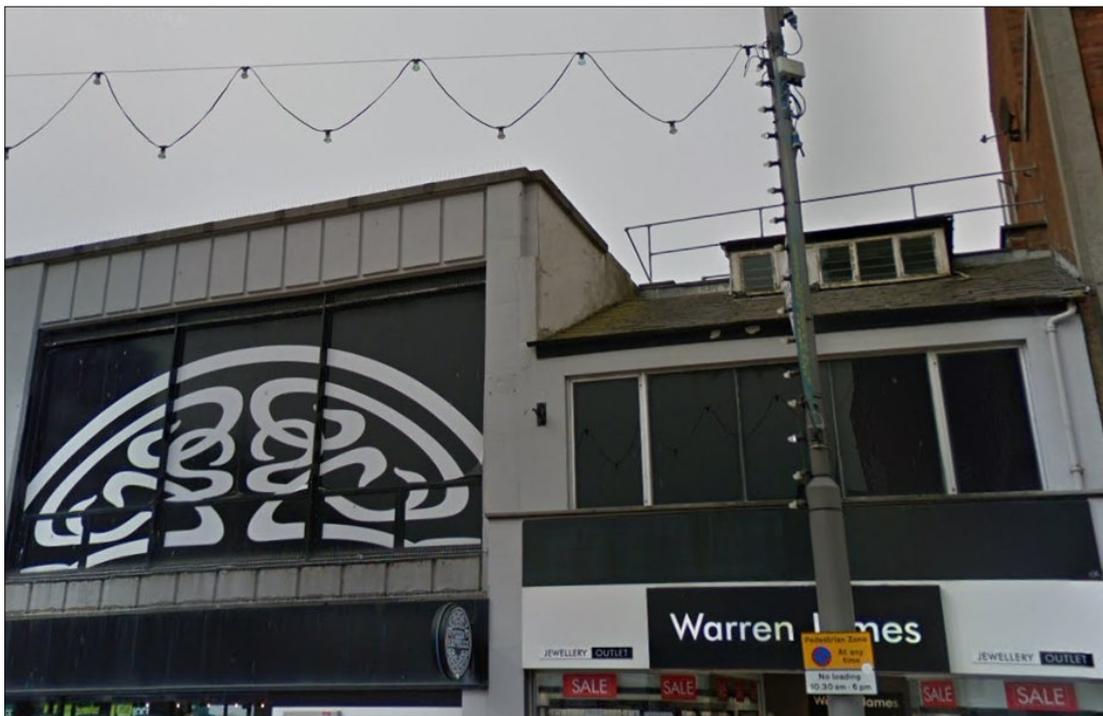
PHOTOGRAPH 2: 1 - 3 Abingdon Street

The building at 1 – 3 Abingdon Street is a retail property in use by Warren James (see Photograph 2). The building is brick built with a lean-to tile roof with a dormer section. The roof appears to be in good condition with no broken or missing tiles.

As a precautionary approach to the works the tiles and dormer window should be subject to soft strip removal and in the highly unlikely event that any bats are found works cease and Ecology Solutions contacted for further advice and guidance.
