Land at North Moor View, Brimington For Vistry Yorkshire

Report no: 3569/1

Date: March 2020

SUMMARY OF GEOENVIRONMENTAL ISSUES

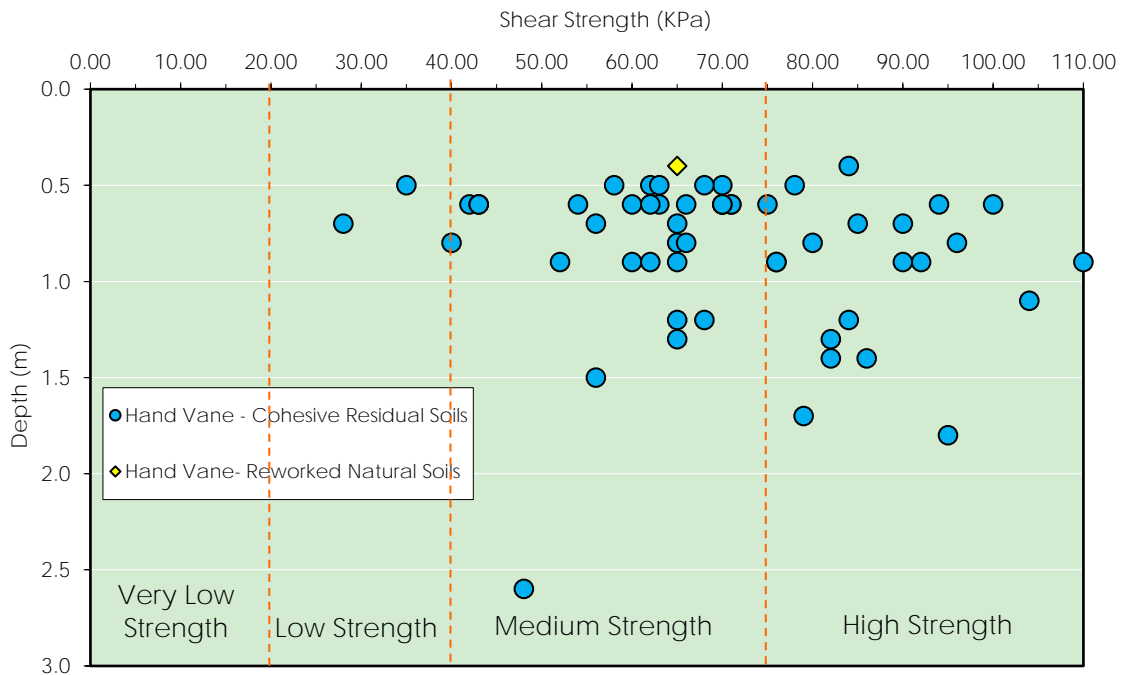
- 11.3.3 Hand shear vane testing was undertaken within trial pits in-situ to around 1.2m depth and from larger blocks of excavated clay below that depth.
- 11.3.4 The results are summarised within the plot below and illustrate the Cohesive Residual Soils have a shear strength within the medium and high strength ranges (40kPa to $>75\text{kPa}$), with the exception of two readings taken within TP22 at 0.5m and 0.7m depth.
- 11.3.5 The plot below provides a summary of undrained shear strengths.

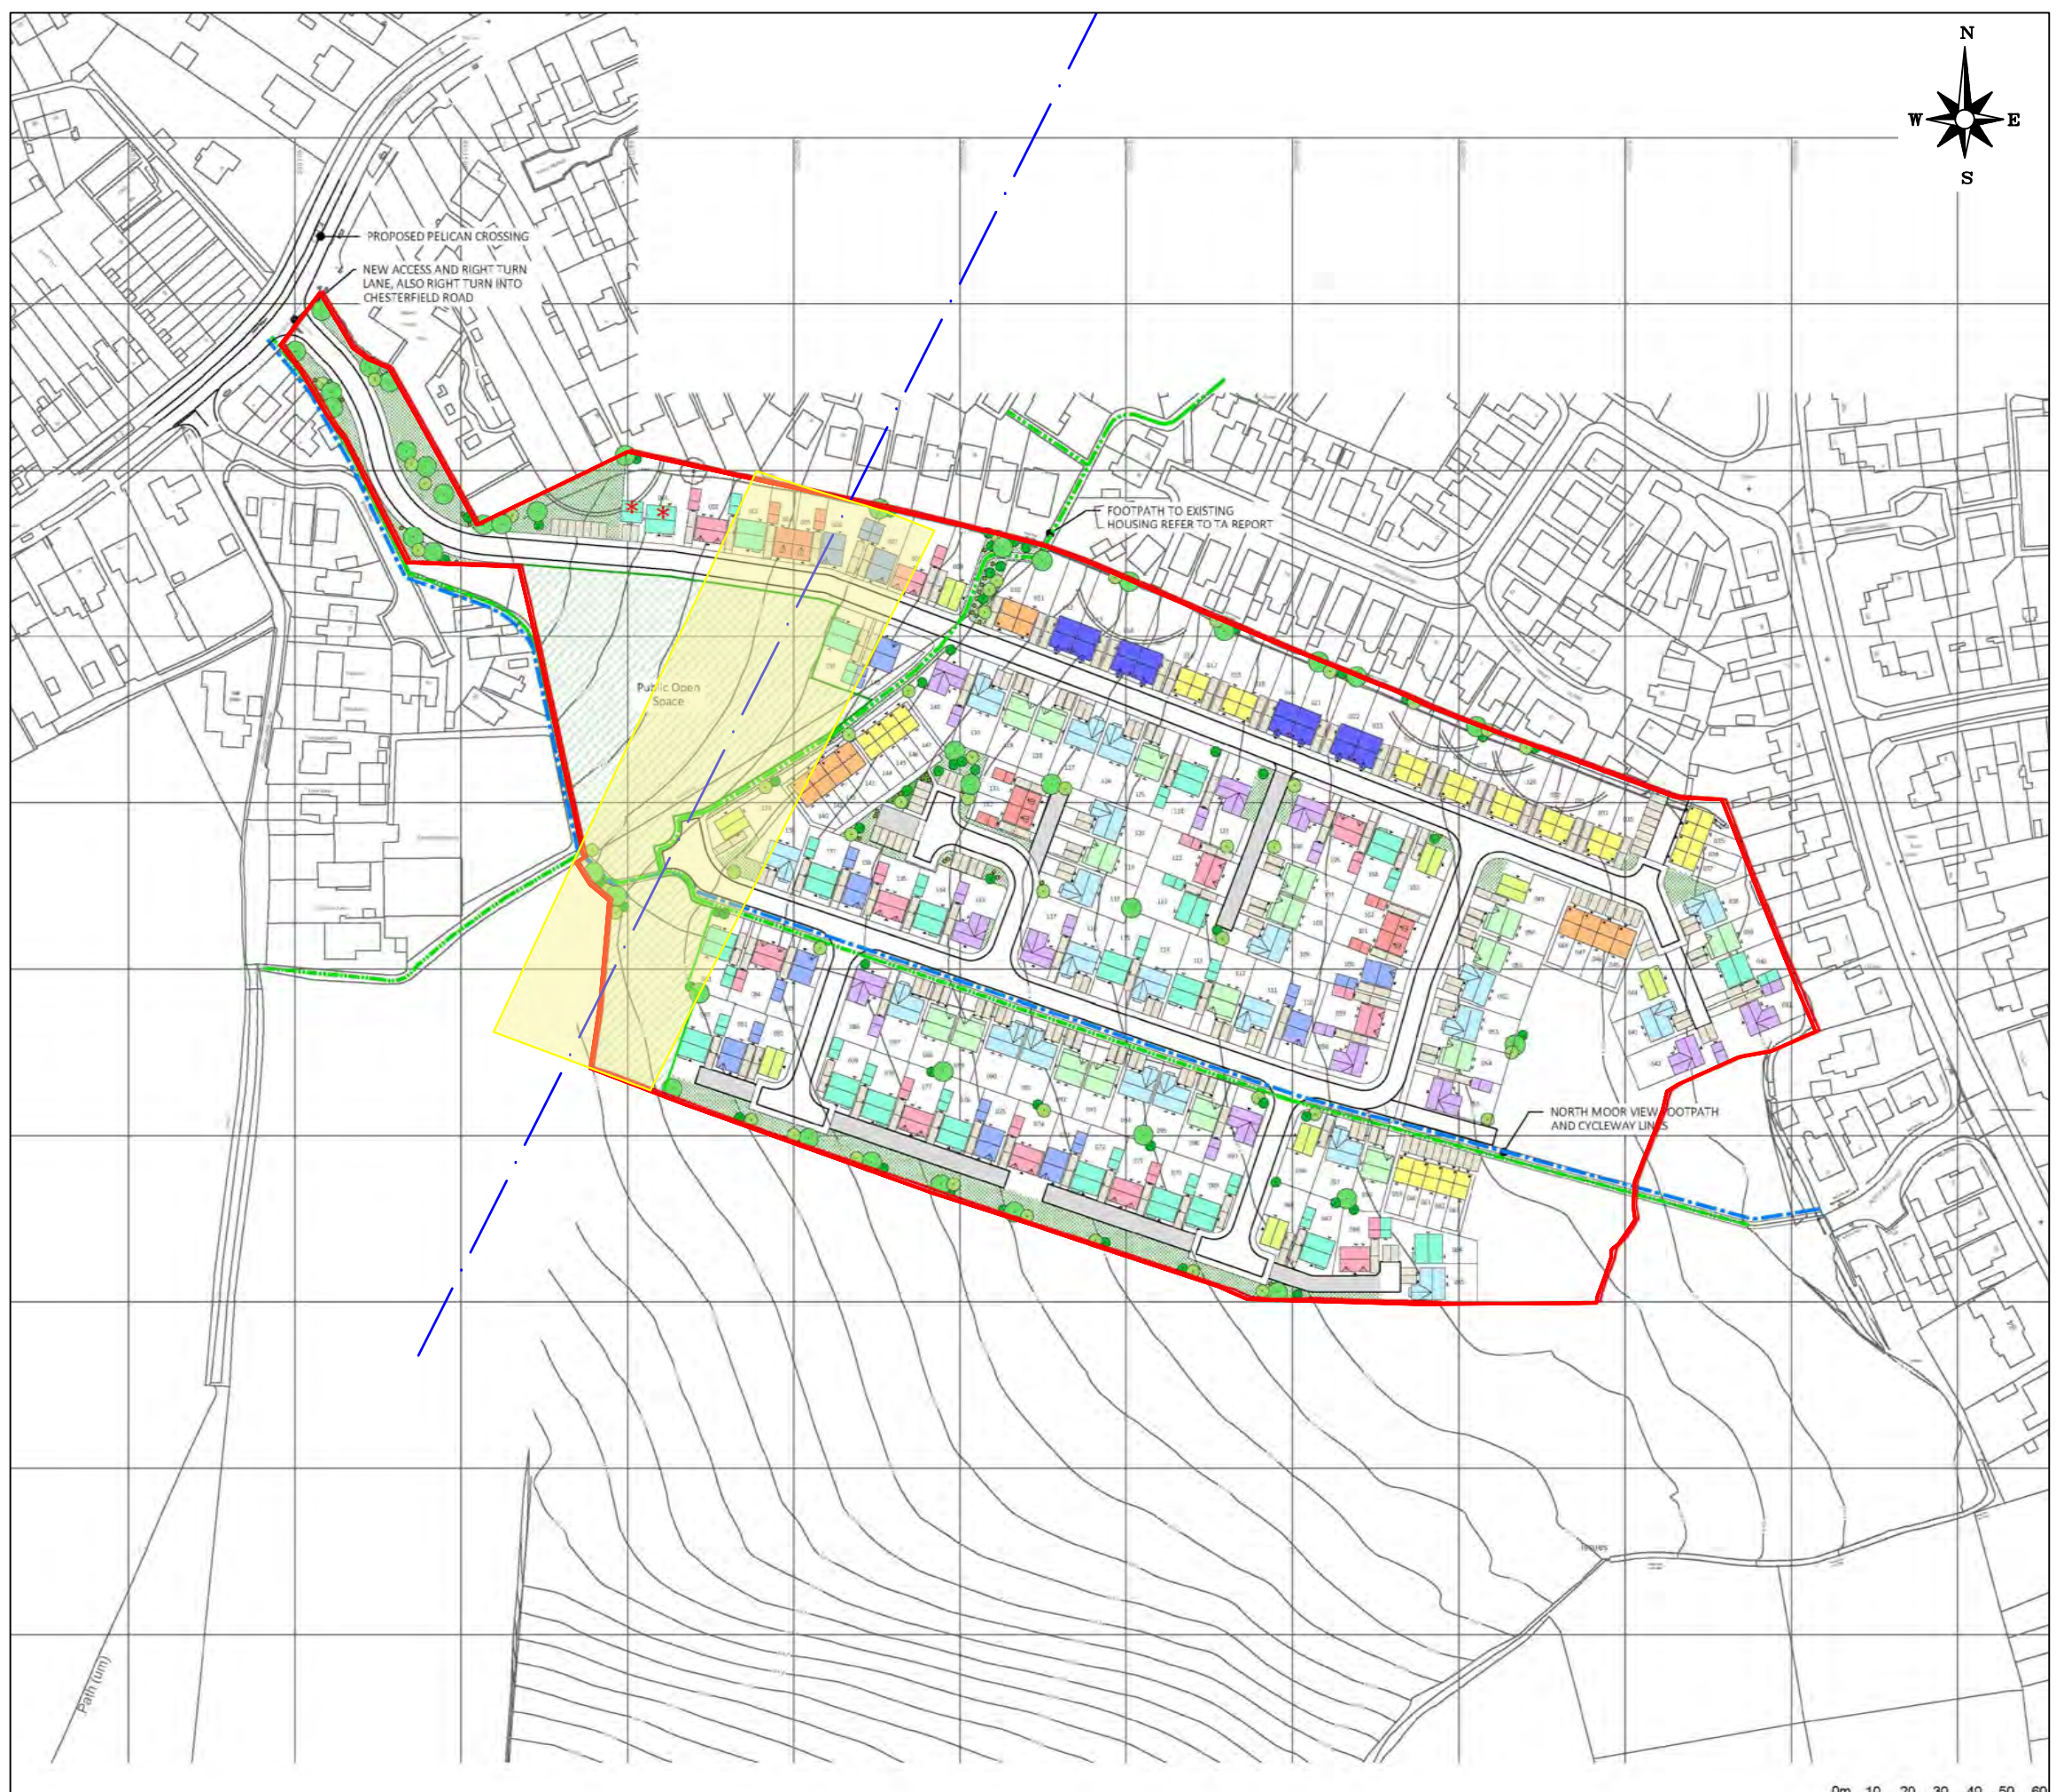
- APPROXIMATE SITE BOUNDARY
- REPRODUCED FROM WHITAM COX ARCHITECTS DRAWING REFERENCE SK-007, DATED OCTOBER 2019
- GEOLOGICAL FAULT
- PLOTS REQUIRING REINFORCEMENT (25M BUFFER)
