Project: Internal Alterations
1 Union Terrace
Aberdeen, AB10 1NJ

Title: Window Condition Analysis

DWG no: 3617-EX(04)002 **Date:** 20.01.21

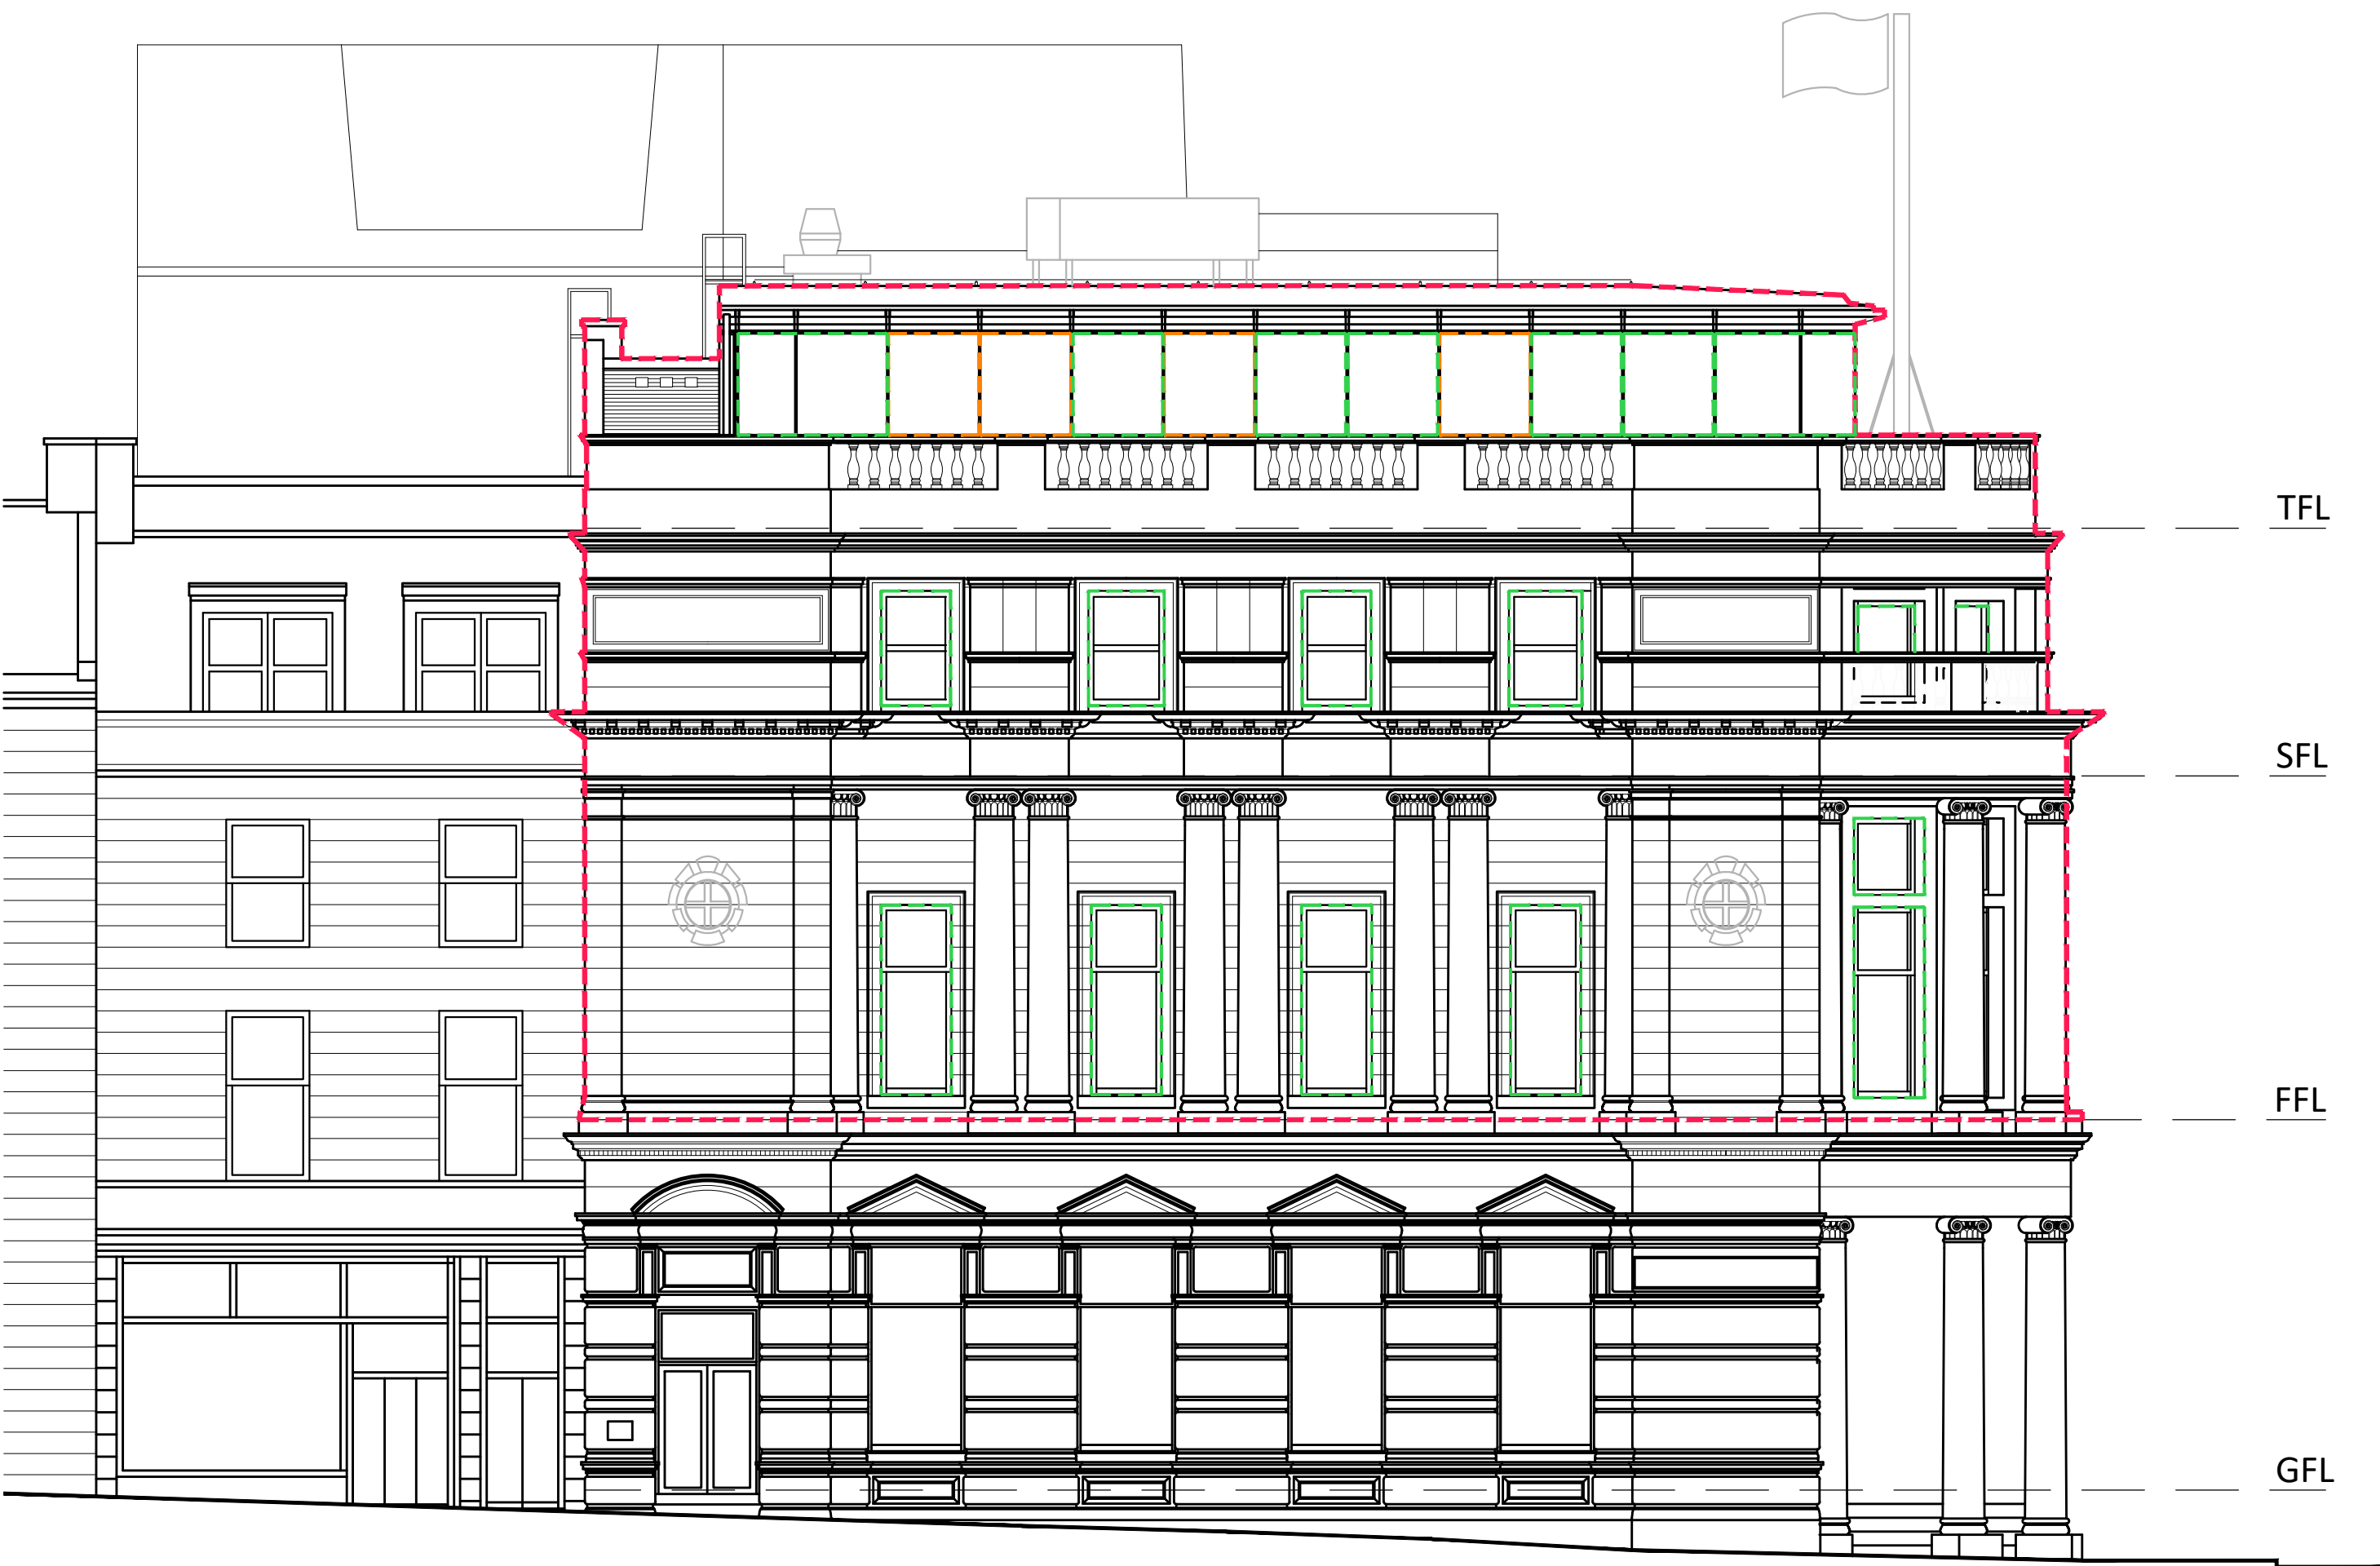
Existing South Elevation
Scale 1:100 on A1

- Boundary
- Window to be removed - in poor condition or required to be removed as part of the proposal.
- Window to be retained - in fair condition. Requires refurbishing.
- Window to be retained - in good condition. Requires minor / no refurbishing.
