Construction Environmental Project Plan

Elm Park

2020-037

Managing Environmental Risk and Realising Opportunities

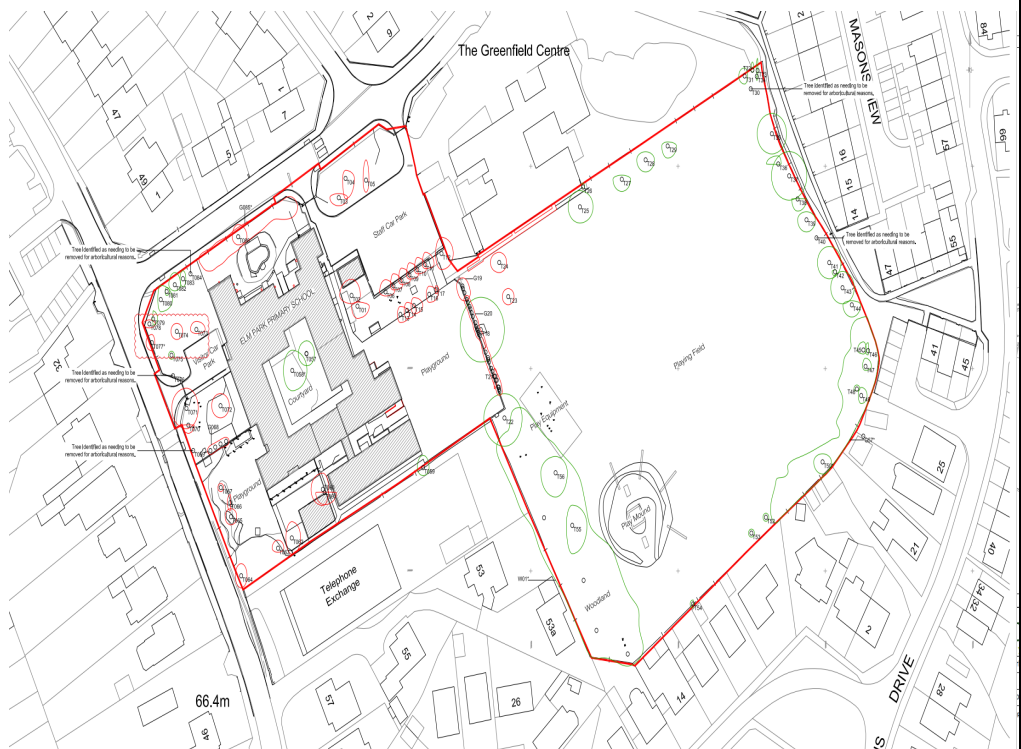
The trees are mainly situated around the boundaries of the school field and car parking area to then north of the school buildings. There is a belt of trees which extends north-south across the eastern edge of the existing playground separating the hardstanding playground from the playing field. This group predominantly consists of a line of Beech trees, presumably planted as a screen. Several of these trees, at either end of the group, have been allowed to grow on. The trees within the centre of the group have been suppressed by a category A Oak trees growing within the centre of the group.

Forty trees will be removed to facilitate the proposed development. It is proposed to mitigate for the loss of these trees by the implementation of a landscaping scheme including replacement trees and shrubs to enhance that landscape and visual amenity of the site.

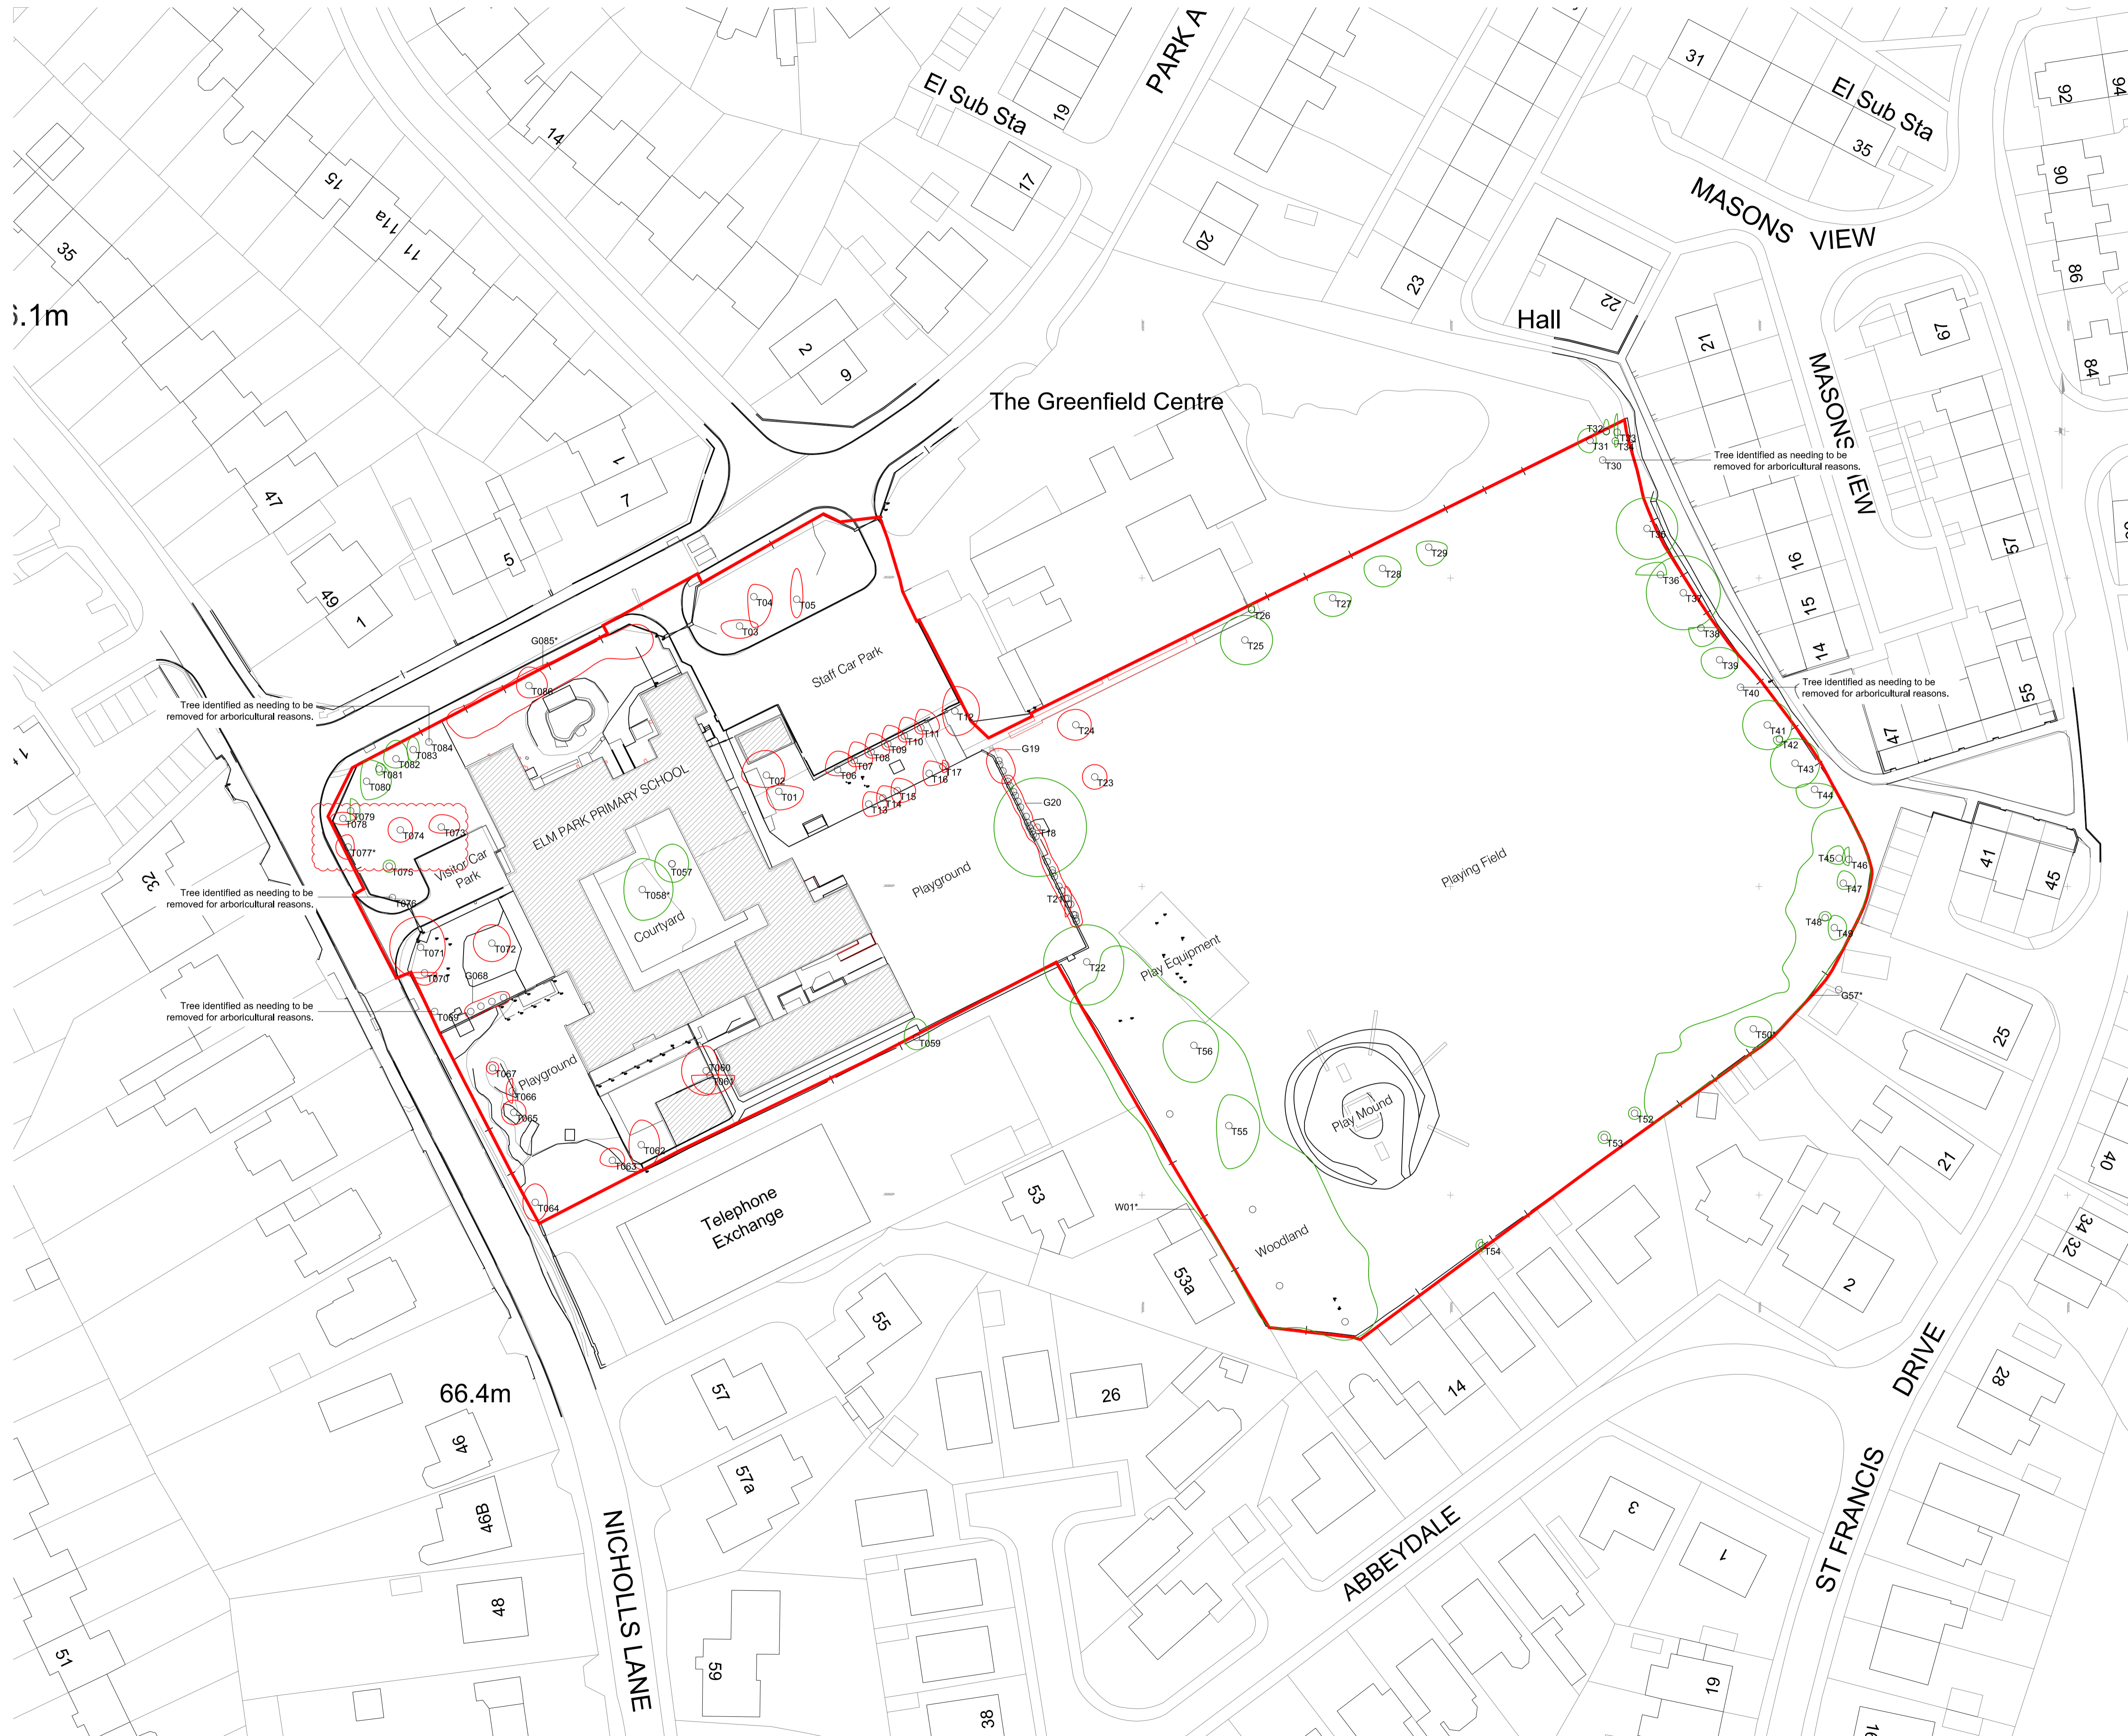
Category Crown Spread
 Root Protection Area

- Key
- Planning Application Boundary
 - Existing Building
 - Trees to be retained and protected
 - Trees to be removed

Tree identified as needing to be removed for arboricultural reasons.

5.2 Constraints on the design of the development are presented in the Arboricultural Impact Assessment Plan (appendix 1). These constraints are also considered in the main body of the report below and recommended remedial works and mitigating measures.

5.3 The Arboricultural Impact Assessment Plan (AIA), (appendix 1), shows the Root Protection Areas (RPAs) for the individual trees identified in the tree schedule tables. This represents the minimum area in m² which ideally, should be left undisturbed around each tree were it to be retained. The AIA also shows a representation of the crown spread of each tree measured in four cardinal directions. The RPA has been calculated in accordance with Section 4.6 of BS5837:2012 Trees in relation to design, demolition and construction – Recommendations.

7.0.1 Below ground protection measures, based on the root protection areas (RPA), indicated in the Arboricultural Impact Assessment Plan (appendix 1), will involve the erection of tree protection barriers as discussed in Section 7.2. Where the proposed site layout encroaches into the RPAs of retained trees, measures are recommended to minimise the potential damage to the roots and the root environment of the trees in question.

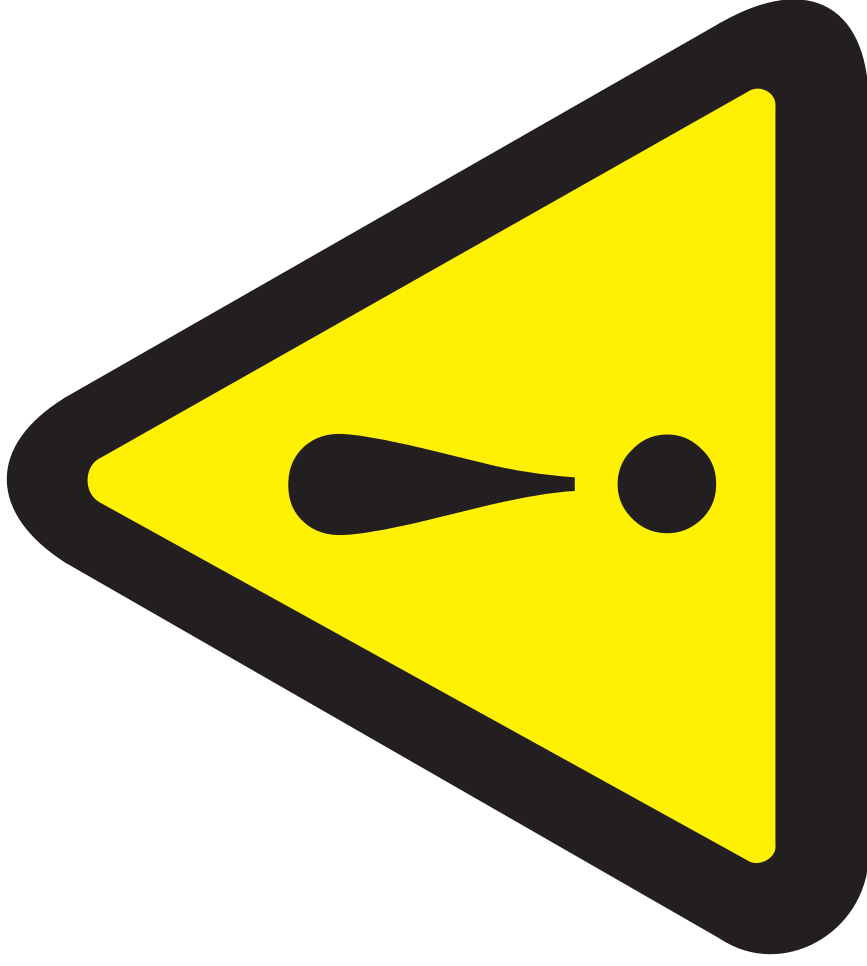
TREE PROTECTION AREA

KEEP OUT !

**(TOWN & COUNTRY PLANNING ACT 1990)
TREES ENCLOSED BY THIS FENCE ARE PROTECTED BY
PLANNING CONDITIONS AND/OR ARE THE SUBJECTS OF A
TREE PRESERVATION ORDER.
CONTRAVENTION OF A TREE PRESERVATION ORDER MAY
LEAD TO CRIMINAL PROSECUTION**

**ANY INCURSION INTO THE PROTECTED AREA MUST BE
WITH THE WRITTEN PERMISSION OF THE LOCAL
PLANNING AUTHORITY**

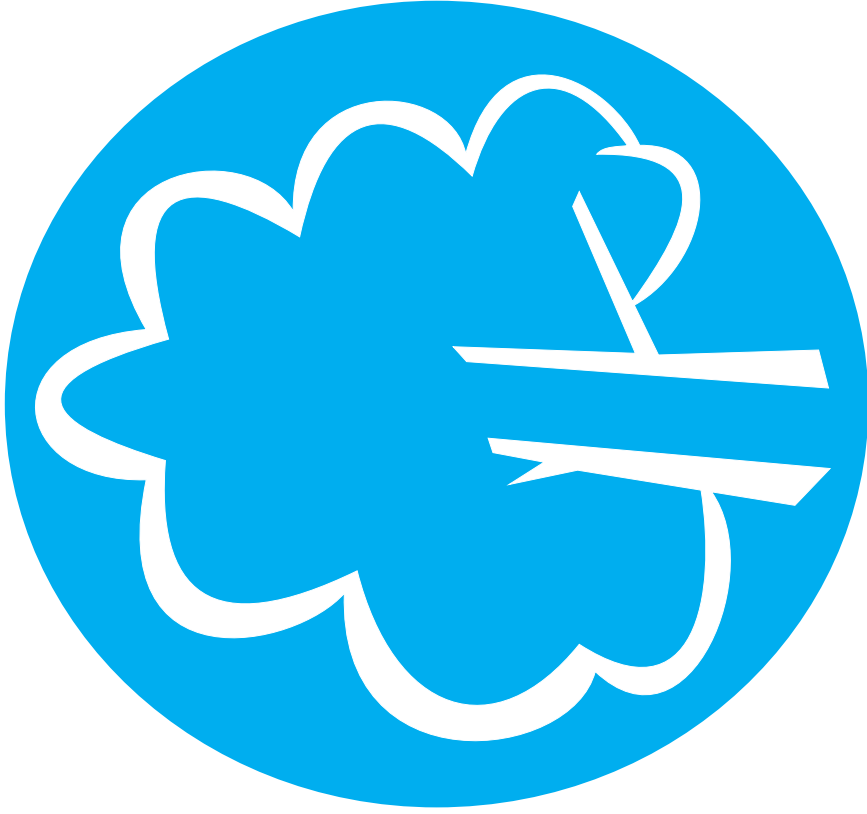
**PROTECTIVE FENCING. THIS
FENCING MUST BE
MAINTAINED IN ACCORDANCE
WITH THE APPROVED PLANS
AND DRAWINGS FOR THIS
DEVELOPMENT.**

- 8.4.2 The protective fencing will incorporate the site hoardings which will be erected around the site prior to the commencement of any works. The protective fencing will be constructed in accordance with BS5837:2012 'Trees in relation to design, demolition and construction – Recommendations'. This will consist of a vertical and horizontal scaffold framework well braced to resist impacts. Vertical tubes will be spaced at a maximum interval of 3m and driven securely into the ground. Weldmesh panels will then be securely fixed to the framework., in accordance with Figure 2 of BS5837:2012 'Trees in relation to design, demolition and construction – Recommendations' (appendix 4).

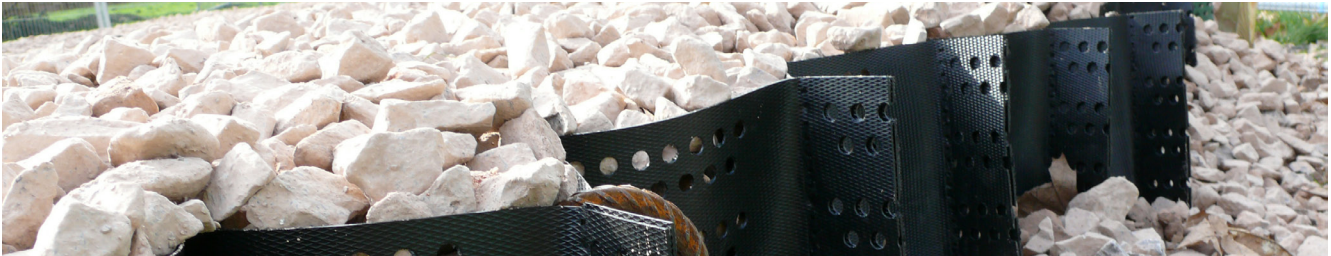
Cellweb® TRP is a 3D cellular confinement tree root protection system. The system provides a 'no dig' solution for the construction of new hard surfaces within root protection areas (RPAs). Cellweb® TRP has been designed and independently tested to comply with recommendations made in Arboricultural Practice Note 12 and BS 5837 2012 – Trees in relation to design, demolition and construction.

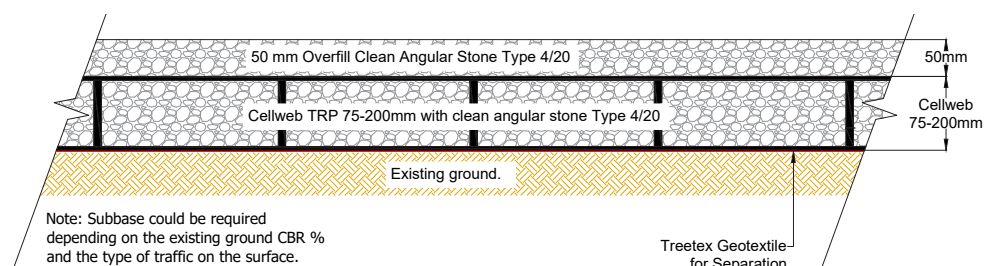
Indicative Cellweb with overfill

The Cellweb® System is provided in four different depths; 200mm, 150mm, 100mm and 75mm. The depth required is determined by the proposed traffic loadings and the site ground conditions. Geosynthetics in house engineering department can provide a free site specific technical recommendation. For free technical and engineering support please contact Geosynthetics Ltd 01455 617139 or the full installation guide can be found on our website www.geosyn.co.uk.

8.5.2 200mm deep ‘Cellular Confinement System’ (CCS) will then be laid across the area. This will provide a load-bearing and permeable structure. The cellular design and perforated cell walls reduce the vertical load pressure on sub soils to tree roots and prevents damage.

8.6.2 75mm deep ‘Cellular Confinement System’ (CCS) will then be laid across the area. This will provide a load-bearing and permeable structure. The cellular design and perforated cell walls reduce the vertical load pressure on sub soils to tree roots and prevents damage.
