HERITAGE IMPACT ASSESSMENT

- 1.1 The focus of this report is to provide an assessment of the heritage impact of the alterations and proposed refurbishment work already carried out and to be carried out at No.75 Broad Street, Chipping Sodbury which was formerly in the ownership of the National Westminster Bank which used to occupy both 75 and 77 Broad Street.
- 1.2 The site is located on the North side of Broad Street in the historic town of Chipping Sodbury. Originally being two properties split roughly equally with both stretching from Broad Street all the way down to the river.

Job No. 789A

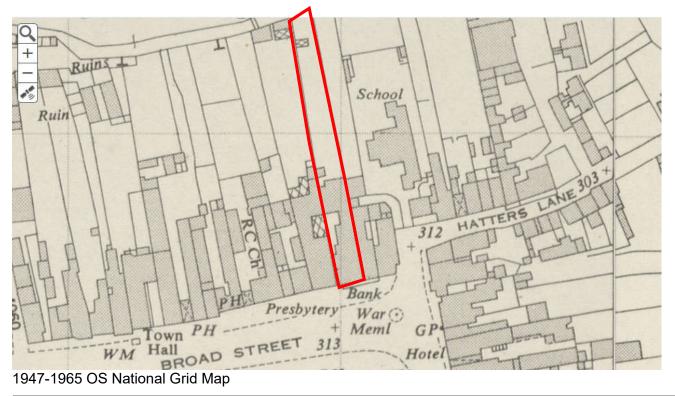
1.4 Whilst the extent of the frontage of the buildings on the site has remained constant through the time since they were first established, the rear of the properties has undergone significant alterations – see the post war map below

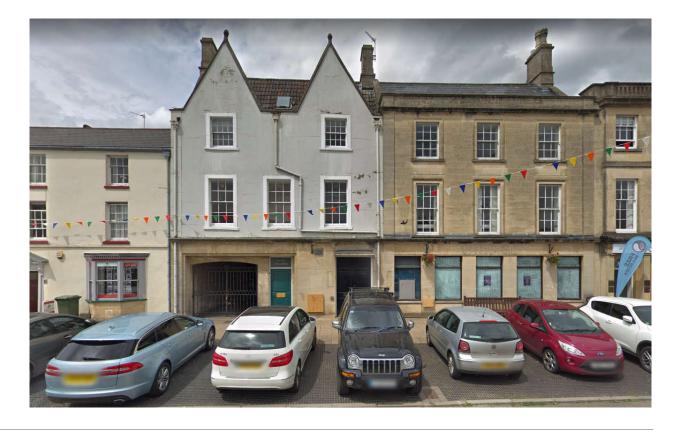
- 1.11 The building frontage of No.75 is earlier than its neighbour at No. 77. The basic structures immediately behind the facades are all similar, being a three storey main structure of approximately 6.5 metres in depth. Numbers 75 and 77 both have a roof structure of two main trusses at approximately 2.8 metre centres spanning from front to back with purlins and rafters establishing a roof line that runs parallel to the street.

Numbers and 77 has had a Georgian façade of cotswold stone constructed on the street elevation which is later that the Flemish style Gabled frontage of No.75. The current vehicular access to the rear may have existed as some form of pedestrian access in the past but has been significantly altered to enable car access in the twentieth century.

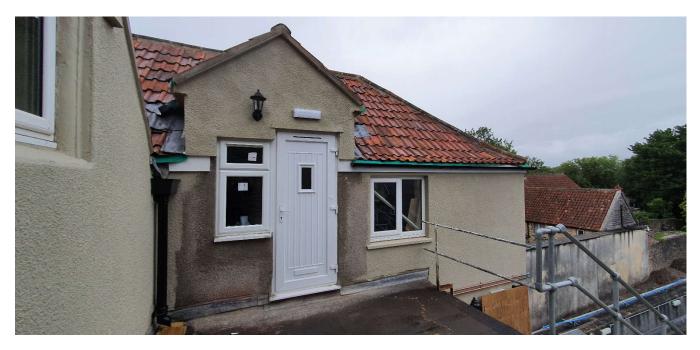
Photograph 1 showing the new dormer and escape door from the second floor hall Note that the PVC window and door will be replaced with a painted timber door and window.

- IV. Form a dormer over the existing escape window from the second floor rear hall to enable it to be converted into a door suitable for fire escape and a rear access from the dwelling to the car park using the existing external escape stair. Install painted timber framed, ledged and braced door in timber frame with sidelight and top hung fanlight window. This to be done at the same time as replacing the roof detailed in III above. See appendix 1 photo1- Note that the PVC window and door will be replaced

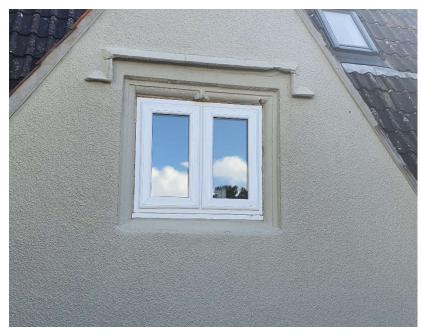
Photograph 2 showing the stone window surround

- V. Reinstate the existing stone mullion on a new cast stone cill to the window to bedroom 1. Remove and dispose of the existing window frame, prop the head of the window and carefully remove the remnants of the existing stone cill. Measure the profile of the ashler stone frame members and the mullion that is being stored off-site and get a new cill cast with stoolings for the frame and mullion to sit on using a bath stone dust mix. Install the new cill and existing mullion and new critall-style powder-coated, double-glazed metal window frames with top-hung opening sashes to upper section. See appendix 1 Photos 2 and 3

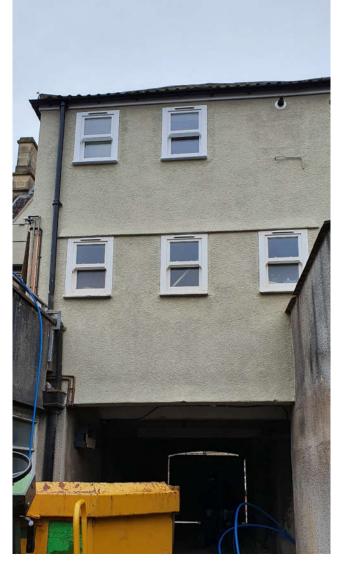
Photograph 4 New sash windows

- VI. 3No. windows on rear elevation of first floor to be replaced with new double-glazed timber box sash windows. Door to rear side elevation to be replaced with half-glazed painted timber door and frame. See appendix 1 Photo 4 and 5

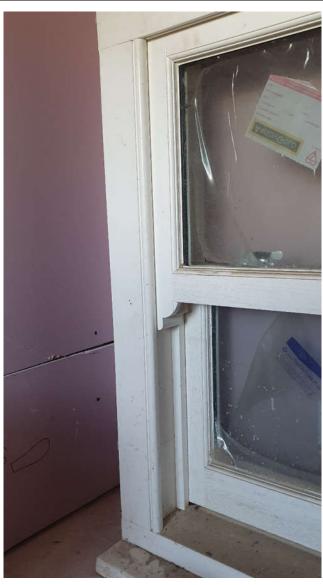
Photograph 5 Detail of sash window construction

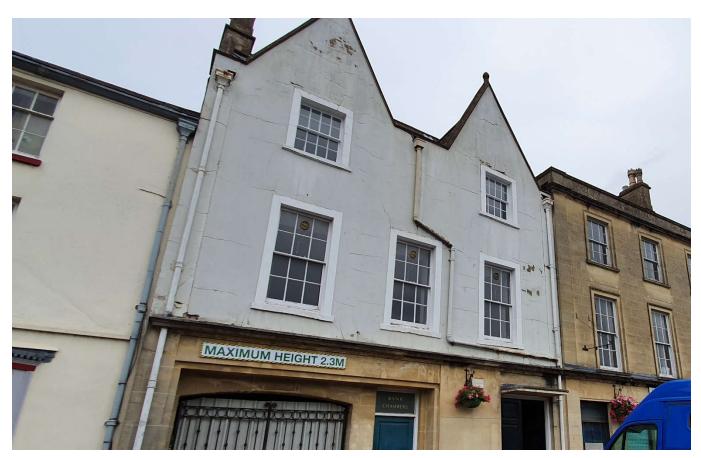
Photograph 9

- IX. To the front elevation it is proposed to remove the existing render which is cracked and de-bonding from the brickwork behind – see appendix 1 photo 9. Following the repair to any damaged brickwork this will be replaced with lime render of a mix to be agreed with conservation officer once the overall condition of the brickwork backing has been assessed.
