103 & 105 Henderson Street, Bridge of Allan, Stirling: Heritage Assessment

AOC Project Number: 25624

December 2020

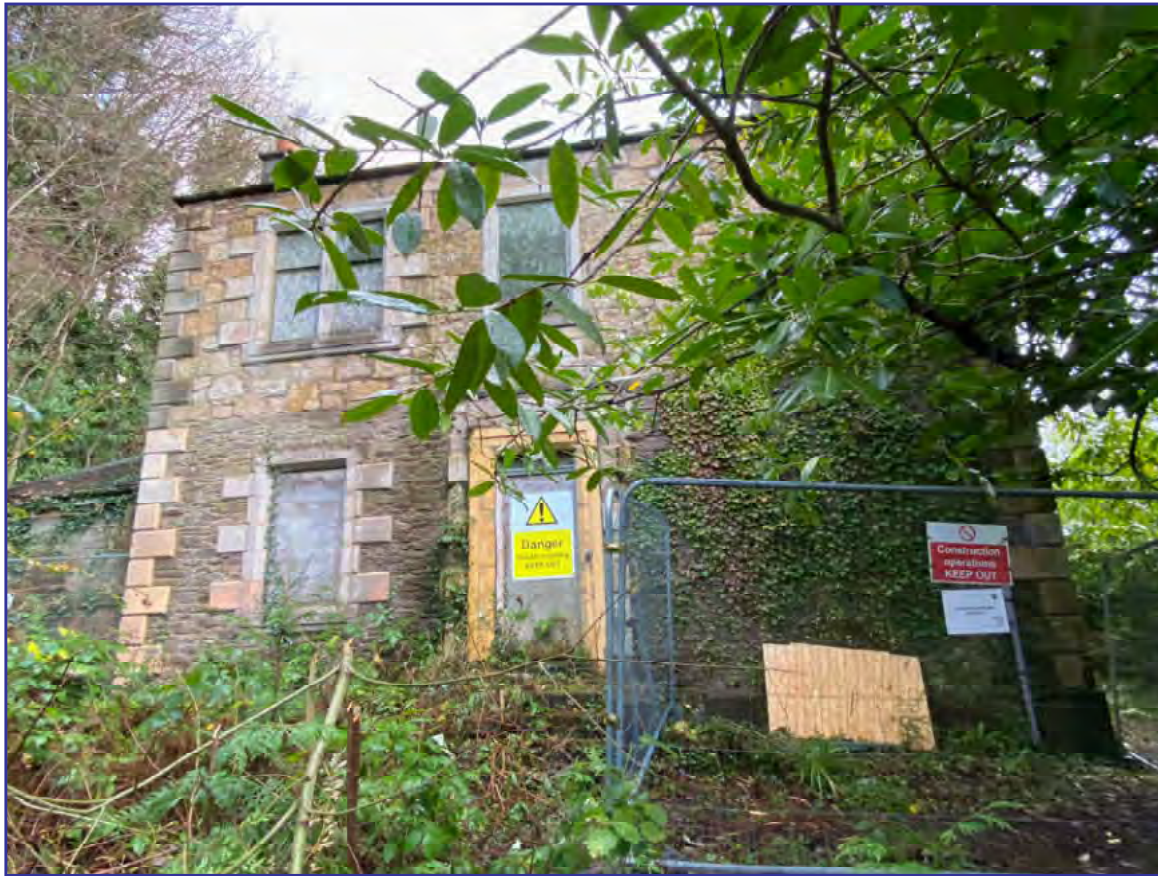
Plate 1: ESE facing view of No.105 Henderson Street (Site 90)

- 5.5.1 The Site was visited on the 14th of December 2020 in dry clear weather with excellent visibility.
- 5.5.2 The site visit established that both buildings are now vacant, derelict and in the case of No.105 in extremely poor condition (Plate 1 & 2). Both buildings are partially fenced off and have large 'Danger Unsafe building KEEP OUT' signage attached prominently to their facades (Plate 3). Smaller signs have been attached to the fencing on both properties by Stirling Council's Building Standards Team, these notices read 'DANGEROUS BUILDING KEEP OUT' (Plate 4). For this reason, neither building could be entered during the site visit. Although the structural integrity of the buildings falls outwith the scope of this report, a large crack was observed immediately below the chimney stack in the upper level of the west elevation of No. 105 (Plate 5), whilst a significant collapse has torn a hole in the upper floor of the building's east elevation, leaving the chimney balancing precariously on the roof above (Plate 6). When seen from Henderson Street to the south, No.105 is largely concealed from view behind a wall of overgrown trees and vegetation all though the building's roofline, leaning chimneys and parts of the upper storeys can be glimpsed in places (Plate 7). Overall, the plot has the appearance of overgrown, unkempt wasteland partially concealing an undeniably dangerous structure.

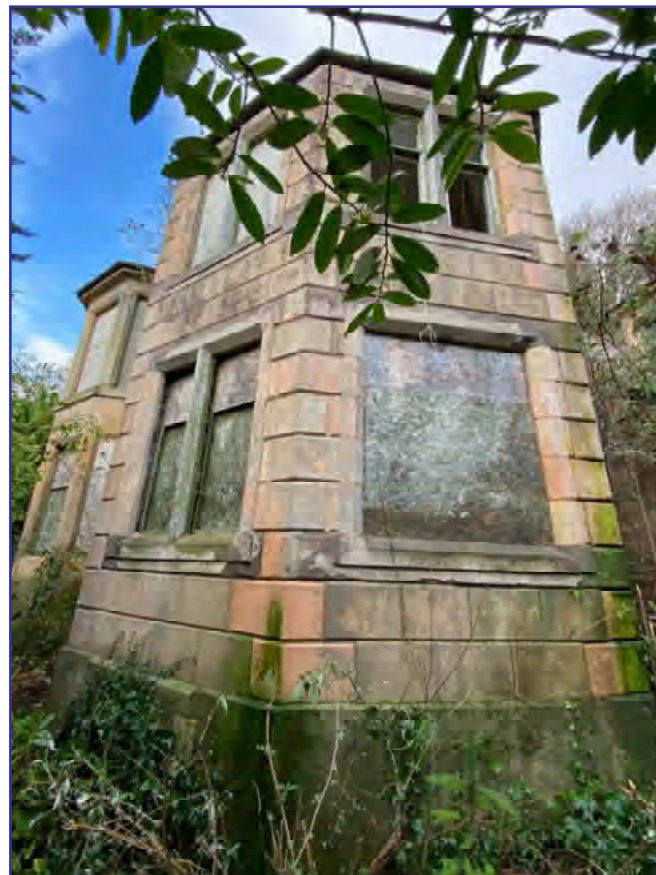
Plate 2: NNW facing view of No.105 Henderson Street (Site 90)

- 5.5.3 The deterioration of No.103 is more recent and, at present, less severe than that of No.105. However, the building is a more conspicuous presence when seen from Henderson Street, as it is viewed from across an open car park (Plate 8). The smashed windows and decay to the timber work on the south elevation of No.103 are clearly visible although the rear and side elevations appear to be in poorer condition (Plates 9-11). The entrance porch retains its wrought iron pillars and roof (Plate 3), although the overlying lattice work balcony that was shown on the 1975-6 photograph and is referenced in the Listing Description has now been lost. The interior of No. 105 could not be visited on safety grounds although a glimpse through the windows suggests that at least some of the original panelling and fixtures survive (Plates 12), as do two external fixtures; the two wrought iron boot scrapers (Plates 13) that are positioned on either side of the main door and also appears to be original (Plate 2).
