# **Protected Species Report for Bats and Nesting Birds**

Mr Ian Goode

Springfield

**December 2020**

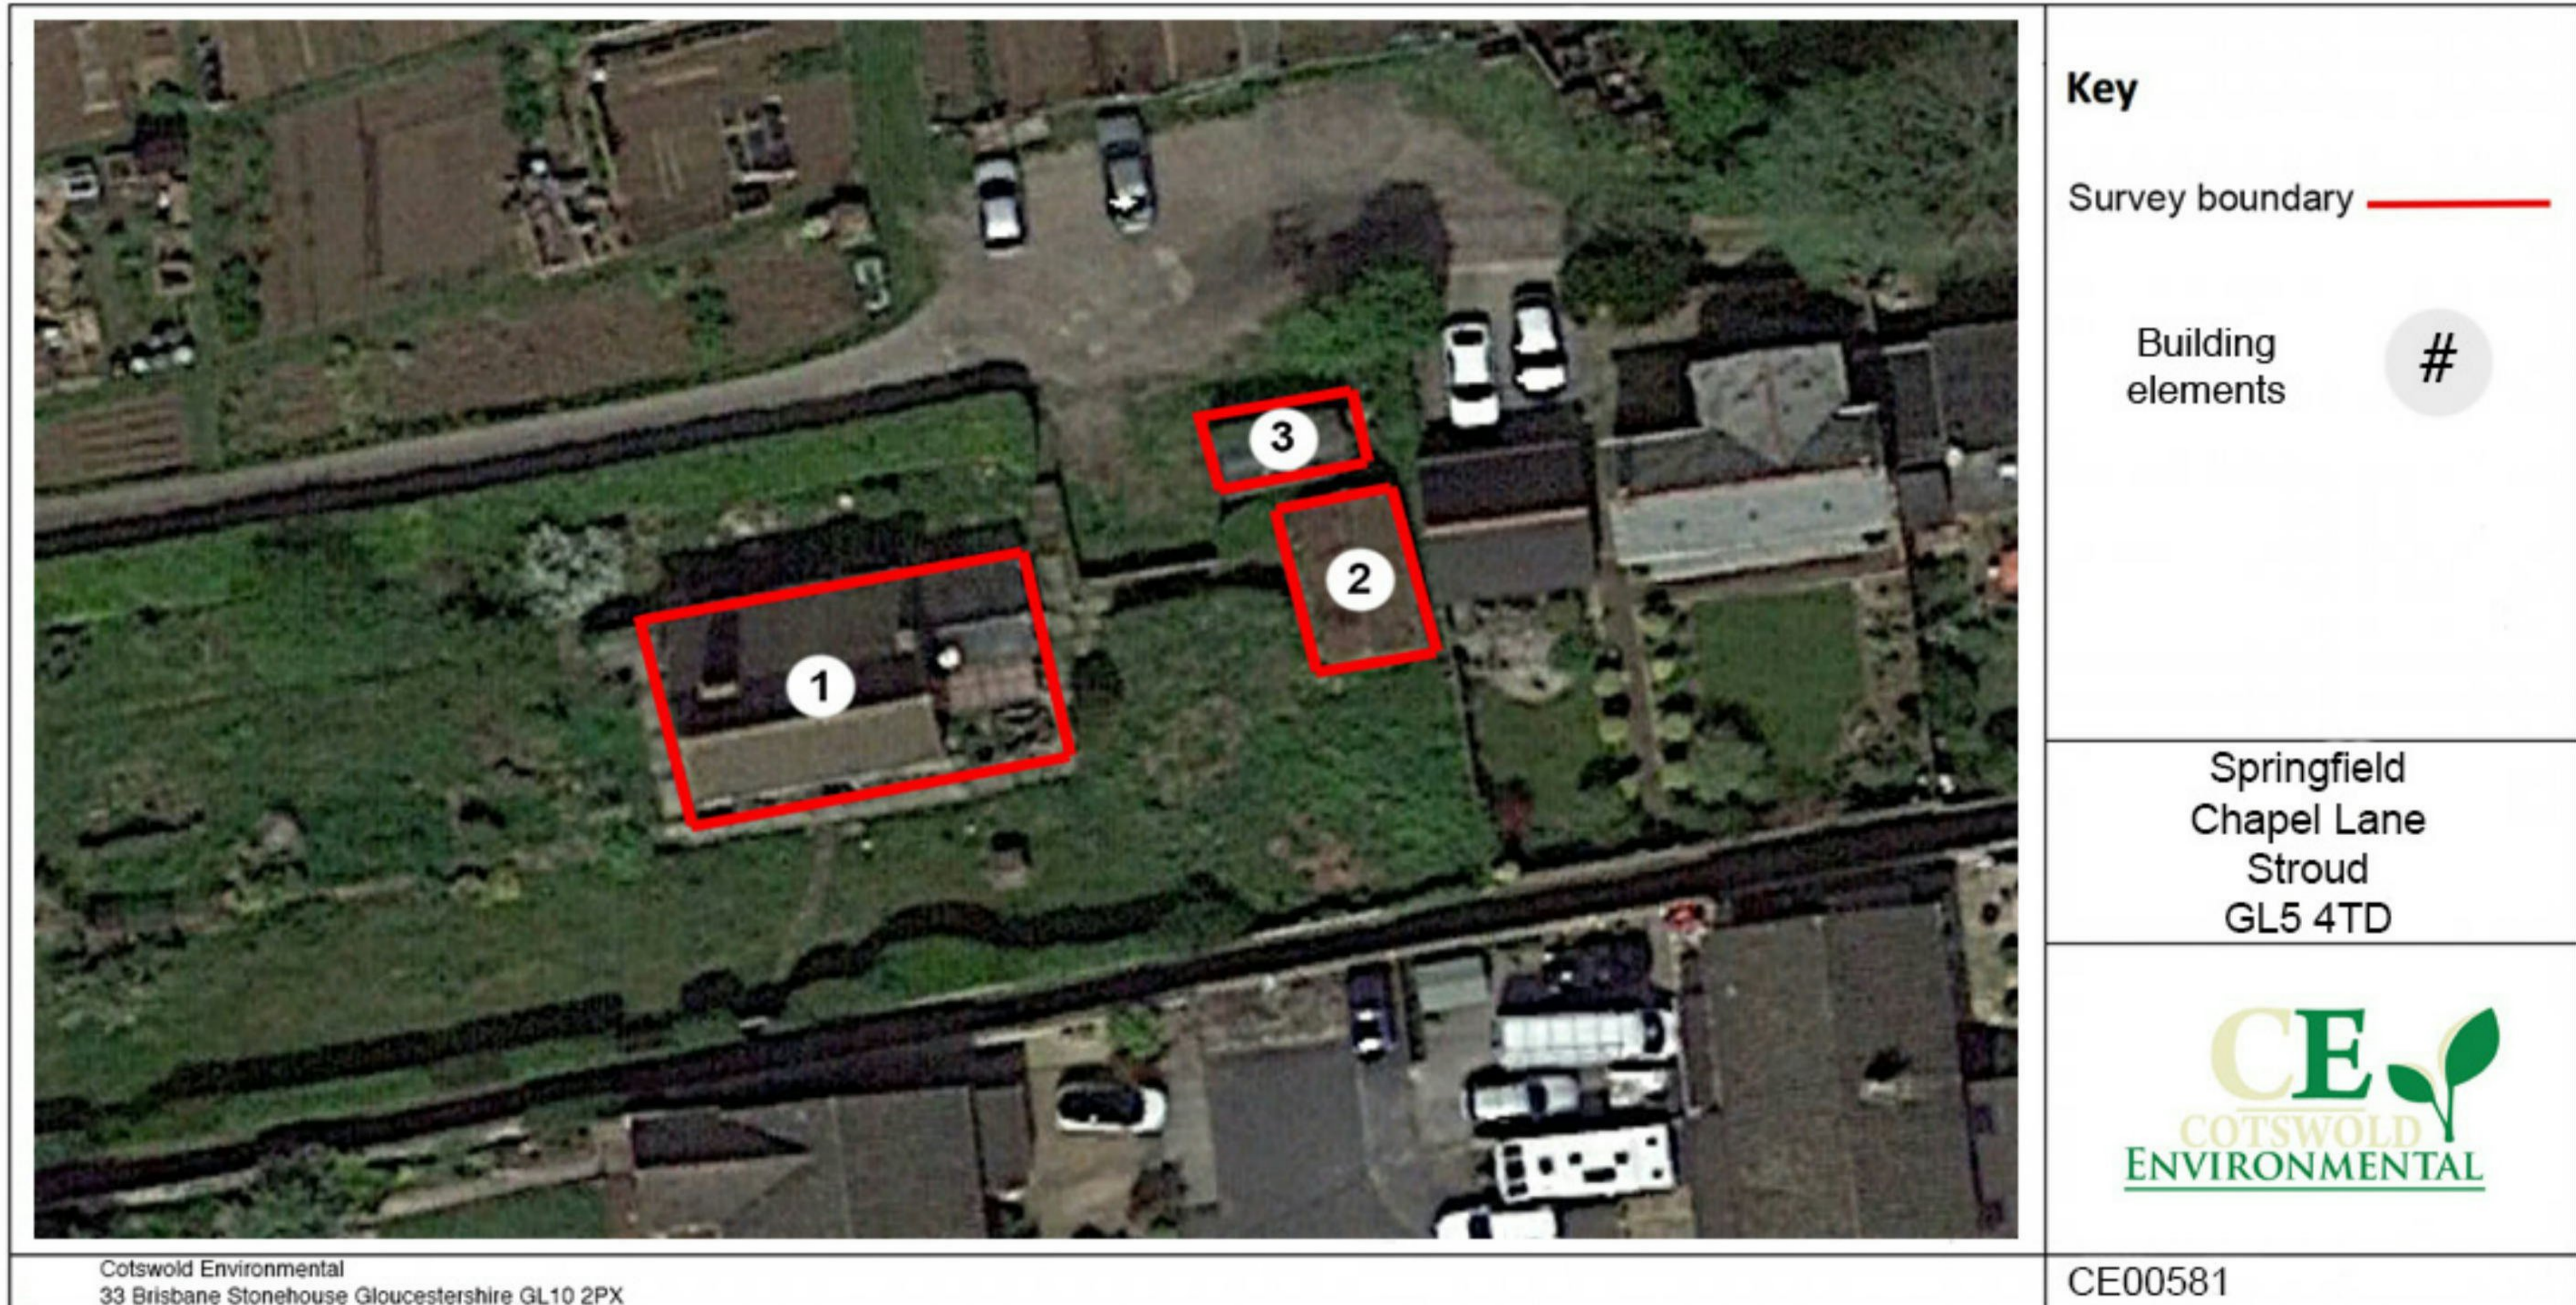
Figure 2: Site Map

- 1.5 Three buildings were surveyed as part of the assessment. For the purpose of this report, a residential dwelling is referred to as Building 1 (B1), outbuilding as Building 2 (B2) and single detached garage and Building 3 (B3) (see Fig. 2: Site Map).

- 3.4 The grounds of Springfield comprise a detached residential dwelling, detached outbuilding and a single garage with associated garden. For the purpose of this report, the residential dwelling is referred to as Building 1 (B1), outbuilding as Building 2 (B2) and single garage as Building 2 (B3). The PRA and all subsequent information pertain to these buildings only (see Fig. 2: Site Map).

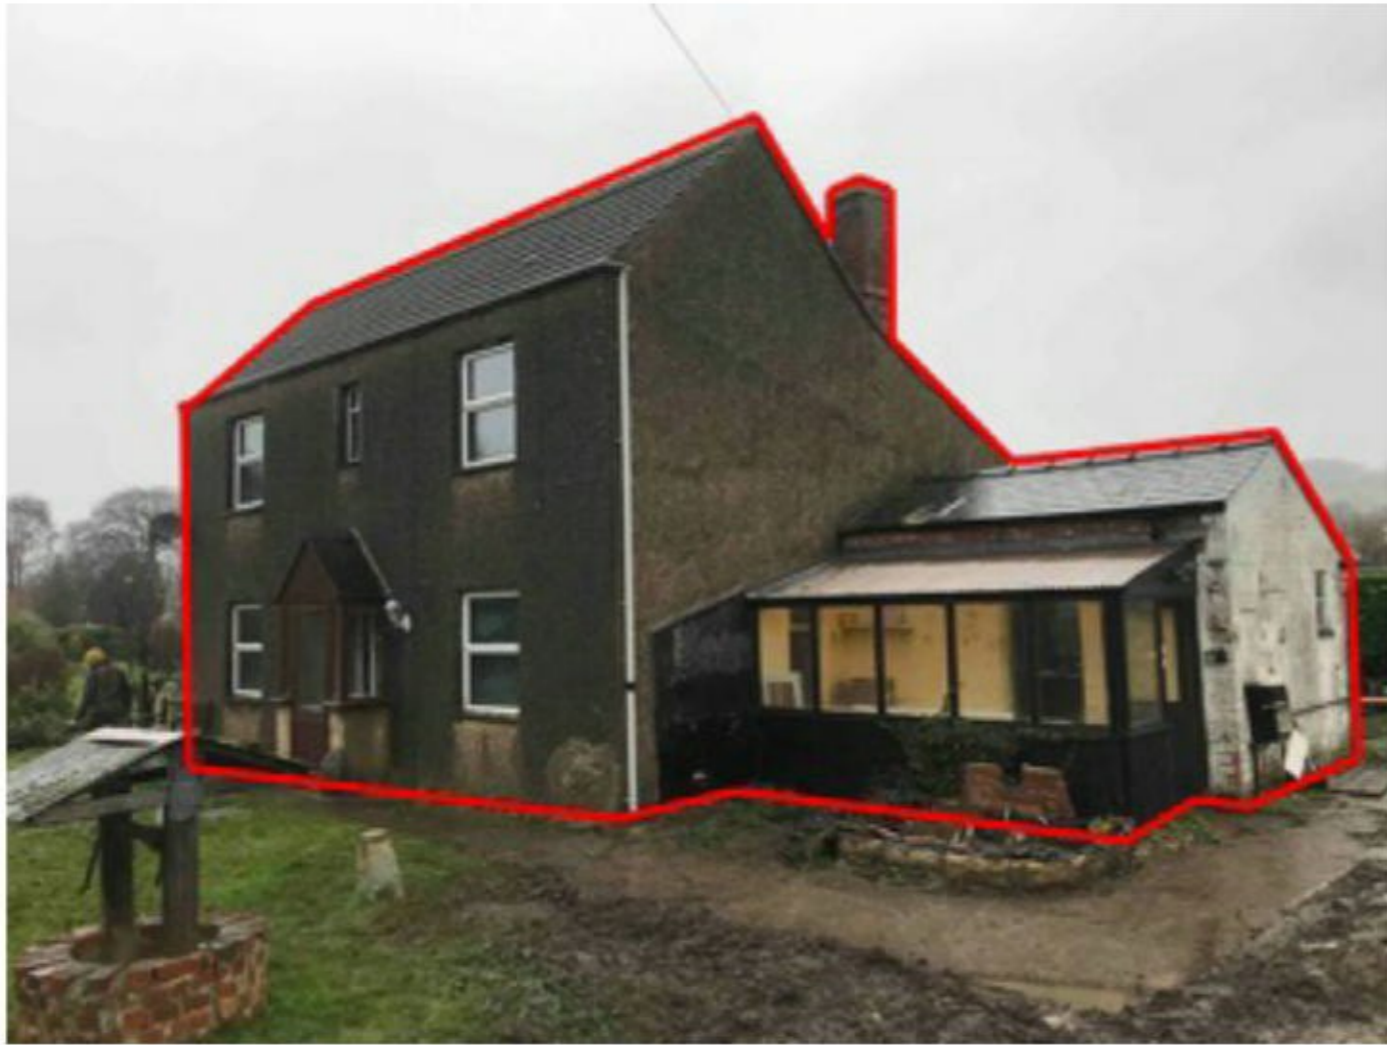
- 3.5 Building One is a two-storey residential dwelling supporting a pitched timber-framed roof clad with clay roof tiles. Adjoining the eastern gable wall is a single-storey element supporting a shallow-pitched roof clad with slate roof tiles. Two separate loft voids are present: a large loft above the main residential dwelling, and a small loft void within the shallow-pitched roof of the single-storey element.

**Photo 1: Red line highlights Building One (B1).**

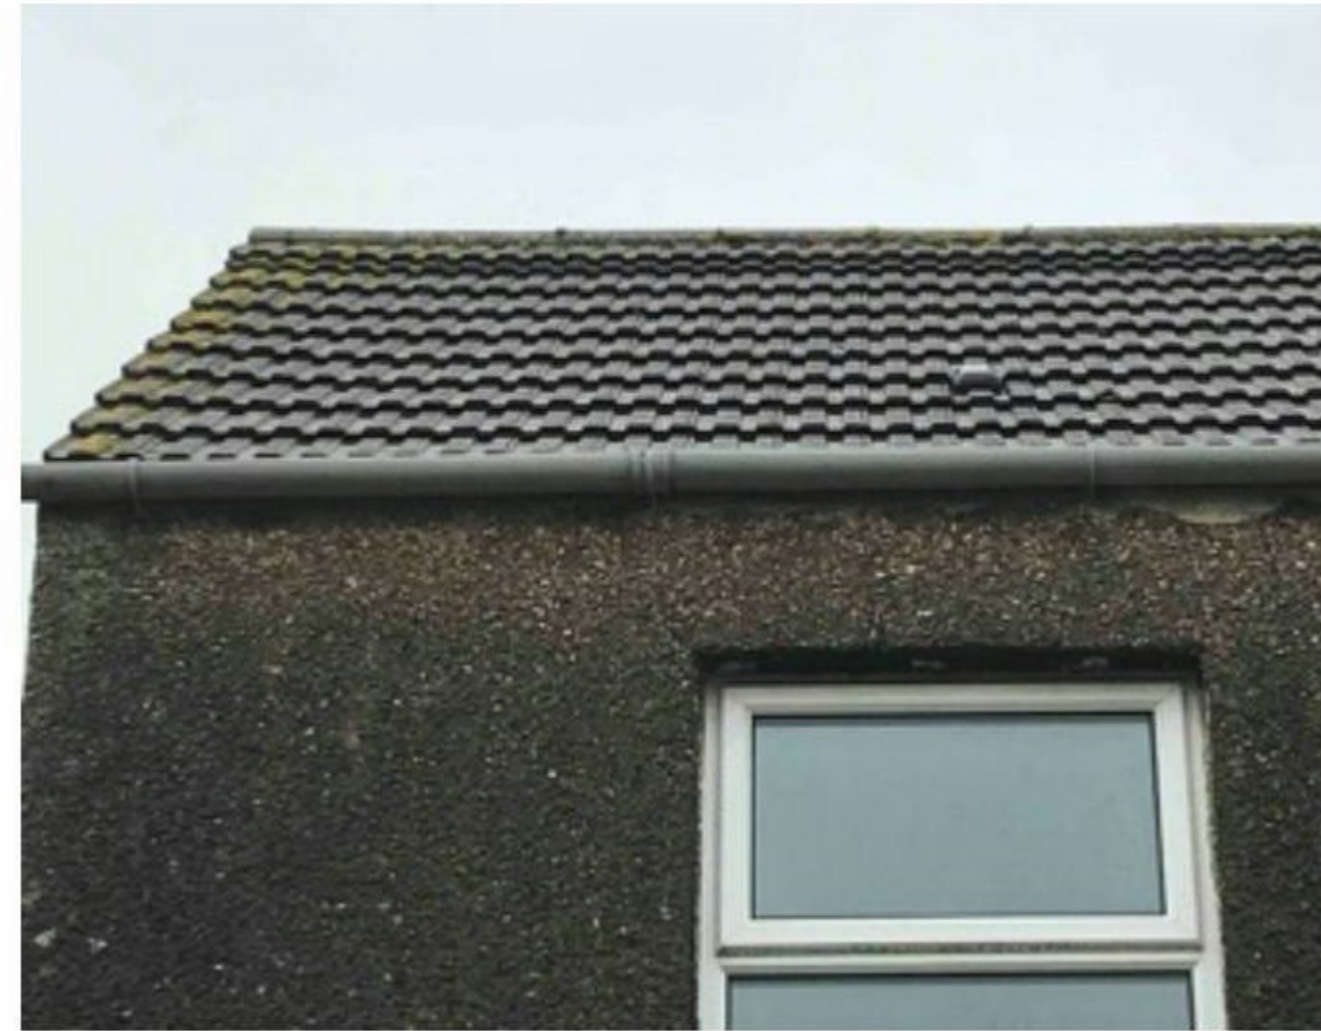
- 3.6 Externally, the roof of both elements is in excellent condition without any slipped or raised roof tiles, and ridge-capping appears to be securely fitted without any obvious gaps. Lead flashing surrounding a chimney was flattened and without raised areas, and no cracking or gaps were present within the external brickwork. Timber-framed windows are fitted throughout, all of which were closed and tightly-fitted at the time of the survey.

**Photo 2: External roof of B1, which was in good condition without any obvious slipped or raised roof tiles.**

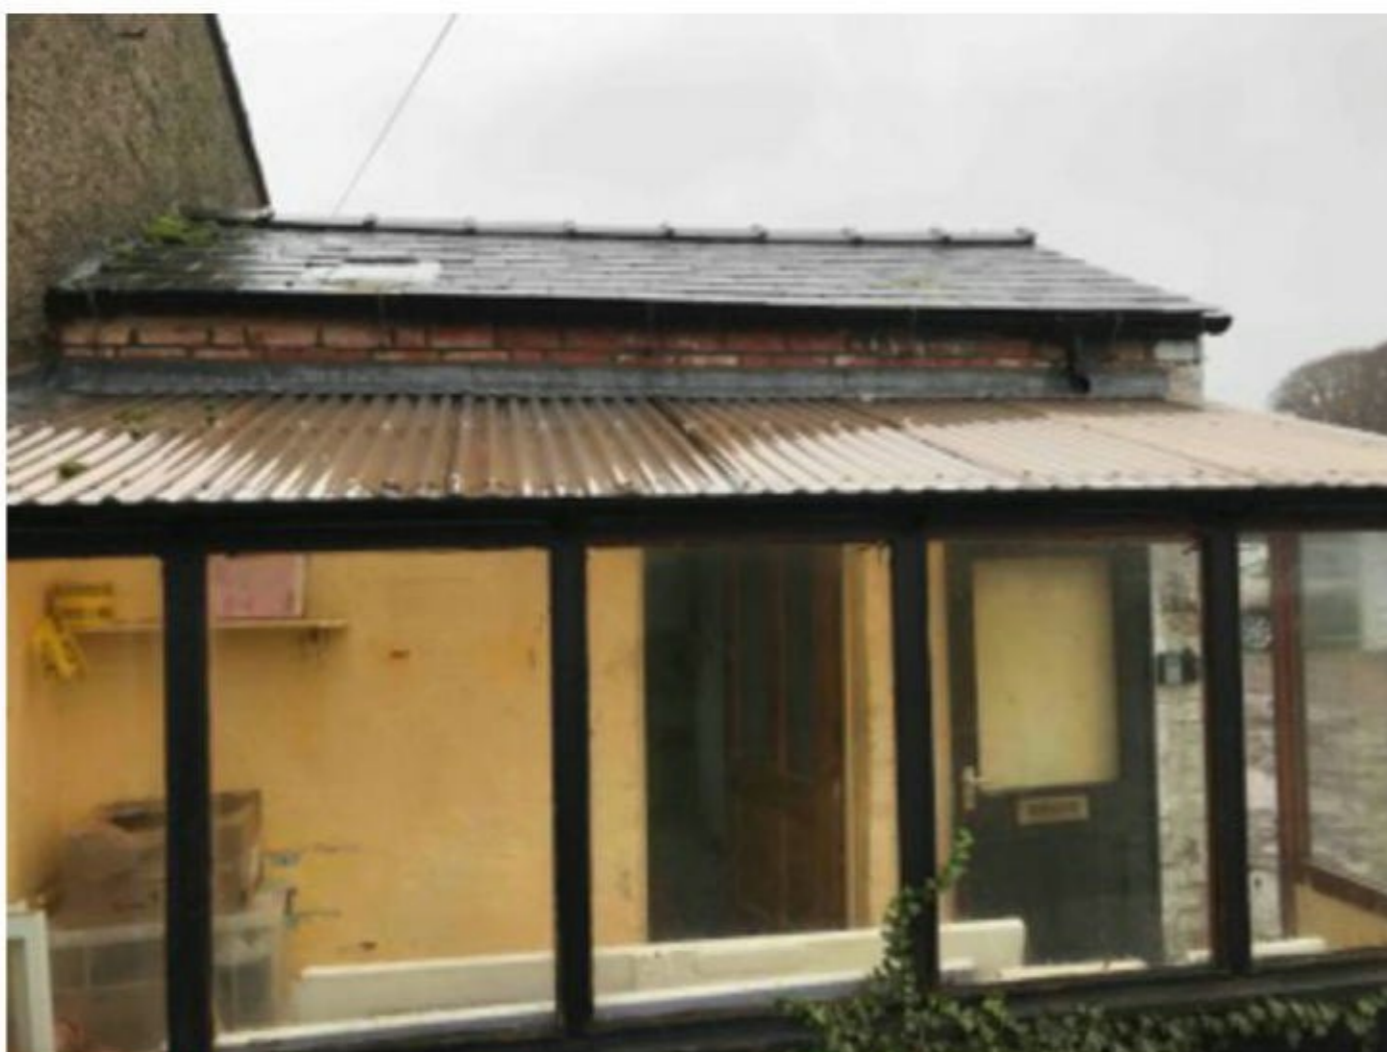
**Photo 3: Single-storey element attached to Building 1.**

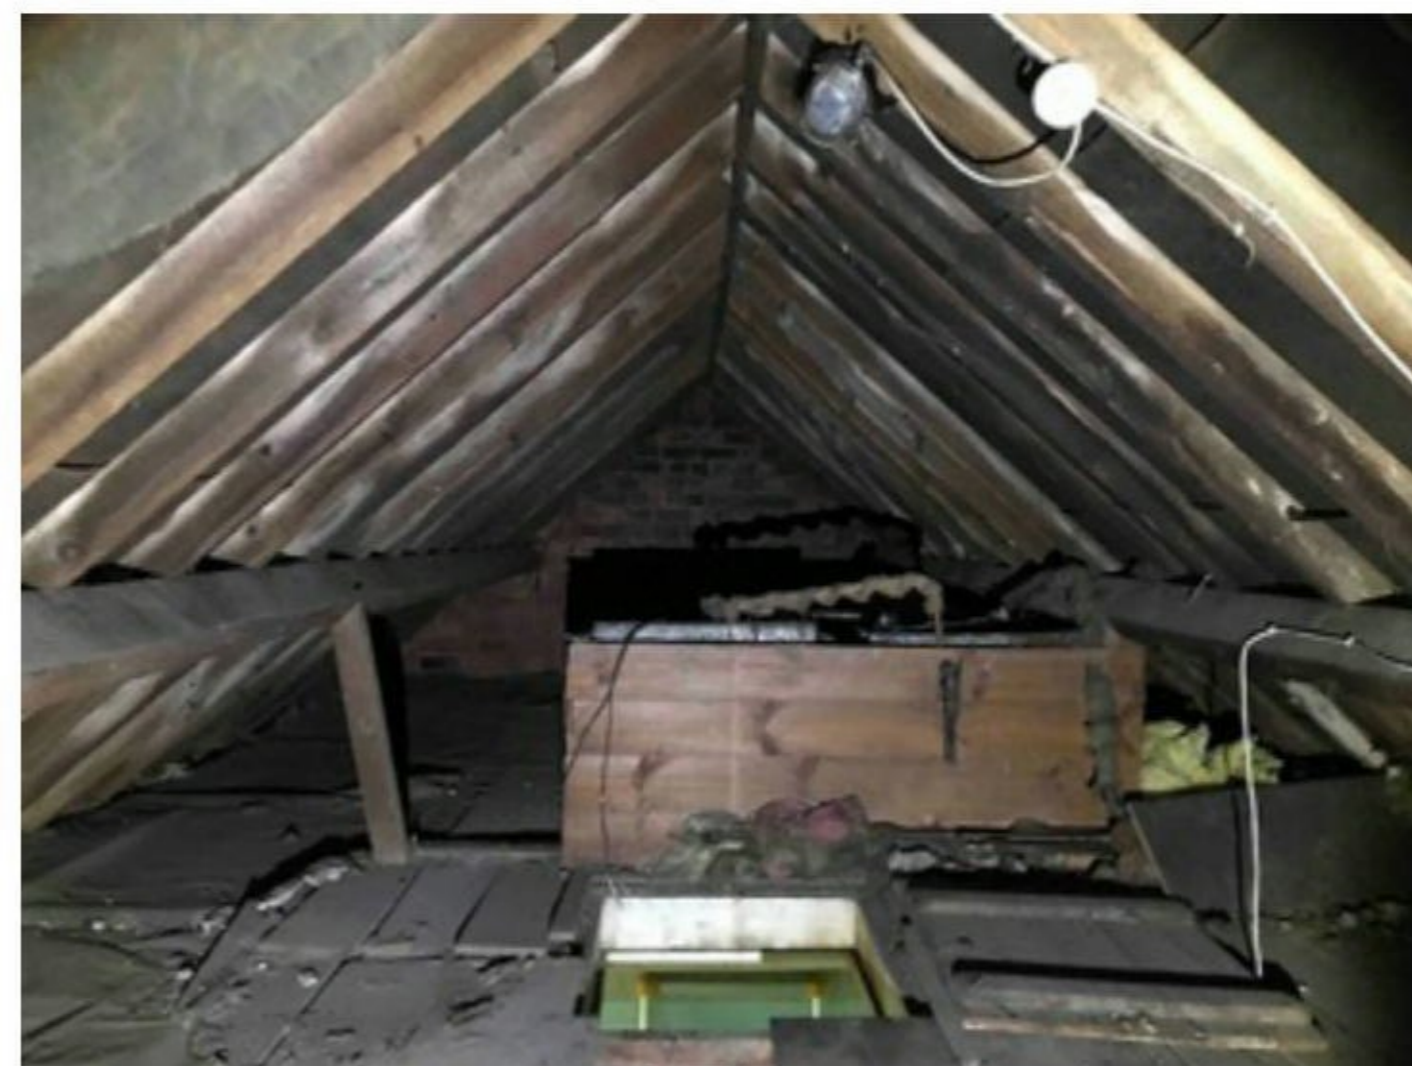
- 3.7 Internally, both loft voids were accessed via traditional loft hatches for thorough assessment. The floors are lined with a thick layer of loft insulation, and roof of the main loft was underlined with bitumen felt that was in good condition without gaps or tears. No areas of daylight or further entry points that would allow bats to gain entry into the building were noted during the assessment. The roof of the smaller loft above the single-storey element is not underlined, though no gaps were present within the roof and no daylight was visible at eaves level. Timber joists and purlins of the roof structure within both loft voids are exposed.

**Photo 4: Internal view of loft element above B1.**

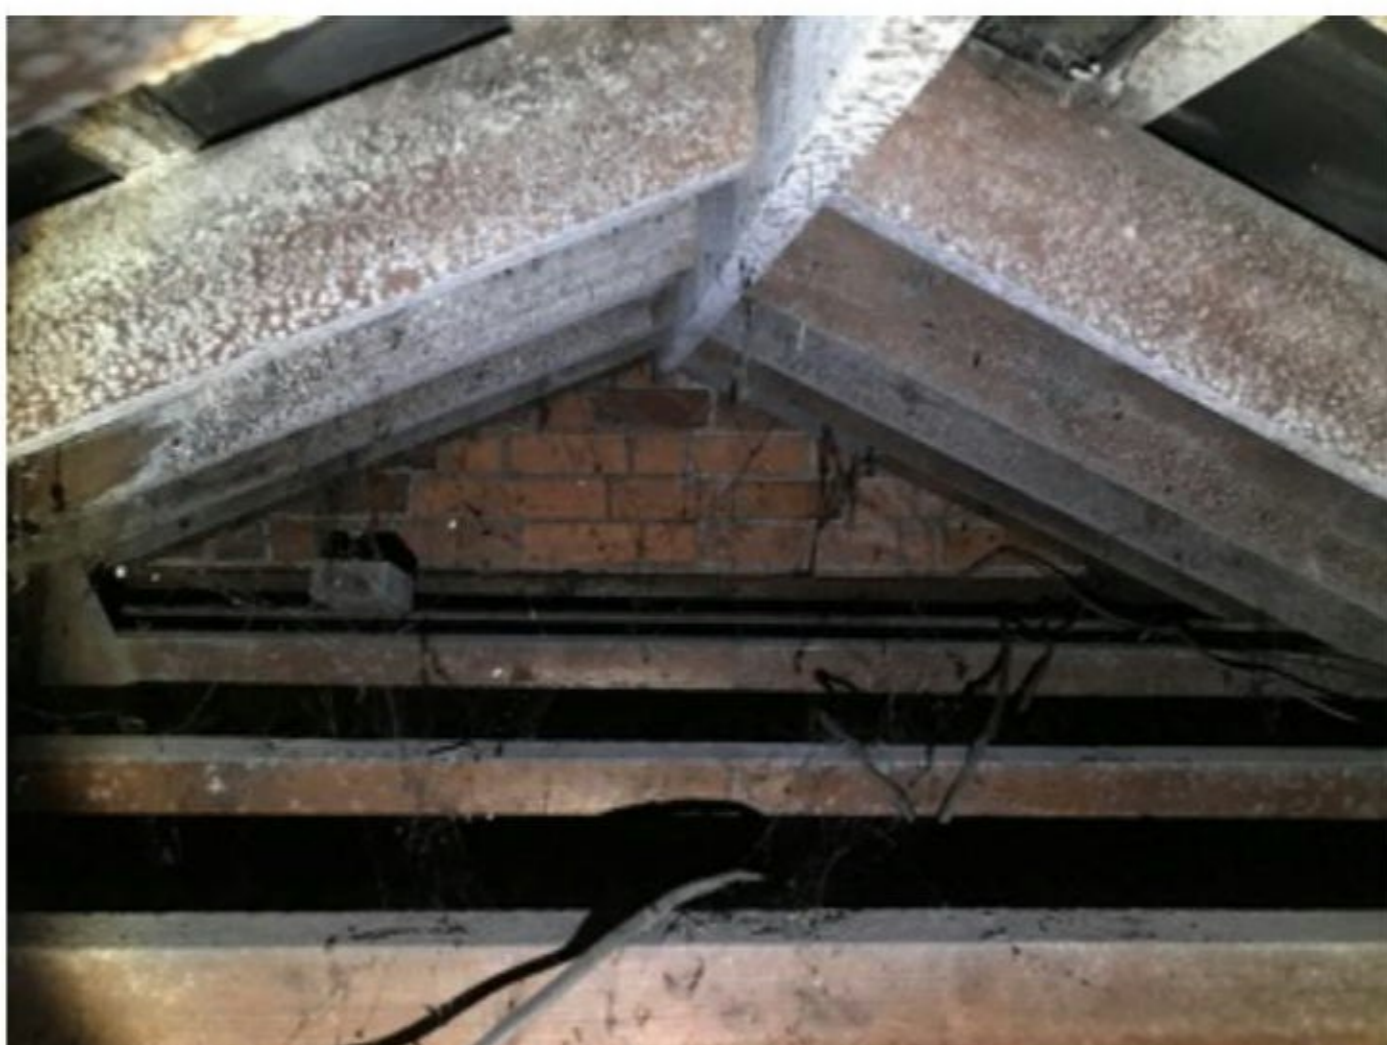
**Photo 5: Internal view of small and shallow loft space above single-storey element of B1.**

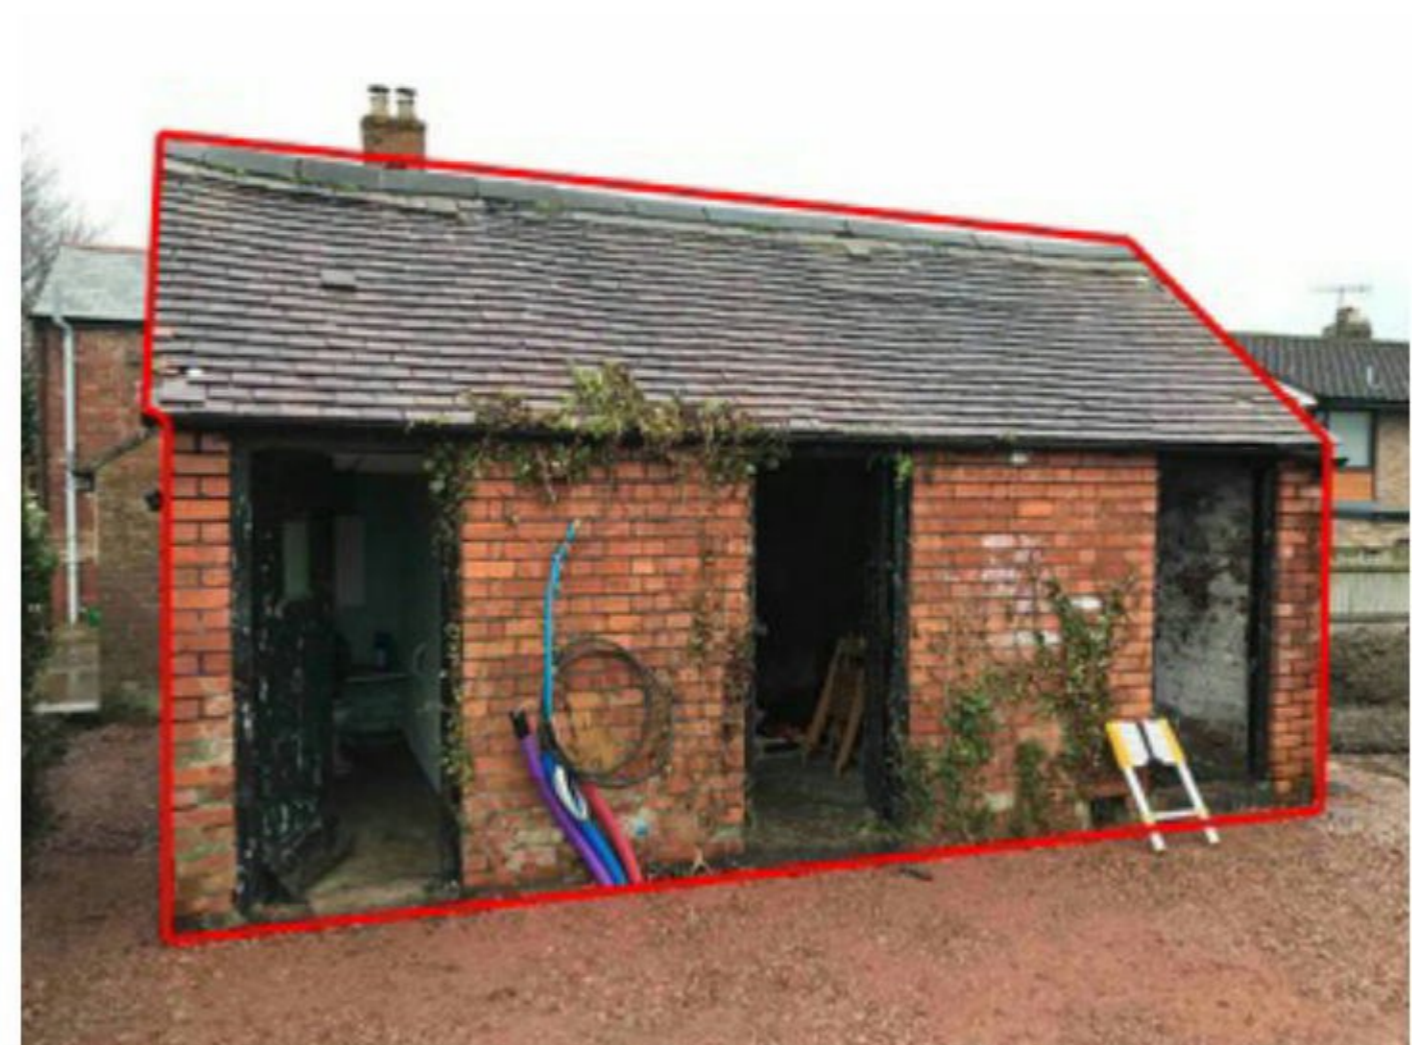
- 3.9 Building Two is a detached single-storey brick-built outbuilding supporting a pitched timber-framed roof clad with clay tiles. It is divided into three elements, each with its own timber access door, and no loft void is present. A small and open-top basement is located within the southerly element, accessible via internal ladder. The building is currently utilised for storage.

**Photo 6: Red line highlights Building Two (B2).**

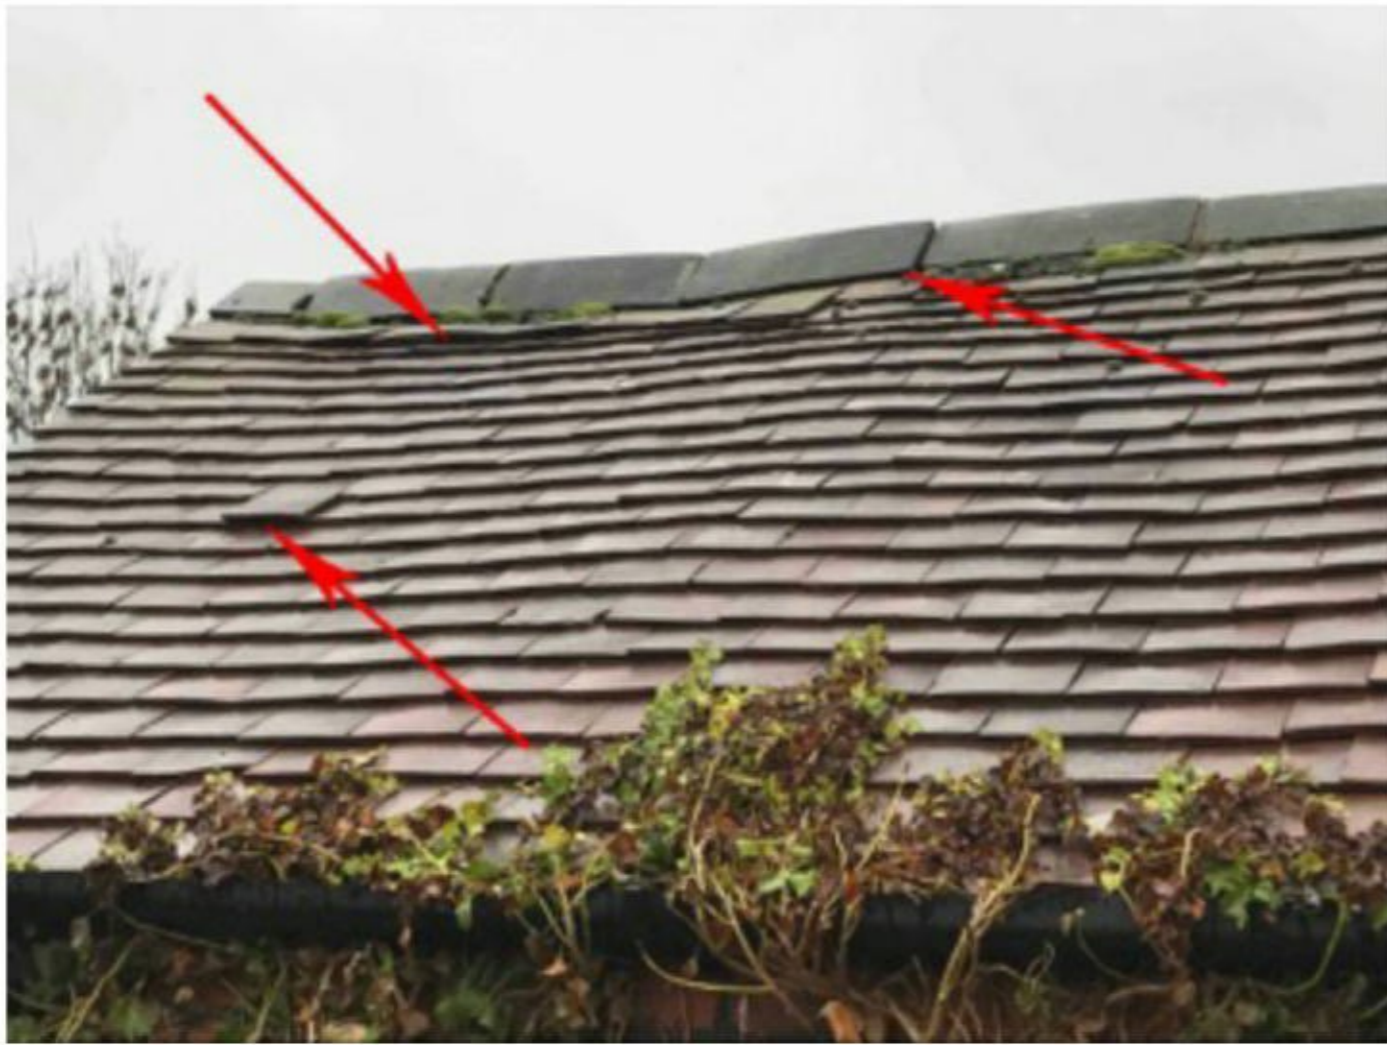
- 3.10 Externally, brick walls of the building were in good condition without cracking of openings that could be exploited by bats for roosting. Numerous raised tiles were present on both the east and west-facing roof aspects, as well as dislodged and absent tiles that would provide access points for bats into the building. Furthermore, ridge-capping was dislodged and raised in areas, and failed mortar was present at ridge-cap ends. Timber doors leading into each element were tightly fitted when closed.

Features (PRFs) including exposed timbers joists and purlins of the internal roof structure throughout all three elements, which would provide value to perch-feeding bats. Bats could achieve entry into the building through openings within the roof structure caused by slipped and raised roof tiles, and loose ridge-tiles provide further roosting value for crevice-dwelling bats. Building 3 is left largely open to the elements due to an open doorway and damage to the roof, and no PRFs were noted within this structure.

**Photo 7: Red arrows point to gaps beneath roof tiles and ridge tiles. B2.**

- 4.7 It is recommended that prior to any works commencing on Building Two, one nocturnal survey should be undertaken to ascertain presence/absence of bats. Following national guidelines, the survey should take place between the optimal nocturnal bat survey period between May and August. Two surveyors would be required to cover the survey area. Should bats be found to be utilising the building during nocturnal survey effort, further surveys may be recommended, and a European Protected Species Licence obtained from Natural England in order for the development to lawfully proceed.

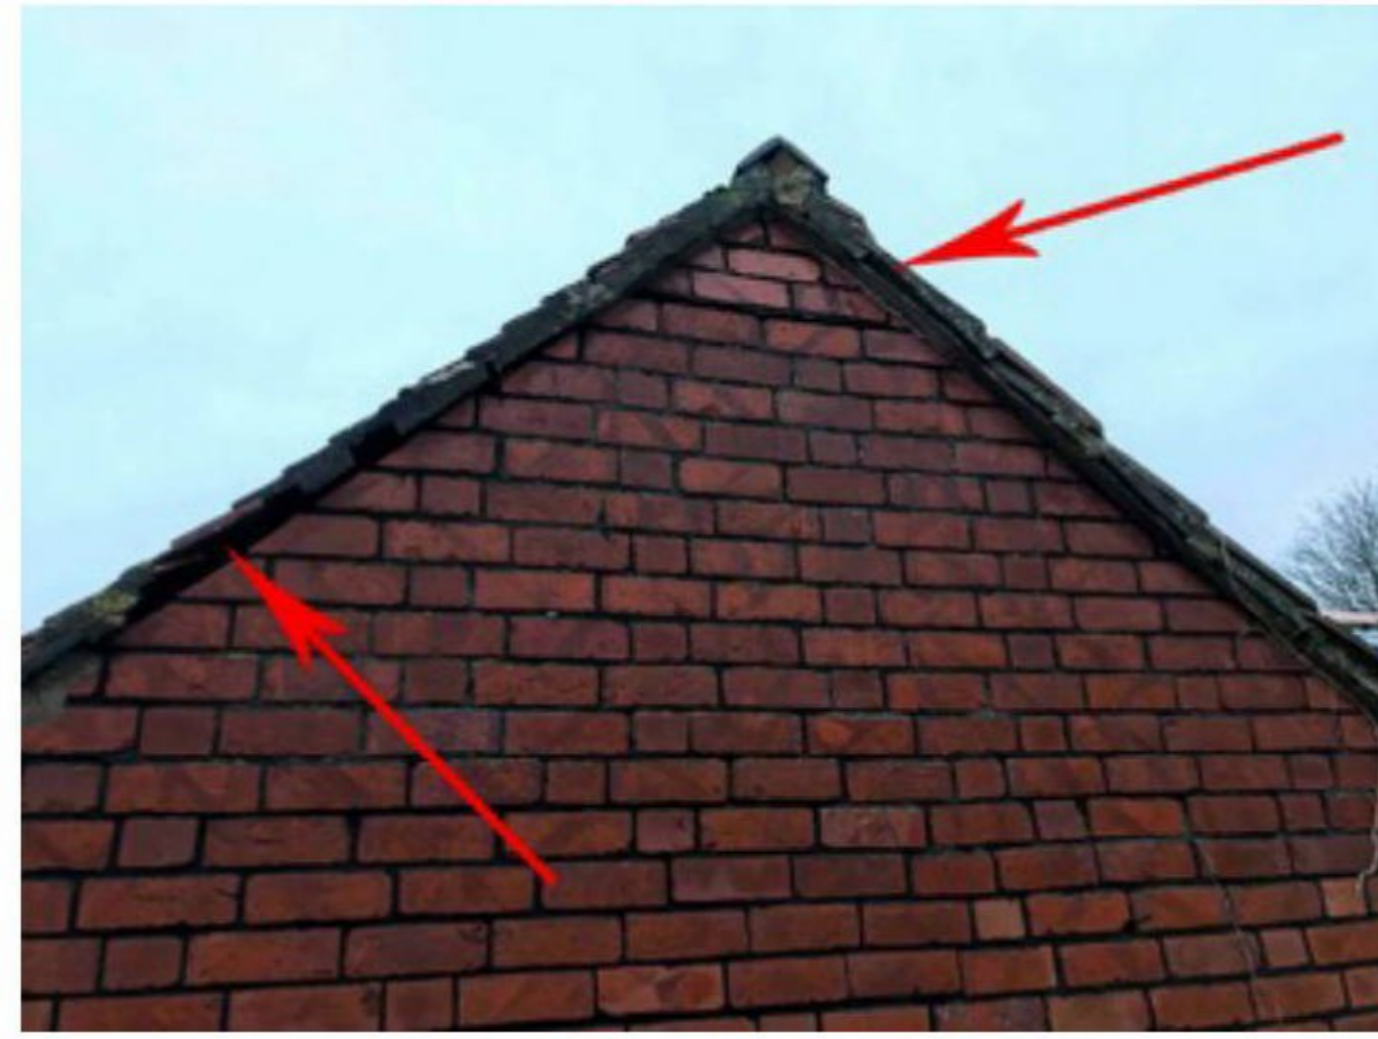
**Photo 8: Red arrows point to gaps caused by failed mortar at southern gable wall. B2.**

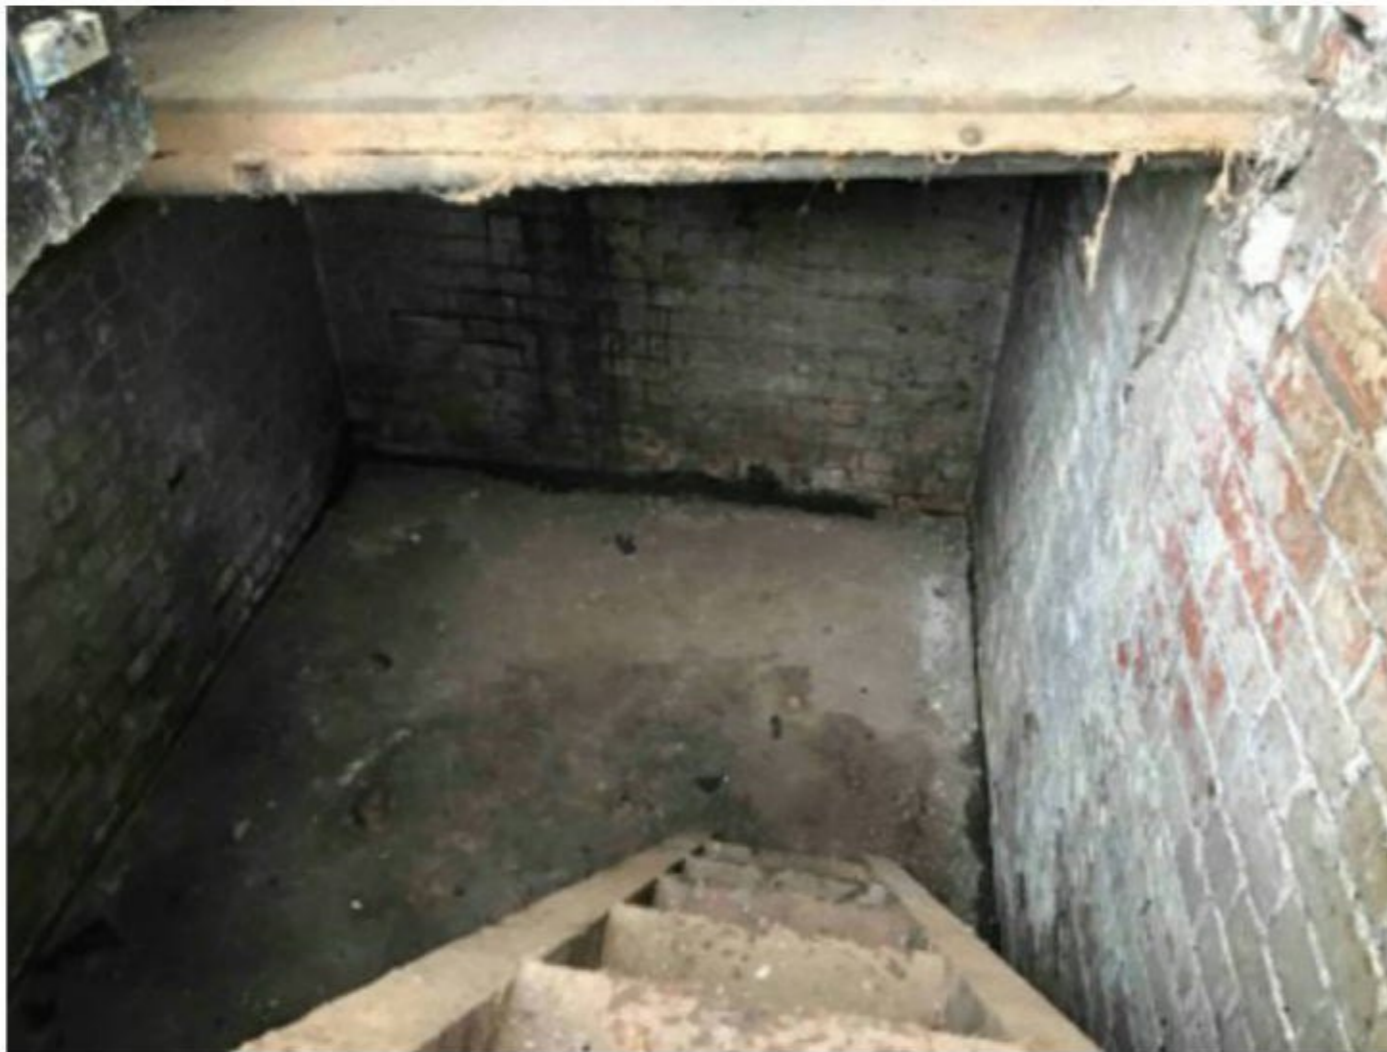
**Photo 9: View of open basement located within southerly element of B2.**

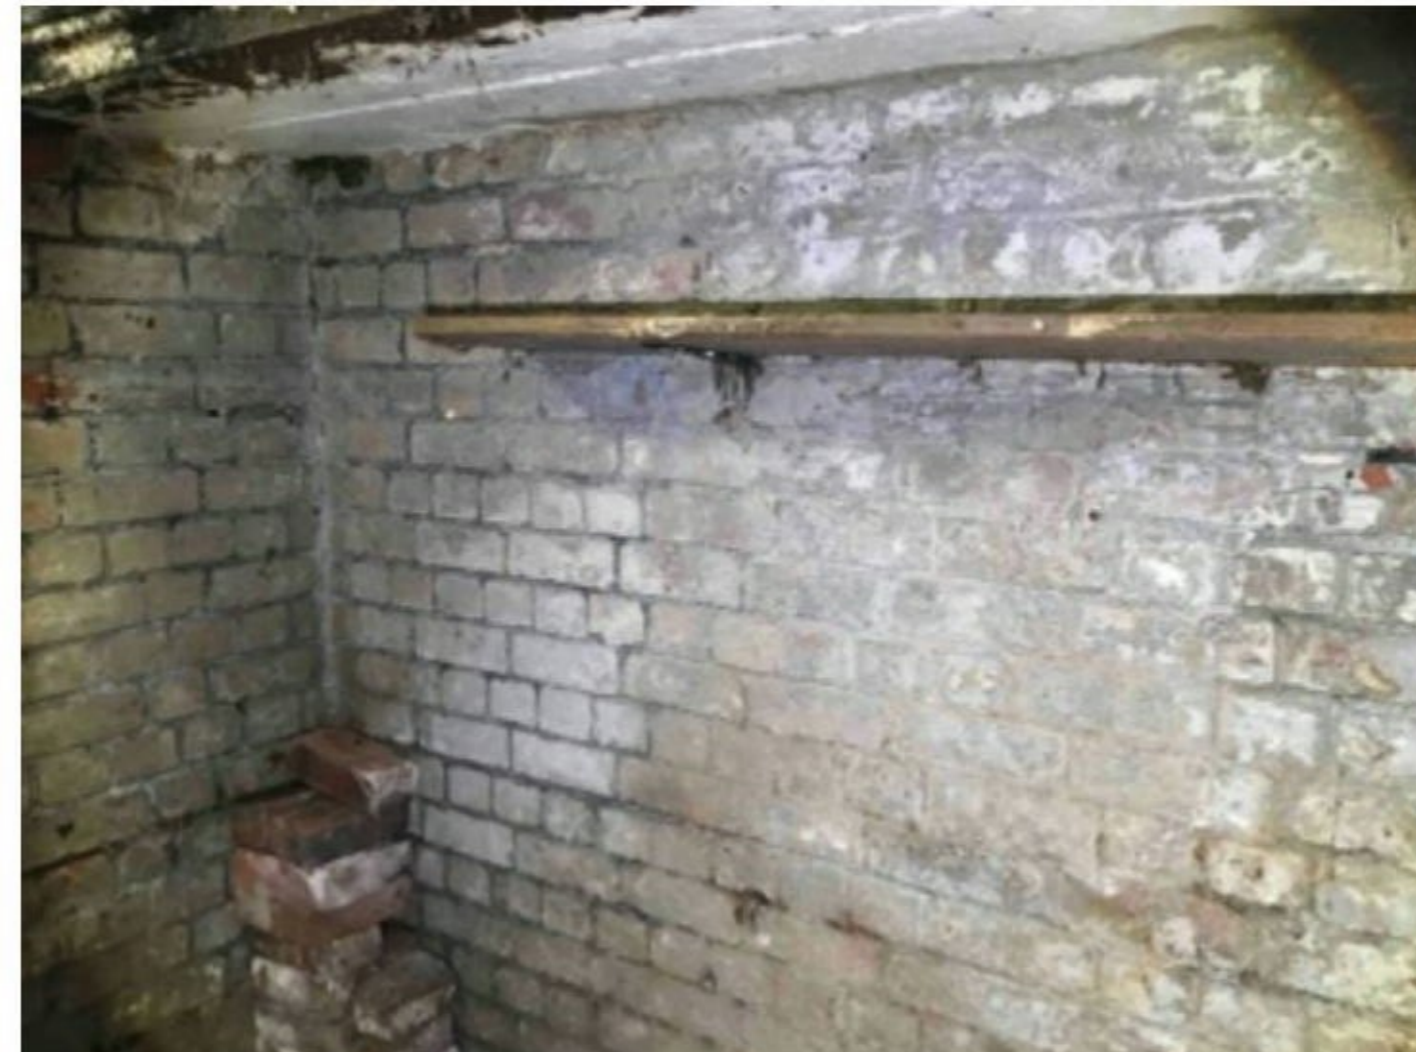
- 3.11 Internally, all three elements are separated by brick dividing walls. The roof is not underlined and a number of openings within the roof structure are visible that would allow bat gain entry into the building. Timber joists and purlins of the roof structure are exposed, offering value to perch feeding bats. An open-top basement area is present within the most southerly-element, which could be easily accessed for assessment via a timber stairway. The internal walls of the basement were in good condition without cracking or gaps that could be exploited by bats.

**Photo 10: Internal brick walls of basement were in good condition without cracking. B2.**

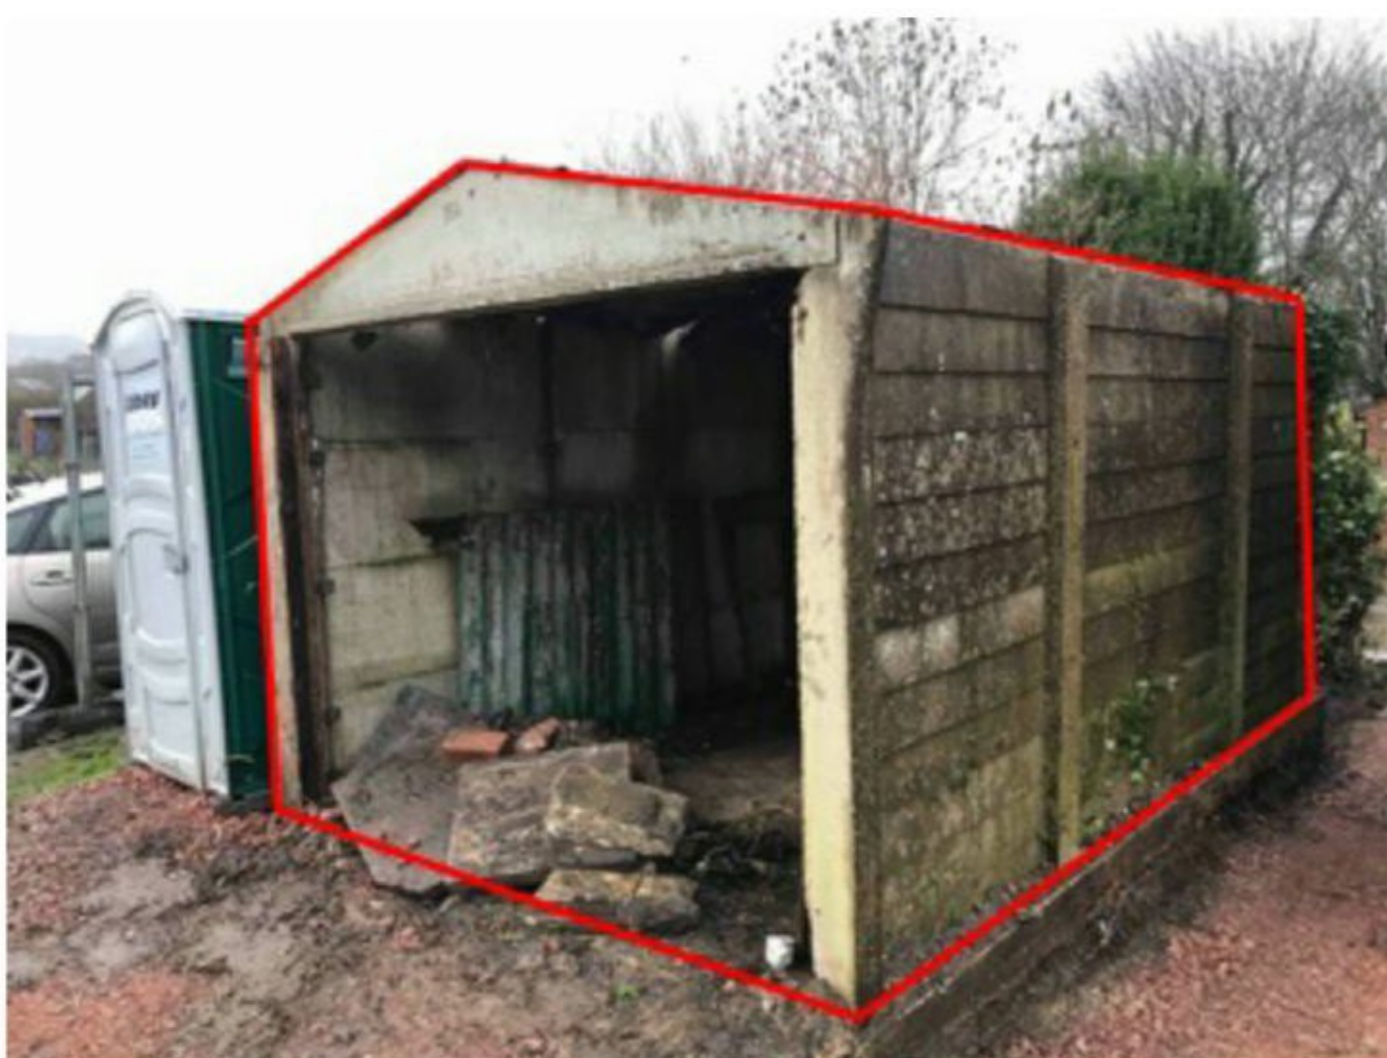
- 3.13 Building Three is a detached concrete-built single garage supporting a shallow-pitched metal-framed roof structure clad with timber board. The building is absent of a garage door and is in a poor state of repair. Externally, the concrete block walls were securely fitted without gaps or crevices that could be exploited by bats. Timber cladding the roof is in poor condition and features a number of open holes caused by damage and rot. Internally, the roof is not underlined, and daylight is visible through gaps throughout much of the roof structure. The open doorway located on the east-facing wall leaves the building largely open to the elements.
- 3.14 No bats, droppings, feeding remains or further evidence of bat activity were discovered in Building Three during the survey effort.

**Photo 9: Red line highlights Building 3.**

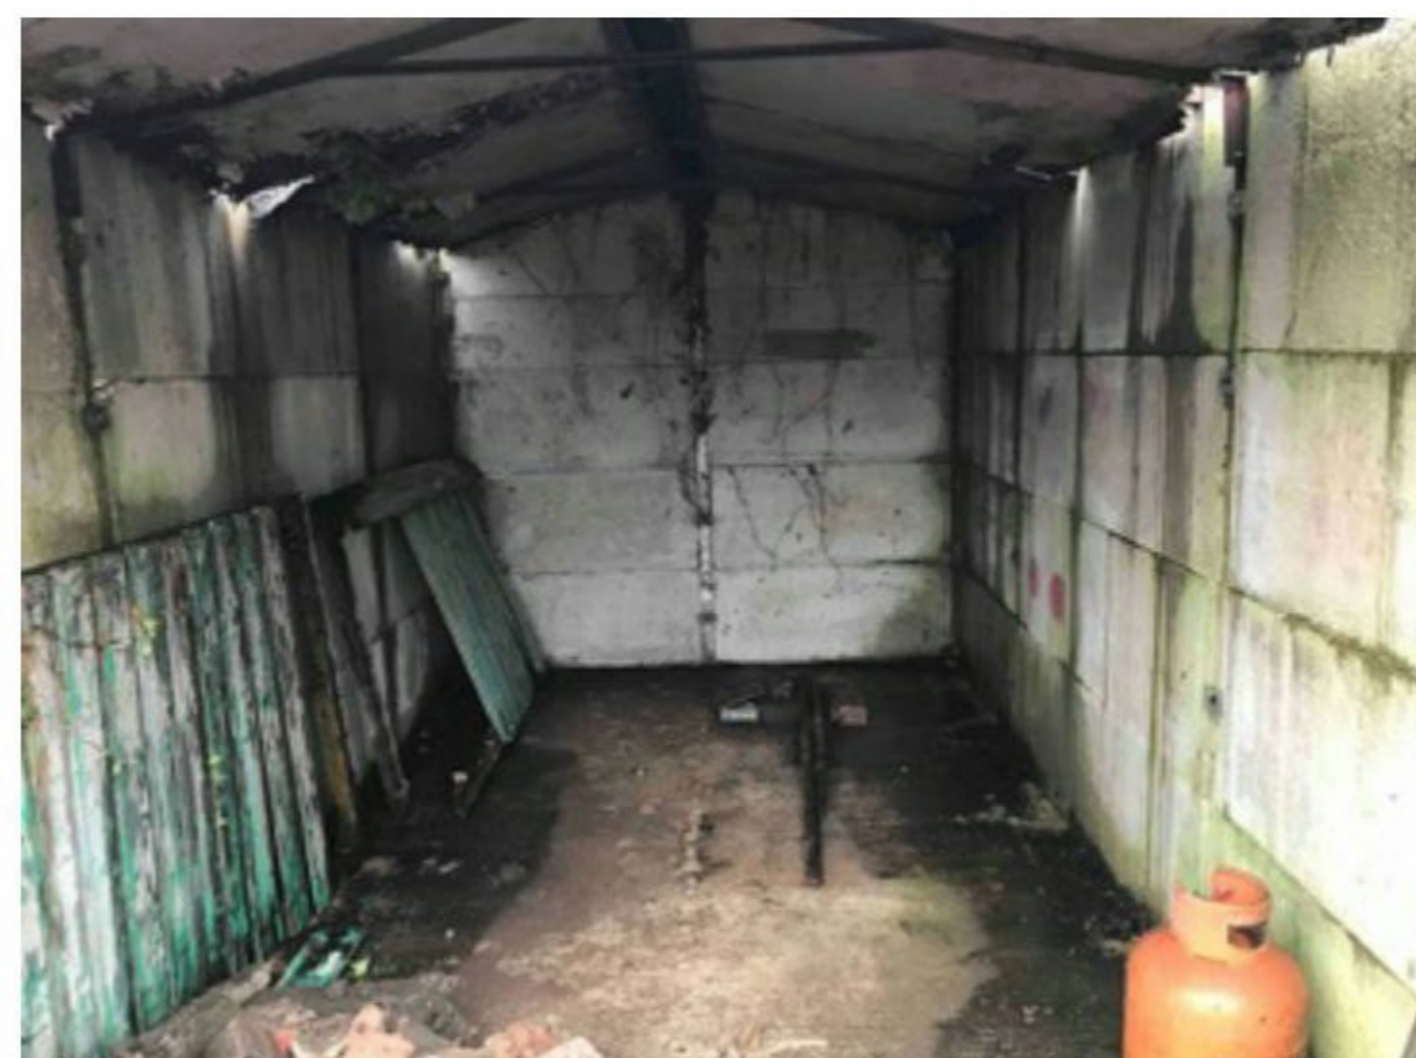
**Photo 10: Interior view of survey Building 3.**
