DESIGN AND ACCESS STATEMENT
IN SUPPORT OF REPLACEMENT OF THE
BALUSTRADED FRONT GARDEN WALL AND
GATE PIERS

28-30 WARWICK AVENUE
LONDON W9 2PT
January 2021

**Design and Access Statement in Support of Replacement of the Balustraded Front
Garden Wall and Gate Piers**

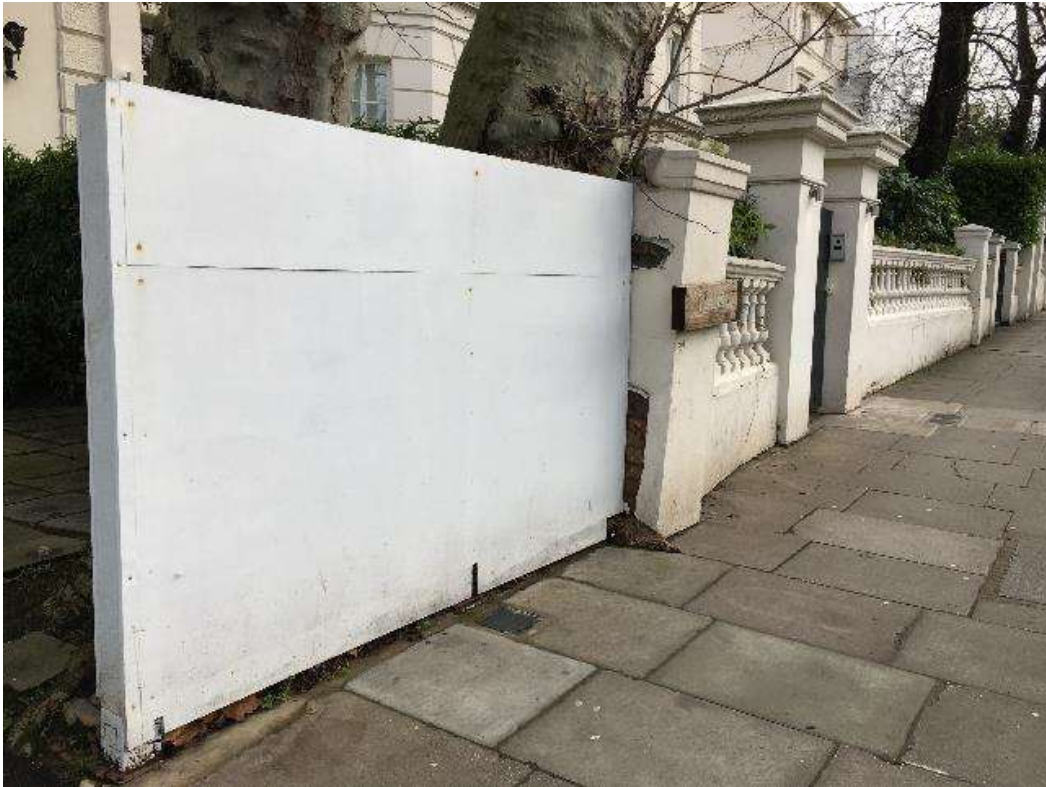
Photo 1: North section of the front boundary wall and remaining gate pier.

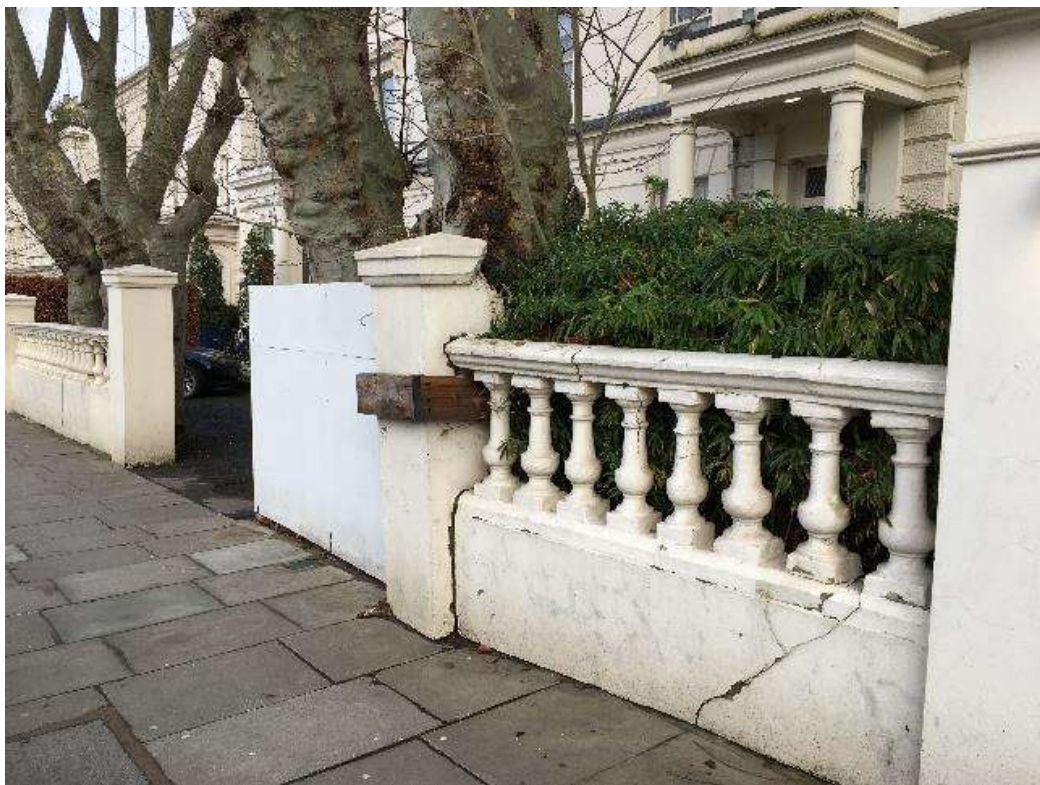
Photo 2: North section of the front boundary wall and remaining gate pier.

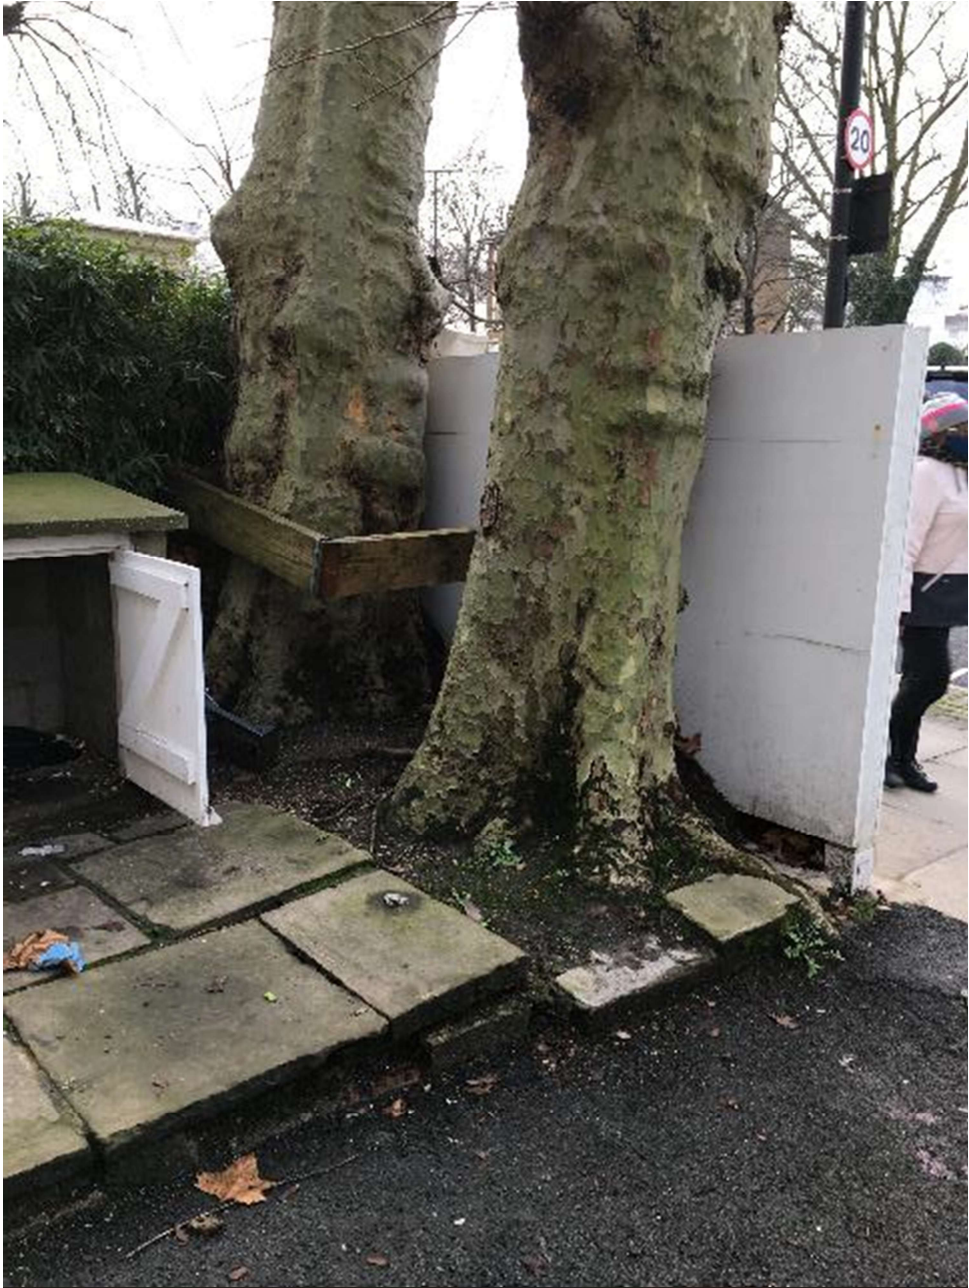
Photo 3: North section of the front boundary wall and remaining gate pier.

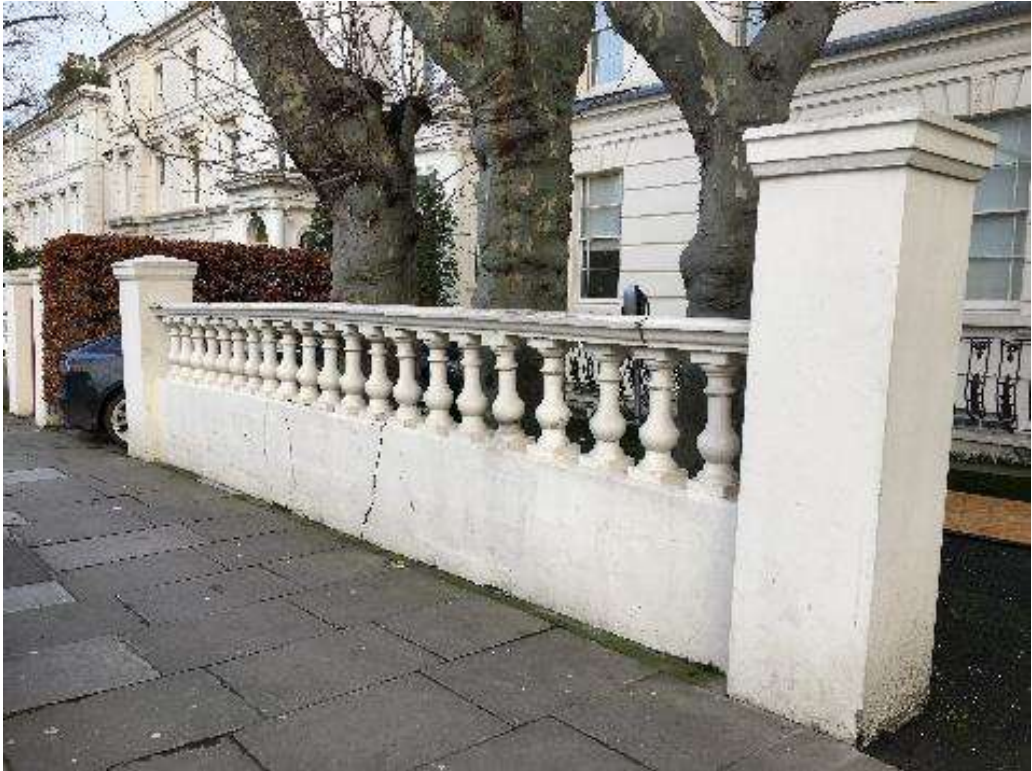
Photo 4: Middle section of the front boundary wall and gate piers.

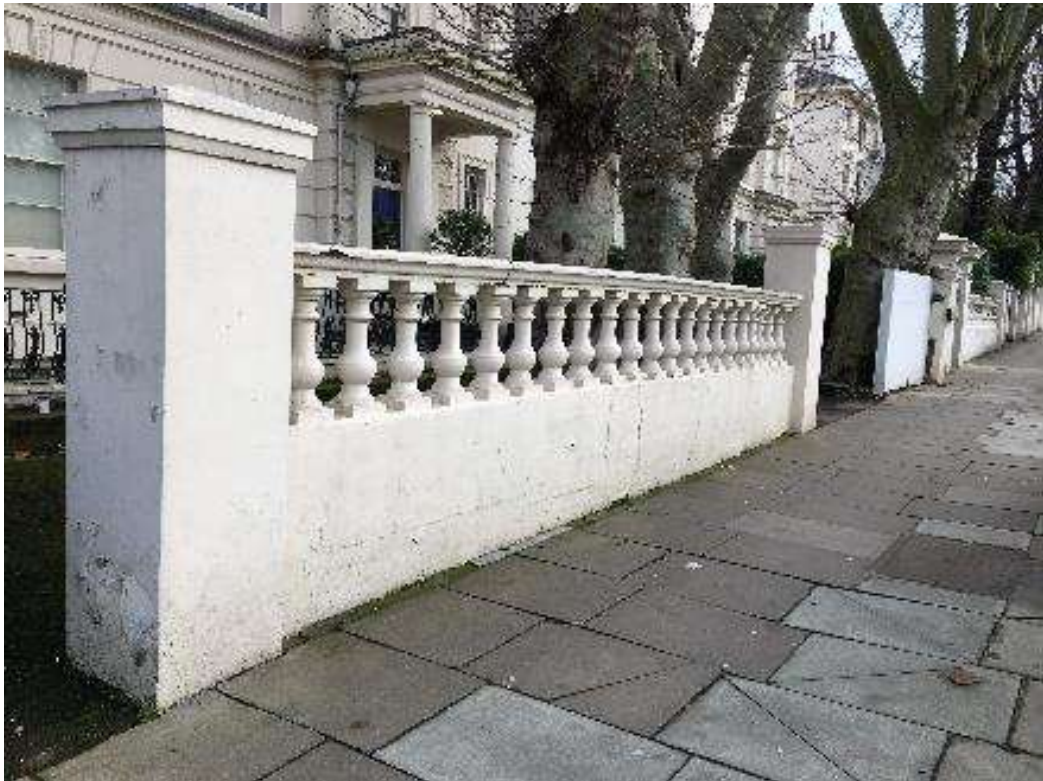
Photo 5: Middle section of the front boundary wall and gate piers.

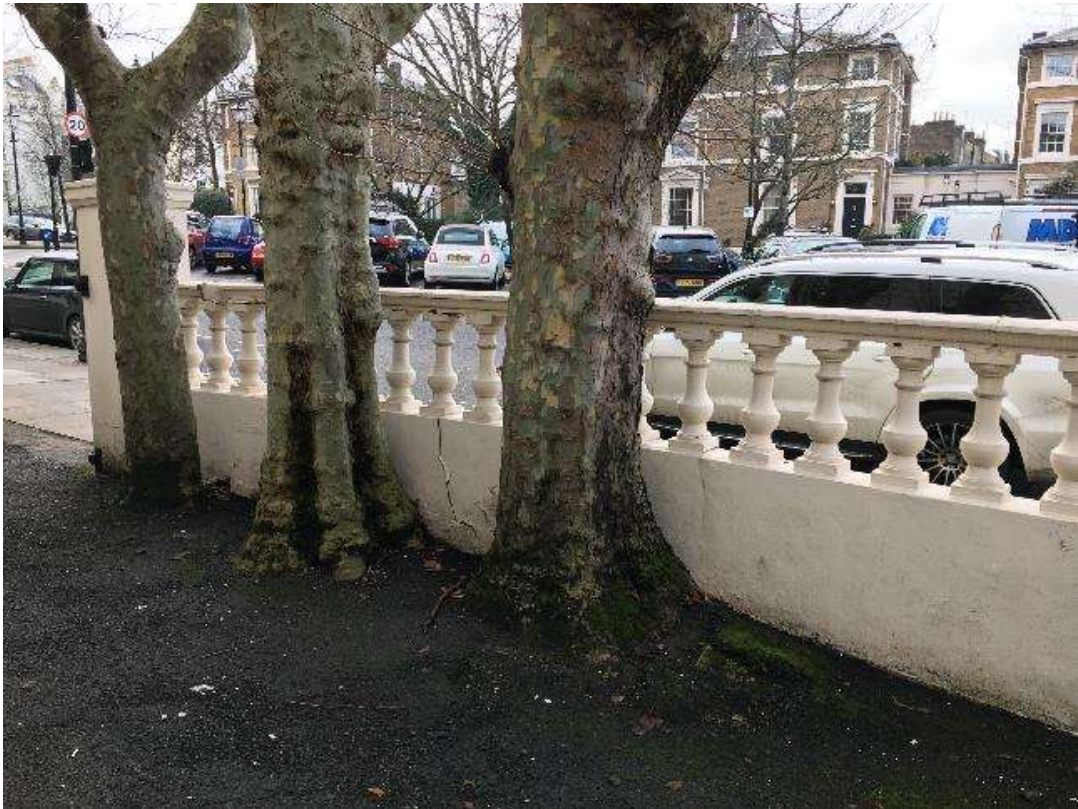
Photo 6: Middle section of the front boundary wall and gate piers.

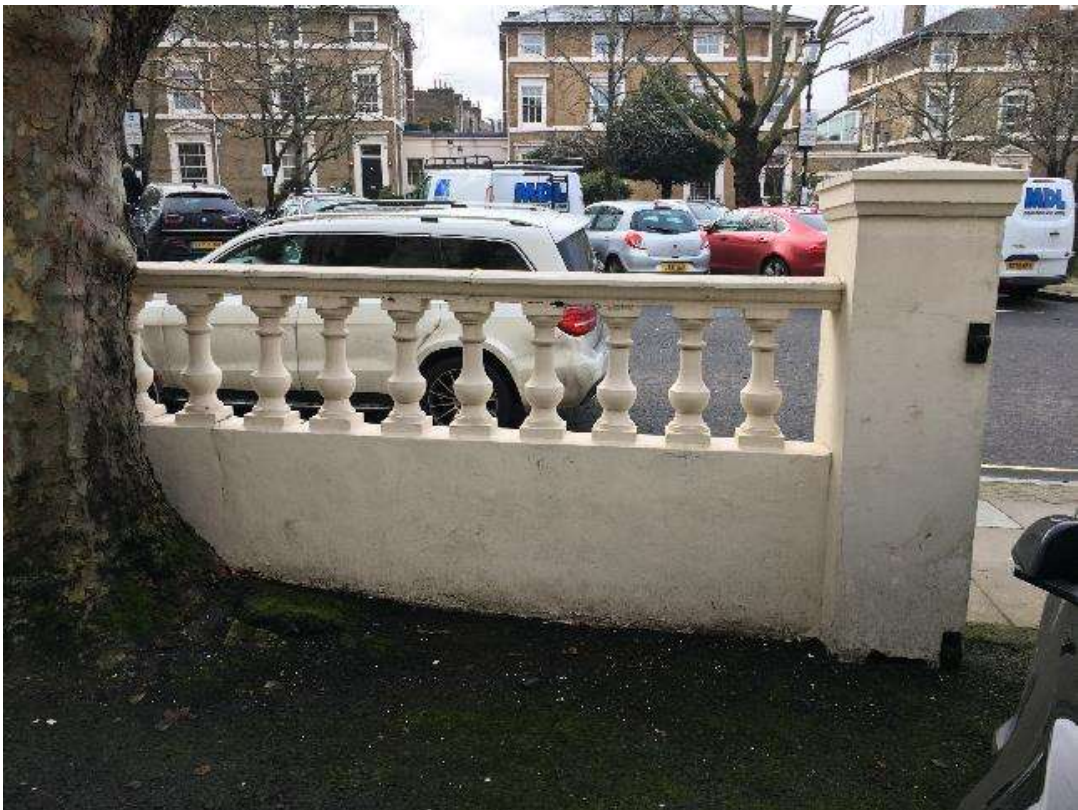
Photo 7: Middle section of the front boundary wall and gate piers.

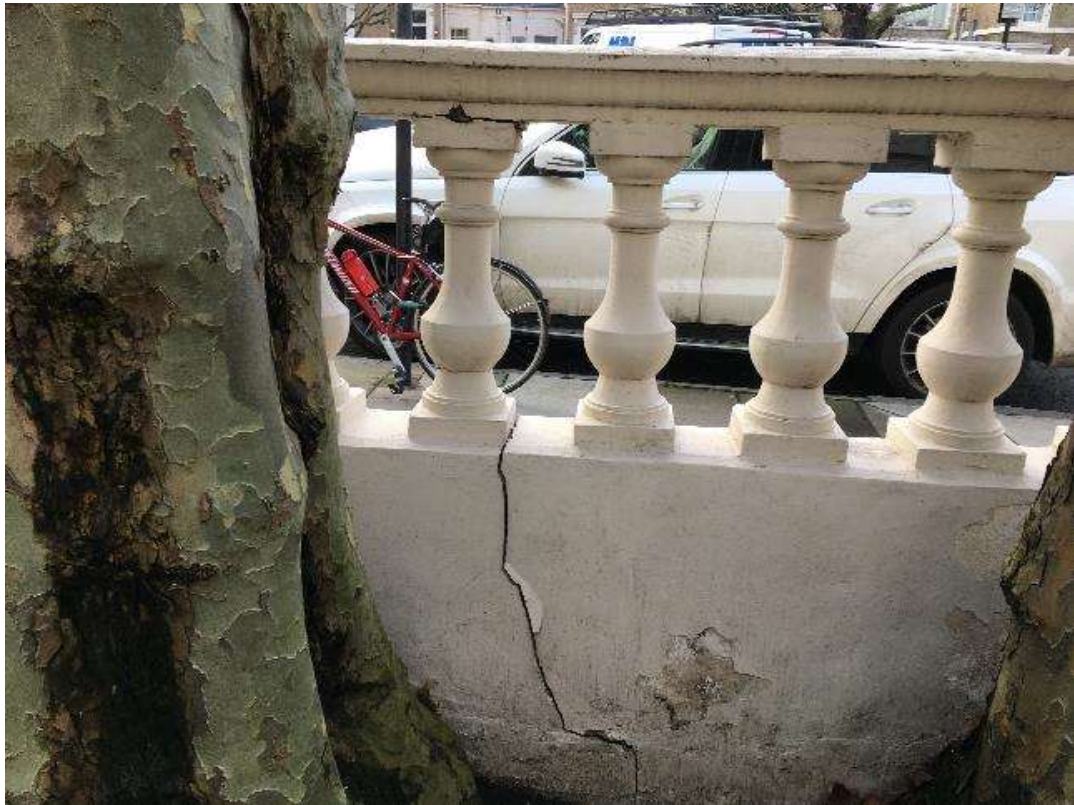
Photo 8: Detail of cracked middle section of wall.

In January 2020 Ridge and Partners carried out a visual inspection to assess the condition of the balustraded front wall and gate piers. During the inspection it was noted that the south section of the wall was close to collapse and the middle section was cracked as a result of the adjacent trees’ growth. During a second inspection in January 2021, it was noted that the south section of the wall had since collapsed and had been replaced with a temporary timber retaining structure.

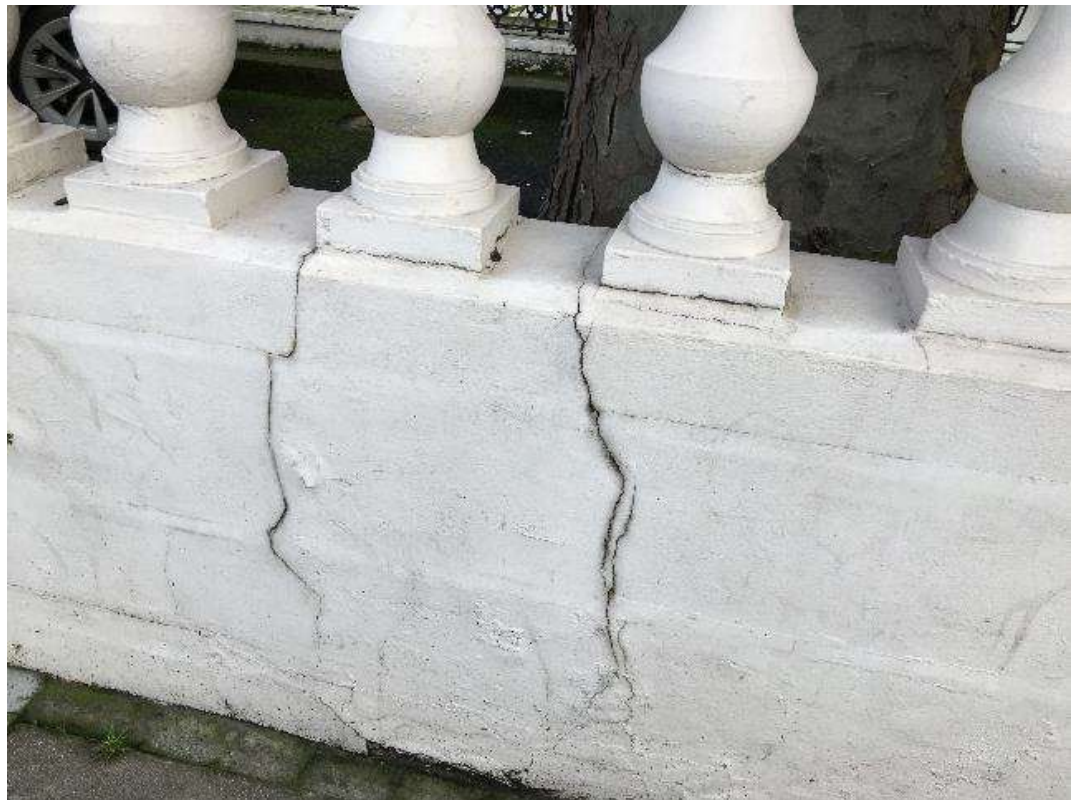
Photo 9: Detail of cracked middle section of wall.

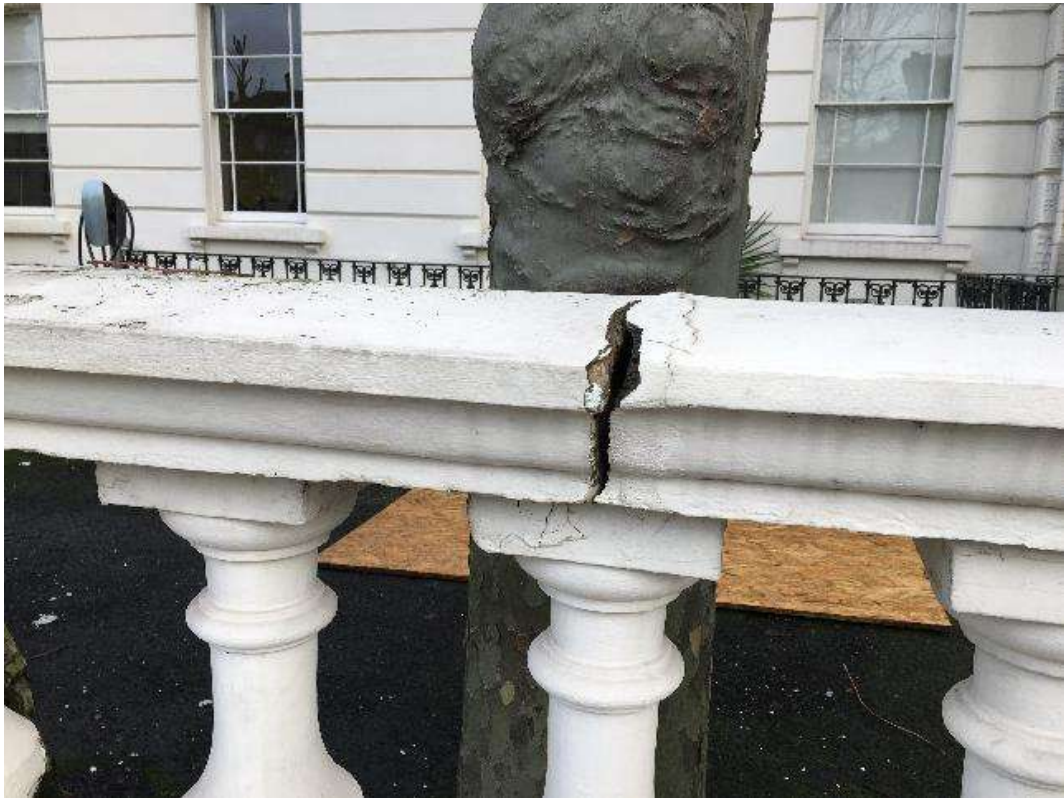
Photo 10: Detail of cracked top rail to middle section of wall.

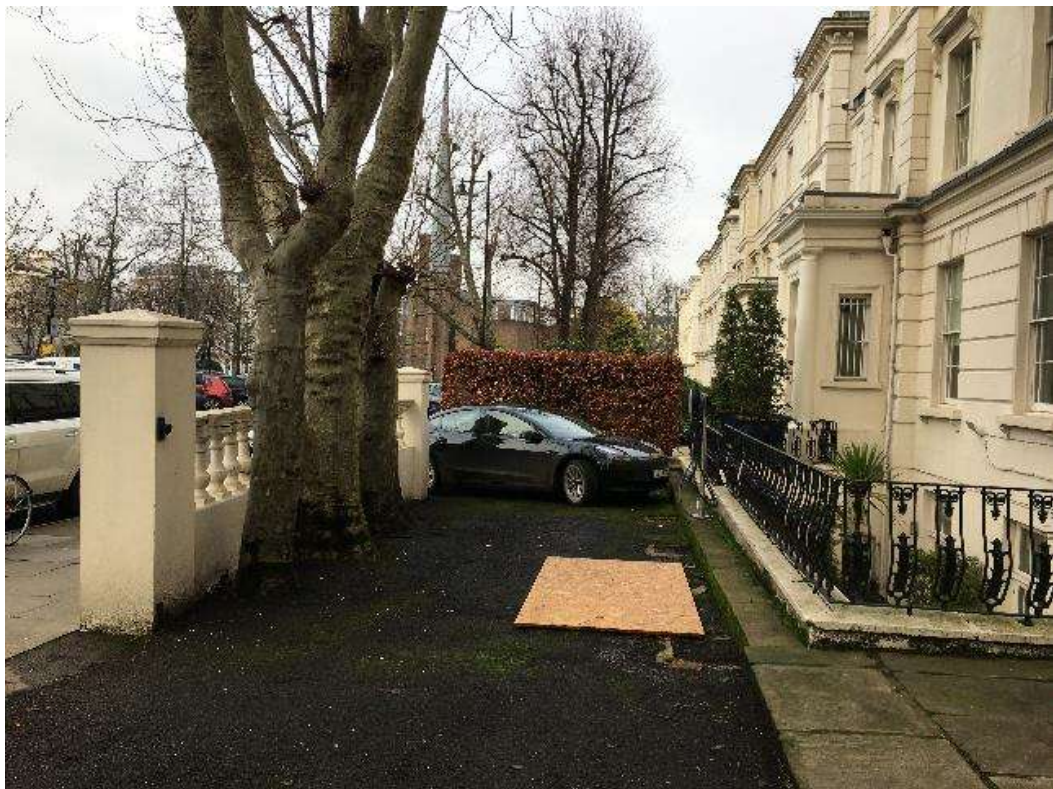
Photo 11: Trees adjacent to middle section of wall.

It is noted that most of the above planning applications refer to previous works carried out to the trees at front most likely to mitigate the effects of their growth onto the adjacent garden wall and gate piers. It is likely that the trees within the property's demise might be protected under the local Tree Preservation Order register.
