Bickleigh House

Heritage Impact Assessment Incorporating Design & Access Statement

Living Space Architects -5th January 2021 REV A

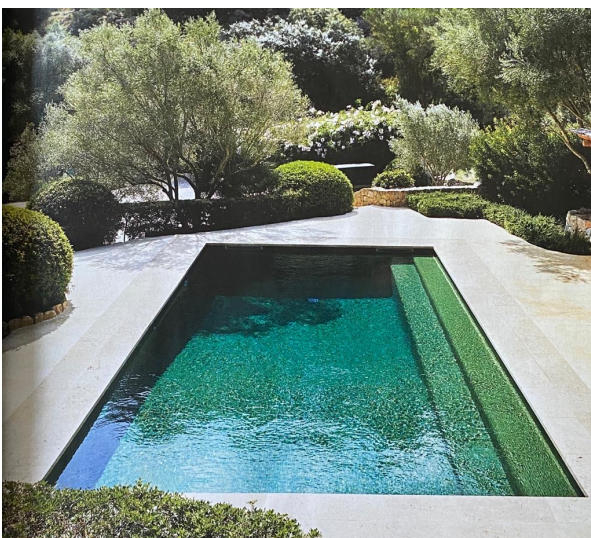
27. Proposed Lap pool in walled garden.

The photograph below shows the proposed design of the lap pool. This will be a simple construction edged with stone as shown.

It is proposed to create a small lap pool within the walled garden, as shown on the accompanying site plan and item 27 below.
