# Preliminary Bat Roost Assessment

24 West Hill, Epsom

February 2021

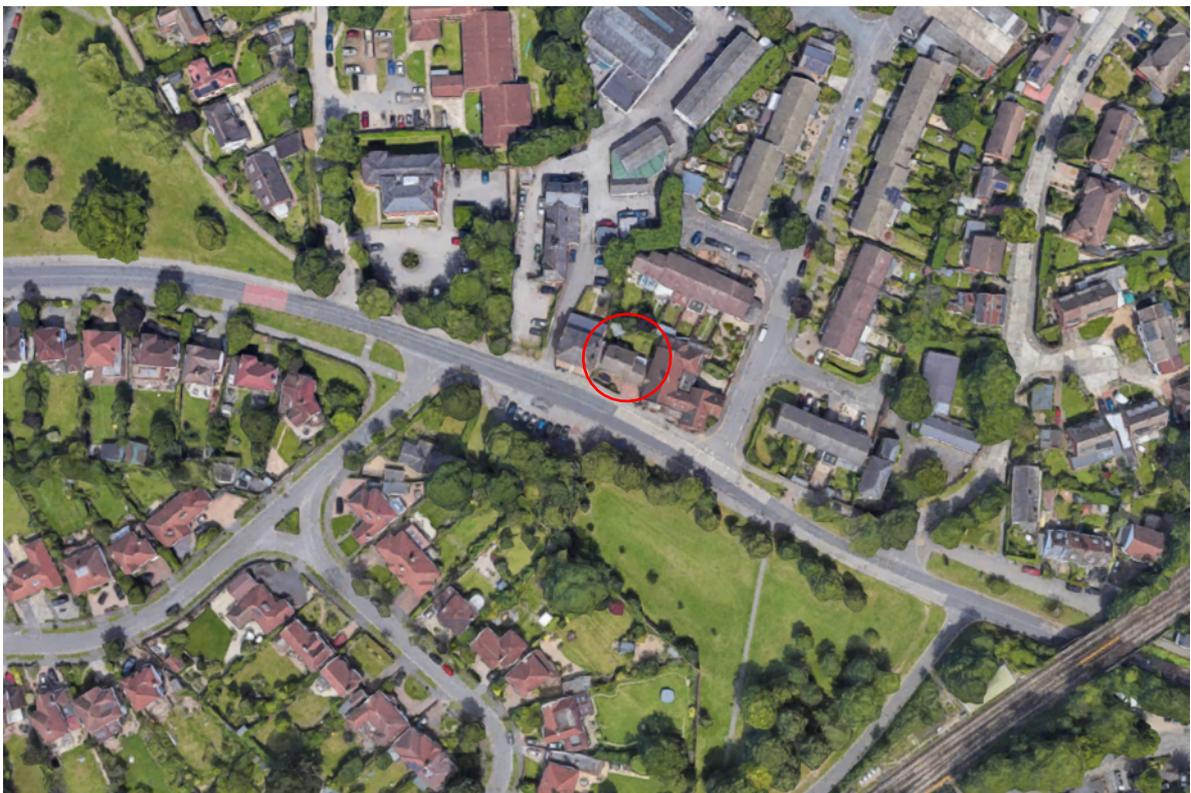
**Photograph 1:** 24 West Hill (indicative only).

The site is located on West Hill road in Epsom in an urban location (see **Photograph 1**). The site is bound by a main road, the Epsom Christian Fellowship Church and other properties and gardens on all sides. The application site consists of the four-bedroom detached property.

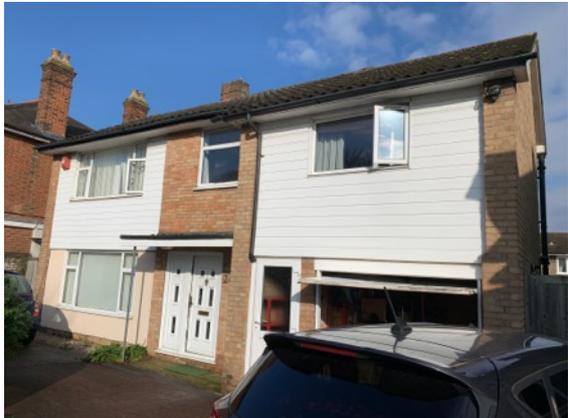
<p><b>Photograph 1:</b> Front elevation of 24 West Hill</p>	<p><b>Photograph 2:</b> Rear elevation.</p>

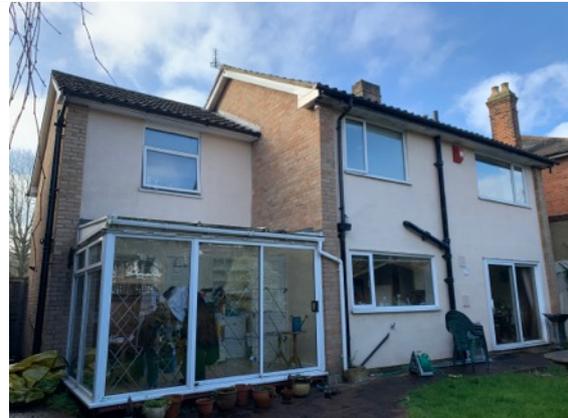
The rear of property was covered with painted render which did not contain any cracks or crevices that would be suitable to support roosting bats. The extension had uPVC soffits and the remainder of the house had white painted wooden soffits. The passage way at the western end was partially covered with plastic corrugated sheeting.

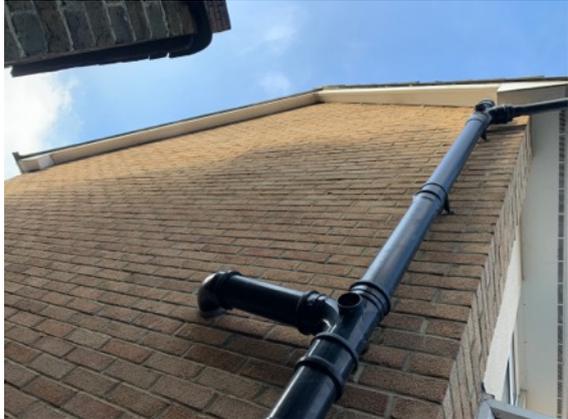
<p><b>Photograph 3:</b> Well fitted soffits on eastern elevation.</p>	<p><b>Photograph 4:</b> Covered walkway on western elevation.</p>

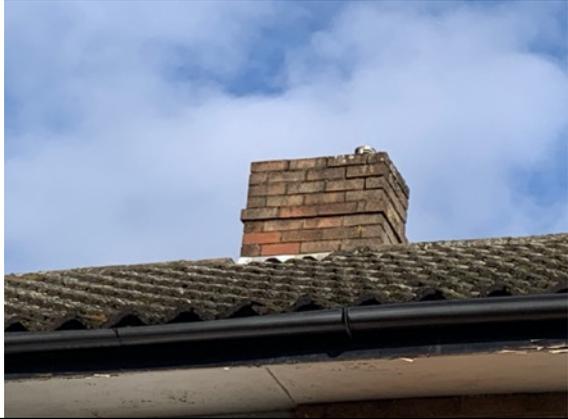
Overall, the roof tiles were in a good state of repair with no missing, broken or slipped tiles that would have potential to support roosting bats. The apex of the roof was covered with domed ridge tiles which were well sealed throughout. The single chimneystack was in good condition and the junction between the chimneystack and roof tiles was well sealed with tightly fitted lead flashing. The soffits were all well fitted throughout. The brickwork on the gable ends was all in good condition.

<p><b>Photograph 5:</b> Chimney with well fitted lead flashing.</p>	<p><b>Photograph 6:</b> Summerhouse in rear garden.</p>

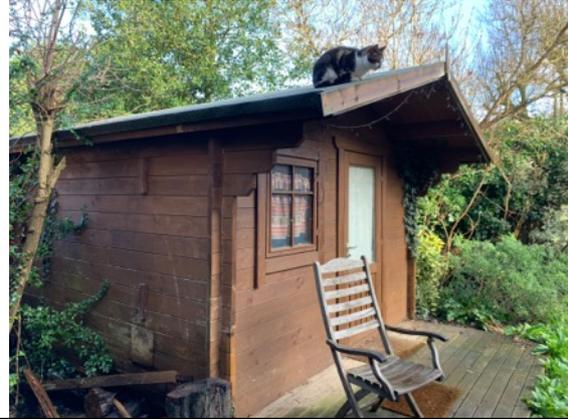
A wooden summerhouse was present in the rear garden. The summerhouse was of typical construction with wooden panel walls and a pitched felt roof. The roof was well fitted and there were no features of potential value for roosting bats.

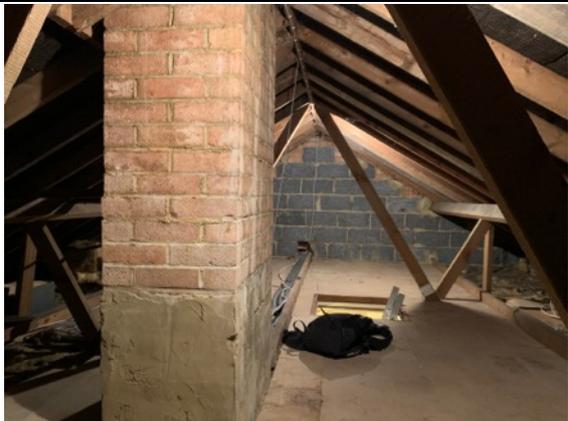
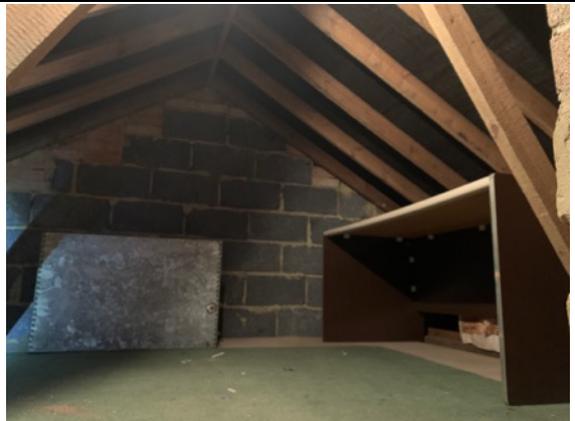
The property contained two roof voids which were both accessible for inspection from loft hatches. The main void measured approximately 7.5m long x 6.5m wide x 1.8m tall with an attic room truss formation. The space was boarded throughout and predominantly empty which allowed a thorough inspection to be undertaken. Mineral wool insulation was present in the bays and the tiles were lined with bitumen felt. The central chimneystack ran through the loft space and all the brickwork was in good condition, along with the exposed brickwork interior walls. No cracks or crevices were observed that could support roosting bats.

<p><b>Photograph 1:</b> Inside main loft void.</p>	<p><b>Photograph 2:</b> Main loft void.</p>

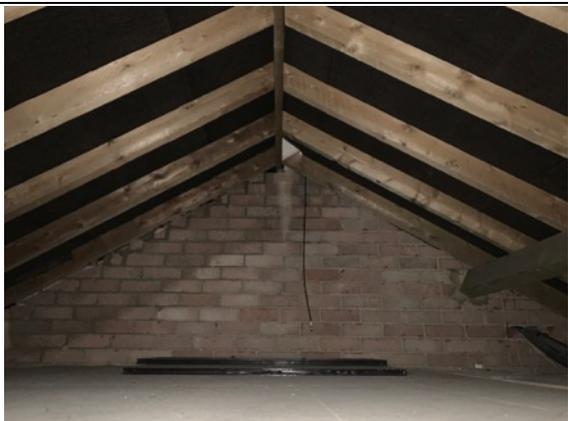
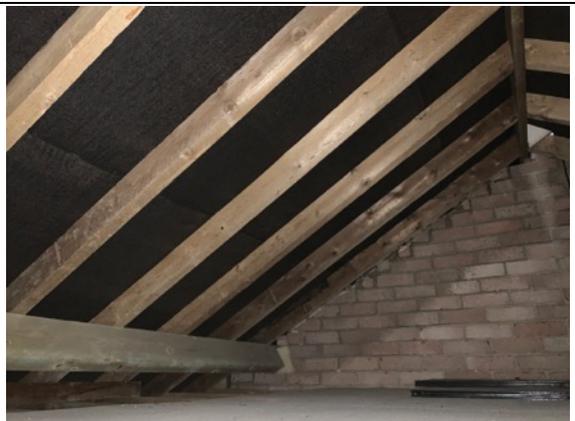
The second void was accessed off the bedroom and was 3.4m long x 4m wide x 1.2m tall. The timber rafters and purlins were all in good condition and the bitumen felt lining was all intact throughout. The loft space was boarded and also empty which allowed a thorough inspection.

<p><b>Photograph 3:</b> Roof void over extension.</p>	<p><b>Photograph 4:</b> More recent timber rafters &amp; purlins.</p>

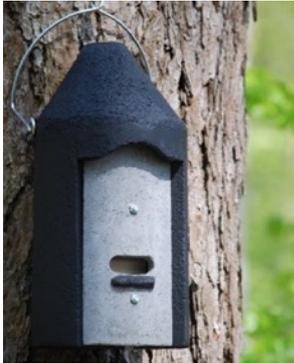
- Bat boxes could be installed on retained trees or attached to the new properties. For example, a Schwegler 2F double-fronted bat box (see below).
- It should be positioned in a shady position, 3-5m above ground level, and face in a south/south-westerly direction with a clear flight path to and from the entrance.

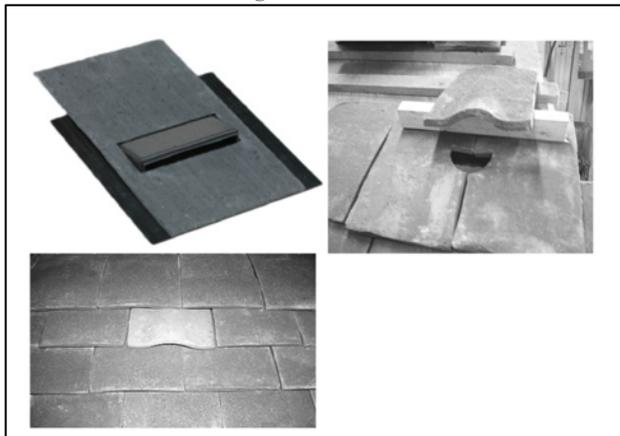
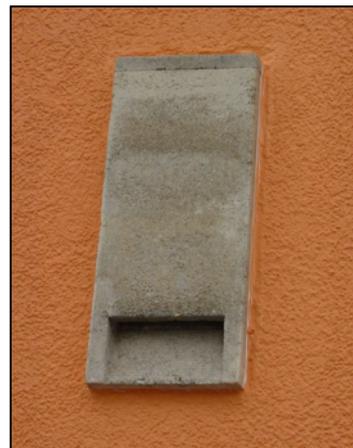
Integral bespoke bat roosting features should be installed on the new properties. This could include the use of roost access tiles onto the roof of the property to allow access by bats to the crevice between the roof tiles and the lining underneath.
