SAMPLE ISSUE SHEET # 001

Sample Ref #: Cleaning Samples to Stone Features

Description of Works / Methodology:

PAYE were instructed to undertake cleaning trials to 4 distinct stone features which demonstrated different levels of surface deposits / staining:

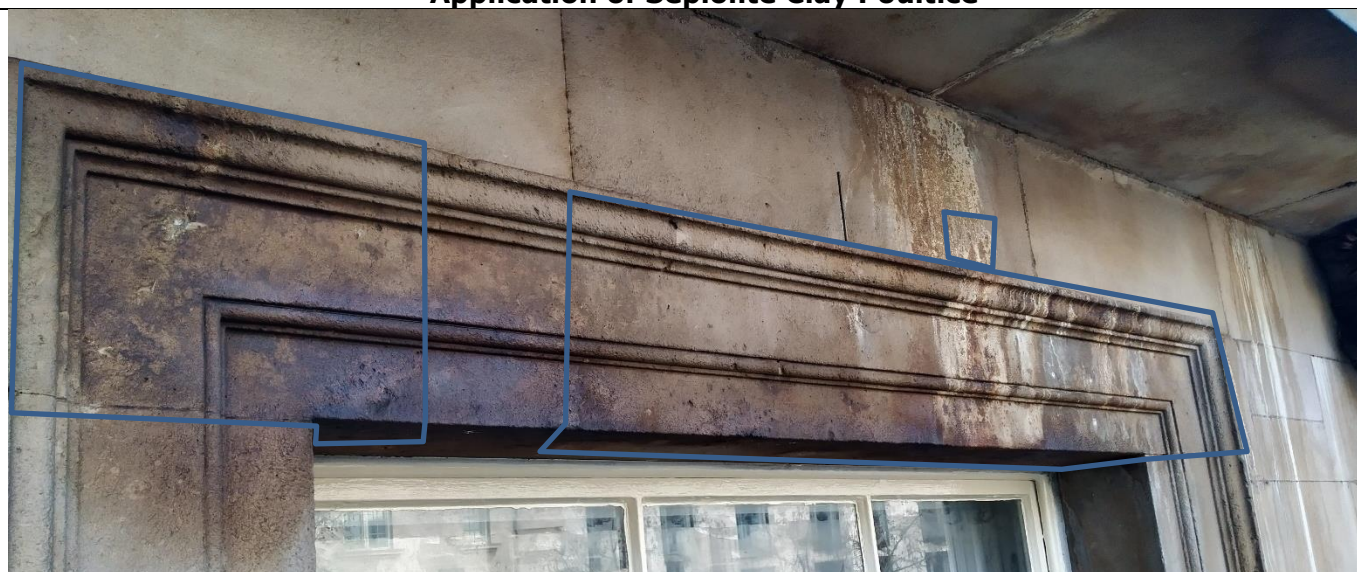
Before (Sample areas highlighted in Blue)

Sample Location 1
Application of Sepiolite Clay Poultice

The brown, tarry stain had mostly been lifted from the stone window head and soffit using one application of sepiolite (a clay poultice). A second application was applied to small, isolated areas that had not initially been fully responsive and were subsequently further drawn out of the stone. A small patch of poultice was applied to the area of heavier staining above the window head and has slightly reduced the staining.

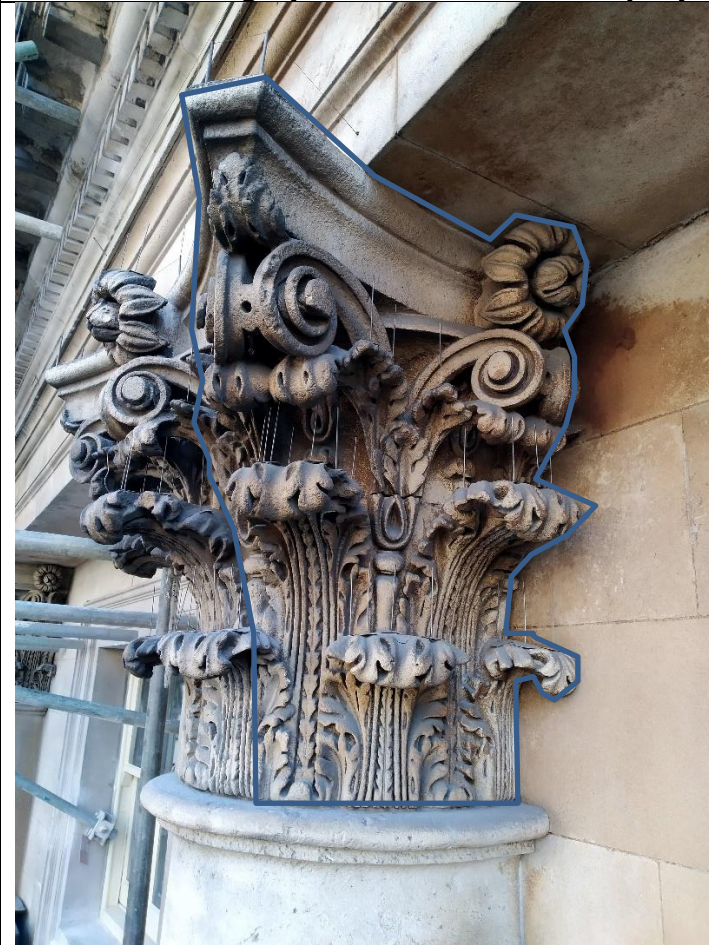
Before

Water Cleaning by Means of Nebulous Sprays of Cold Water and Pressurised Steam Clean

The capital head was cleaned by means of nebulous sprays and pressurised steam cleaning, and the result demonstrates that light surface soiling has been successfully removed. However, the clean was mostly unsuccessful at removing the heavier carbon which have settled on / within the carved, decorative features.

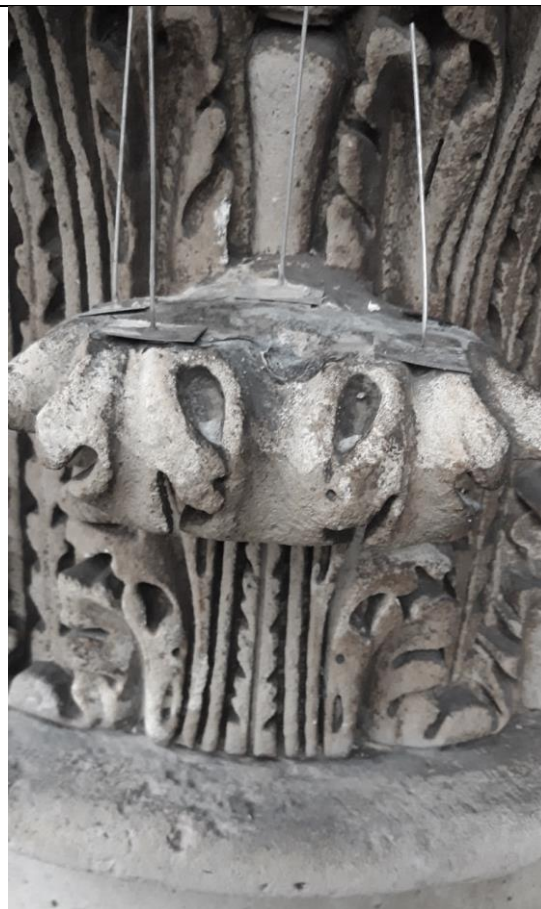
Sample Location 2A
Poultice Clean by Means of Carb-Rid

Subsequent trials of a poultice named Carb-Rid (produced by Stonehealth) were undertaken, which saw two applications of the poultice, however, they proved relatively unsuccessful in really removing these heavy deposits and exposing the stone (there are some slight signs of removal but this is minimal). It should be noted that this was either because the build ups are somewhat heavy encrustations that may not have previously been treated (or at least not for a long time) or the fact that the temperatures at the time of the trial were too low to make the product reactive.

In order to better remove these deposits, the TORC system could be adopted here (which sees a swirling vortex of low pressure water and a fine medium of calcite combined to gently abrade the deposits without being detrimental to the stone), however, owing to the time, cost and quality constraints we were aware that this will likely have to be reviewed in a later phase of maintenance.

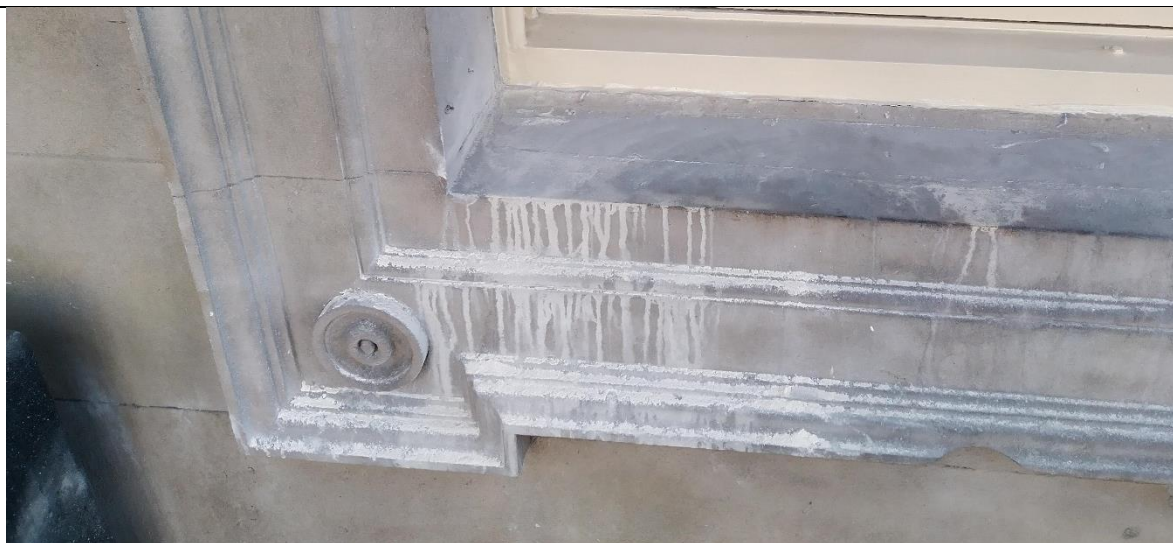
Before

Sample Location 4
Brushing via Hand and Low Pressure Steam Cleaning

The white 'staining' seen in these locations is actually highly cleaned stone that has had concentrated volumes of water cascading over its face since the scaffold erection. The residue / slurry of Portland stone dust that was presumably left by scaffold tie drilling has been removed.
