Heritage statement

Derbies Barn
Stalisfield Road
Stalisfield
ME13 0HN

Proposed Barn Conversion, Alterations to Roof
Structure, Roof Covering to Main Barn, Glazed
Screen to Carport and Internal Alterations

Date: Feb 2021

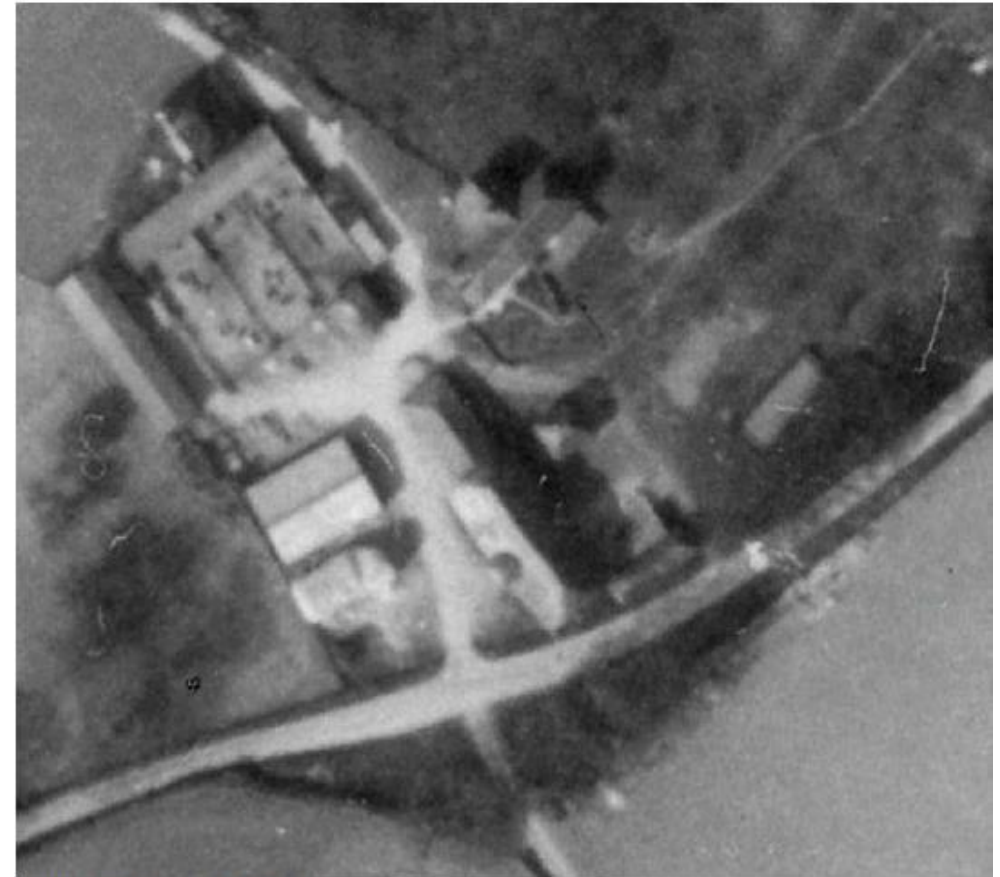
1940 Ariel photo of the site.

As can be seen in 1940 the site had had two additional buildings built on it with the retention of the original buildings. The single storey building has been partitioned external areas suggesting livestock use; Derbies barn Also shows signs of livestock use in the wearing and patina of some of the internal timbers which would be typical of cattle.

This photo is interesting as it shows the structure to the east of the barn along the boundary of the site.

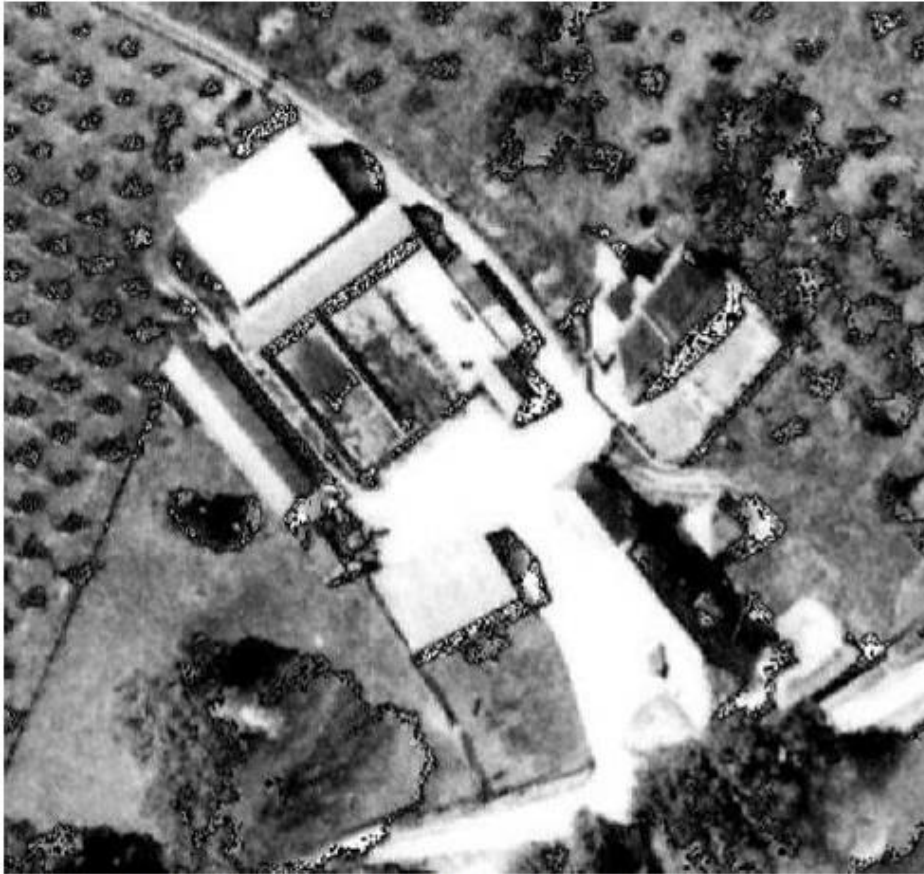
1960 Aerial photo taken in 1960 showing the site and farm.

The photo taken in 1960, while of poor quality, does show the loss of one of the buildings to the west of the barn and also the gain of a large building to the north of the single storey building in the farm. This period of time saw great change in agriculture and the introduction and adoption of modern techniques and the buildings which would be deemed to be required for this, using modern concrete portal framed barns to achieve the span and open spaces which were required.

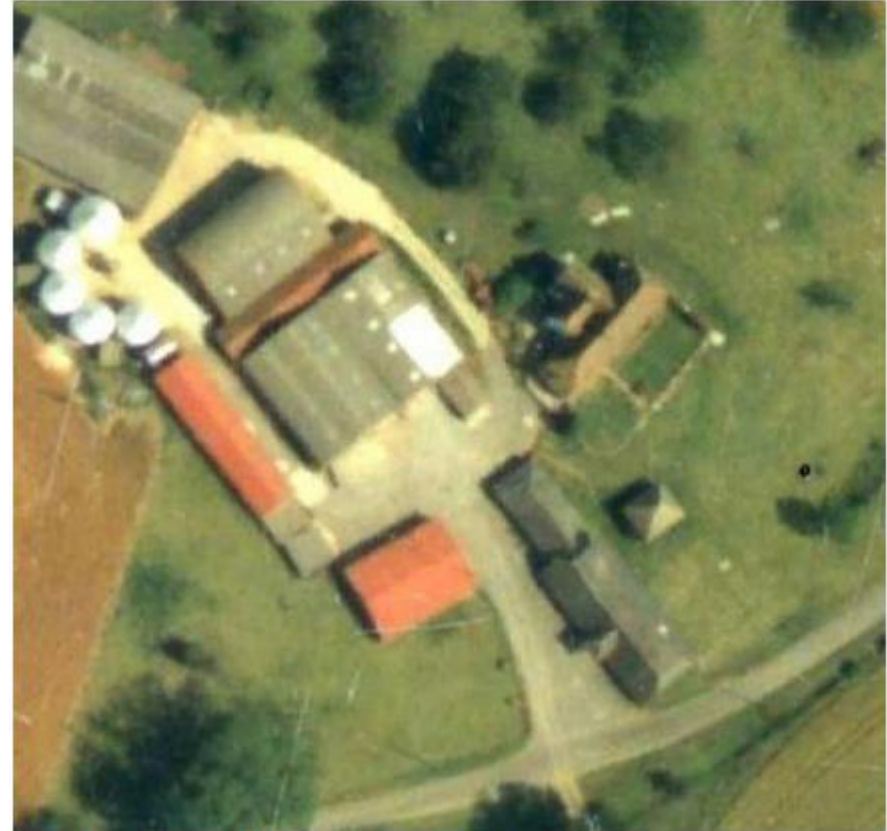
1990 aerial photo taken of the operating farm.

As can be seen in the photo taken in 1990, the farm grew and evolved between 1960 and the 1990's. This evolution resulted in the creation of the five grain silos and the additional large barn. This reflects the farm at its largest in its history. Even at this time the barn and the manor house shared the landscape to the east of the barn. The manor house sits upon a raised retaining wall and this may have allowed the live stock in the barn to be grazed in the field in front of the house without risk of escape or damage by the animals on the house.

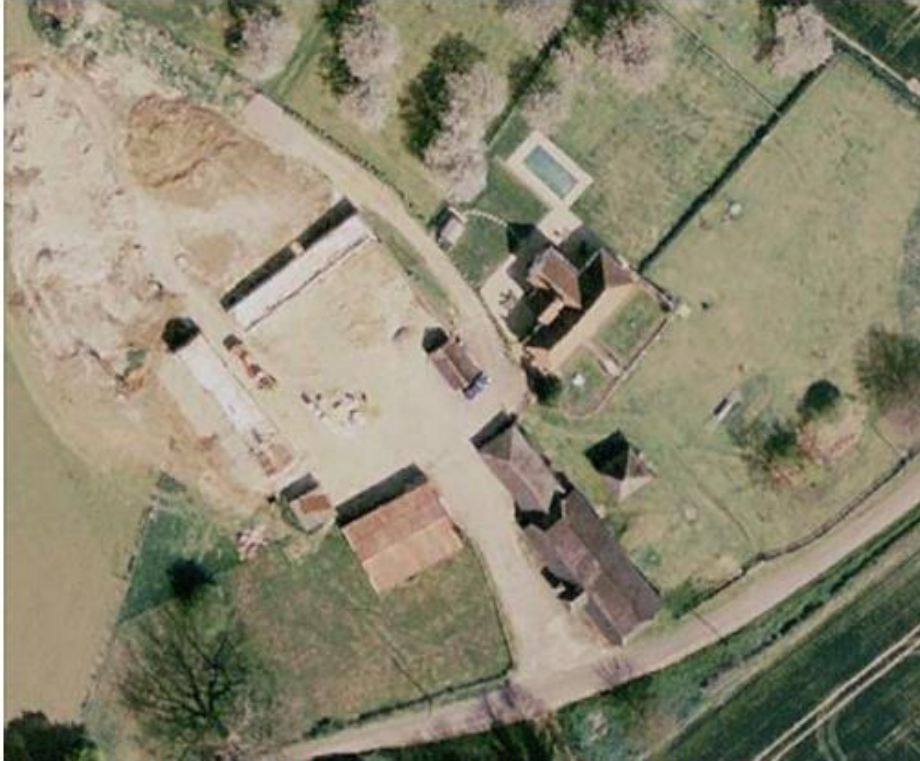
Aerial photo taken in 2007 showing the demolition of the farm buildings.

By 2007 the farm had ceased operating and the farm was being demolished leaving the site in a similar layout to that shown in the C1900 map.

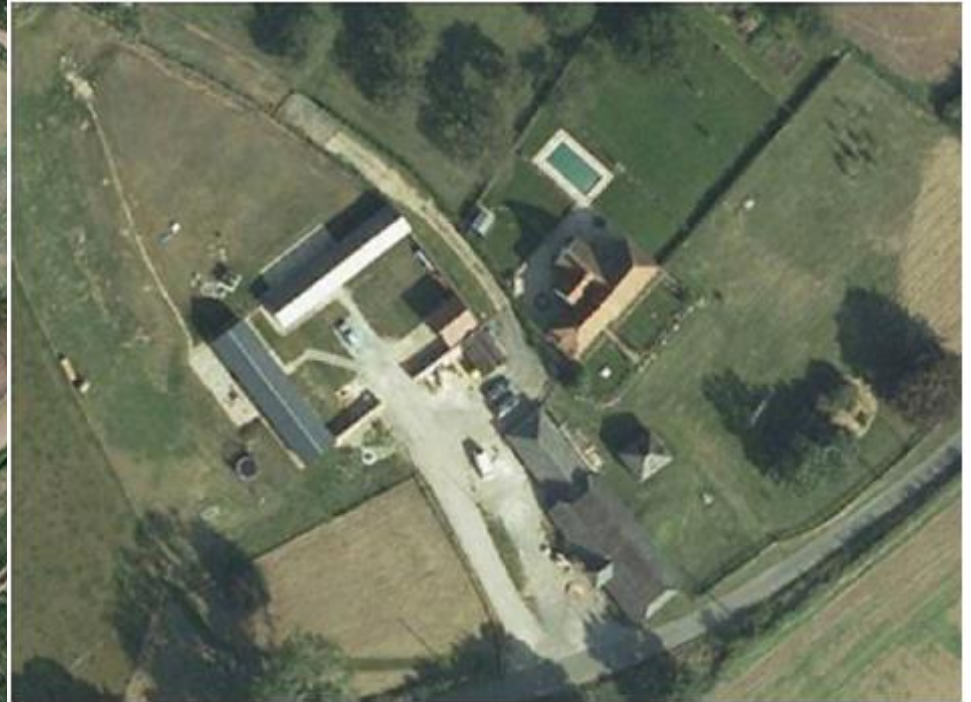
Aerial photo taken in 2008 showing the farm.

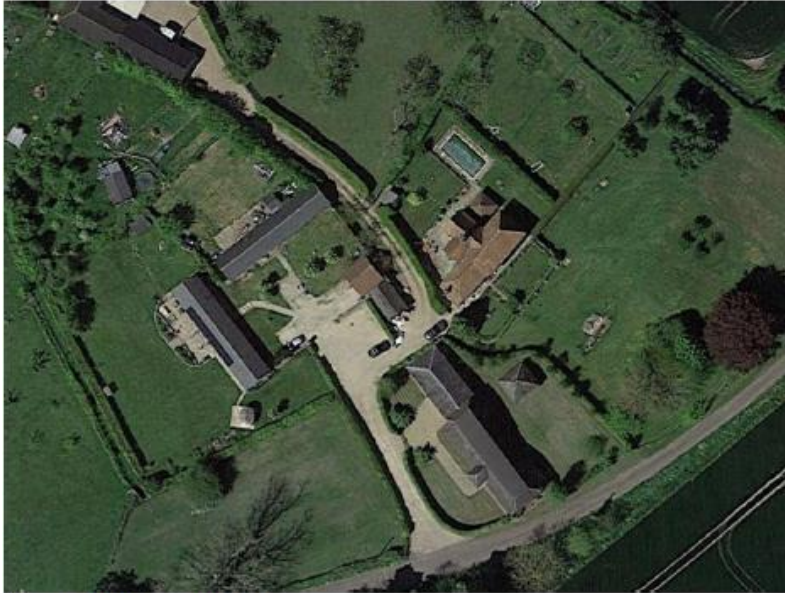
Aerial photo taken in 2019.

After the demolition work the remaining farm buildings were converted in to dwellings and these dwellings remain today. Since this time there has been some development to the north of the farm however this is screen and located far enough away from the listed buildings that they do not need to be looked at in this report.

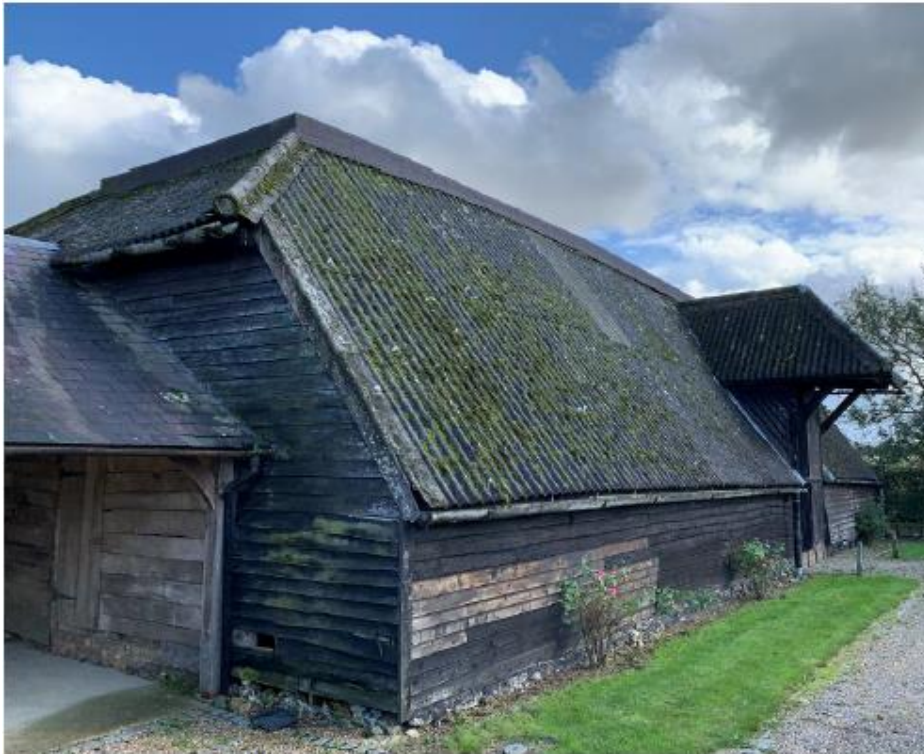
Photo of the barn looking south-west.

As can be seen today the barn has undergone many alterations and repairs, the asbestos covered roof which has been truncated and the myriad of timber repairs using a 'modern' sawn timber, this is evident in both the weatherboarding and the alterations to the timber frame and roof structure. While the barn originally dates from the 16th Century, the existing materials of the barn today are mostly of 19th Century and 20th Century origin. This however must not detract from the fine examples of 19th Century and earlier details and materials which comprise the building.

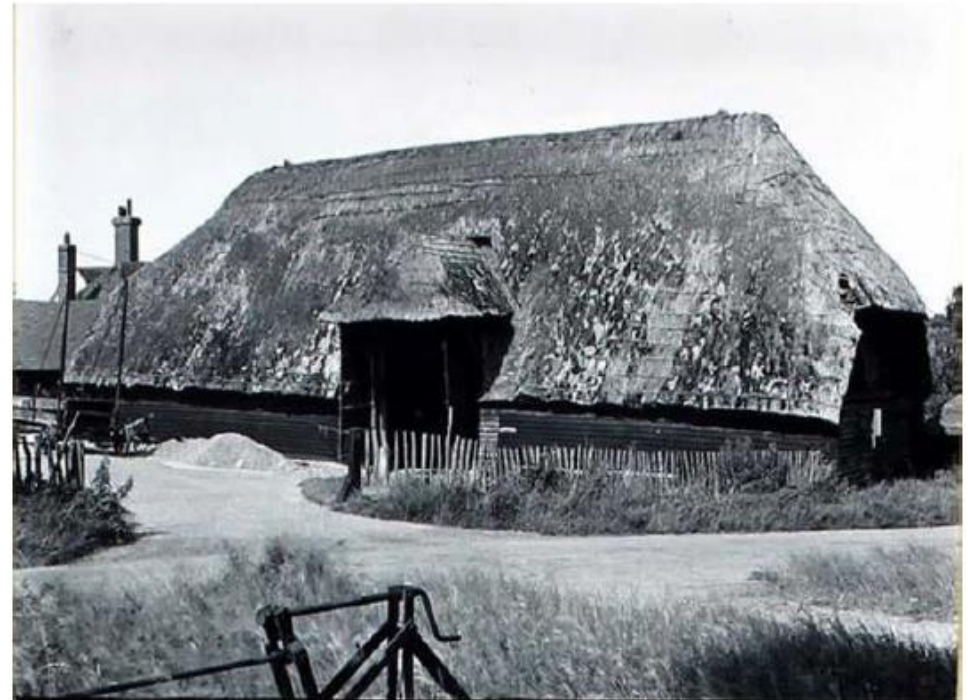
The earliest information we have about the original form of the building is with the photo taken in the 1950's as shown below, this shows the original form of the roof and confirms the thatched covering it once had. This photo is useful as it shows the eaves in today's barn are the original heights and this is confirmed by some of the timbers within the barn.

Photo of the barn taken in the 1950's.

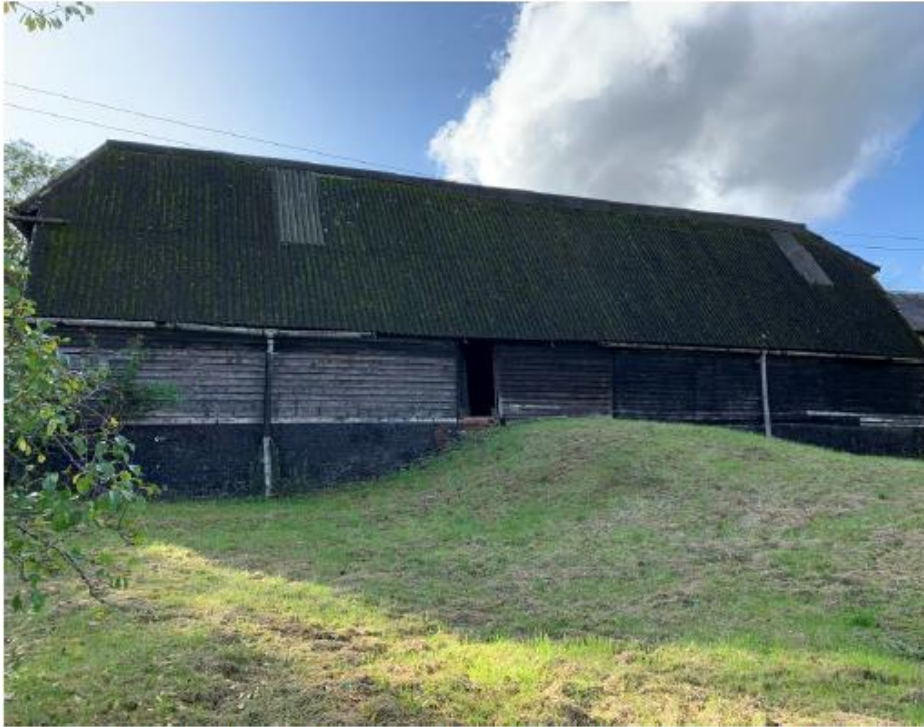
Along with Derbies Court the barn is one of the oldest buildings on the farm, the cart entrance/exit which is still present on the western elevation of the building, has been removed on the eastern side of the barn, this would be sensible as the horse drawn carts would have been driven through the barn to unload various produce. This is confirmed by the presence of the ramp which is obviously there to allow the cart to enter or exit the building.

Photo of the eastern elevation showing the raised ground for access into the barn.

The biggest item of interest in the site from an archaeological perspective is the raised ground to provide cart entrance on the east side of the barn. This is clearly made ground and will need to be dug into when undertaking any repair work to the wall.

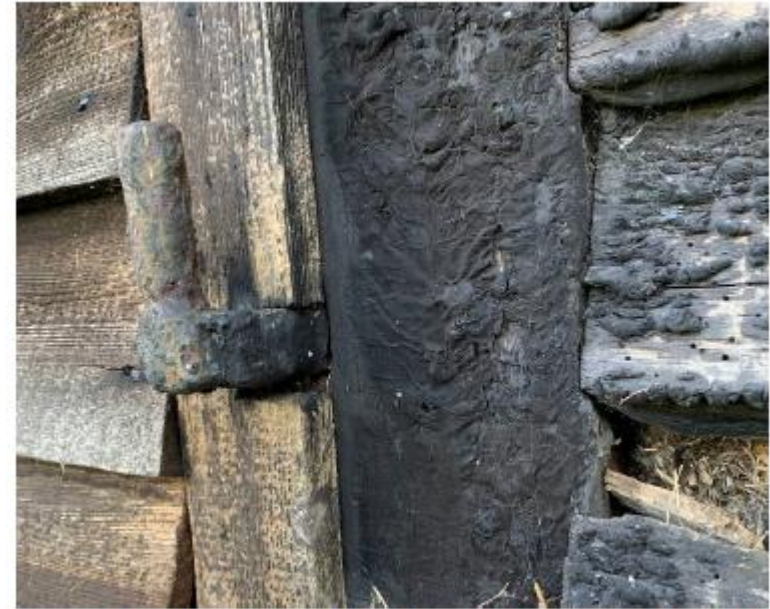
There are other items which confirm this, the presence of the pintle on the northern side of the original opening which has a 20th Century timber cut around it to finish the modern weather boarding into.

Photo of the remaining pintle on the northern side of the opening.

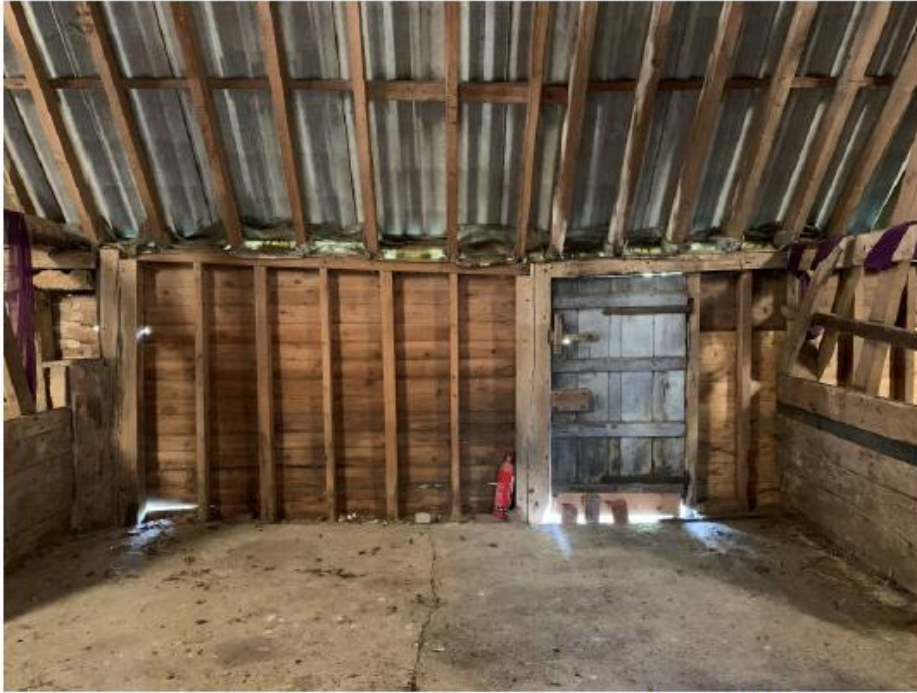
This is confirmed by the timber work of the infill timbers of the wall which are clearly 20th Century in date. The door which currently sites within this wall is a fine example of a 18th-19th century door with a charming timber cased lock. This door has been relocated from elsewhere in the building. It could be suggested that this was maybe on the northern pedestrian doorway rather than the modern door which is now present in this opening.

Internal photo of the in-filled opening on the eastern side of the building.

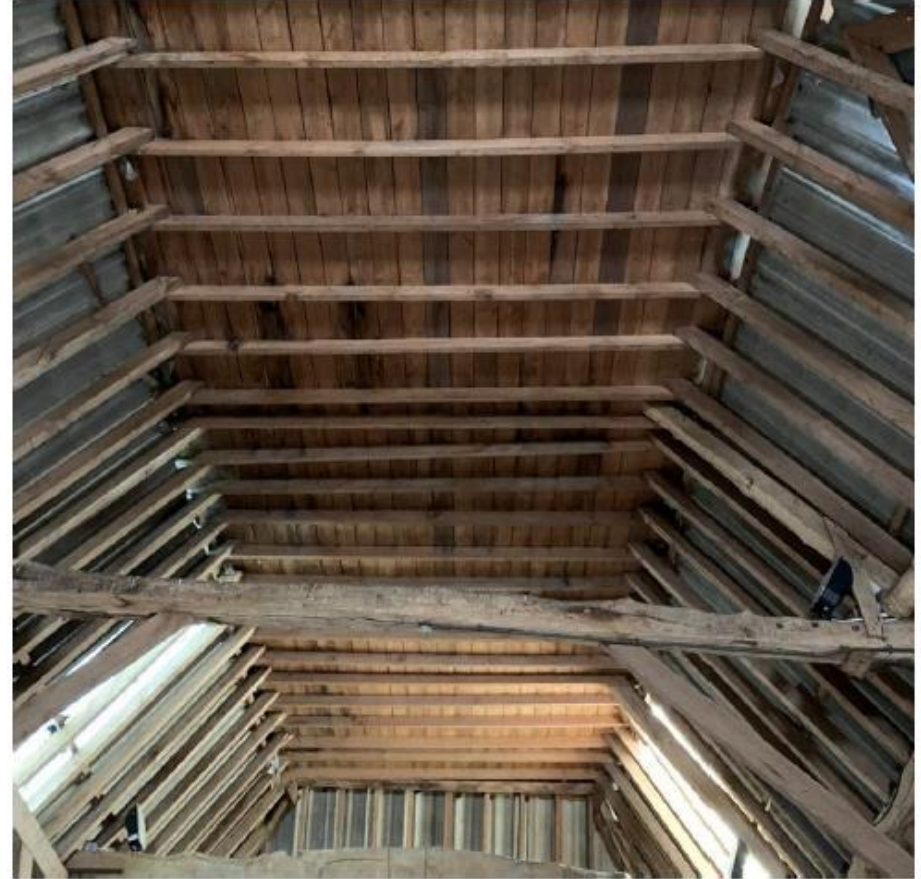
The timbers of the main roof have been mostly lost during the rather unsympathetic alterations in the 1960's where the roof was reduced, and the asbestos sheet laid.

The roof has been rebuilt using common rafters throughout with joists to form the flat roof at the top.

Photo of the 1960's roof which has replaced the original roof.

It is proposed that the existing roof be reinstated to extended up to the original ridge height using seasoned oak framed roof structure.

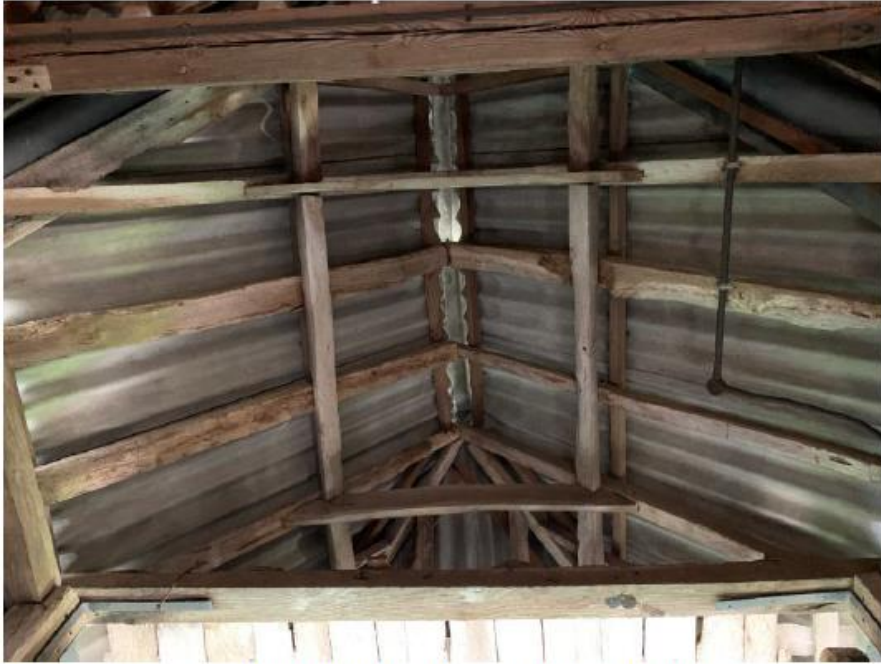
An area of roof which escaped the unsympathetic alterations if the existing cart entrance the western elevation. This shows the timber detailing which one would expect to see for this age of building. The rafters show a mortise and tenon joint with an oak peg at the top, this is a detail which exists nowhere else in the building.

Photo of cart entrance roof showing the rafter and purlins with tie beams.

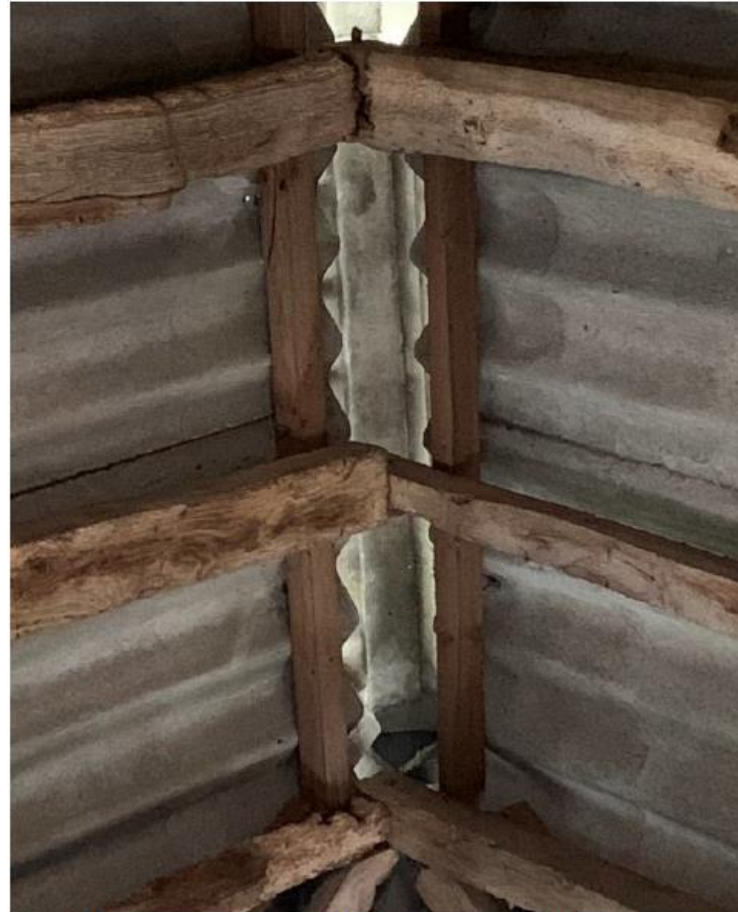
Photo of the timber joint detail in the apex of the roof of the cart opening.

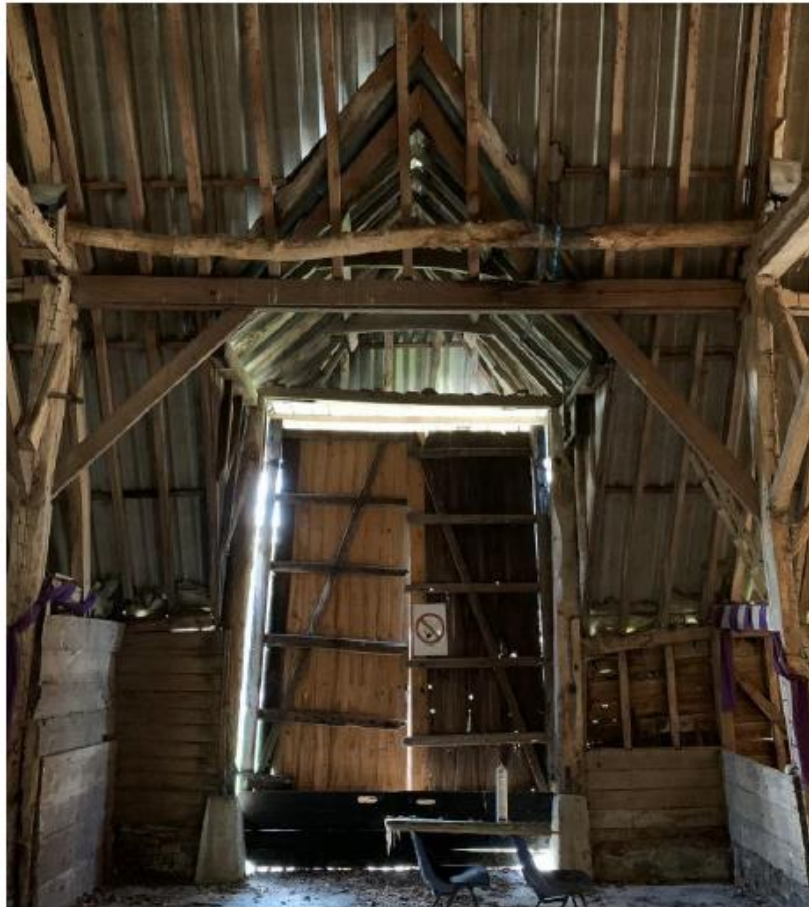
The timber frame of the doors of this opening are also suspected to be original to the cart opening, the boarding has been replaced over time, however the main frame appears to be original.

Internal photo of the timber door to the cart entrance on the eastern elevation.

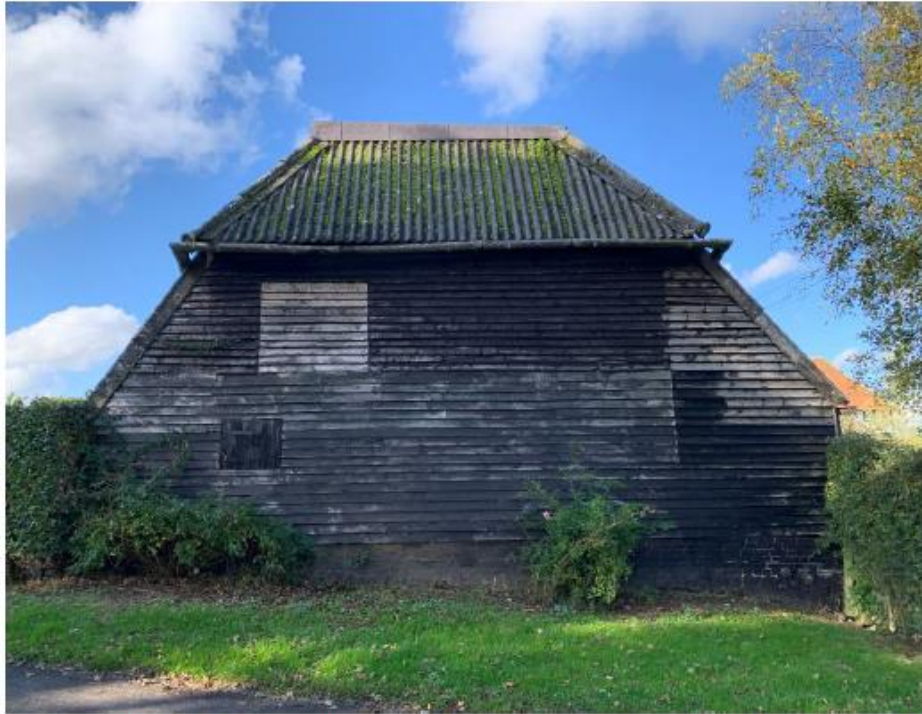
The southern elevation of the building is a combination of original timbers and reused timbers, the weatherboarding has had various campaigns of repair and it is a patch work of new and old boarding.

Photo of the southern elevation of the barn showing the patchwork of new and old boards.

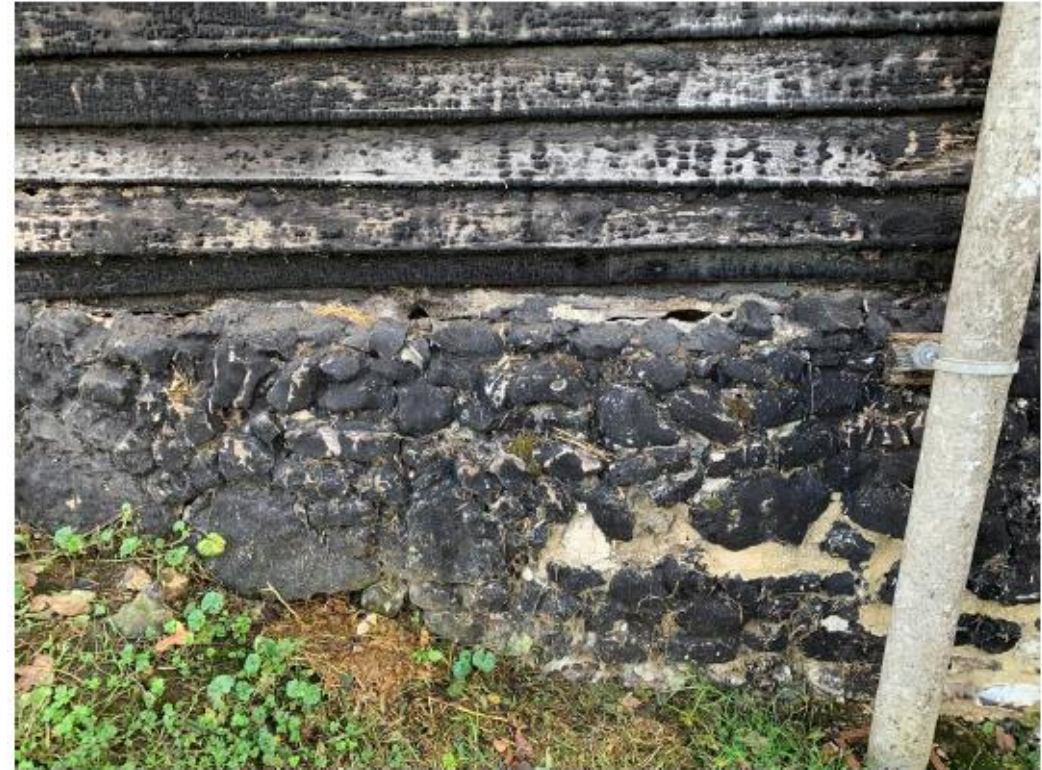
The masonry base walls of the barn have not much alteration and there are signs of significant structural movement and erosion of the wall, much of the wall has tar over it and therefore it is easy to see areas which have been worked on since the 19th century.

Photo of the north-eastern length of the base wall, this is typical of the poor condition of the wall.

The structural movement of the base walls of the barn are of some concern as the building appears to be failing at its base and is in need of repair and stabilisation to prevent it from becoming worse.

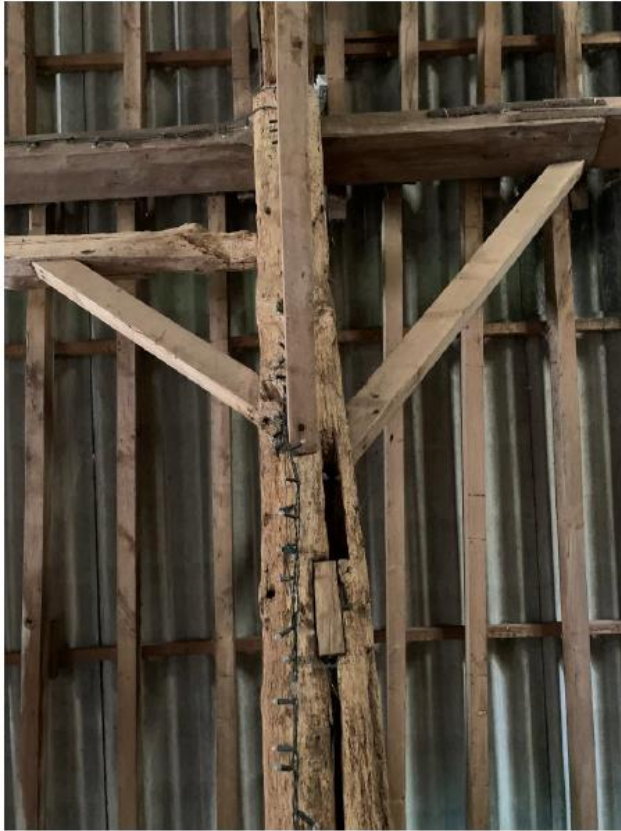
In the order of significance, it is considered, frames 3 and 5, have had significant timber replacement, frame three has had the eastern post

Photo of east post and nailed and sawn timber braces of frame 4.

replaced, frame 5 has had the eastern post replaced and the main cross tie beam replaced.

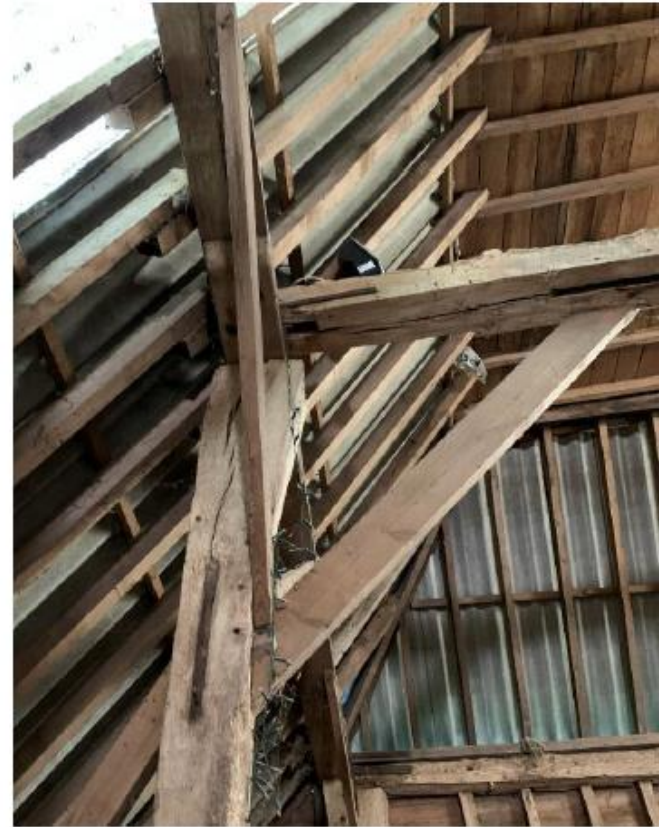
Every frame has suffered from new timber being nailed to the frames, the high level wall plates which run the length of the building have been replaced in considerable lengths on the eastern side and some of the timber on the west.

Photo of frame 5 on the eastern post, showing the typical 1960's sawn timbers.

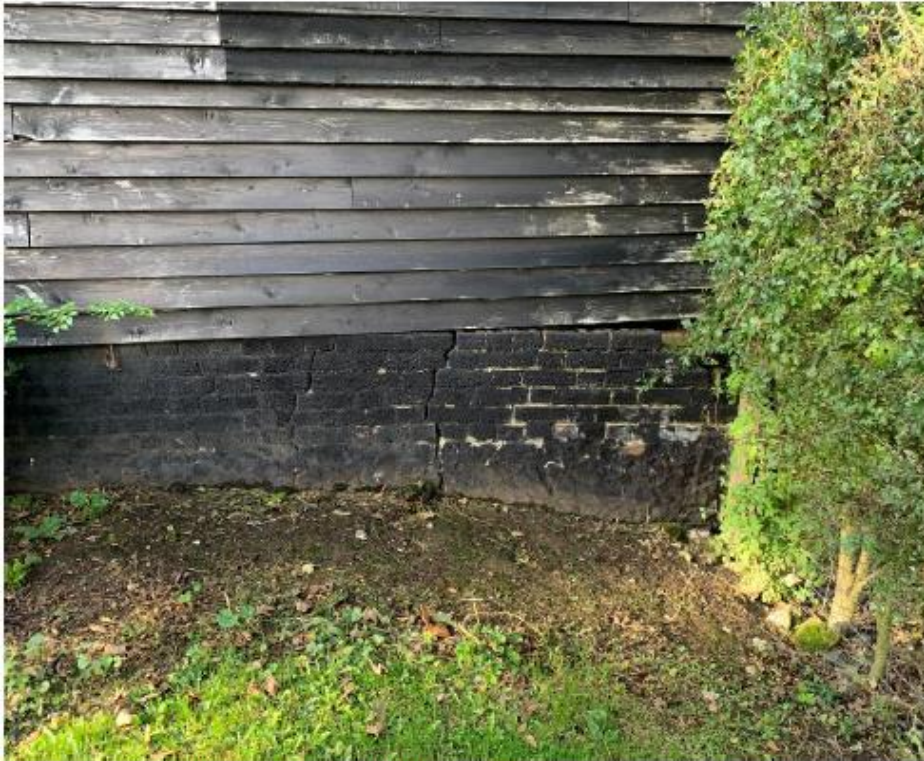
Photo of the south-east base wall where there are signs of movement.

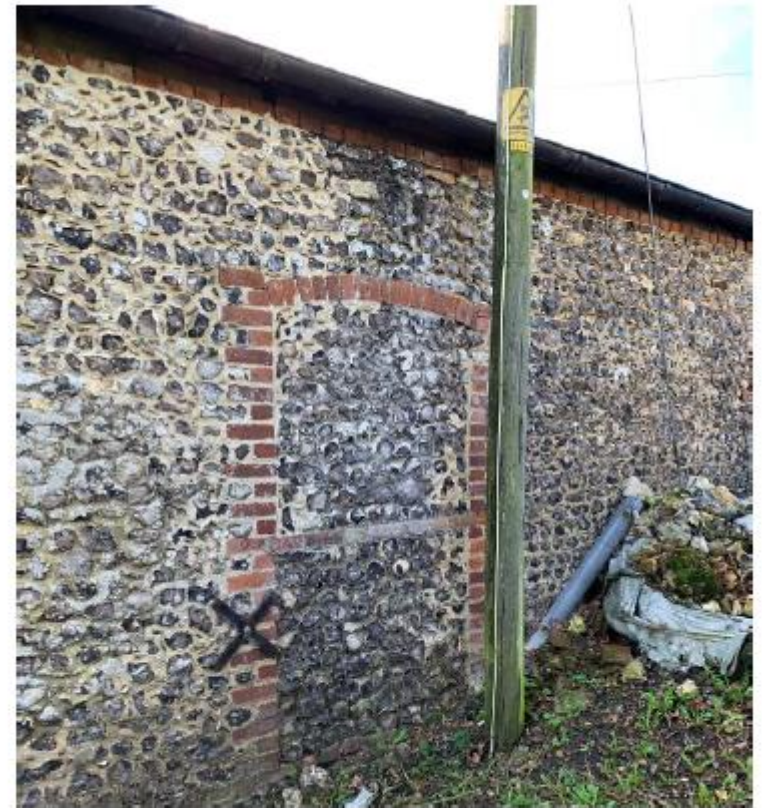
The original building may have been stables or a cart shed, it was ancillary to the main barn and unfortunately can only be partially seen in the 1950's photo. In the masonry wall on the eastern elevation a blocked-up opening can be seen, some restraining steels have also be placed in this wall at floor level in an attempt to restrain the base wall and halt its movement,

this seems to be quite recent and the timber posts in the open area of the barn can be seen have been set into the concrete slab with the sole purpose of holding the ends of the threaded bars to these restraining steel crosses.

Photo of the eastern wall of the single story building, showing the historic opening and the steel wall restraint.

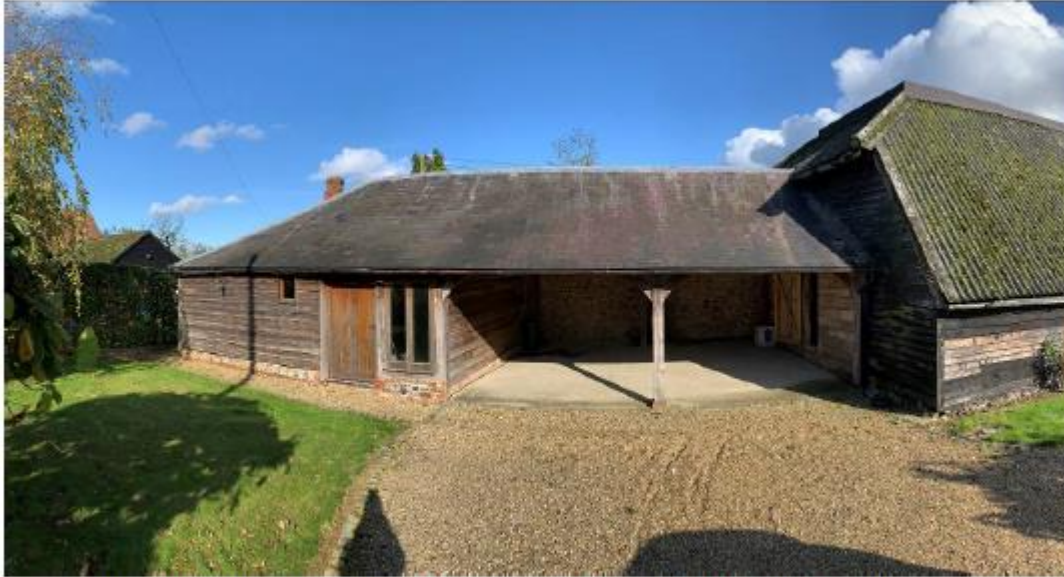
Photo of the western elevation of the single storey building north of the barn.

The building has a slate roof and the photo in the 1950's shows what looks like a Kent peg tiled roof, the timber work of this building is of limited significance and it is the retention of the single storey form and massing of the building which could be argued is the most important thing about the building as everything except the eastern wall seems to have been rebuilt in the recent past.

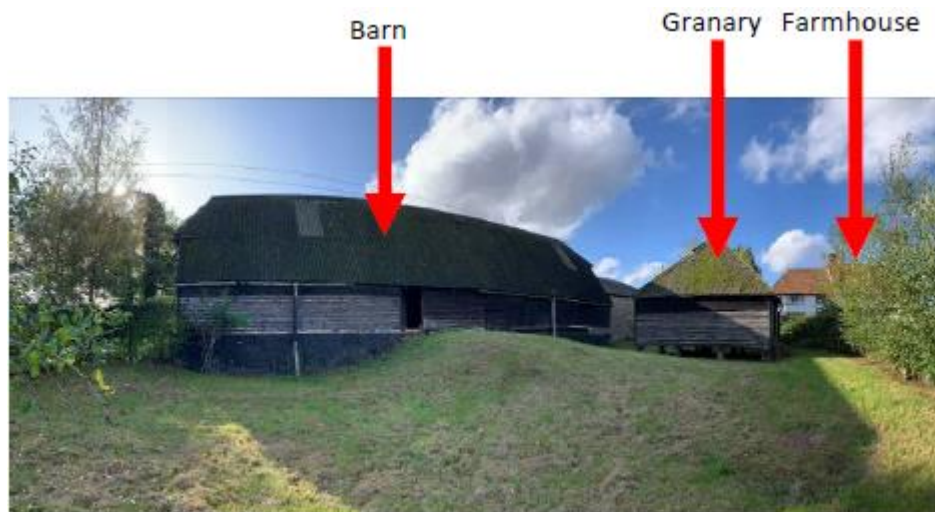
Photo showing the barn, granary and Derbies Court together.

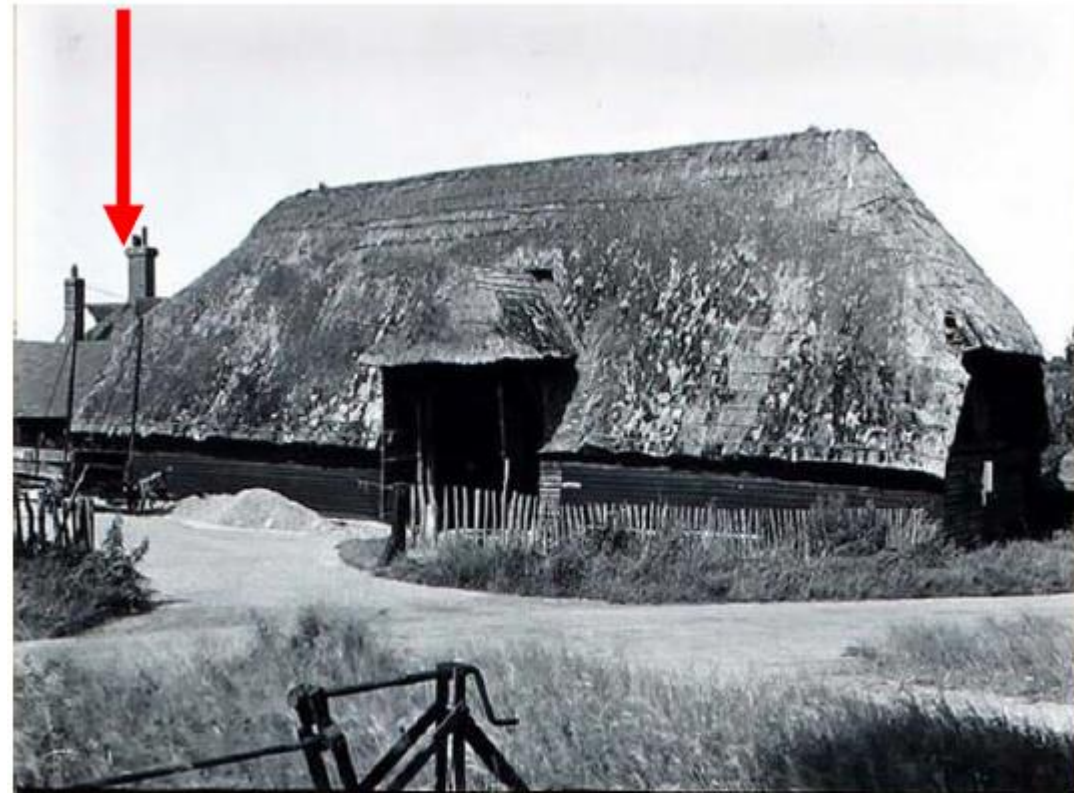
When the barn had the original roof the barn would have been the dominant building on the farm, this is confirmed by the 1950's photo which shows the farm

Photo taken in 1950 with the farm house in the background (red arrow).

When viewed from the high ground to the west of the site, the barn can be clearly seen today, with the original roof, the barn would have been quite dominant in the landscape of the farm. Derbies Court, the farmhouse is on a raised platform, this does elevate it in the landscape however this would not provide the building with a presence to rival the barn. Today, even with the hedges which provide privacy to the land around the converted stable buildings and the farmhouse, it is clear that the buildings across the whole site can be seen in the context of each other. As the photo taken in the 1950's can be seen the site today has more
