Bat emergence surveys
20 Egloshayle Road, Wadebridge, Cornwall
September 2020

Site address: 20 Egloshayle Road, Wadebridge, Cornwall, PL27 6AD
Grid reference: SW757260
Report date: 20th October 2020
Report Author: Michael Sanders BSc (Hons) (Natural England licence no: 2016-24281-CLS-CLS) and John Blackburn BSc (Hons), MSc, (Natural England licence no: 2019-39576-CLS-CLS)
Report checked by: Colin Hicks BSc (Hons), MCIEEM (Natural England licence no: 2016-24281-CLS-CLS)
Report no: WOR 1688

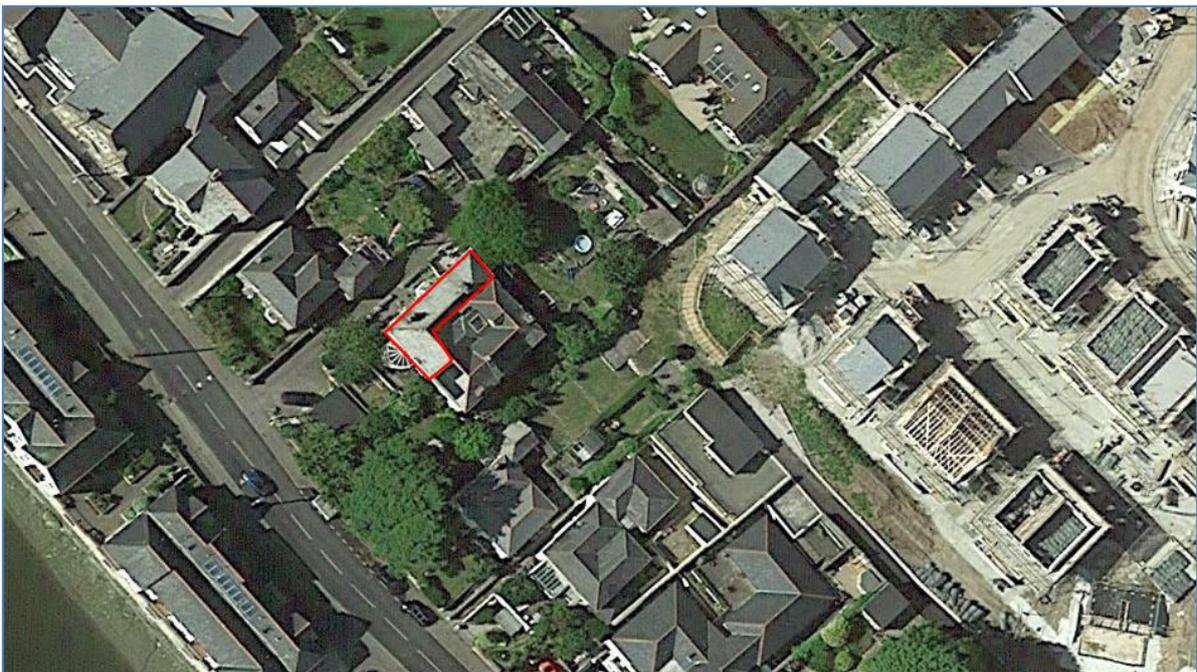
Plan 1b. The building surveyed at this site

The property at 20 Egloshayle, Wadebridge is in an urban setting within Wadebridge, in North Cornwall (Plan 1a and b). Residential gardens with associated habitats are present in the immediate surrounds and to the south, 100m, lies the River Camel. Across the river lies an area of open amenity grassland and further urban development. 500m east lies a small woodland which leads into open farmland.

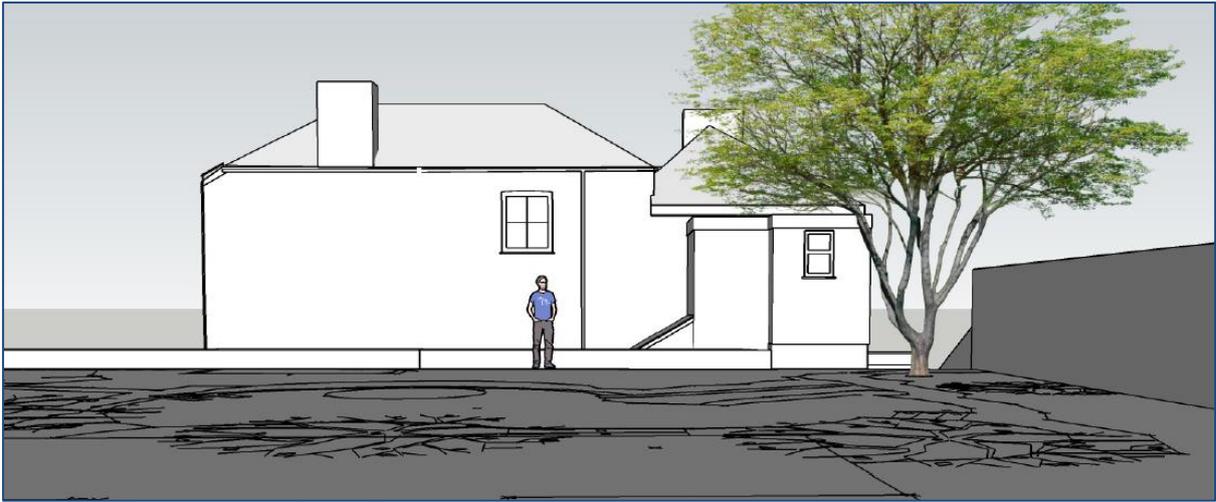
Plan 2a. North-east aspect - Existing

Works will be carried out to either remove an interior section of the chimney (with additional support works in that area of the roof void) or remove the chimney entirely. An extension will be added to the north-east aspect (Plan 2a and b). There may be some flashing in association with the new flat roof at the Northern end which may require some temporary slate stripping of the bottom slate courses before being reinstated.

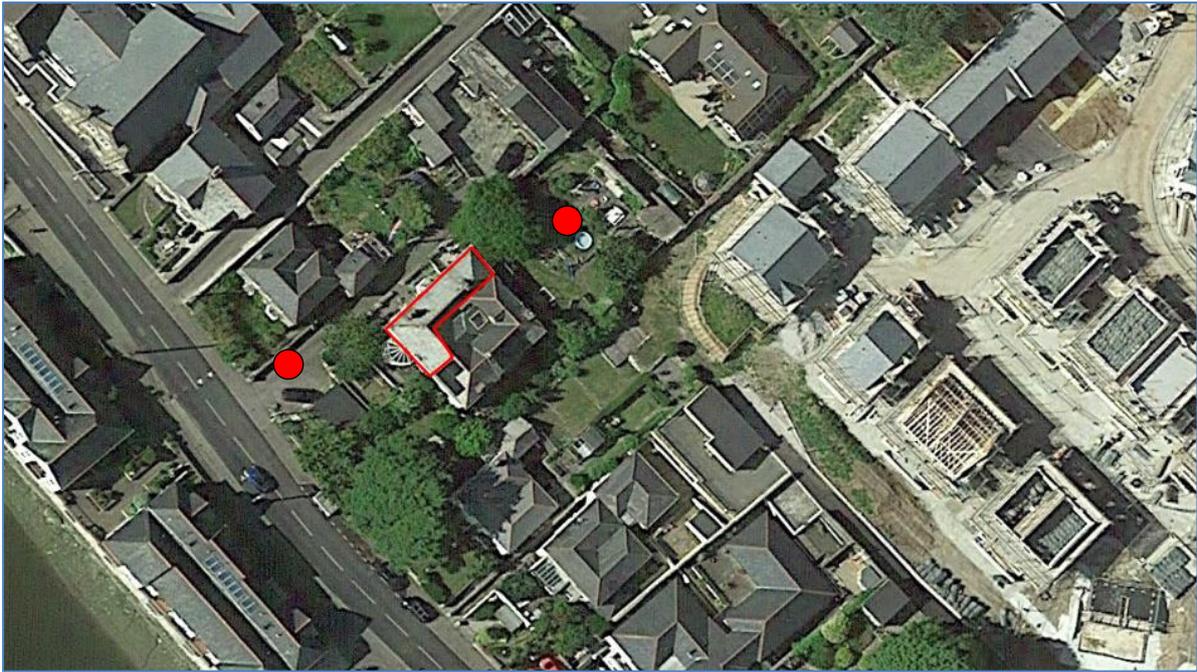
Plan 3. The location of surveyors for both surveys (red dots).

These surveys consist of a sufficient number of experienced bat surveyors monitoring a built structure for bat activity. BatBox Duet heterodyne bat detectors and an Echo Meter Touch time expansion bat detector, attached to a Huawei P20 tablet running the Echo Meter app, are used during the surveys. The surveyors, including at least one licenced bat ecologist, are stationed around the building in such a way that any bat leaving or entering the structure is likely to be observed (Plan 3). The survey normally begins 15 minutes before sunset and continues until at least 90 minutes after sunset or when light levels are so low that any emerging bats cannot be seen.

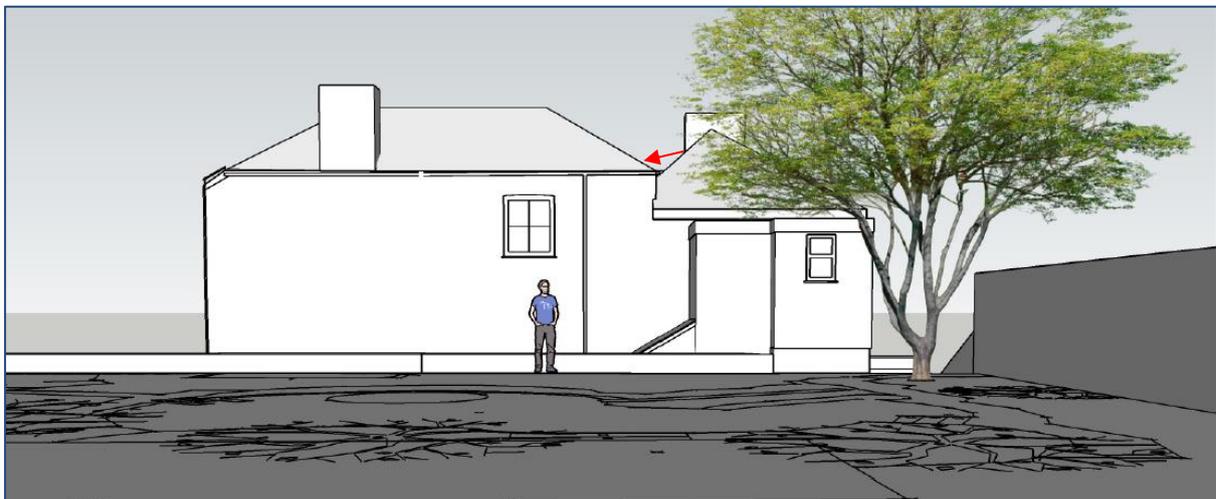
During the survey 1 common pipistrelle (20:02) emerged from the building from around the chimney area. Roost locations are detailed in plan 4 and table 4. Bats were recorded throughout the survey, the bat emerging being the first contact. Other species recorded include a noctule at 19:48 flying above the river to the south.

Plan 4. North-east aspect – existing. Location of emerging common pipistrelle (red arrow) during 1st emergence survey.

1 x common pipistrelle	Day roost	20 Egloshayle Road	Chimney on south facing aspect	1	Crevice roost in association Missing mortar around chimney	Low	Local importance
------------------------	-----------	--------------------	--------------------------------	---	---	-----	------------------

Without mitigation, works associated with the chimney have the potential to disturb, injure or kill small numbers of day roosting common pipistrelle bats.

In the long term, works to, or removal of, the chimney would lead to the loss of the following roosts:

To proceed legally, these activities would require a Mitigation licence for European Protected Species with a supporting method statement to protect bats during the process.

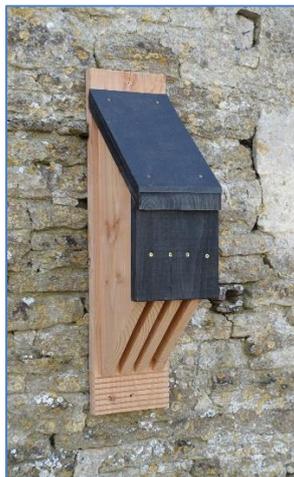
Figure 1. Vincent Pro Bat Box

Prior to any works commencing on site, alternative temporary roosting boxes must be provided for the common pipistrelle bats. This will be in the form of 1 Vincent Pro Bat box (Figure 1) secured to trees or untreated wooden posts (the base of the posts may be treated) at least 3 metres above the ground within the garden (Plan 5).

Alternative roosting provision must be installed under the licensed bat ecologist's supervision prior to any works commencing.

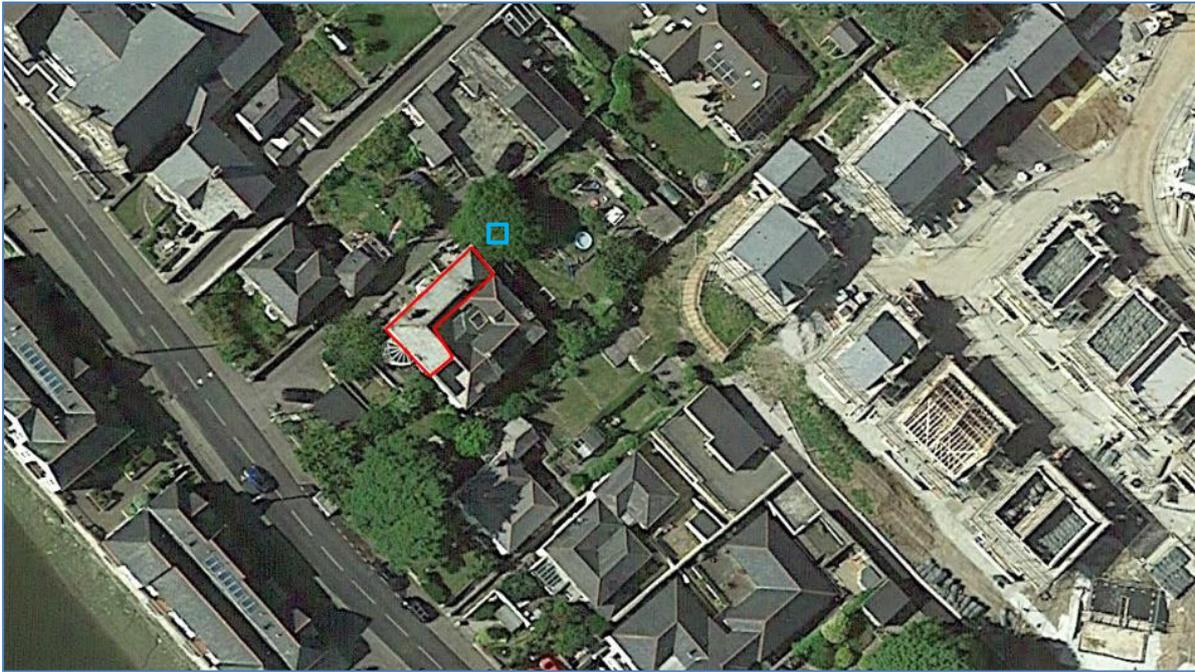
Plan 5. Outline of existing building in red. Location of Vincent Pro bat box (blue square).

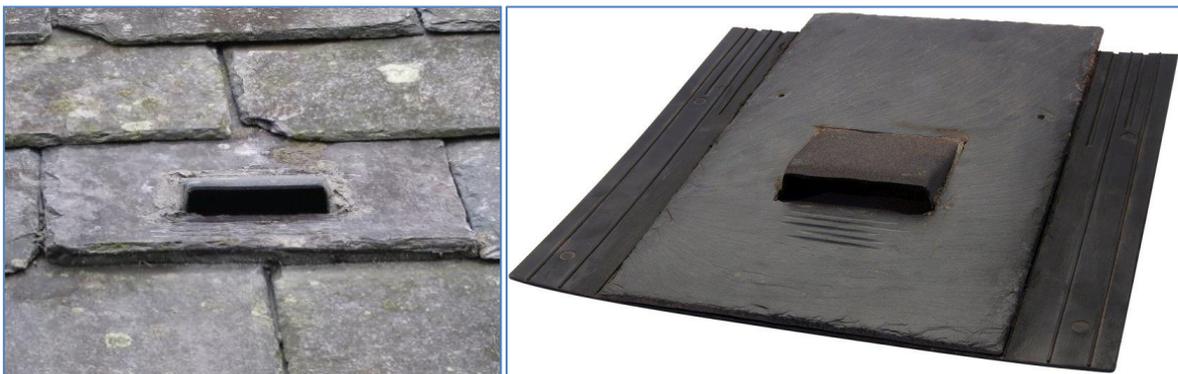
Figure 2. For illustration purposes only; modified slates to allow bats access into roof covering.

For the common pipistrelle bat roosting in association with the roof, a modified tile (Figure 2) will allow this bat into the roof covering. Guidance from Natural England is that breathable roof membranes (BRMs) should not be installed into roosting areas used by bats. The underfelt for all areas associated with the roosting bats will comprise bitumen 1F felt. This must be approved and supervised by the licensed bat ecologist.
