RSE\_4196\_L1 12th AUGUST 2020

## RE: STABLE BUILDING AT THE SAWMILL, HAWSWORTH: BAT BUILDING ASSESSMENT

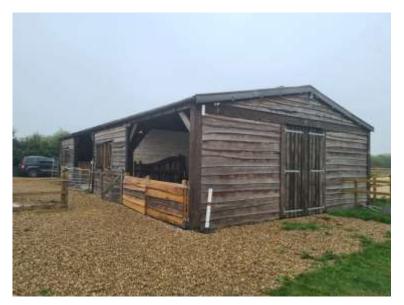
## Figure 1: General View of the Stable Building

The site was formed of a timber frame stable building which is understood to be c. 4 years old. It has a pitched roof clad with bitumastic tiles and the walls are also clad with a waynei edge boarding detail. However, the waynei edge boarding is not backed behind and owing to its age is in very good repair. Internally a solid breeze block wall was present however this was intact with no gaps present and the gap between the wall and exterior cladding was excessive and unsuitable for roosting bats.

No evidence of bats was found and no further survey or more detailed reporting is considered necessary or proportionate at this site in support of any proposals for the structure which is considered to be of negligible scope for roosting bats.

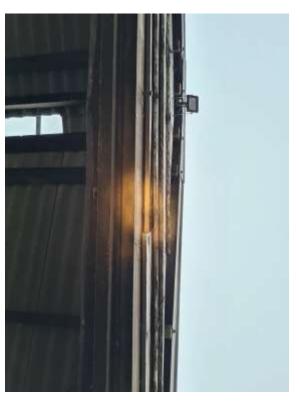
## Figure 2: partially warped wanei edge board

There are a very small numer of areas where the weather conditons have begun to warp these boards, however these are deminuative and have not yeiled crevices capable of supporting roosting bats.

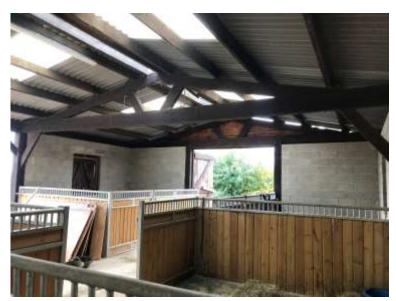
## Figure 3: General view of roof / interior

The interior space was light owing to the open sides of the stable structure and also a central ridge featurign a perspect skylight across the length of the structure. The roof stood proud of the wall plates with a gap c7cm between wall plate and faters. The structure was also formed of machine cut timbers and lacked any suitable secluded crevices that are normally assocaited with morticde joints for instance.
