Blackpool Ambulance Service Hub,
1 Parkinson Way,
Blackpool.

On behalf of Galliford Try.

**Preliminary Ecological Appraisal and Bat
Scoping Report**

Report number: GT/21-001

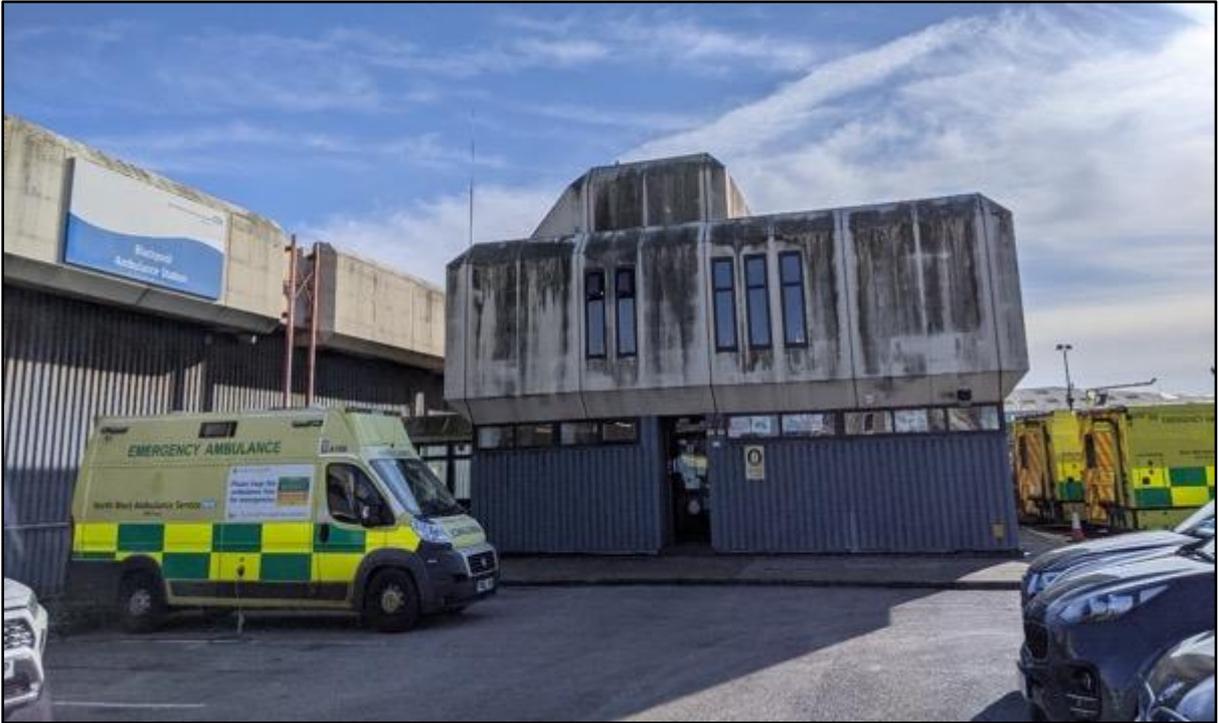
Photograph 1; A view of the main entrance to the Ambulance Hub, including the western elevation.

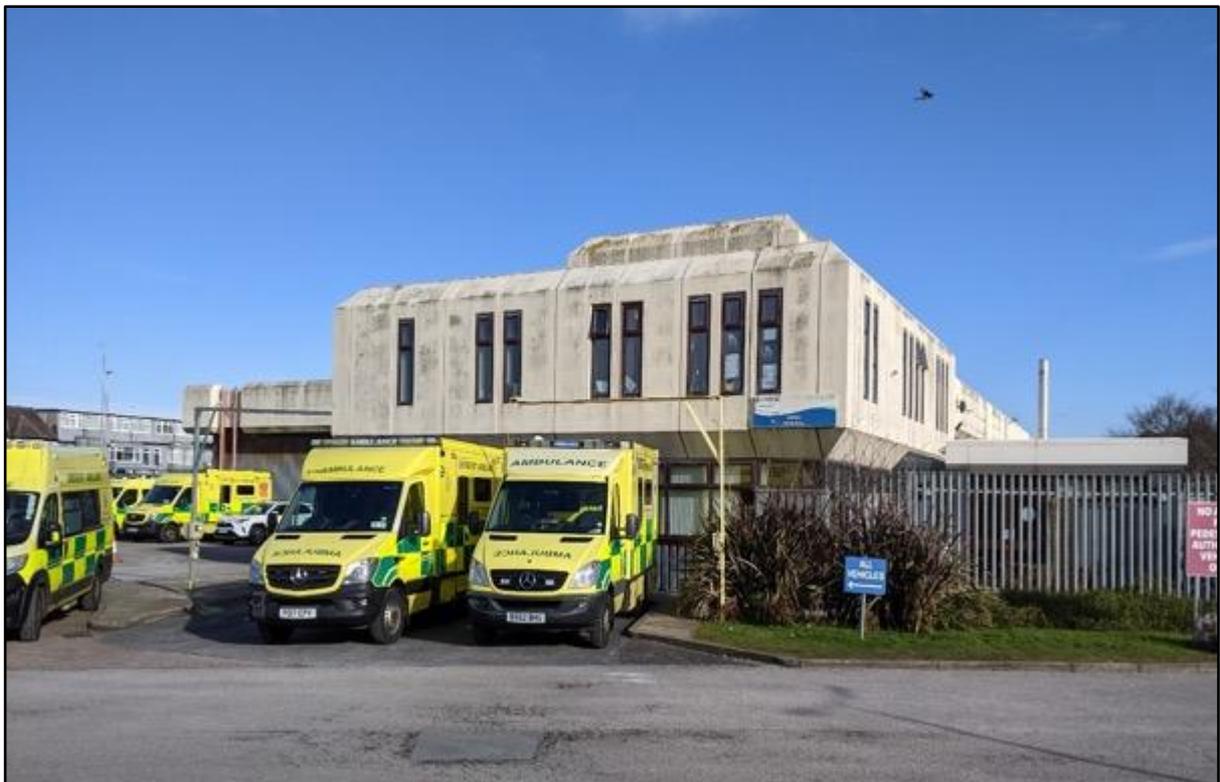
Photograph 2; A view of the western elevation as seen from Parkinson Way.

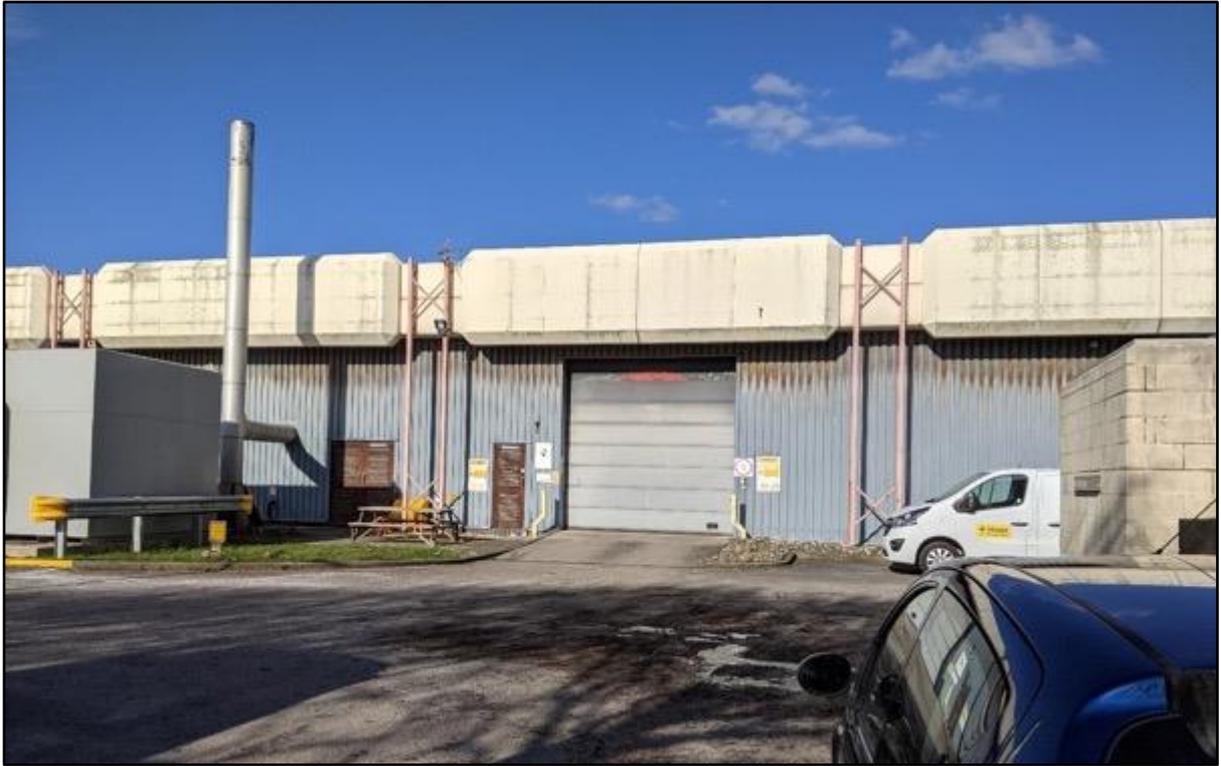
Photograph 3; A view of the southern elevation and entrance to the workshop.

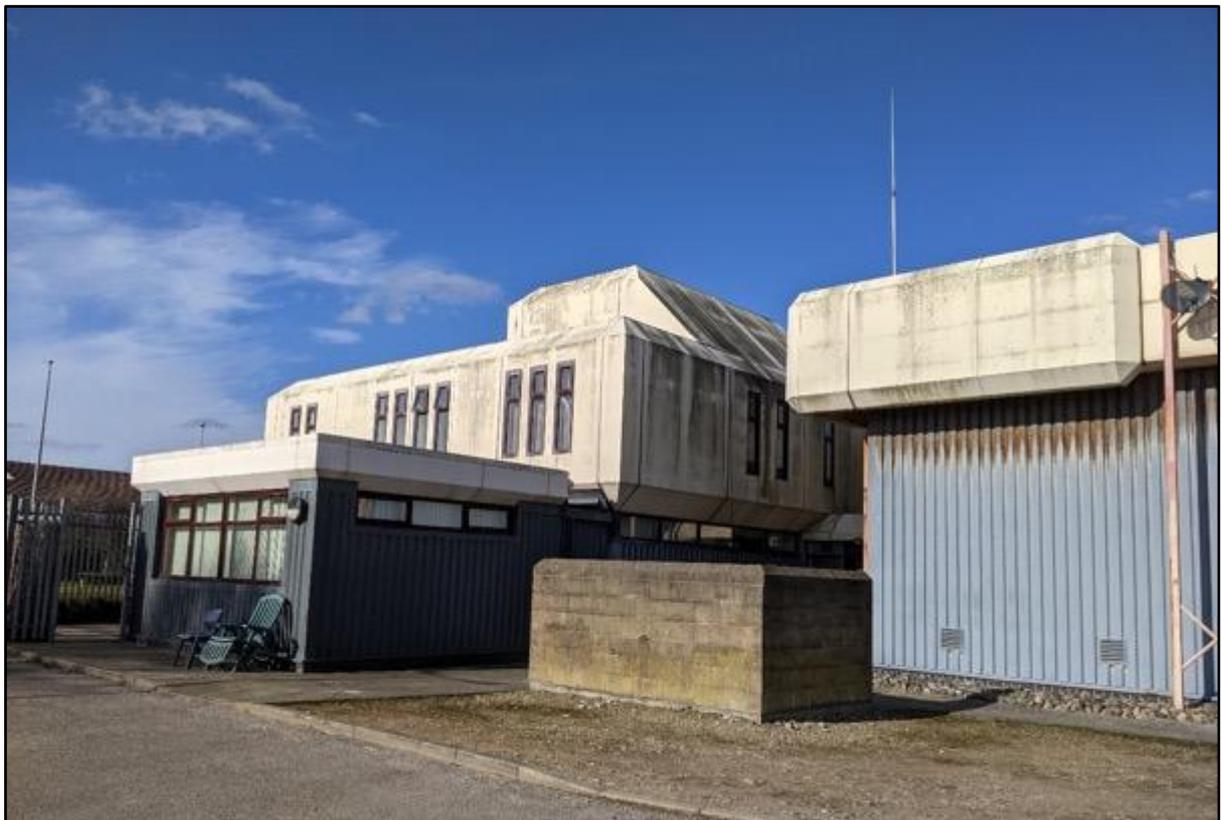
Photograph 4; A view of the southern elevation of the main entrance and offices.

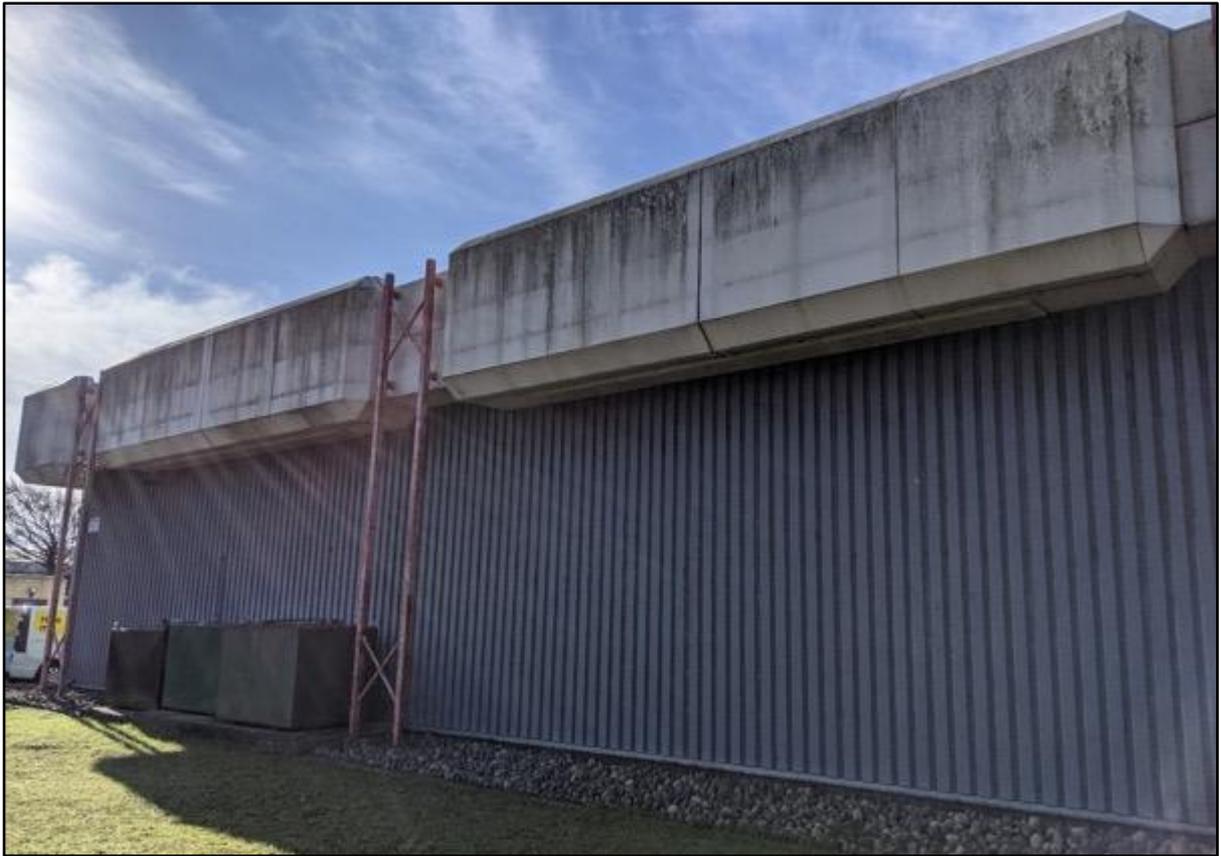
Photograph 5; A view of the eastern elevation of the Ambulance Hub.

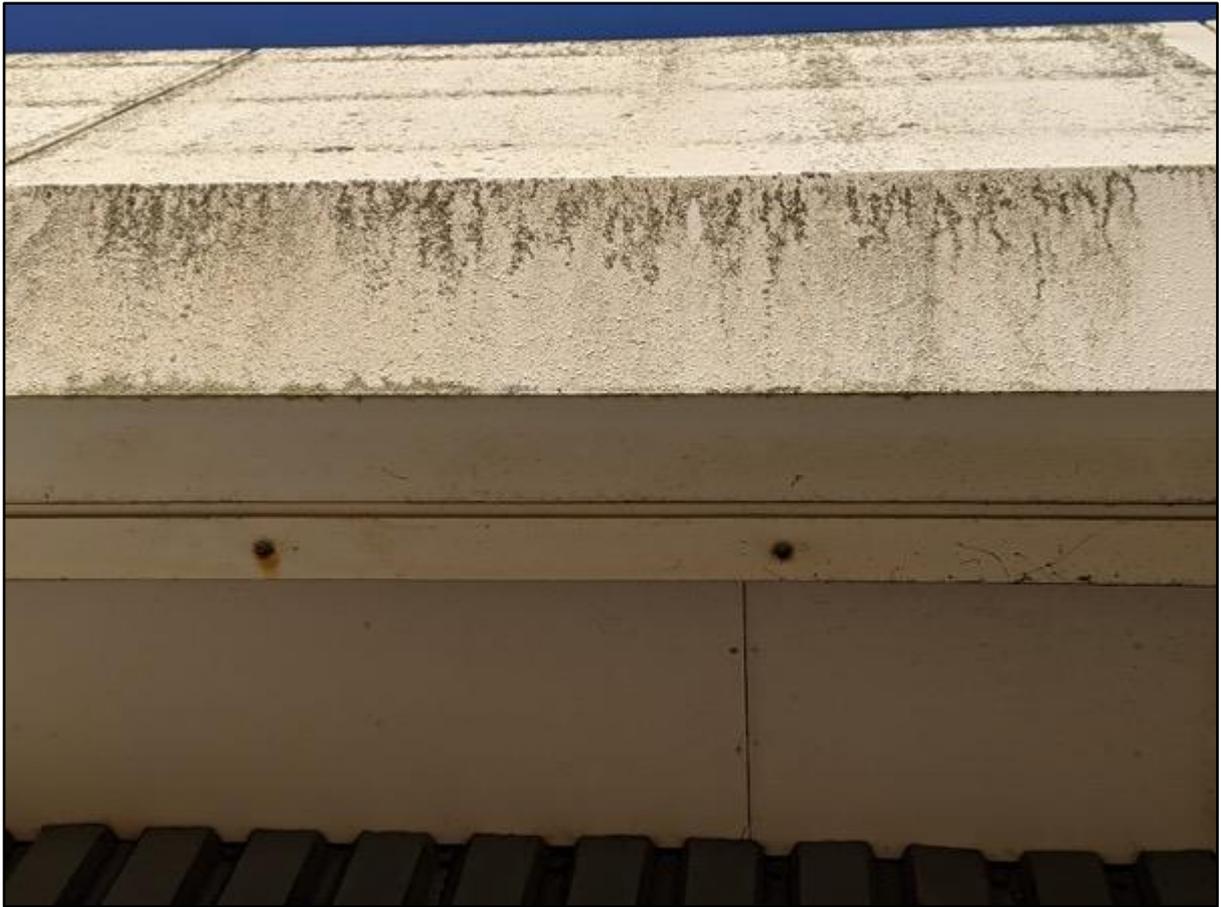
Photograph 13; A view of the wooden soffit that meets flush with the corrugated paneling of the walls, and the decorative-shaped metal roof features.

The buildings at the Ambulance Hub are constructed from breeze block with steel support struts and finished with corrugated or molded metal sheeting. The roof is flat with metal paneling and decorative shaped edging. As a result, there are no 'typical' roofing features such as tiles or barge boards.

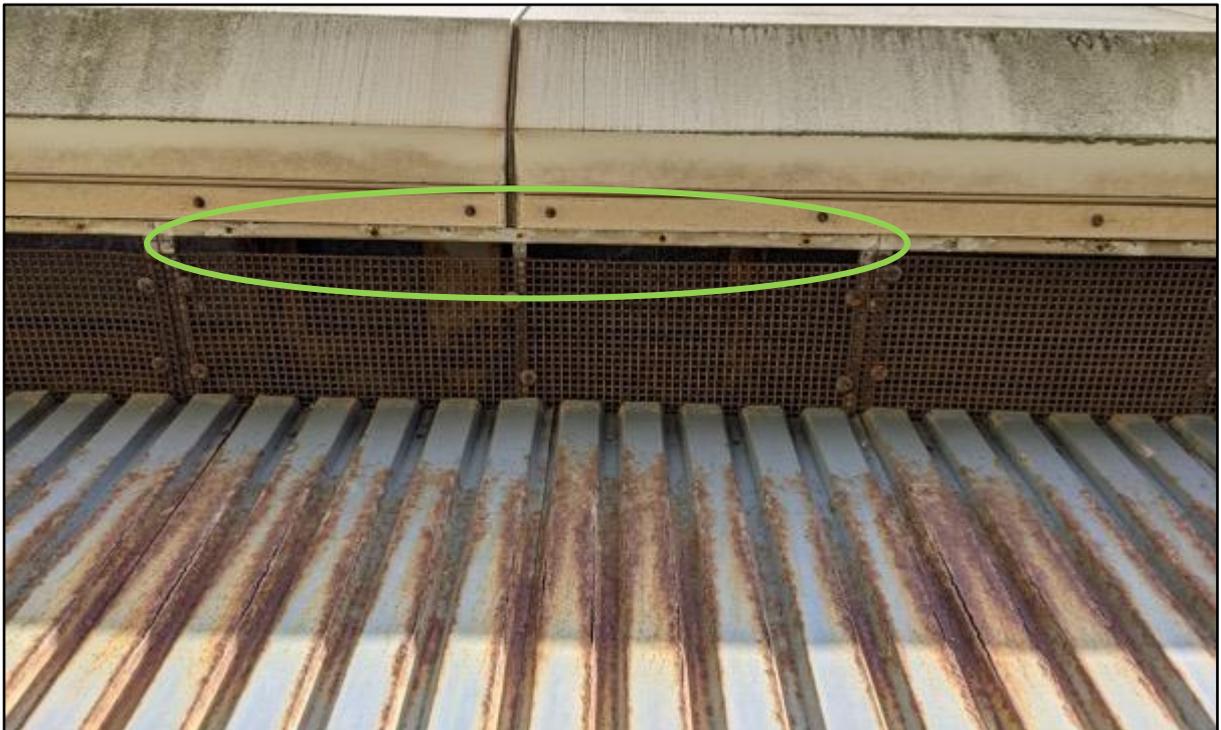
Photograph 14; A view of the vented soffits to the west of the building, which evidences a small gap as shown above. Pigeons are able to access the workshops and were present at the time of the survey.

There are no notable voids from the external view, however, there is access from ventilation soffits present on the western elevation of the workshop. Overall, the condition of the building is good and well-sealed, with no noteworthy apertures or openings allowing access to the spaces within.

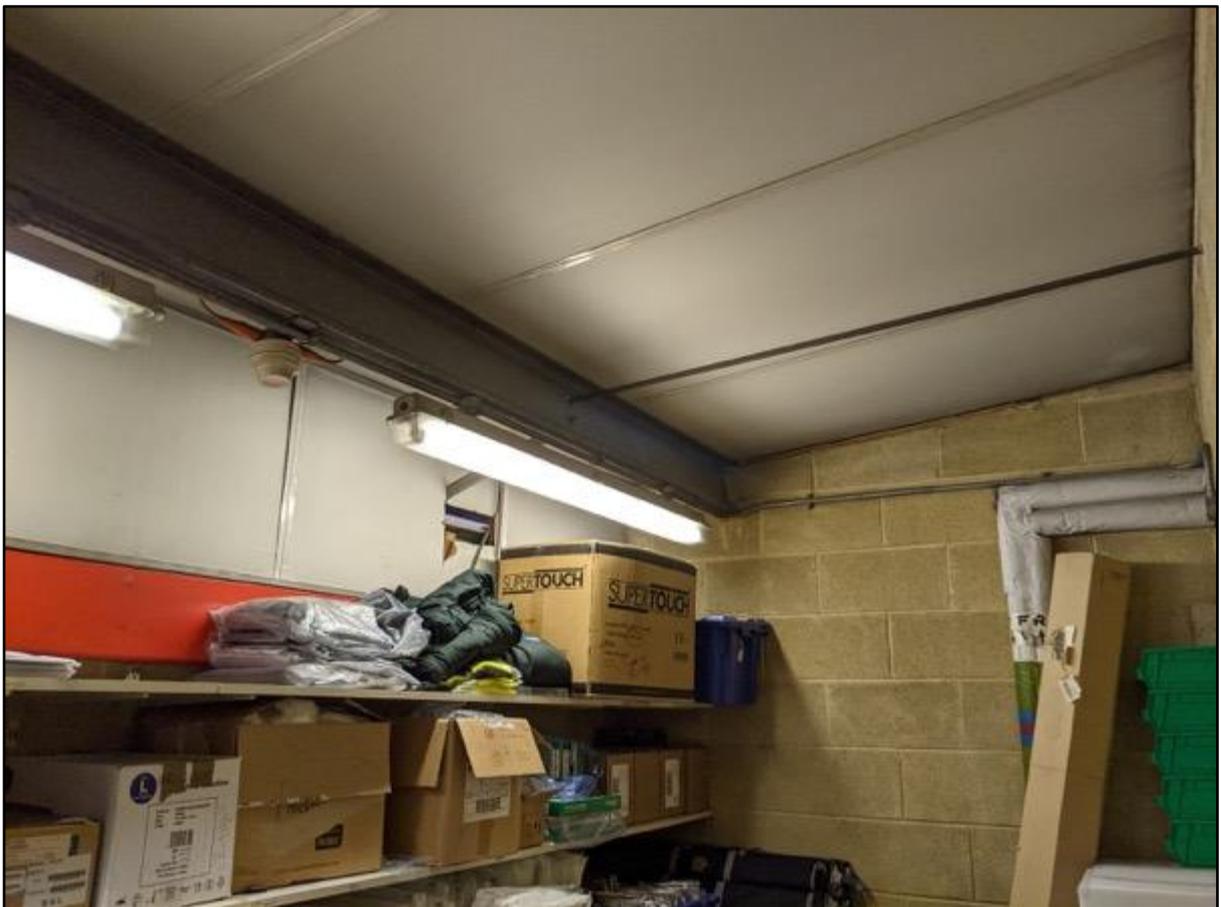
Photograph 16; An internal view of additional storage rooms on the first floor. Note that the room is well-sealed with no access from the outside.

On the first floor of the main entrance are a number of offices and changing rooms for the staff. These are well-sealed with no roof voids, however, there are voids between the ceiling and the roof, but these are well lit and sealed. There are some additional first-floor rooms comprised of toilets, storage, and break rooms within the two main workshops which are again, well-sealed with no notable bat-friendly features.

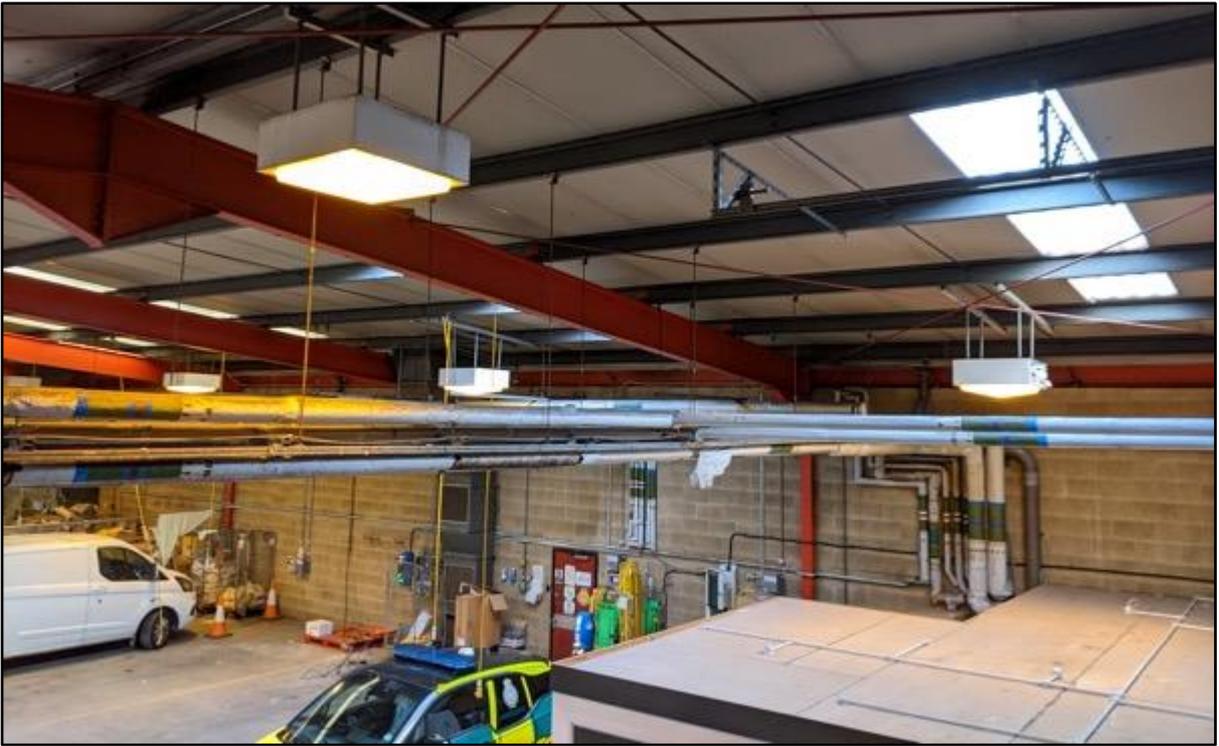
Photograph 17; An internal view of the workshop and indoor car parking for the ambulance vehicles. Note the lighting and skylights.

There are two levels within the Ambulance Hub, the ground floor is largely dominated by workshop spaces with large rolling gates to allow ambulance vehicles into the space. There are some office spaces, storage spaces, toilets, and break rooms for employees on the ground floor. The internal roofing structure is comprised of steel struts and support beams with no notable lining on the ceiling. Several skylights are built into the ceiling and the areas are heavy with human traffic and very well lit.

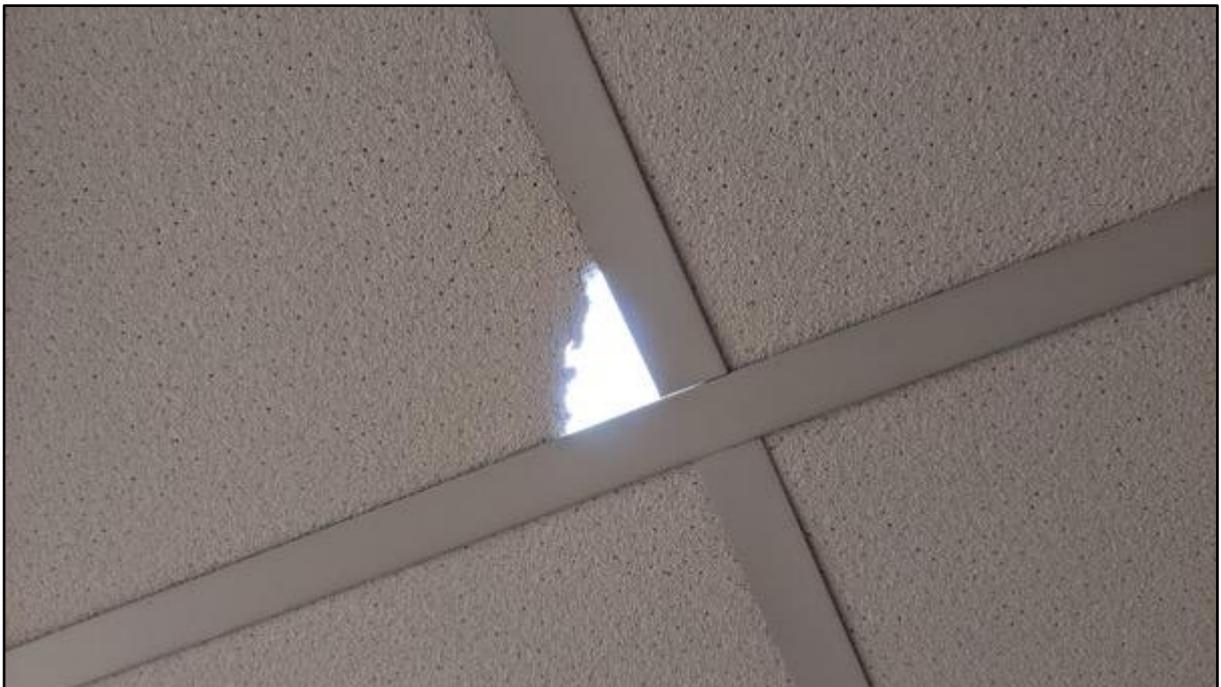
Photograph 20; A view of the lighting behind the ceiling tiles which is likely unsuitable for roosting bats.

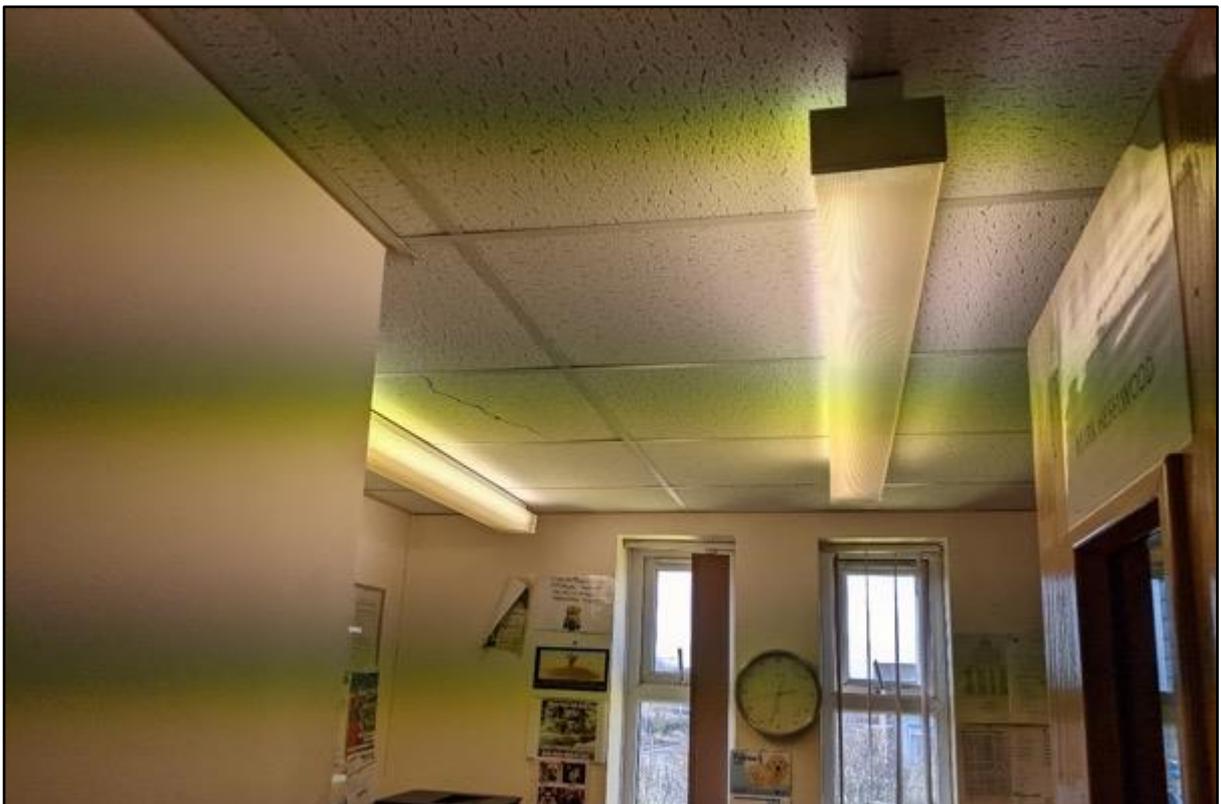
Photograph 22; An internal view of one of the first-storey office spaces. Note there is a small ceiling void behind the ceiling tiles.

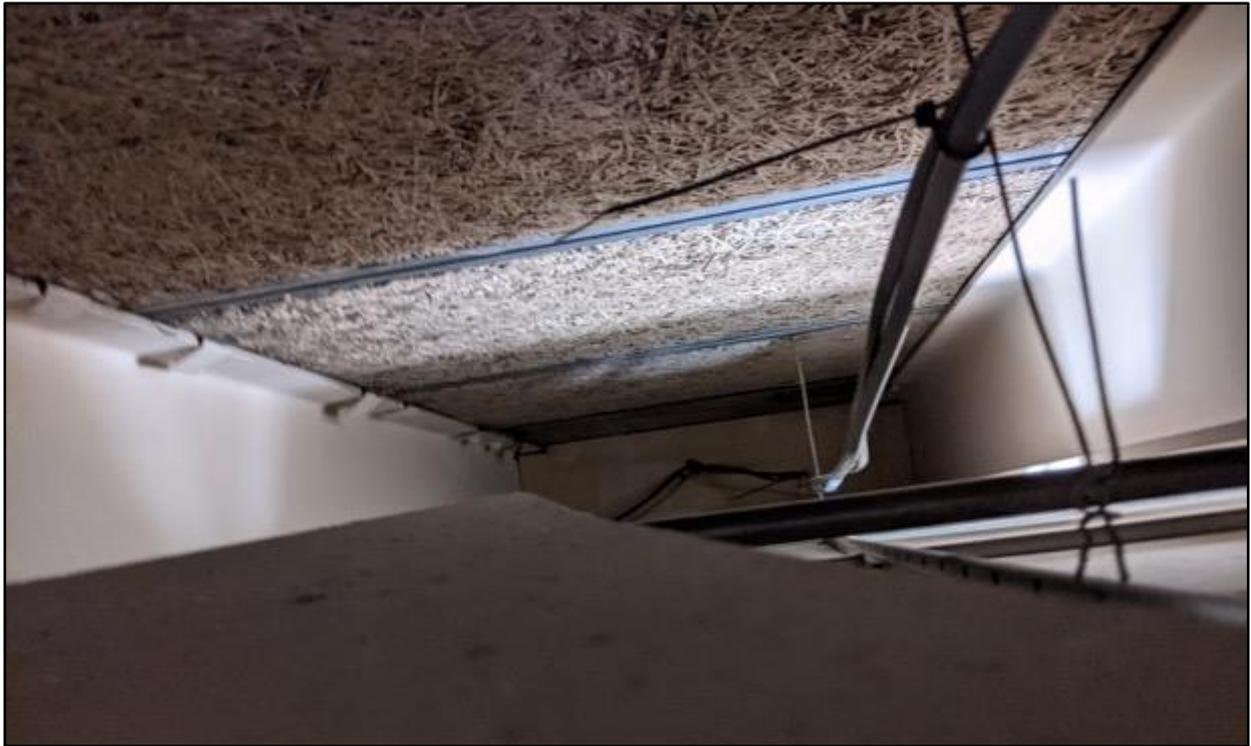
Photograph 23; An internal view of the ceiling void above the first-storey office spaces. Note the lighting and no notable access from the outside.

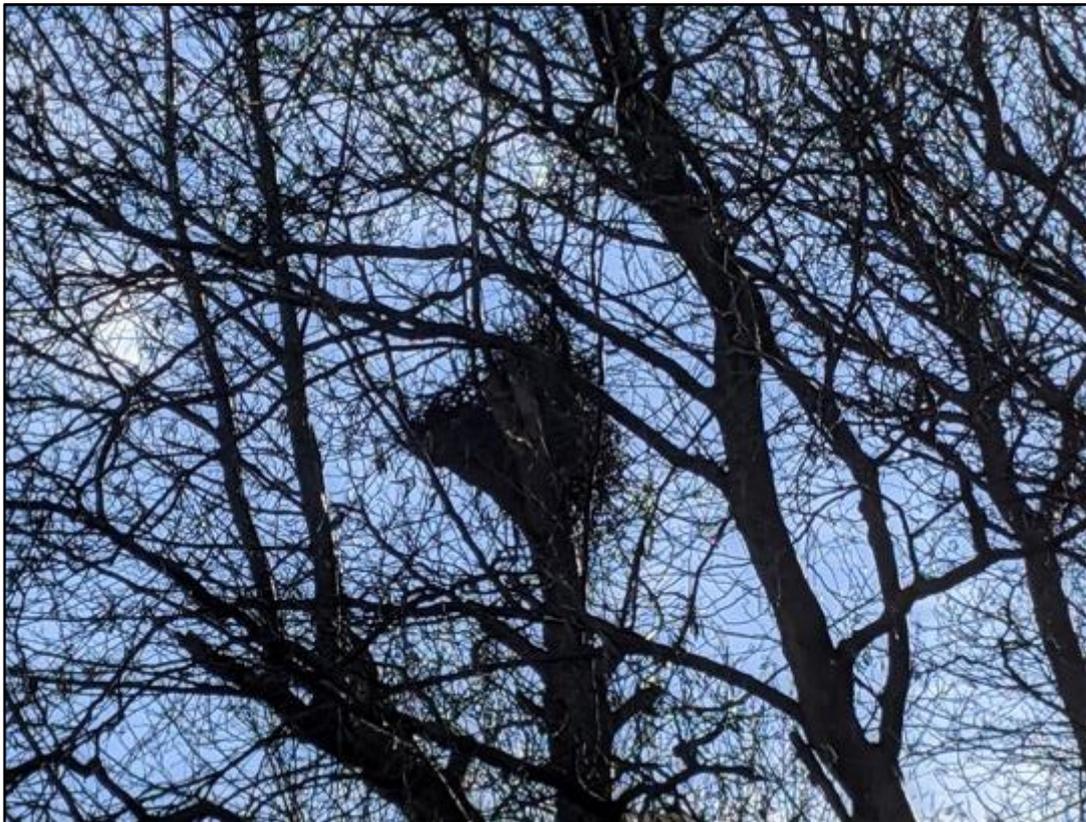
Photograph 24; A view of a small suspected squirrel drey within the mature trees in the south-east of the site.

The proposed site may present suitable transient habitat for mammal species, evidenced by a small grey squirrel (*Sciurus carolinensis*) drey. In the south-east corner of the site is a patch of scrub and ruderal with fallen trees and leaf litter, which may provide habitat for hedgehogs (*Erinaceus europaeus*).

Hedgehogs (*Erinaceus europaeus*) may frequent the area during their nightly foraging activity; therefore, it is suggested that any fences erected within the proposed development should contain hedgehog highway gaps to allow free movement between gardens and the wider area.
