### 10 Bloomsbury Place Brighton BN2 1DA

Front Elevation showing Balcony/Railings

# **Existing/Proposed**

#### PL003

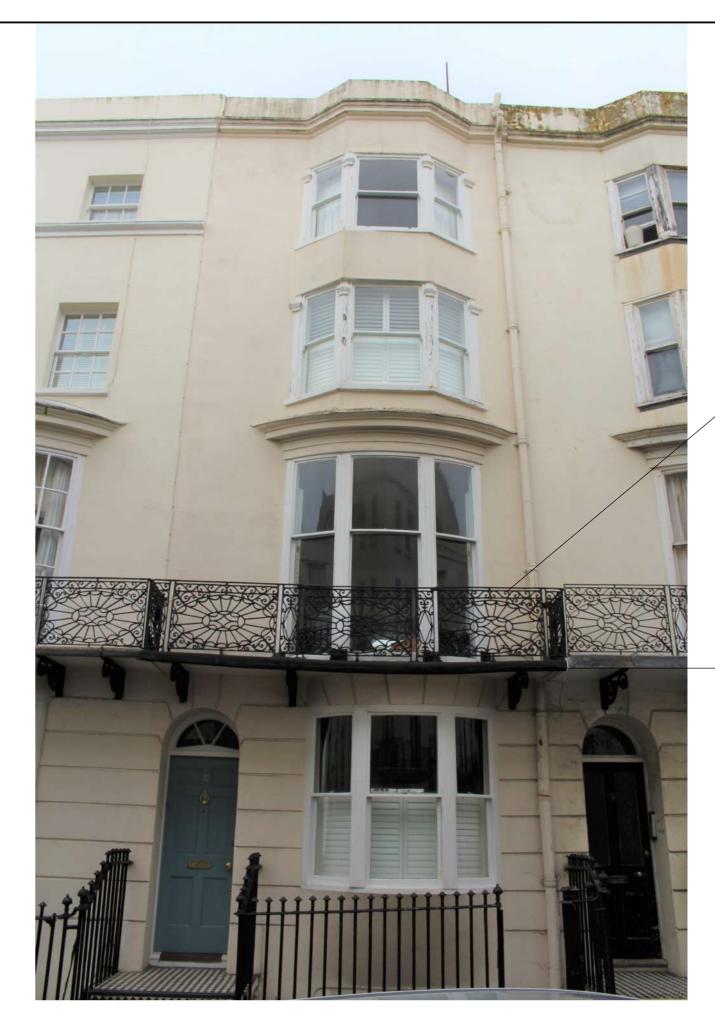
**FRONT ELEVATION**

Removal of the existing corroded railings followed by shot blasting and refurbishment off site and their subsequent re-installation.

The removal of existing asphalt covering and replacement of rotten timbers. The laying of a new asphalt covering. New lead flashing at interface with existing bay window
