Mr G Pound
Crouchers, Birdham Road, Chichester
TIMBER DOORS ON FF

Scale(s): Date: Engineer: Checked:
1:20@A3 JAN'21 OR PJG
Project No: Drawing No: Revision:
20308 **009** —

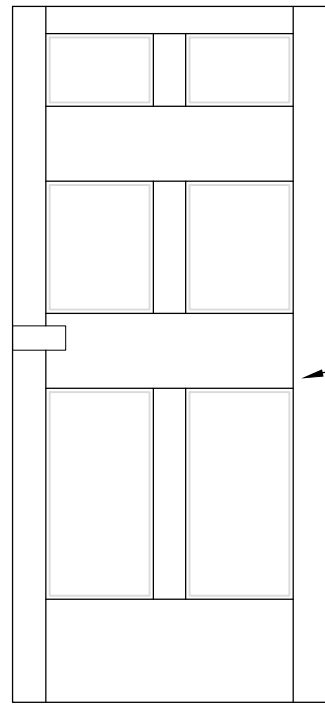
28mm thick timber planks.

Timber Door in Bedroom 5 on First Floor I.
(Showing elevation)
(1:20)

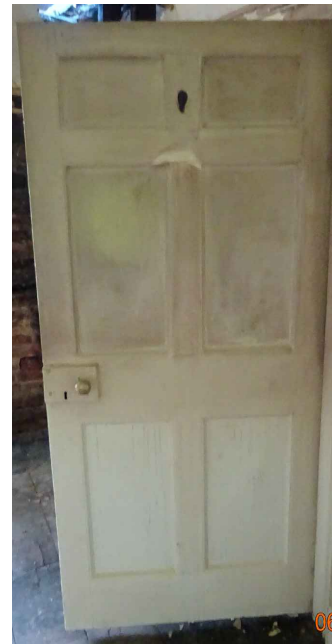
Timber Door in Bedroom 5 on First Floor II.
(Showing photo of existing door)
(1:20)
