PHILIP GOACHER ASSOCIATES
Consulting Civil and Structural Engineers
Park House • 122A Newland Road • Worthing • West Sussex • BN11 1LB
TEL: 01903 217723 • EMAIL: mail@pgoacher.co.uk
www.pgoacher.co.uk

Mr G Pound
Crouchers, Birdham Road, Chichester
TIMBER WINDOWS IN BASMENT

Project No: Drawing No: Revision:
20308 007 -

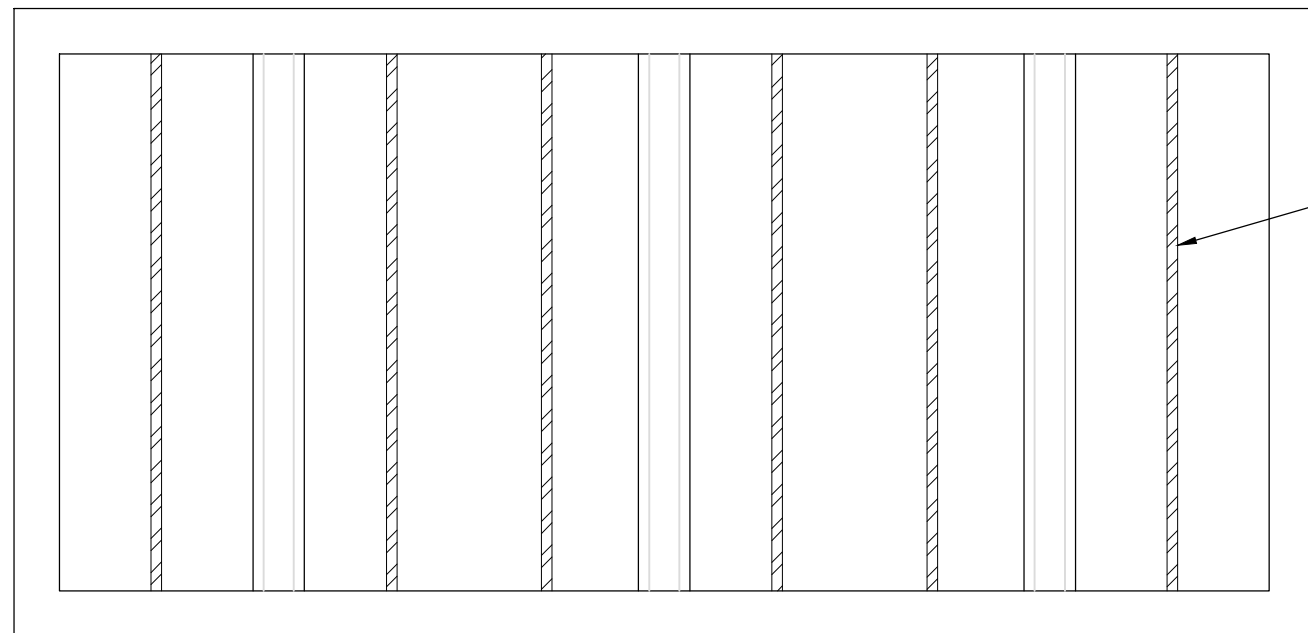
Timber Window in the Basement I.
(Showing elevation to the frame)
(1:10)

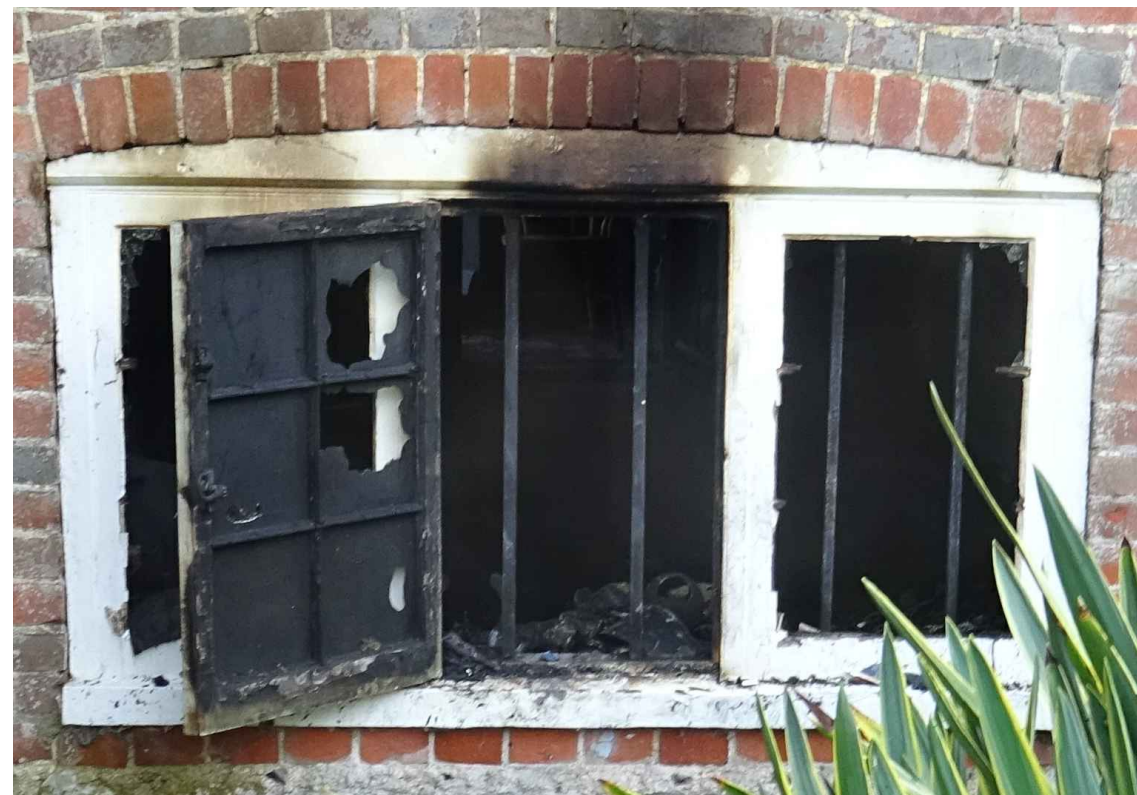
Timber Window in the Basement II.
(Showing elevation to the frame)
(1:10)

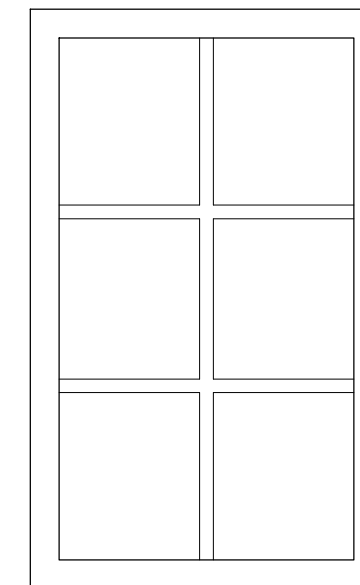
Timber Window in the Basement III.
(Showing elevation to casement window)
(1:10)

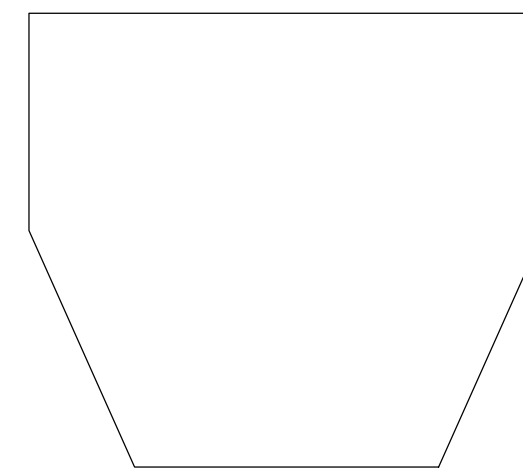
Timber Window in the Basement IV.
(Showing detail of mullion)
(1:1)
