# Preliminary Roost Appraisal

## The Old Rectory Banningham

2108-GE-SW

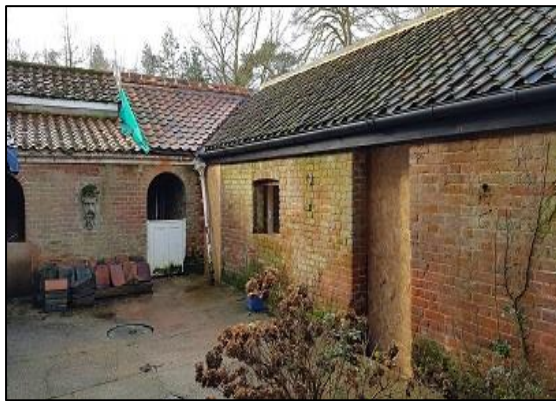
5.2.2 The single-storey building was of brick construction with a pantile roof (Figure 1) and surrounded a small courtyard adjacent to the main house.

*Figure 1: View of courtyard and building.*

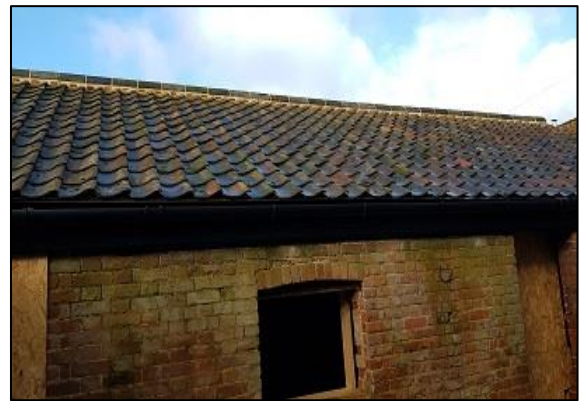
5.2.3 The roof on the western section had recently been repaired and the tiles were very tightly sealed and in good condition (Figures 2 and 3).

*Figure 2: Tightly fitted tiles.*

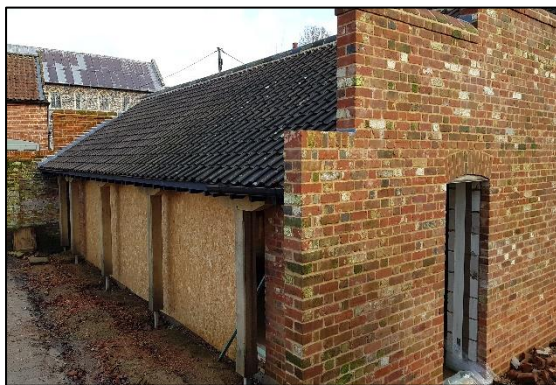
*Figure 3: Western aspect of roof.*

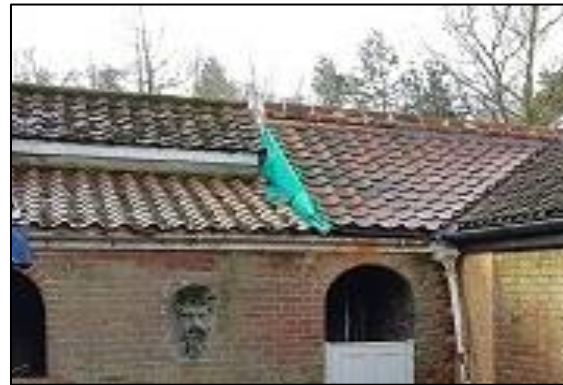
5.2.4 The roof on the southern section had been partially repaired, although they remained in relatively good condition with no lifting of the tiles (Figure 4)

*Figure 4: Partially repaired southern building roof.*

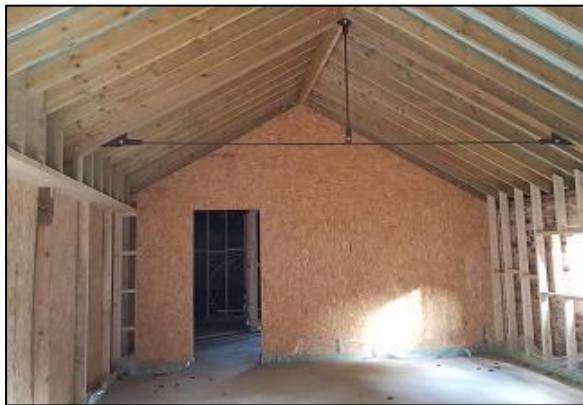
5.2.6 Internally the building was currently under renovation and the interior of the main southern section was in good condition (Figure 5).

*Figure 5: Interior of southern building.*

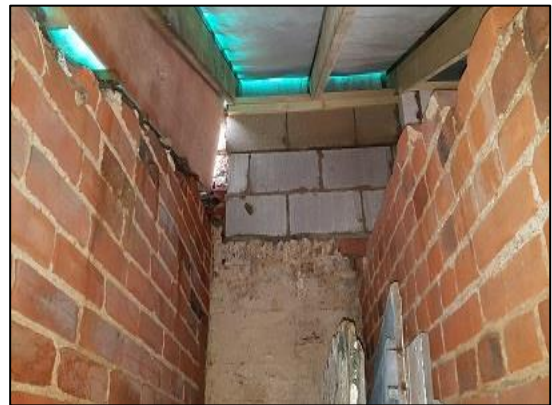
5.2.10 The small room to the left of the main section which was partially refurbished (Figure 6). It was a small space, dark but draughty and heavily cobwebbed. There was an open doorway to the courtyard.

*Figure 6: Small space to left of main section.*

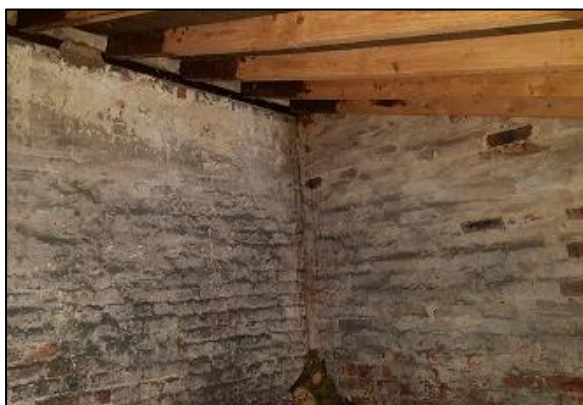
5.2.11 The room nearest the main house was open to the courtyard via an open doorway. The roof lining was in good condition (Figure 7) although the lack of raised tiles on this part of the building gave no potential access to the lining. This space had not undergone any refurbishment. There was a lot of water ingress evident on the beams and floor.

*Figure 7: Wood store – not refurbished but in good condition, but water ingress evident.*

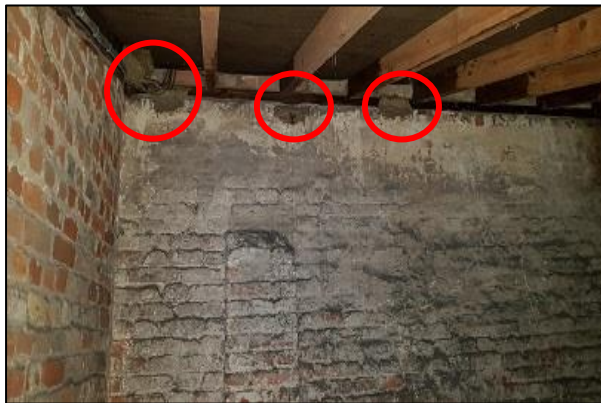
5.3.1 There were two several old swallow nests in the old woodstore (Figure 8). There were no droppings or feather associated with the nest and it was thought the nests were several seasons old, having not changed since the first site visit in 2019.

*Figure 8: Old swallows' nest on the southern wall of old woodstore.*

- A bat box to be installed on to a suitable tree in the garden at least 3m high. An [‘Improved Cavity Bat Box’](#) or similar would be suitable.
- Two swallow nest boxes to be installed in the stable area to the east of the site, to encourage swallows to continue to nest there. Something similar to the [Eco Swallow Nest](#) would be suitable. Swallows are sociable birds but a minimum distance of 1m between nest cups is recommended. To ensure the swallows have sufficient room in the nest cup and when arriving and leaving there should be at least 6cm free space above the nest cup.
- Two nest boxes suitable for wrens/robins to be sited low down (less than 2m from the ground) in an area well-hidden with vegetation. The [Wren and Robin FSC nest box](#) or similar would be suitable.
